# Gnoll Country Park, Neath

**Title** Ground Conditions Assessment Report

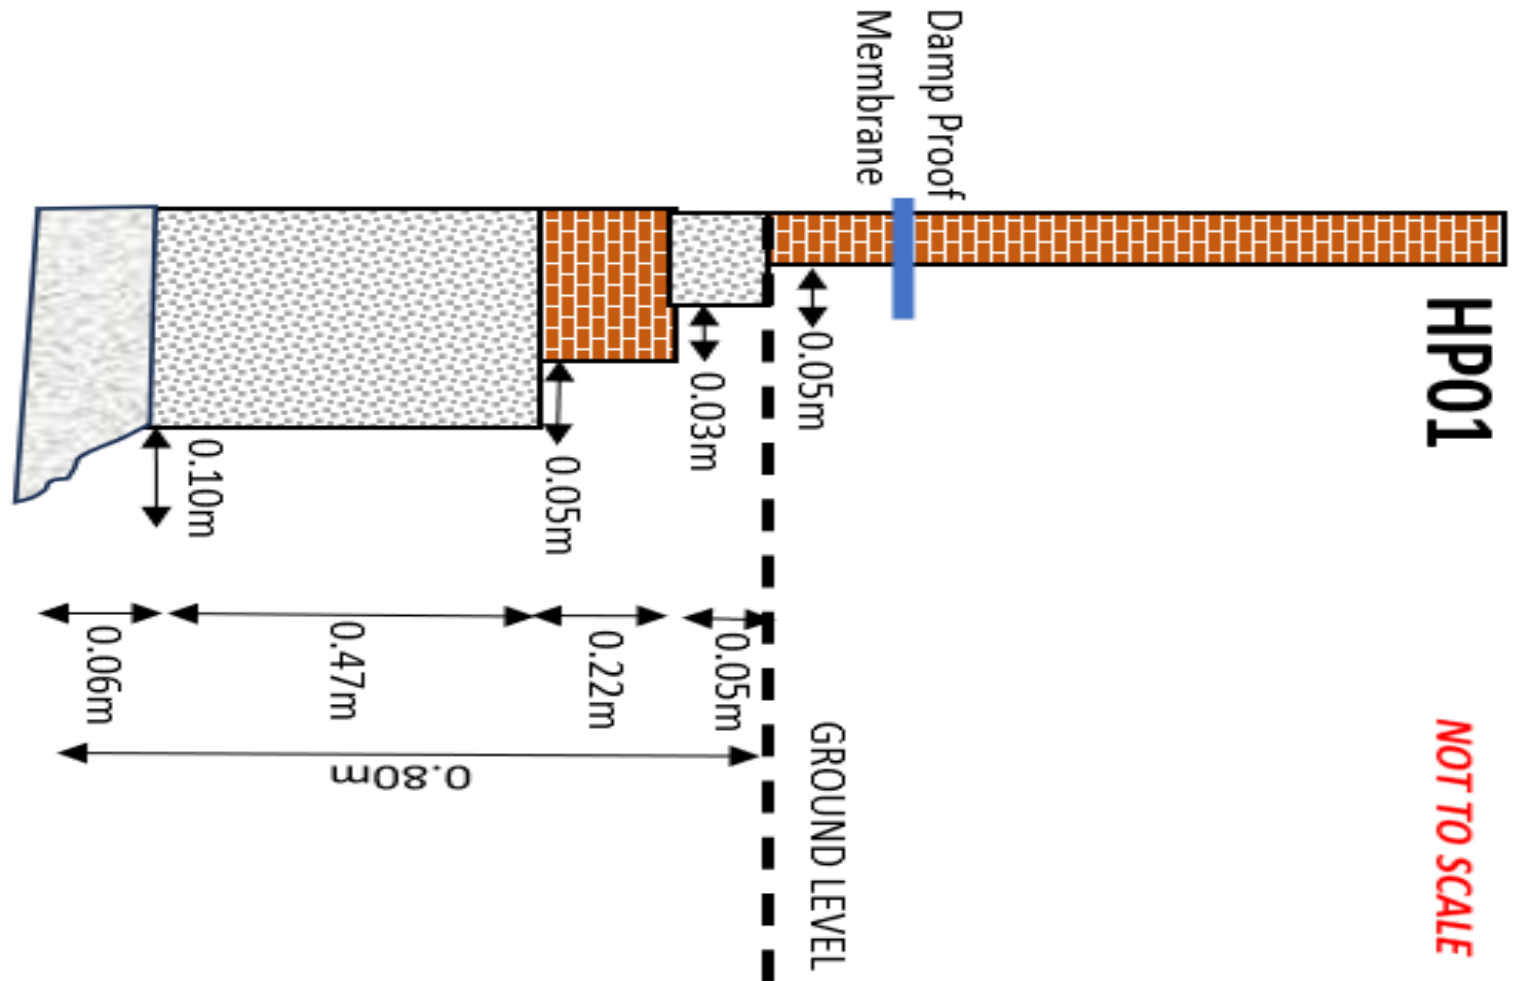
Site Name: Gnoll Park  
 Project Number: 17887  
 Drawing Title: HP01 Foundation Sketch  
 Drawing Number:  
 Scale: Not to scale
