**30 TAILLWYD ROAD, NEATH ABBEY**

**BAT SURVEY**

**JULY 2024**

**Bat Survey Report**

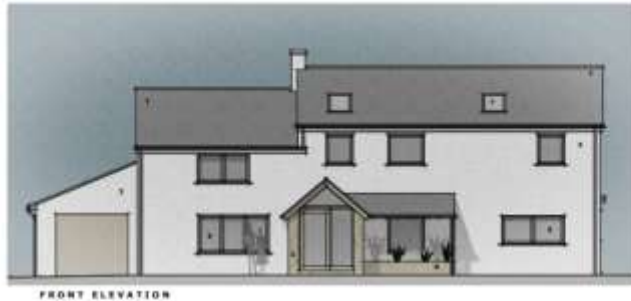
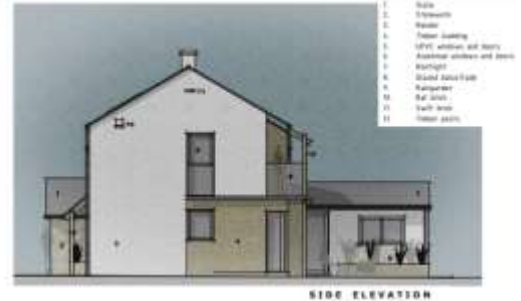
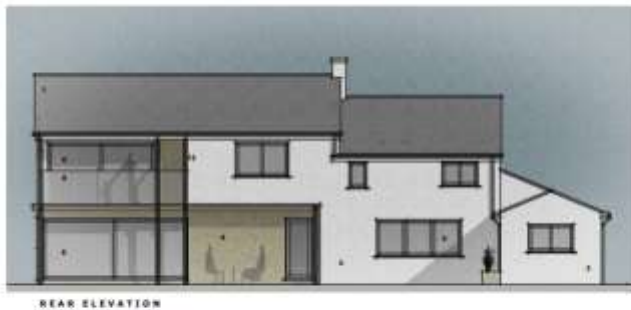
It is proposed to extend the property to the north east along with modifications to the garage.

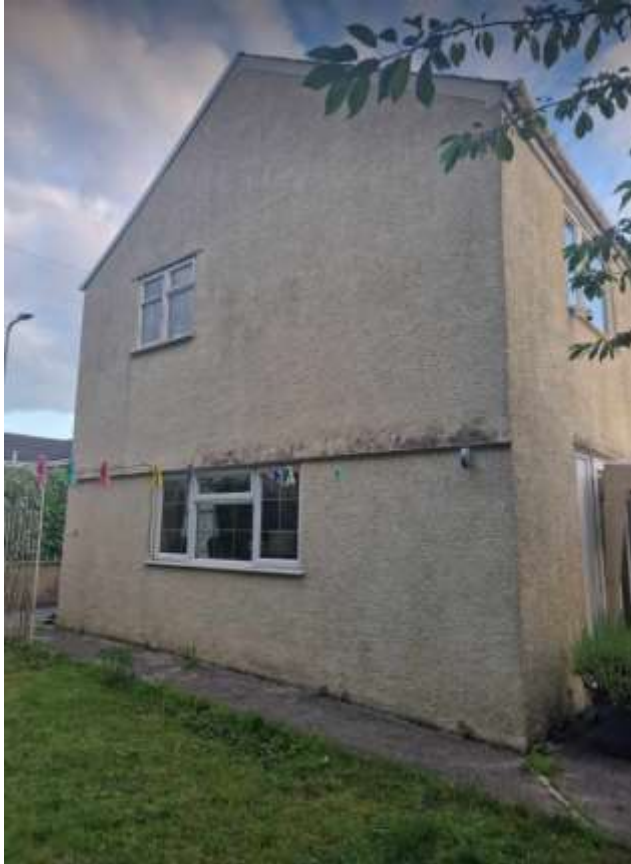
**Plate 1- Photograph of gable that extension is to be attached**

The survey carried out by BE Ecological Ltd revealed no droppings or evidence of bats on the exterior of the buildings. The barge boards/fascias/soffits of the building are relatively tight to the render with no obvious access points for bats at this location in a number of locations.

The tiles are generally tight fitting, however, there are a potentially a small number of gaps on the pitches of the rooves where tiles have slipped over time.

Supervision for the tying in of the extension will be required.
