**22 VICTORIA GARDENS, NEATH**

**BAT ACTIVITY SURVEY - ADDENDUM REPORT**

DOCUMENT REF: E24124401/Doc 02. July 2024

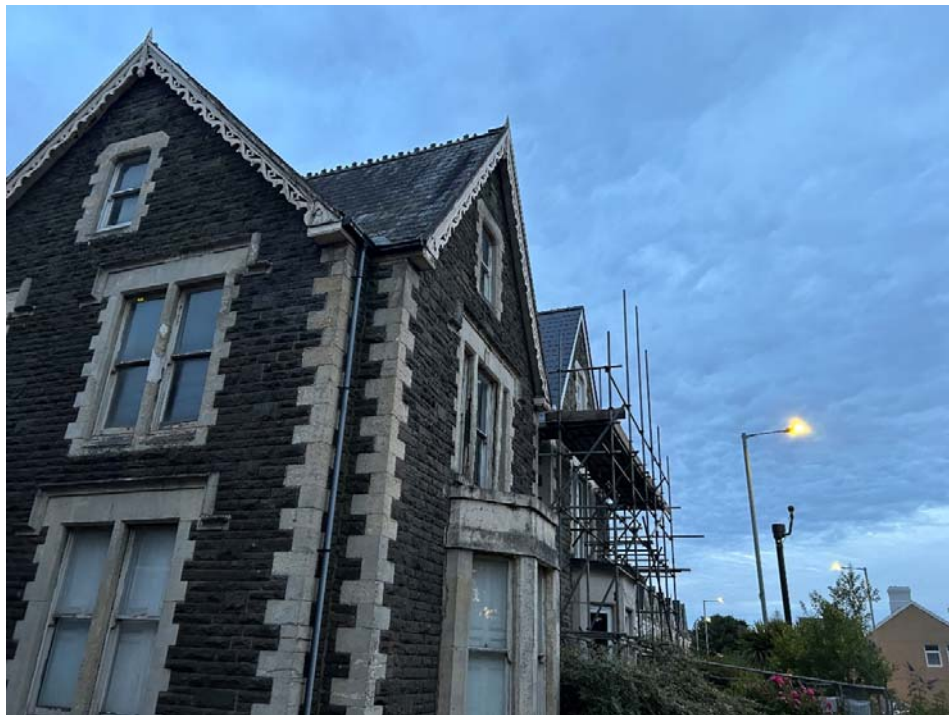
2.3 Weather conditions were not considered a constraint during the survey with air temperatures 16°C at the start (21.15h) and 14°C at the end of the survey, no rain and calm conditions (Beaufort scale Light Air – Force 1). Street lighting is present along Victoria Gardens, with lights on from approximately 21.40h – this lighting did illuminate the western frontage of the building (e.g. see front cover photograph).
