## Preliminary Roost Assessment Survey

63 Heol Cae-Gurwen,  
Gwaun Cae-Gurwen,  
Ammanford,  
SA18 1HG

**DKEcology**  
20 Glanymor Road,  
Loughor,  
Swansea,  
SA4 6SA

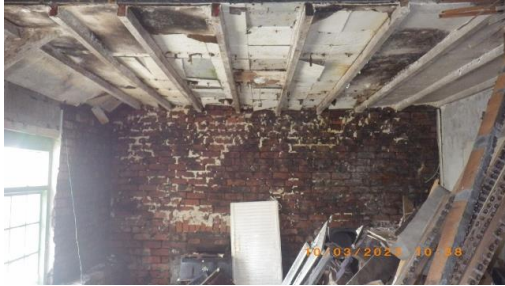
- 4.2.2 Section A for the most part has solid well pointed or rendered external walls with no obvious cracks or crevices noted that could be exploited by bats. The eaves were also solid throughout. A temporary OSB board partition wall has been erected along the west elevation of the building for security and safety purposes. However a small number of free flight access points were noted into the interior of the building via missing window panes on the east elevation, gaps above the temporary partition wall on the west elevation.

Section A street side

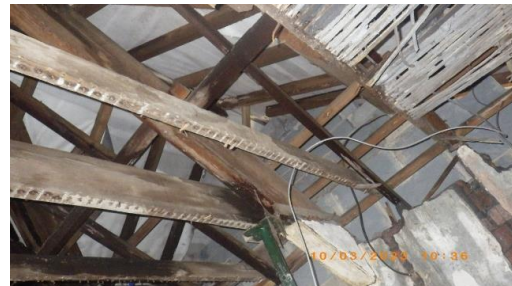
- 5.2 The property is in very poor condition it has been empty for a number of years and following the removal of the roof of section A of the building 2 years ago and the deterioration of the

roof of section C most of the building has been effectively open to the elements for a considerable period of time. There is extensive internal damage due to water ingress particularly in the upper floors of section A and all of section C which were seen to be very wet throughout, had damp and fungal growth over walls and ceilings and were drafty and well-lit by daylight via numerous windows or via gaps in the roof. A number of potential access points into the building were noted including free flight access points into section A which potentially would enable both crevice and void dwelling bat species to enter the building. However once inside the building conditions are very poor and largely unsuitable for both day and night roosting bats. What remains of the loft area in section A is completely exposed and the majority of the loft floor has also deteriorated exposing the floor below. The inspection of the interior of both section A and C noted no suitable crevice roosting opportunities and no signs of bat activity.

Roof timbers and tarpaulin over section A

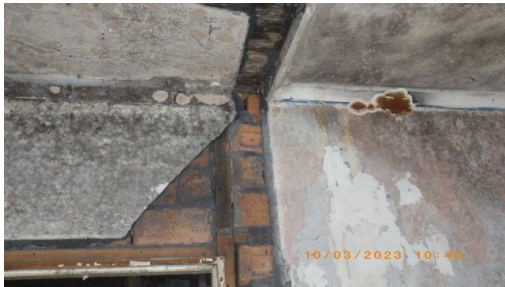
Damp and fungal growth in section A

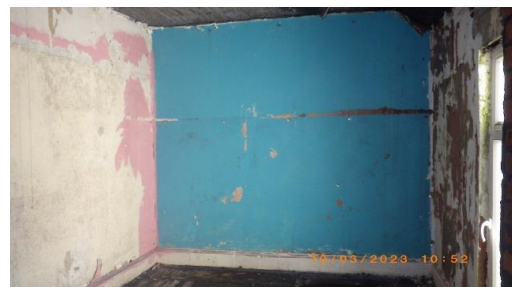
Section A to the rear side of the property

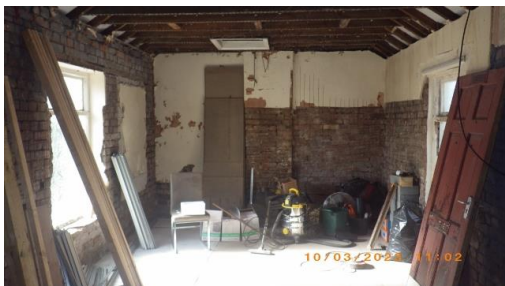
- 4.2.5 Inside section B the upper floor ( 7.3m x 3.6m x 3.8m in height) was well lit with daylight, dry and open up to the roof line. The roof was intact and lined with breathable roofing membrane. The floor was boarded throughout. The interior walls consisted of well pointed red brick and were solid with no crevices/gaps noted that were suitable for use by bats. Gaps above the east adjoining wall enables access into the adjoining section A. The lower floor
-

Upper floor Section B

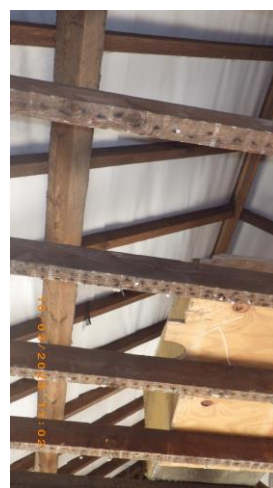
Exposed loft and roof line in section B

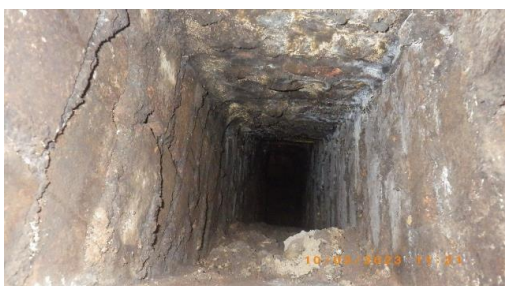
(8m x 3.6m x 2.5m in height) was darker. All interior walls and ceiling were intact with no potential bat roost opportunities noted. The remains of a well pointed chimney stack were noted within the east wall.

Remains of chimney stack in section B

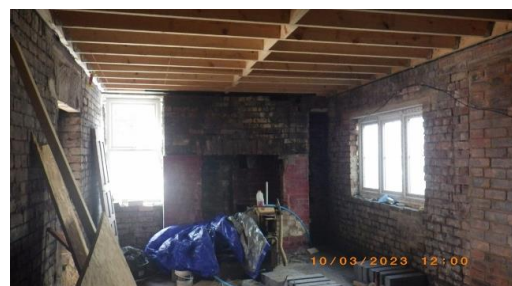
Lower floor section B

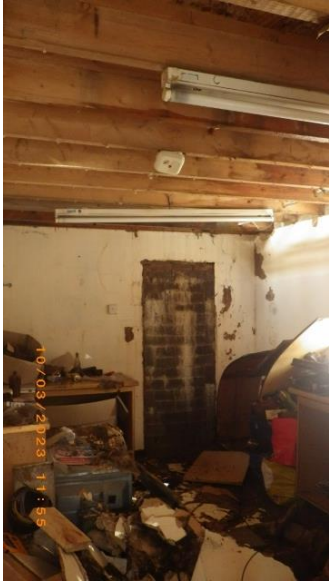
- 4.2.6 Section C (approx. 7.3m x 3m x 2.5m in height), all external walls were solid. The felt lining of the roof and some of the boarding were missing and the roof was partially sealed with tarpaulin. Potential access points were noted where the tarpaulin was missing but no free flight access points were noted. Internally it was found to be wet, light and exposed to the elements. All of the interior walls were solid with no potential roost features noted.

- 5.4 Section C is assessed as having no potential for supporting bats as it is in very poor condition due to water ingress and clearly has no suitable bat roosting features. Therefore no further surveys of section C of the building are required. The proposed reconstruction of section C is highly unlikely to result in the disturbance or destruction of any bats or bat roosts and a European Protected Species license will not be required to carry out the proposed works. However, the final arbitration is with Natural Resources Wales and the Welsh Government.

Section C

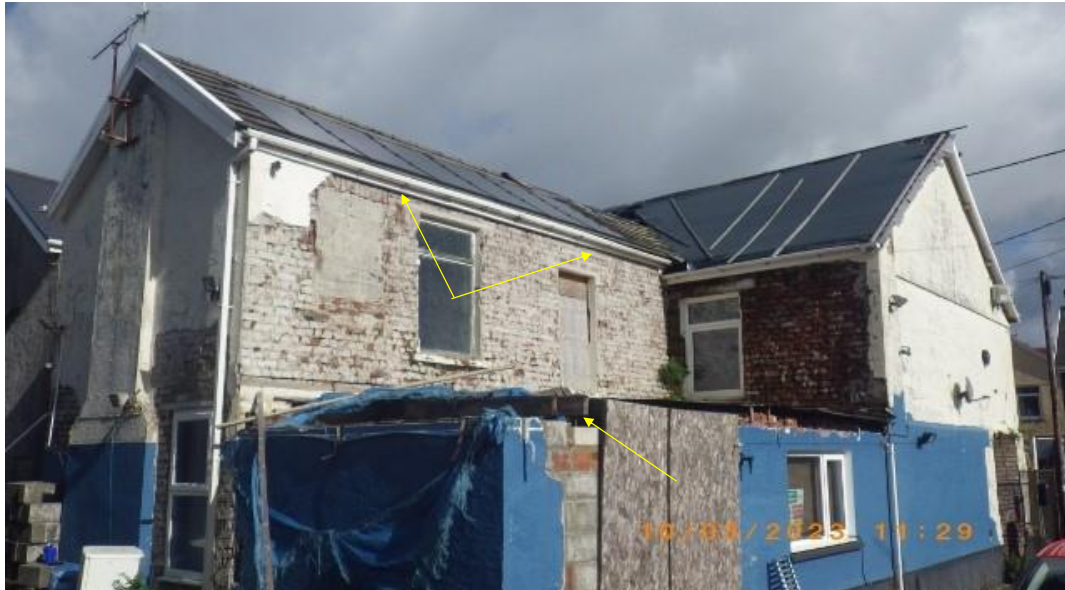
- 4.2.4 Section B, all of the external walls were solid and well pointed with no obvious cracks/crevices noted apart from around the windows enabling access into the interior of the extension. Gaps were also noted behind the fascia boards on the north and south elevations. The roof is intact with no obvious gaps noted. No free flight access points were noted.

**Gaps behind fascia boards and via loose/missing tarpaulin**

- 5.6 If any bats are using section B then the proposed refurbishment works have the potential to impact bats/roosts. Therefore it would be recommended that a minimum of 1 bat activity survey of section B be carried out to verify bat presence or absence during the bat breeding season, which runs between May-August. Further surveys may be required depending on the results of the initial surveys. It would be advisable to verify which species and numbers are present, or absent, in order to proceed lawfully and with any appropriate cautions and mitigations being in place. No further works should be carried out on section B particularly works that will affect the roof, eaves and the areas surrounding the existing windows until the recommended survey has been completed.

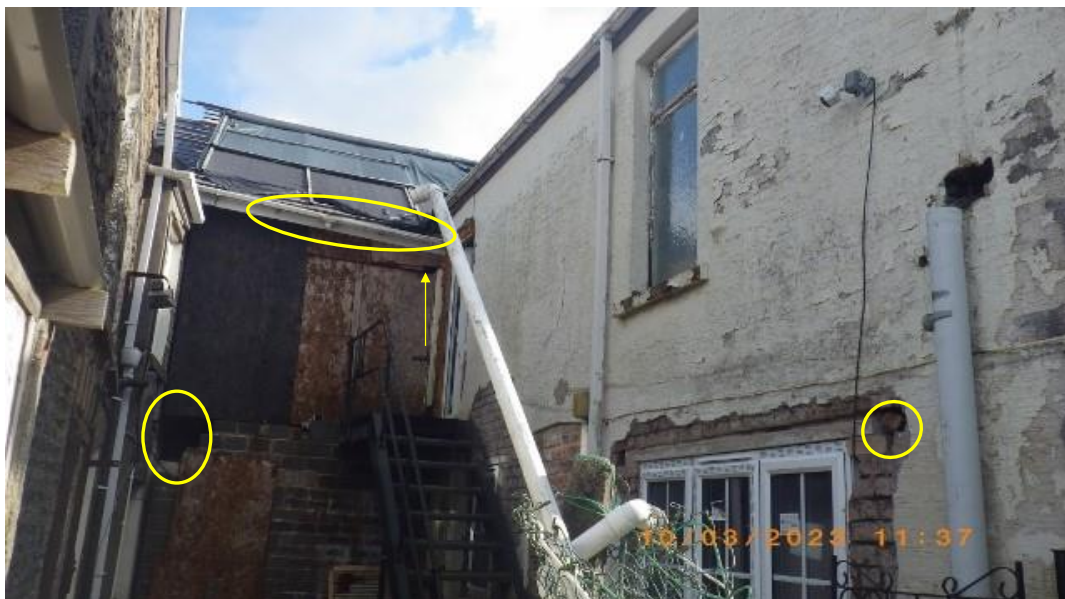
**Free flight gaps in wooden boarding, missing tarpaulin and crevices/holes around windows.**

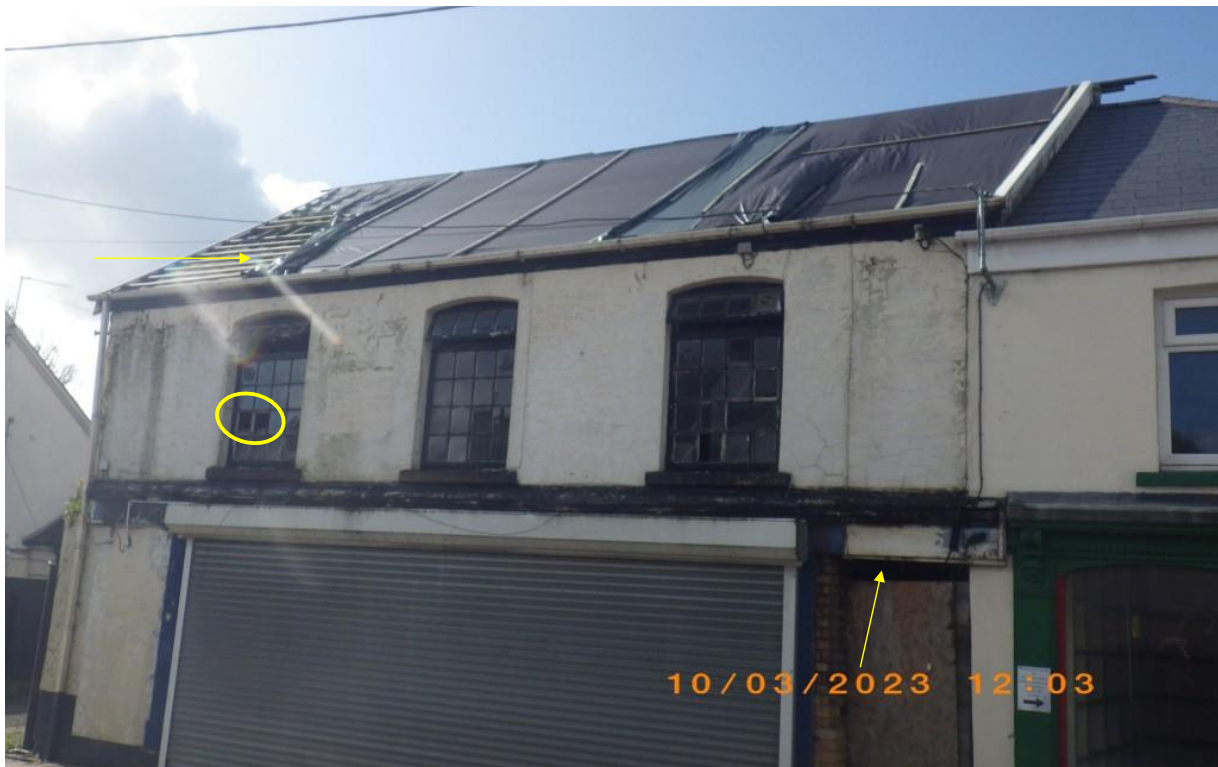
**Free flight gaps via broken windows/gaps above boarding and missing tarpaulin**
