**Waterfalls Country Centre – Pontneddfechan, Neath**  
**Proposed Commercial & Leisure Development**  
**Factual Exploratory Investigation**

Report Reference: ESP.8715.4014

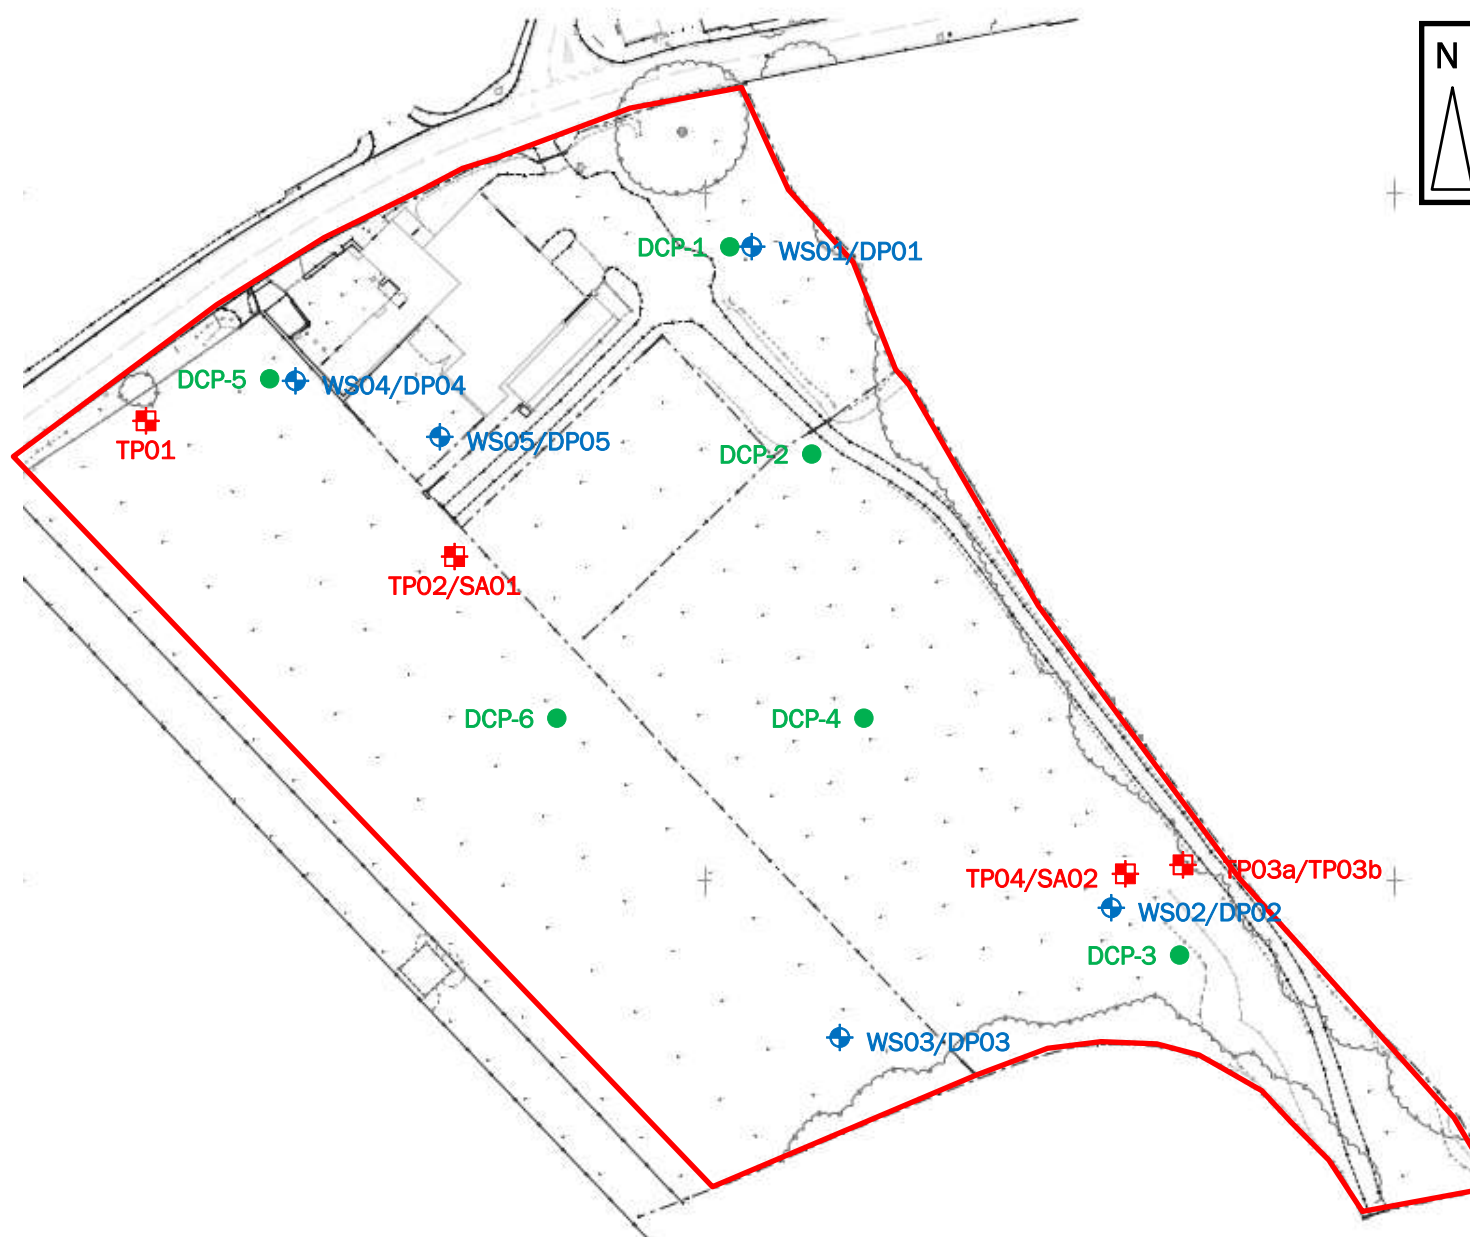
Figure 1 – Investigation Point Plan

The results of the infiltration testing, and the calculated infiltration rates, are presented in Appendix E. The positions of the test pits are shown on Figure 1.
