| Project Name | Tata Steel UK Limited (Tata Steel) Steelworks, Port Talbot |
| Client | RSK Geosciences |

| Project Name | Client | Report Reference |
|---|---|---|
| Tata Steel UK Limited (Tata Steel) Steelworks, Port Talbot | RSK Geosciences | S2RA-1004 |

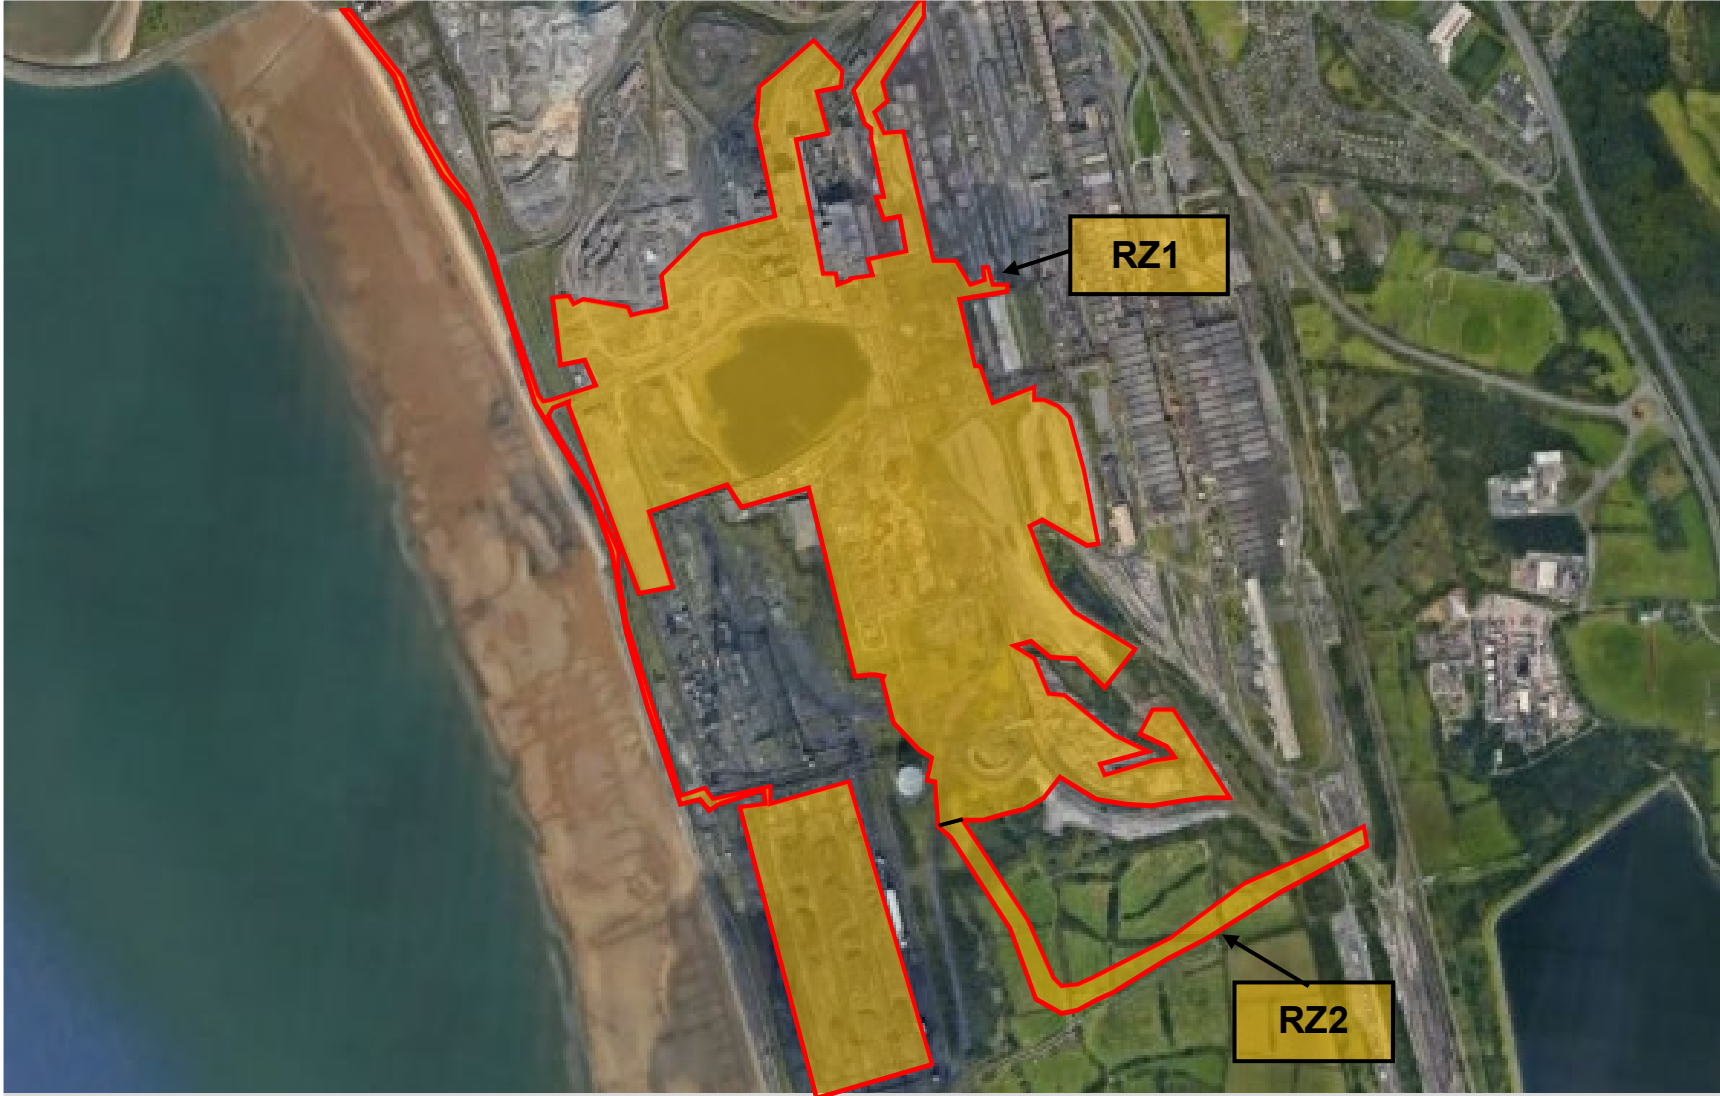
**Risk Mapping Key**

| <b>RZ1</b> | <b>Moderate Risk</b> from German UXO |
| <b>RZ2</b> | <b>Moderate Risk</b> from Allied and German UXO |

Please refer to **Section 11** of the S2RA for a more detailed breakdown of UXO risk and RSK OM’s recommended risk mitigation measures (**Section 14**).
