# Technical Note

Ref. ST20879-0001

| <b>PROJECT:</b> | Project EAF |
| <b>SUBJECT:</b> | Coal Mining Risk Assessment |

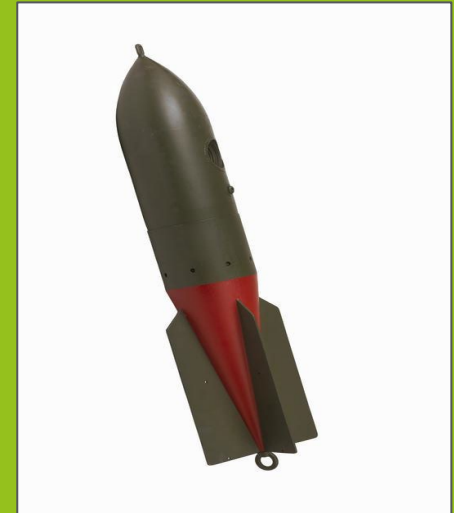
**50kg HE Bomb**

| Bomb Weight | 54kg |
| Weight of Explosive Fill | 25kg amatol/TNT/trialen |
| Bomb Dimensions | 1090mm x 280mm |
| Type of Fuze | Impact or electrical time delay |
| Notes | Most dropped bomb by weight over Britain. Useful against light targets. |

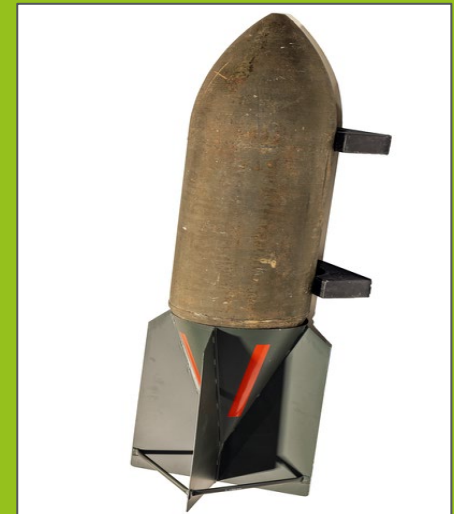
**250kg HE Bomb**

| Bomb Weight | 256kg |
| Weight of Explosive Fill | 130kg amatol/TNT/trialen |
| Bomb Dimensions | 1640mm x 512mm |
| Type of Fuze | Impact or electrical time delay |
| Notes | Increased penetrative ability proved useful against sub-terranean targets. |

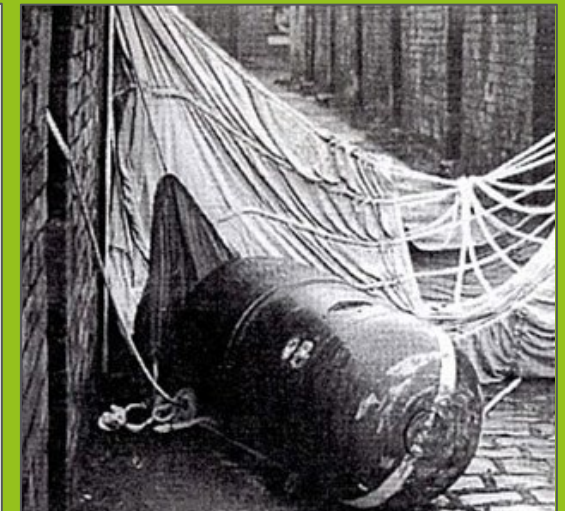
**Parachute Mine (Luftmine B)**

| Bomb Weight | 1000kg |
| Weight of Explosive Fill | Approximately 700kg amatol/minol |
| Bomb Length | 2640mm |
| Type of Fuze | Impact or electrical time delay |
| Notes | Larger than Luftmine A (500kg). Descent retarded by parachute. |

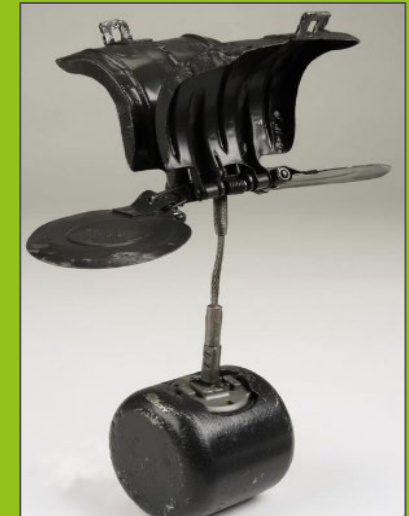
**SD2 AP Butterfly Bomb**

| Bomb Weight | 2kg |
| Weight of Explosive Fill | 220g amatol |
| Bomb Diameter | 762mm |
| Type of Fuze | Time delay, anti-handling device |
| Notes | Fragmentation device. Bomb armed by wings as they spun on descent. |

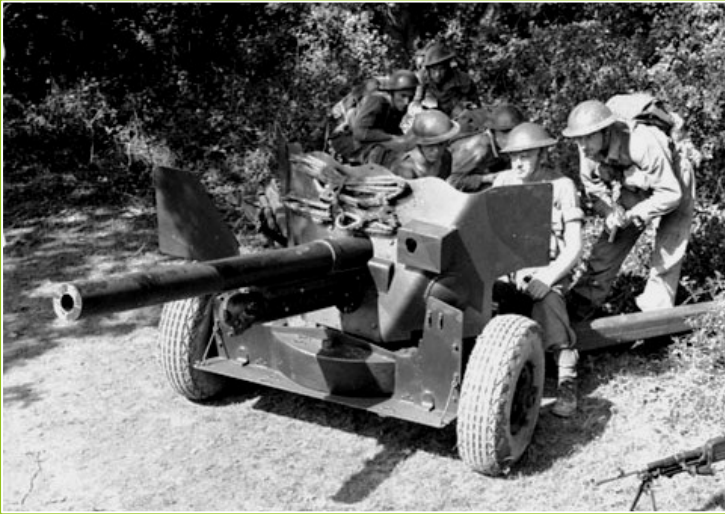
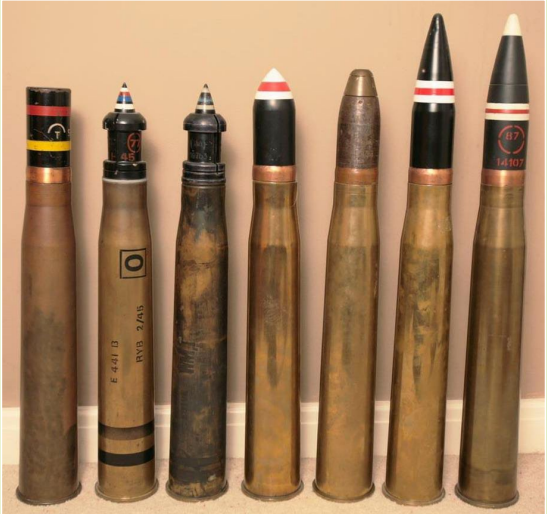
| 6 Pounder Anti-Tank Gun | |

| 6 Pounder Anti-Tank Gun | |
|---|---|
| Shell Weight | Approx. 3kg HE shell, 1.42kg APDS |
| Fill Weight & Fill | HE shell 590g of TNT |
| Fuze | No.243 percussion |
| Dimensions | 57 x 441mm |
| Appearance | Later rounds possessed discarding sabot with ballistic cap |

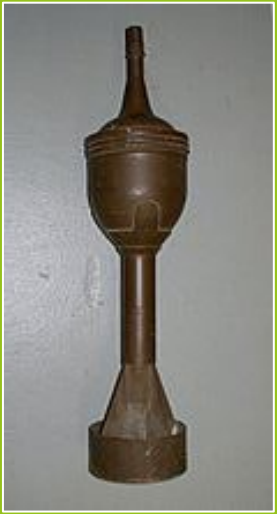
| PIAT | |

| PIAT | |
|---|---|
| Shell Weight | 1.1kg |
| Fill Weight & Fill | 570g Nobels 808 PE |
| Fuze | No.426 Point-Initiating |
| Dimensions | 83 x 407 mm |
| Appearance | HEAT versions green/brown, practice version white and drill version black |

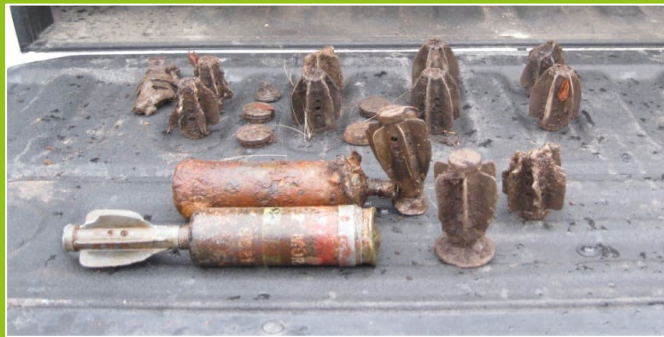
An overview of two 2" mortars, one with tail fin attached, alongside spare nose caps and tail fins. Red and green bands are present on the 2" mortar with the fins.

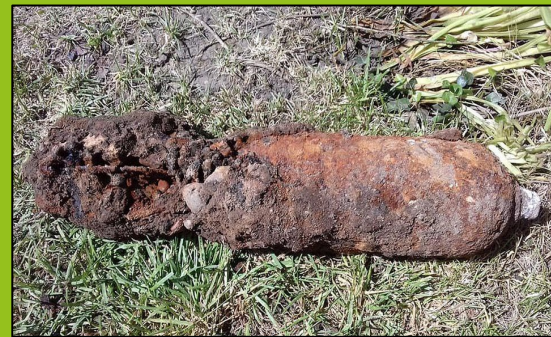
An unexploded 4.2" mortar found in a garden. Although corroded and dirty, the tail fins, teardrop body shape and No.152 fuse can be identified. Found less commonly than 2" mortars, 4.2" mortars possess a much higher Net Explosive Quantity.
