| 22181/R2 | September 2024 |
| Project | <b>BLAENDULAIS – SUPPLEMENTARY GROUND INVESTIGATION</b> |

**Spectrum Geo Services**  
**Foxglove Cottage,**  
**Cwm Risca Lane,**  
**Tondu,**  
**BRIDGEND**  
**CF32 0EH**

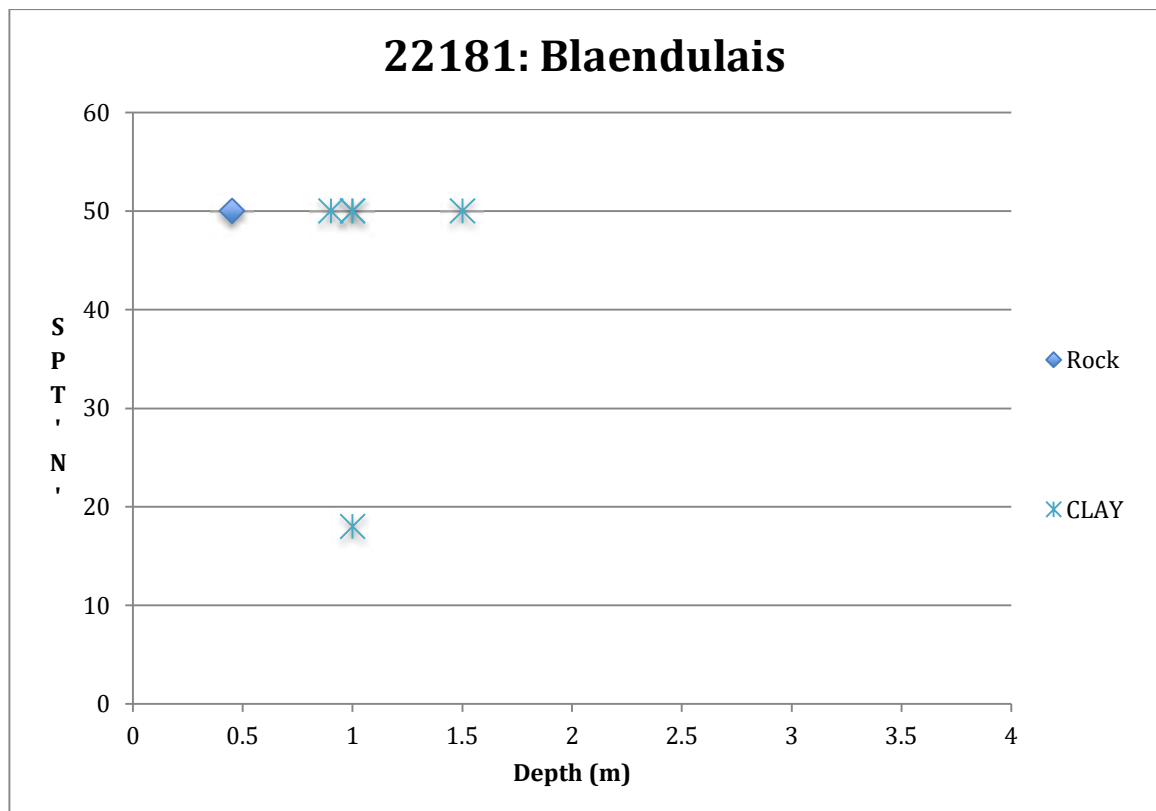
**Figure 8.1. SPT N vs Depth**

This section presents geotechnical parameters, which will be taken forward into the foundation options appraisals, and assigns parameters to the strata encountered. We have chosen not to assess geotechnical parameters of the Made Ground, as it is variable both laterally and vertically.

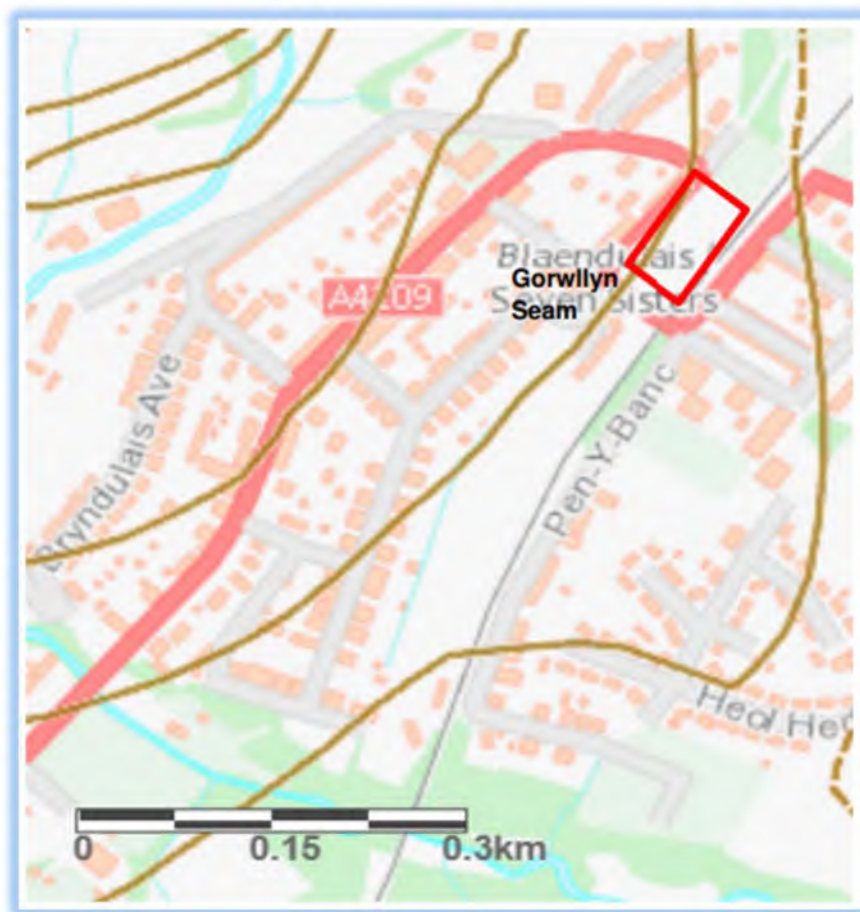
**Fig 11: Geoindex Extract**

The drilling operations noted in the original phase of investigations, noted no coal. The two boreholes during this phase noted a thin coal (200mm to 300mm thick) at 22m to 25m depths. No workings were noted and no loss of flush recorded in any of the holes.

This, combined with the knowledge that there was no flush take during the drilling, indicates that there are no workings within these seams, which would by their dimensions, likely to be non-economic for deep mining.

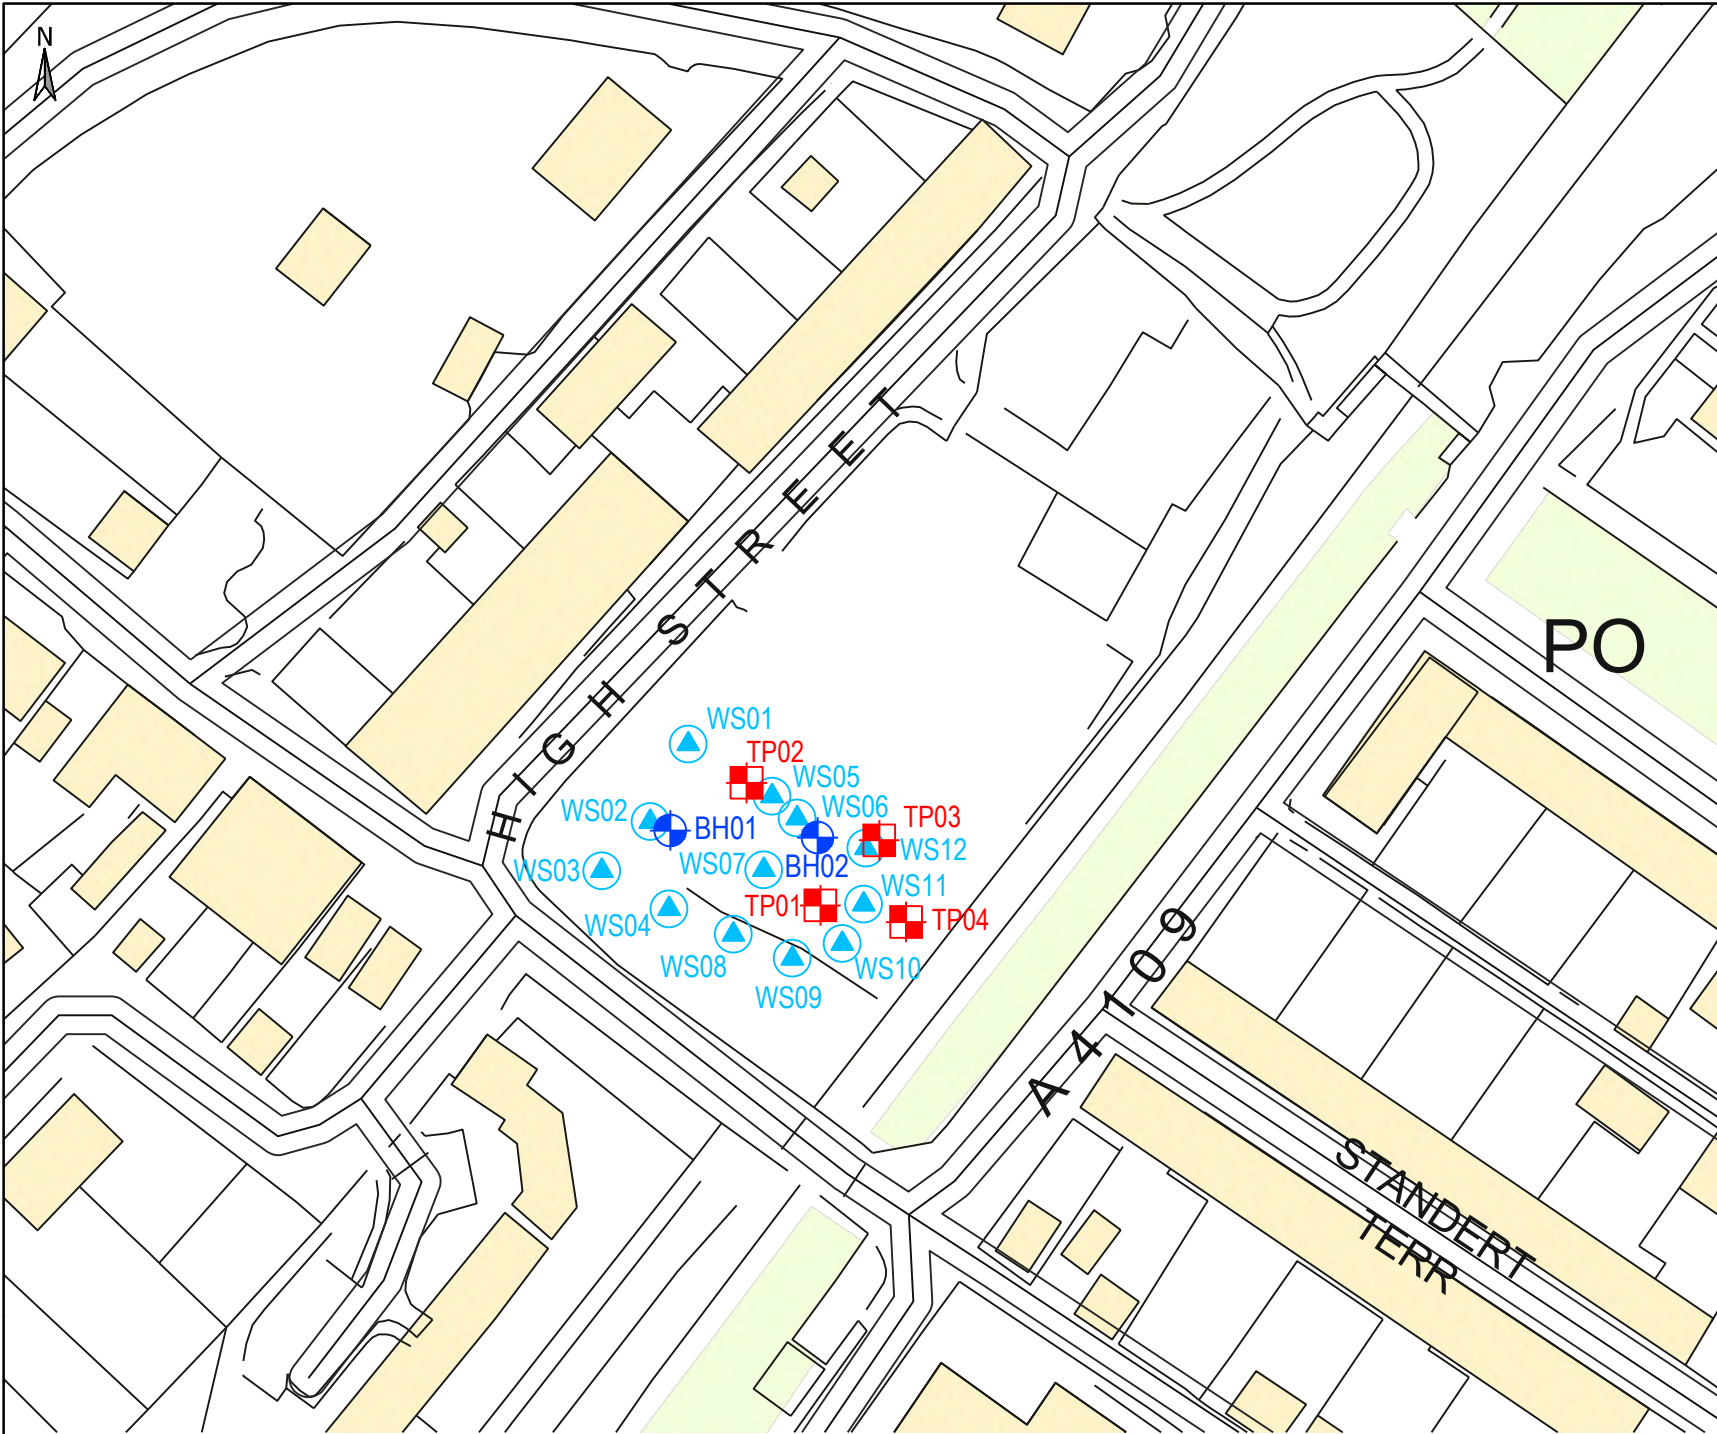
| ID | Location | Land use | Dates present | Group ID |
|---|---|---|---|---|
| A | 141m NE | Refuse Heap | 1921 | 286926 |

- LEGEND:
- TRIAL PIT
  - BOREHOLE
  - WINDOW SAMPLE
