Pontardawe Swimming  
Pool  
Bat Survey Report  
Date: September 2024

Megan Price  
Ecologist (Planning and  
Consultancy)  
Countryside and Wildlife Team  
Neath Port Talbot CBC

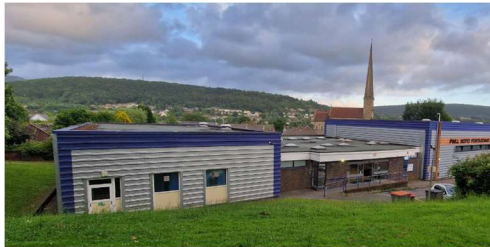
When looking at the structure it appears to be divided up into three parts. Two parts are metal clad flat roof with the middle section being slightly lower and constructed of brick with a flat roof lined with felt. PVC fascias/soffits are present on the NW elevation of this section however they are tight with minimal access points. The SE elevation does not have the PVC soffits and there is a slight gap which has low roosting potential.

| <p>Overview of north-western elevations showing the three distinct sections of the building.</p> | <p>SW elevation showing brick construction</p> |

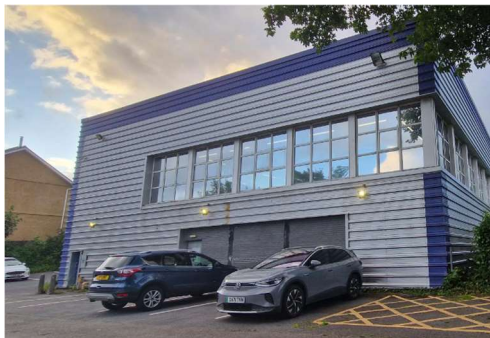
The metal cladding does have an overlap at roof level; however this is assessed as having negligible/low potential due to the fluctuating temperatures which are present in metal sheet buildings.

| <p>South elevation showing metal structure.</p> | <p>Overview of NW elevation showing artificial lighting at night</p> |

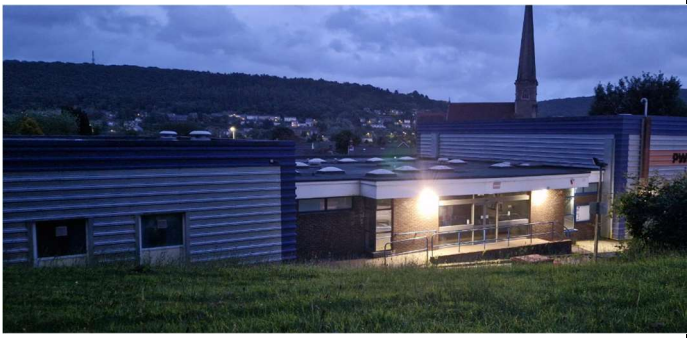
There is a lot of artificial lighting on the site on the NW and S aspects as well as light spill from the urban environment. The North and East aspects of the site are a lot dark due to the adjacent park not being lit up and there is a perfect commuting corridor down the SE aspect of the site.

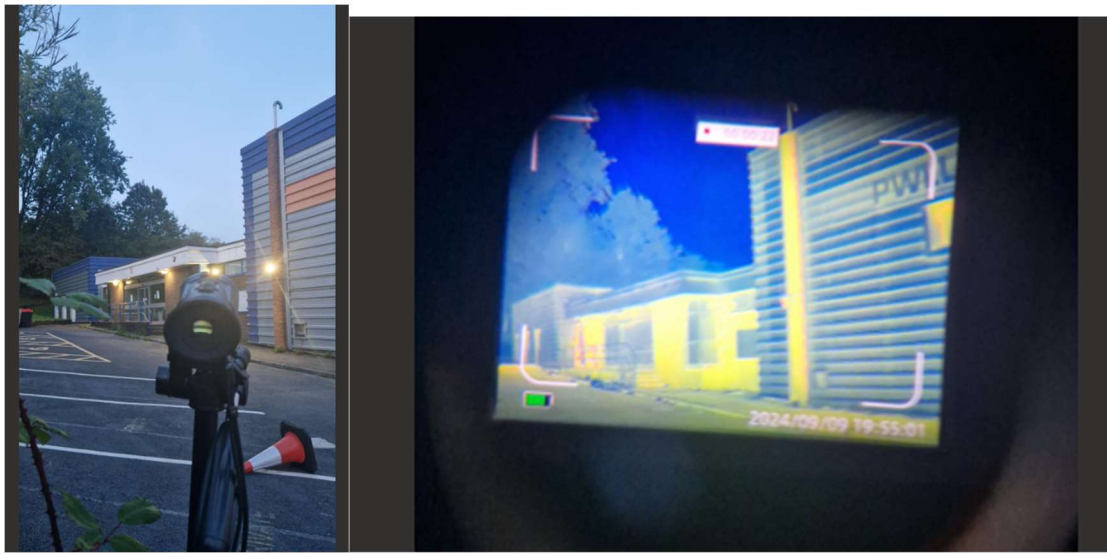
Figure 2 - Example of thermal camera position and view of structure

See Appendix 4 for the location of the thermal imaging cameras. No bats were observed emerging from the building upon review of the footage.
