# Geotechnical and Geoenvironmental Report

Site: Land off Tabernacle Terrace, Cwmafan

**REPORT TITLE :** **Geotechnical and Geoenvironmental Report:  
Proposed Residential Development, Land off  
Tabernacle Terrace, Cwmafan, Port Talbot**

**REPORT REFERENCE :** **14611-CA-GGR-5**

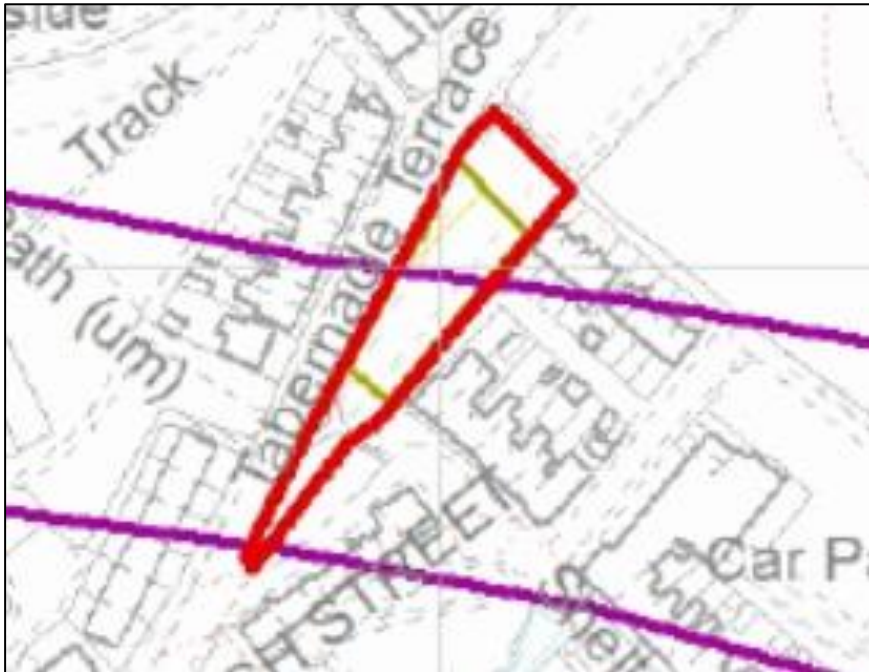
**Figure 3.2 Coal Authority Report Map Extract (Annex B)**

The Coal Authority Report states that there are two coal seams outcropping on the site, and that the site is in an area where there is coal at or close to the surface which may have been worked at some time in the past. These seams can be seen in **Figure 3.2** and are projected to outcrop perpendicular to the site's length, in the southernmost extent and centrally, striking approximately east-west. Due to the steep 60-70° north-northeast dip of the local geology, this puts the entirety of the site at risk of potential shallow mine workings.

The seams outcropping on site are likely to be the Four-Foot and Five-Foot seams. This is based on information from the 1:10,560 geological map. However, the geological map of the area conflates these two seams into one, which also appears to terminate abruptly 360m to the east of the site. It can be confidently assumed that this seam would extend along strike and outcrop beneath the site. Whereas the geological map records the Four and Five Feet seams combined, the Coal Authority offer an alternative representation, showing the two seams separately. This difference in records suggest these two seams to be separate but stratigraphically very close together. Furthermore, the Coal Authority records the lower seam as the Lower Nine Foot (Top Leaf), but with reference to geological mapping it is understood to be synonymous with the Lower Four Feet seam across the wider district. In this context, it is likely to represent the Four Foot seam
