## Appendix J

### Infiltration Testing

**COMPLIATION  
REPORT  
on  
INVESTIGATIVE WORK**

**1, HENFAES ROAD  
TONNA  
NEATH GLAMORGAN.**

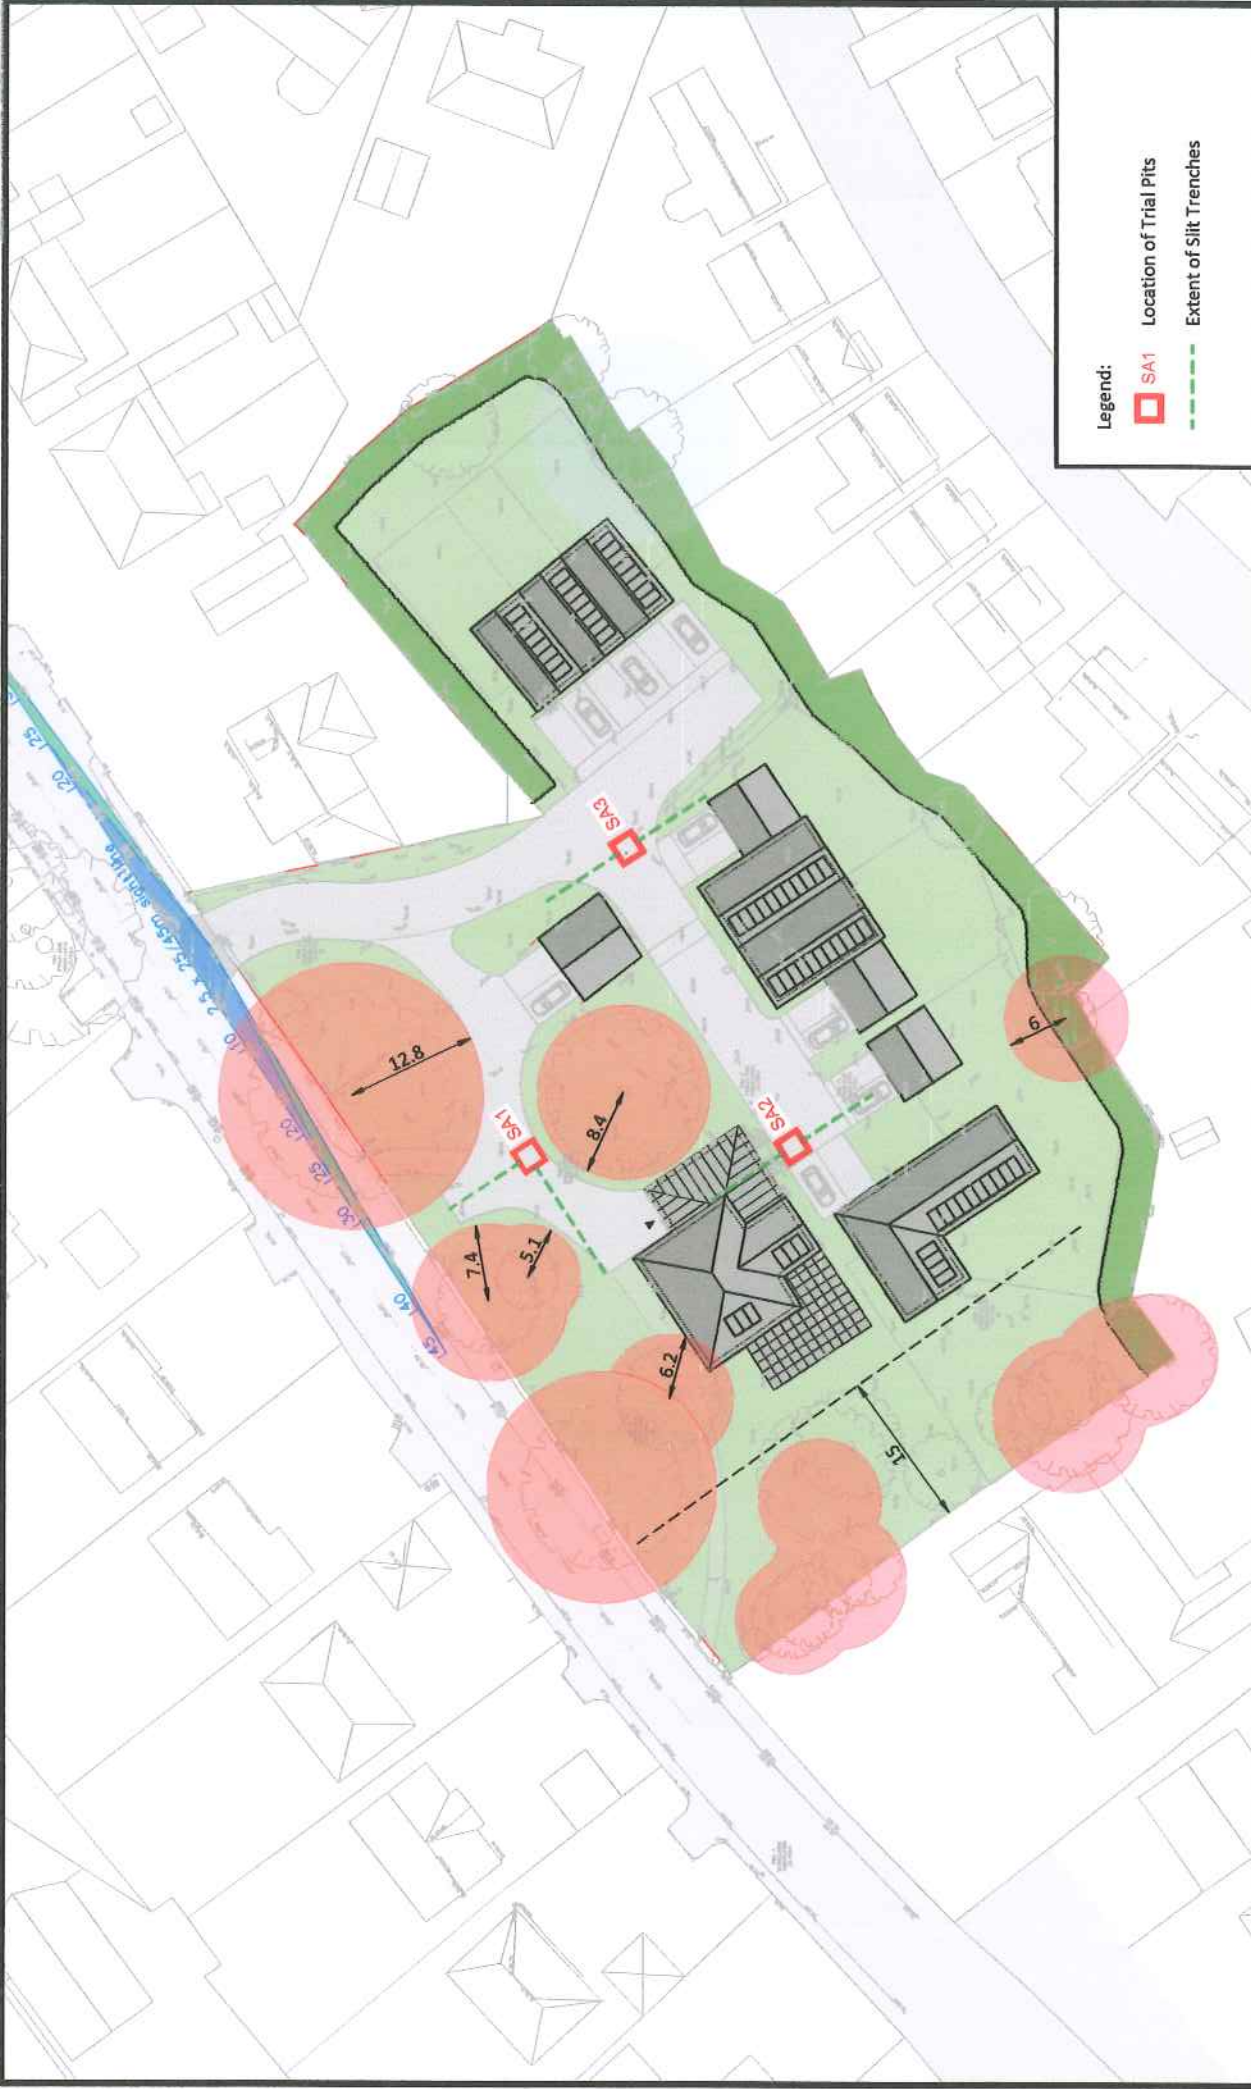
Legend:  
 SA1 Location of Trial Pits  
 SA2  
 SA3  
 Extent of Silt Trenches

The plan appended to this report indicates the approximate position of the three trenches/trial holes constructed during the investigation. The excavation works, trenches, insitu testing and sampling were undertaken in October 2024 in fair weather conditions.
