**COMPLIATION  
REPORT  
on  
INVESTIGATIVE WORK**

**1, HENFAES ROAD  
TONNA  
NEATH GLAMORGAN.**

# **PHASE 1 WALK OVER STUDY REPORT.**

# **REPORT ON PHASE 2 STUDY**

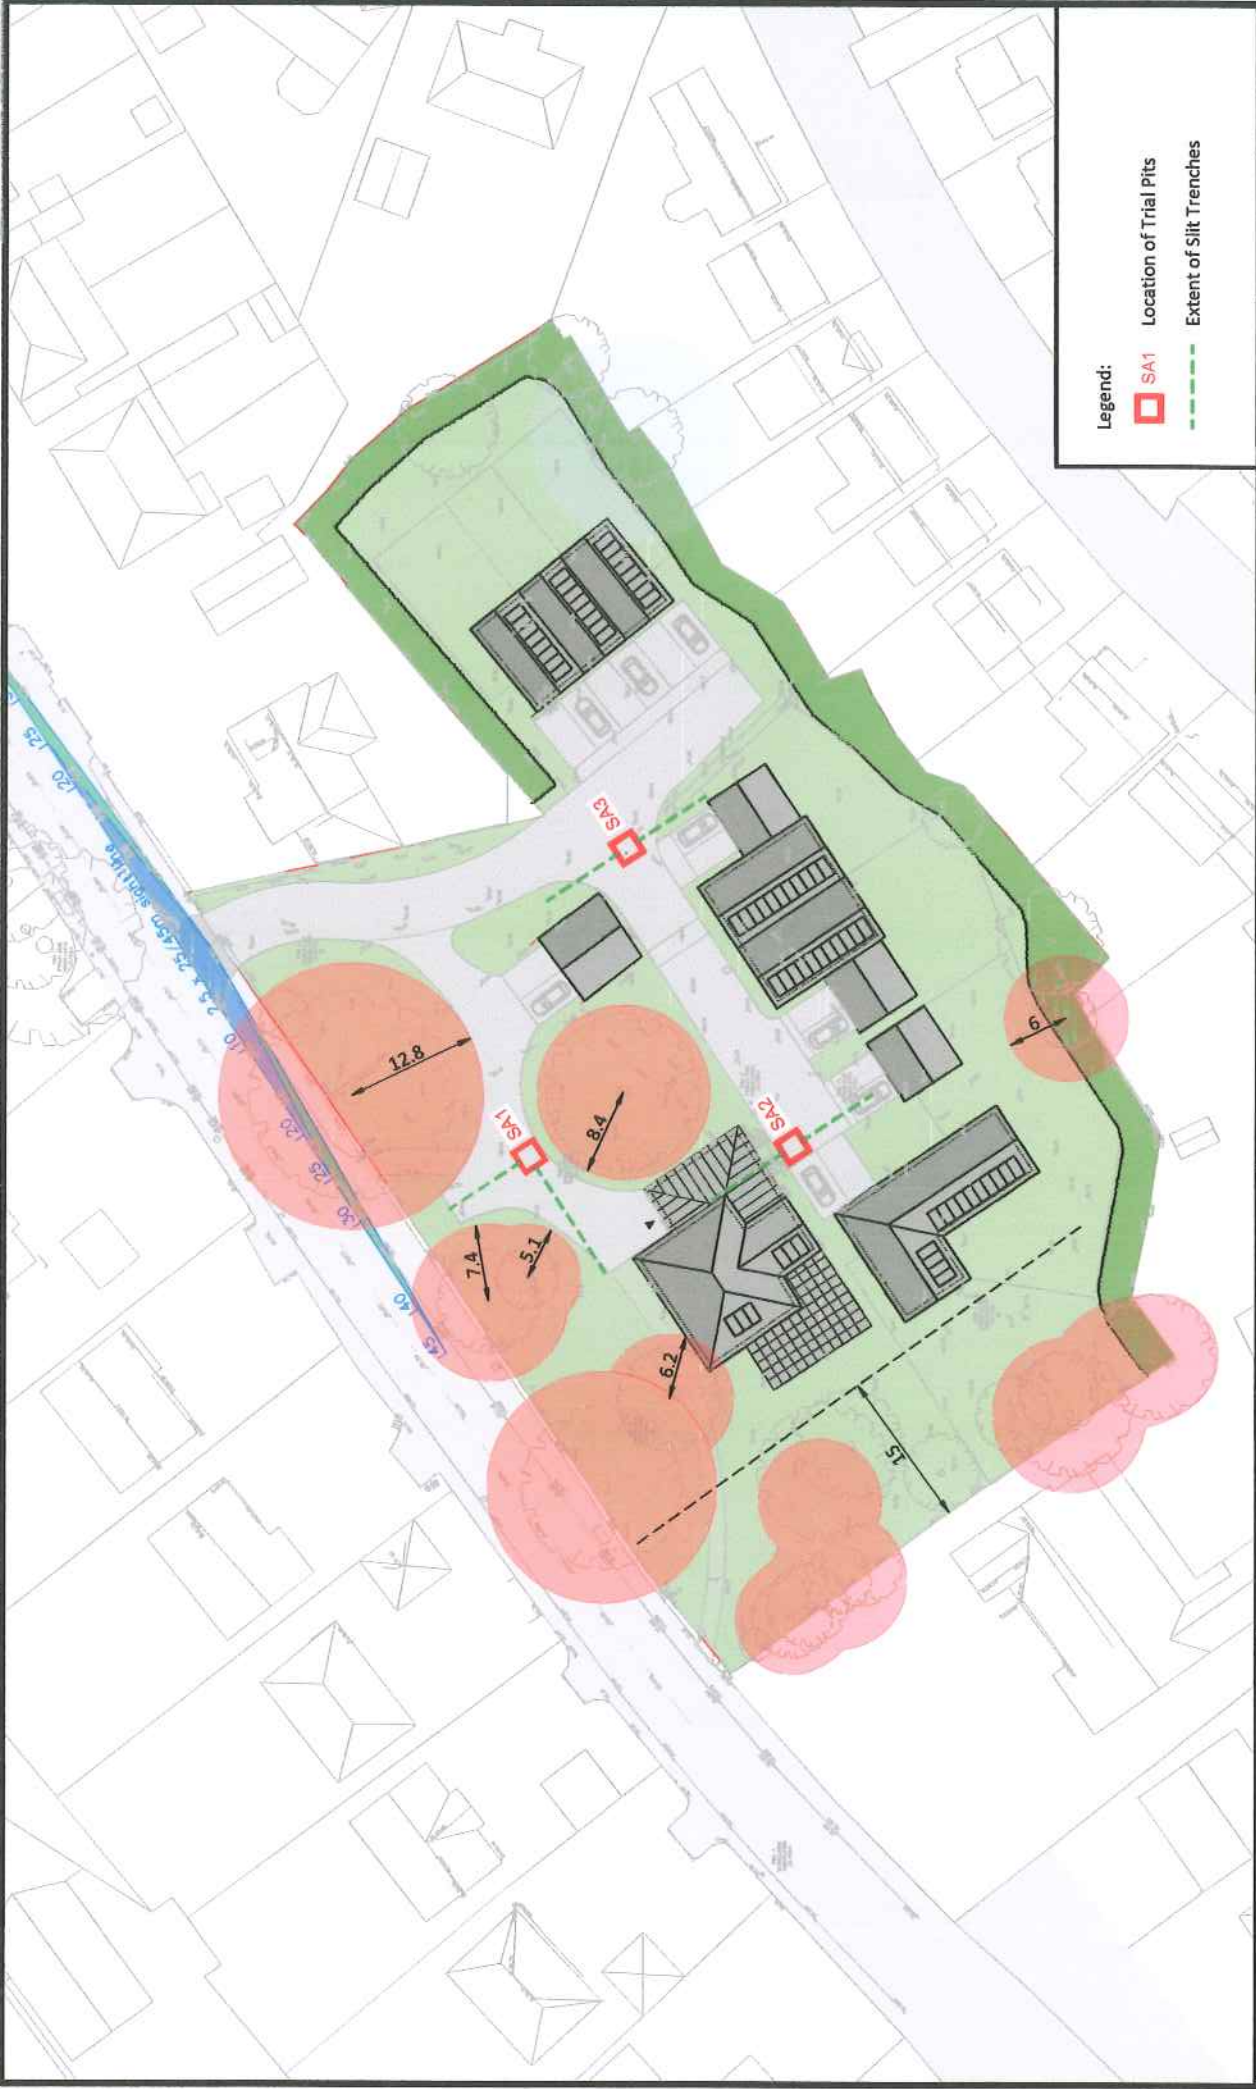
TP-01

The plan appended to this report indicates the approximate position of the three trenches/trial holes constructed during the investigation. The excavation works, trenches, insitu testing and sampling were undertaken in October 2024 in fair weather conditions.

SA1 Location of Trial Pits

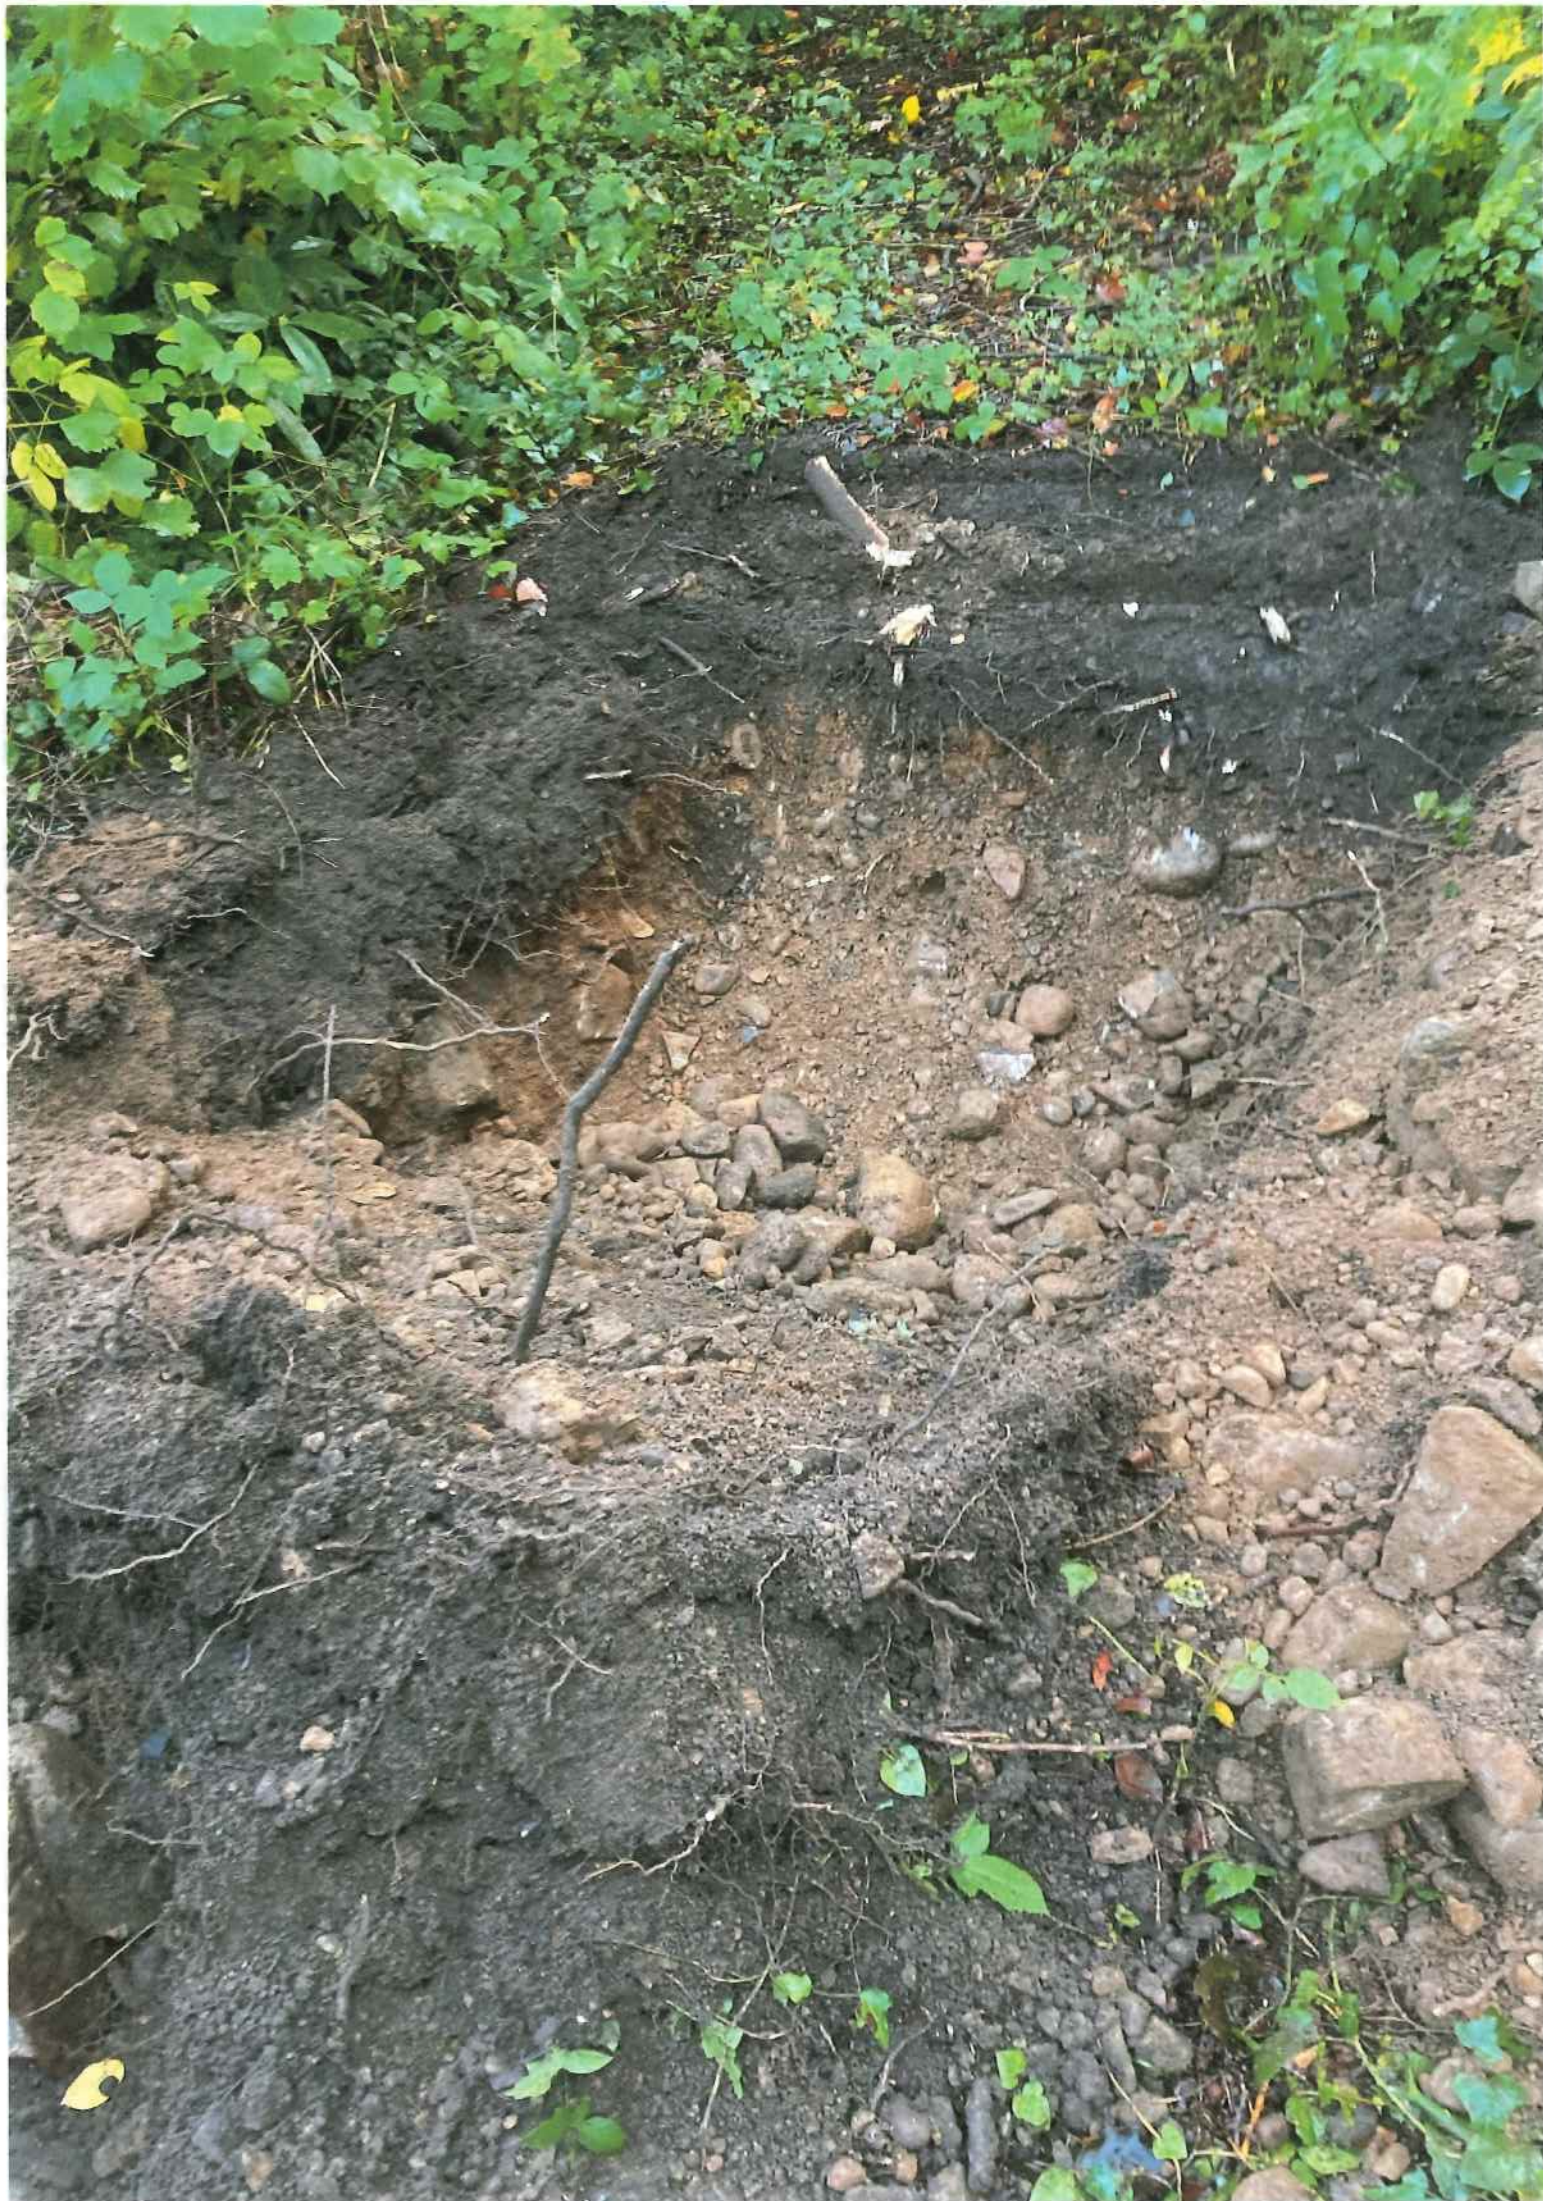
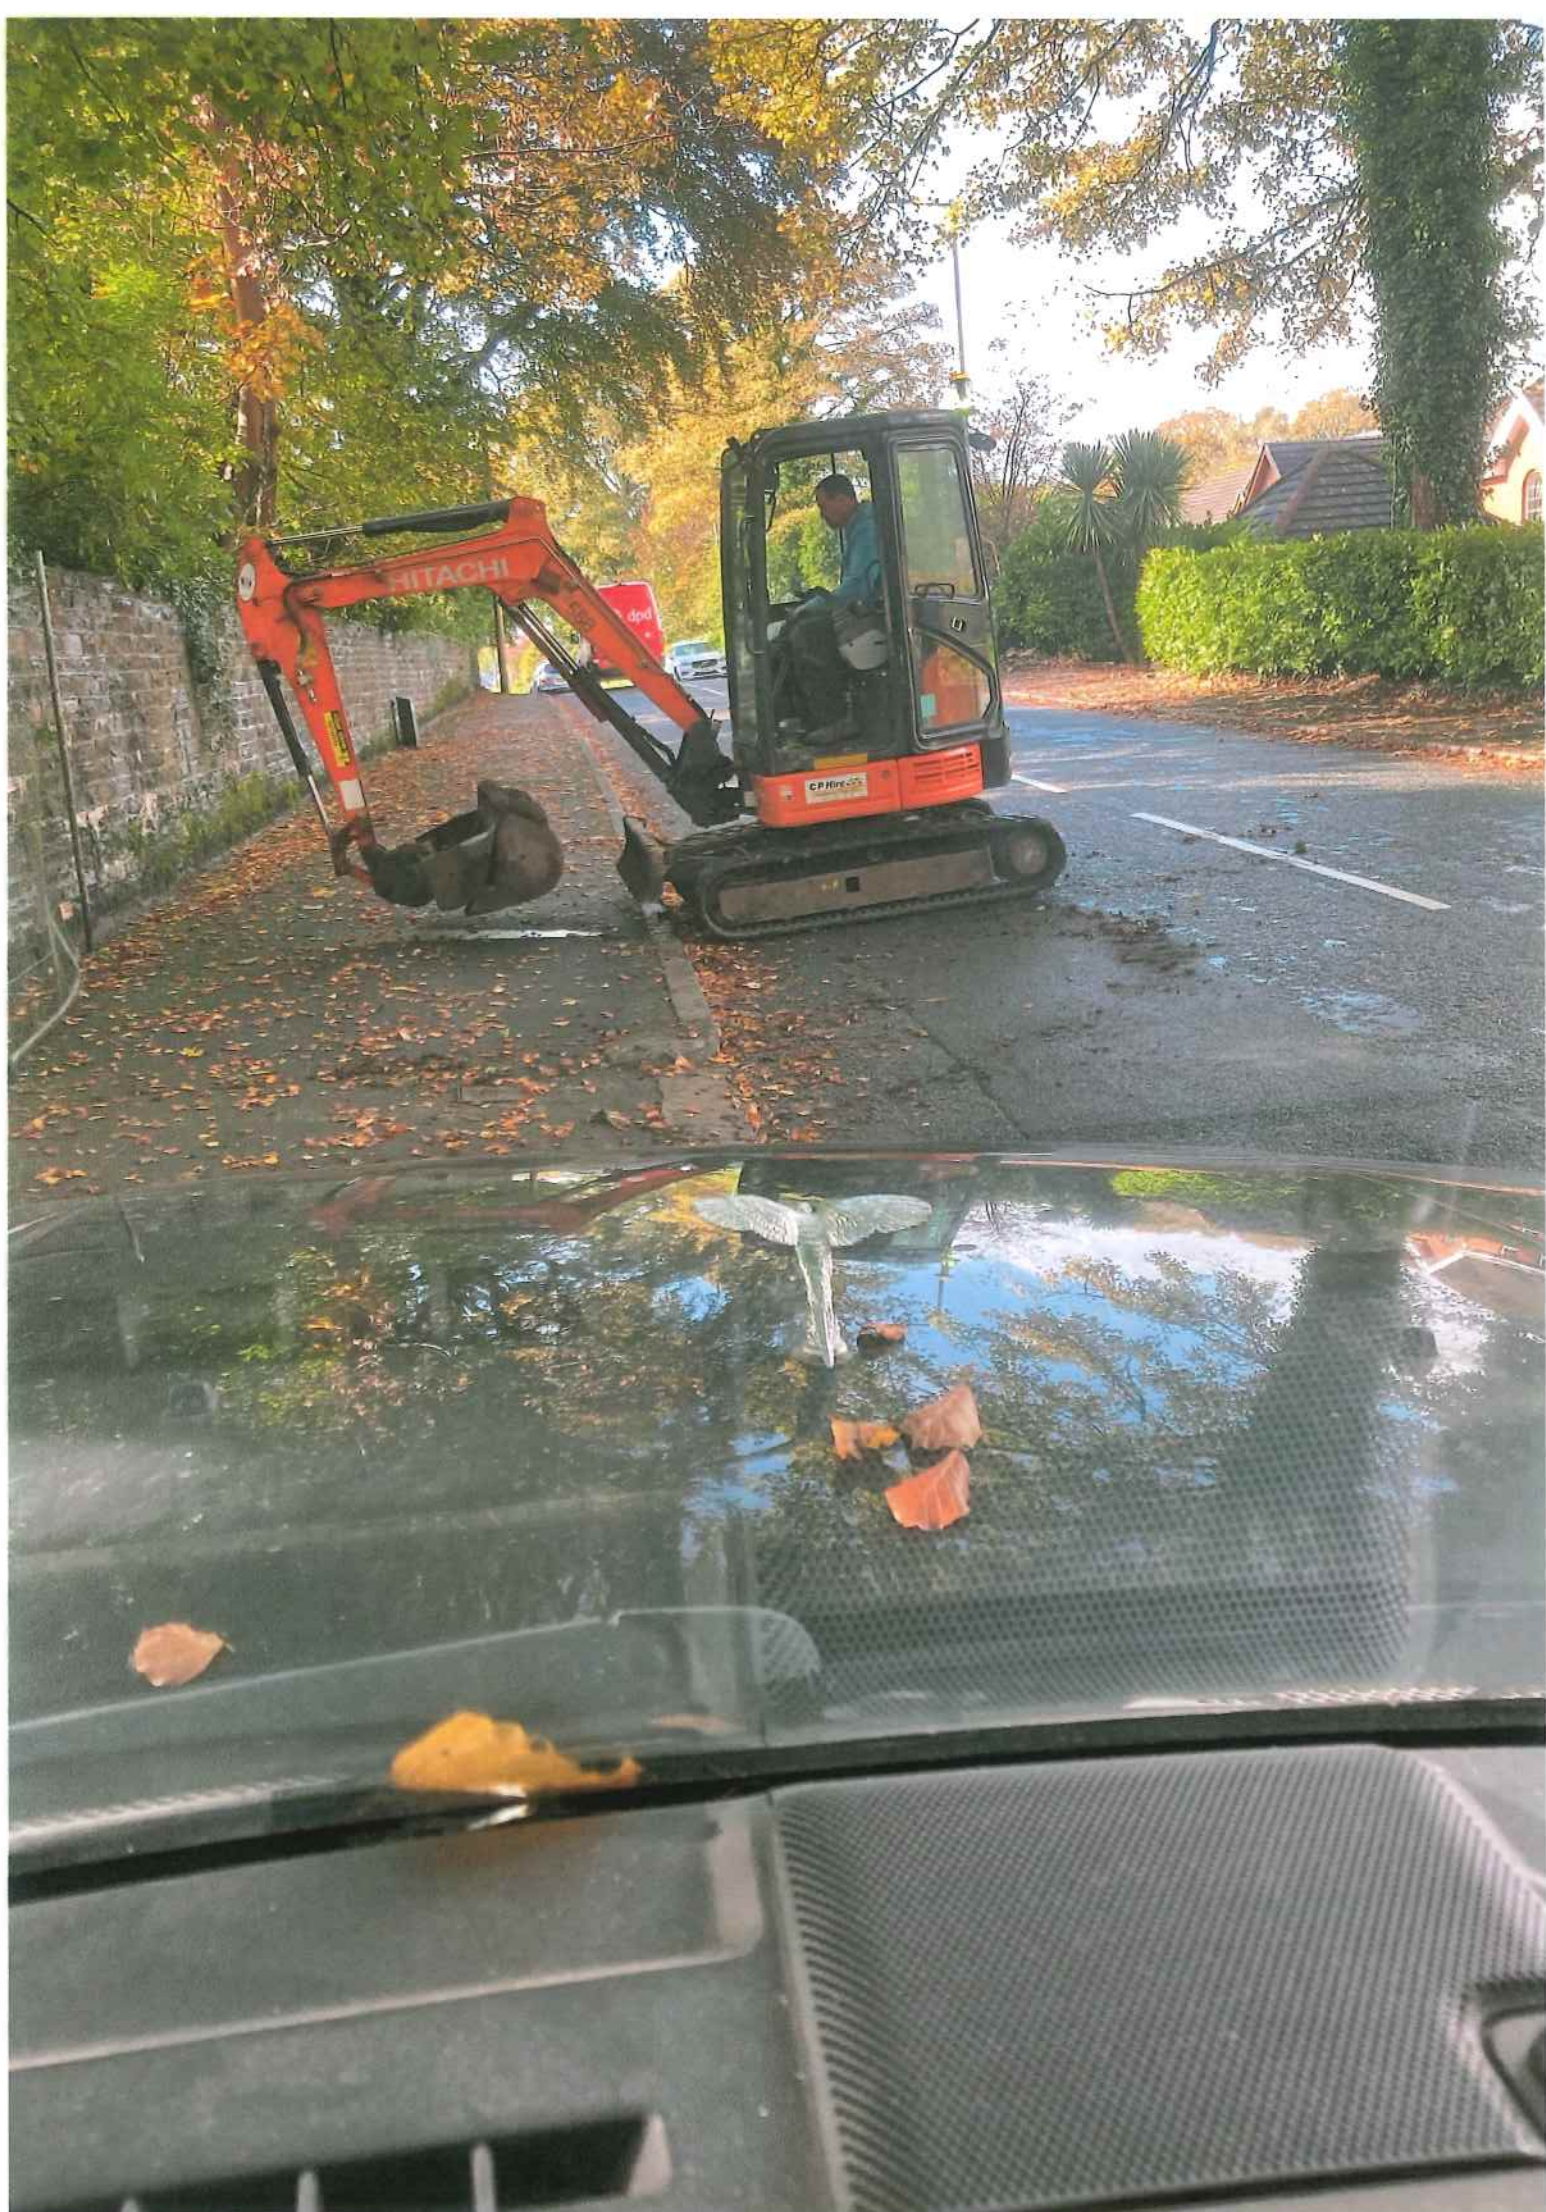
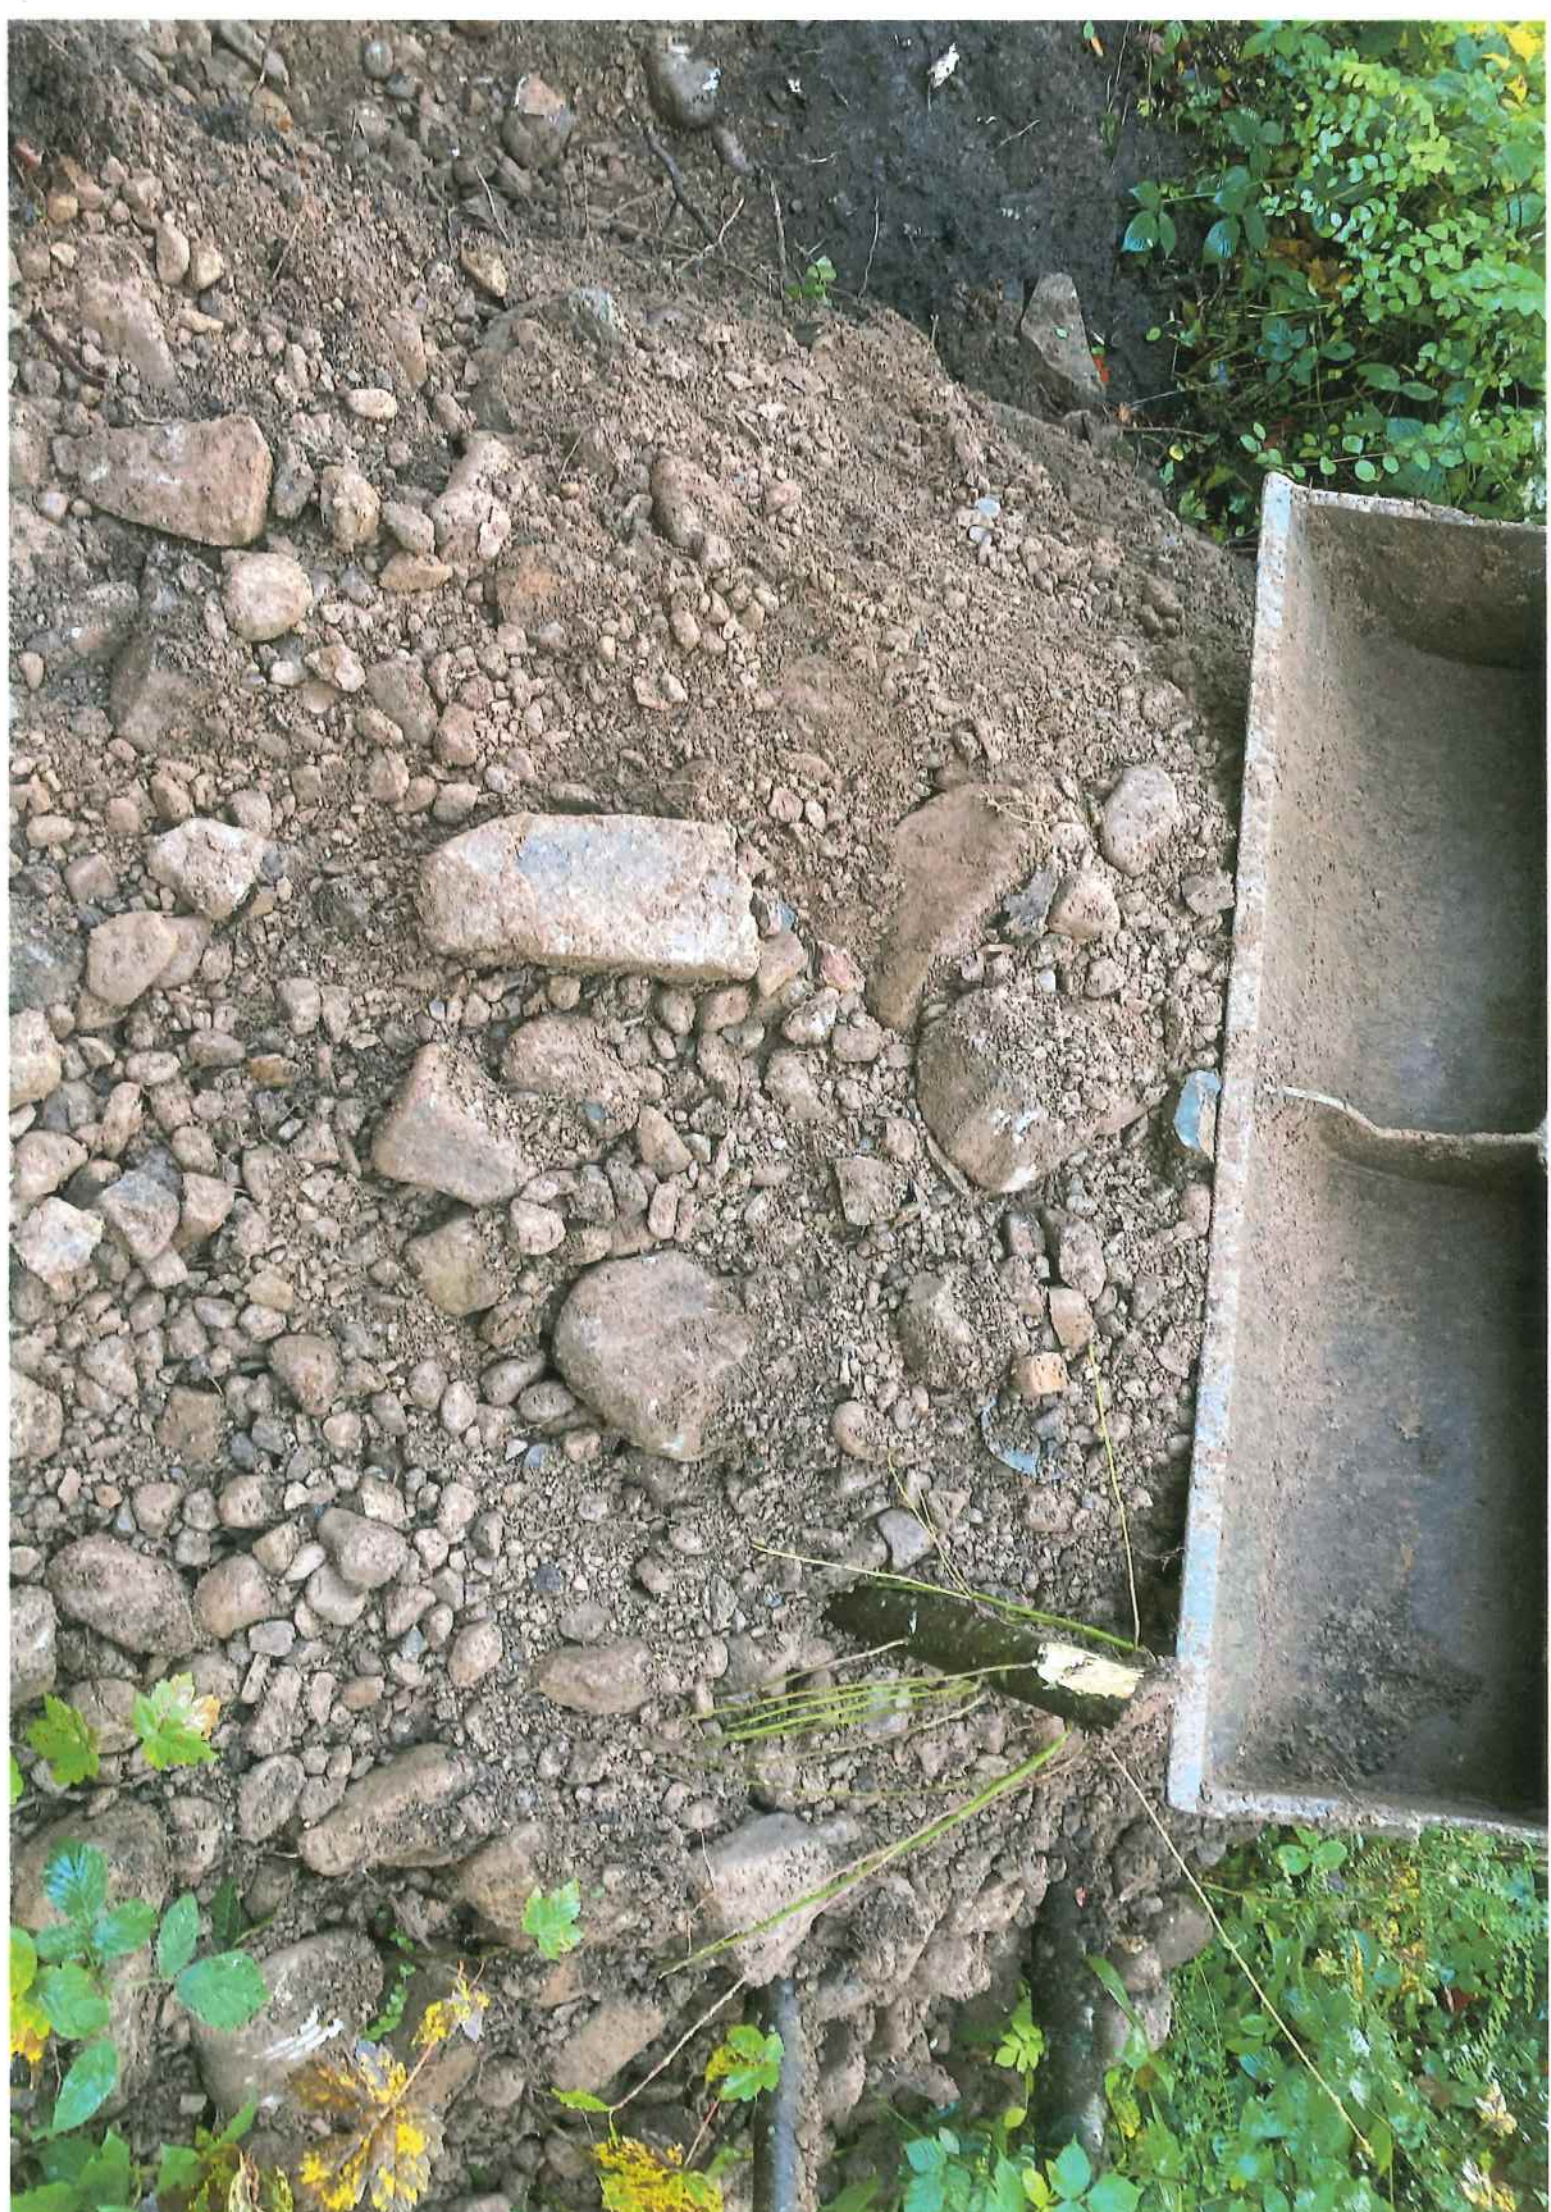
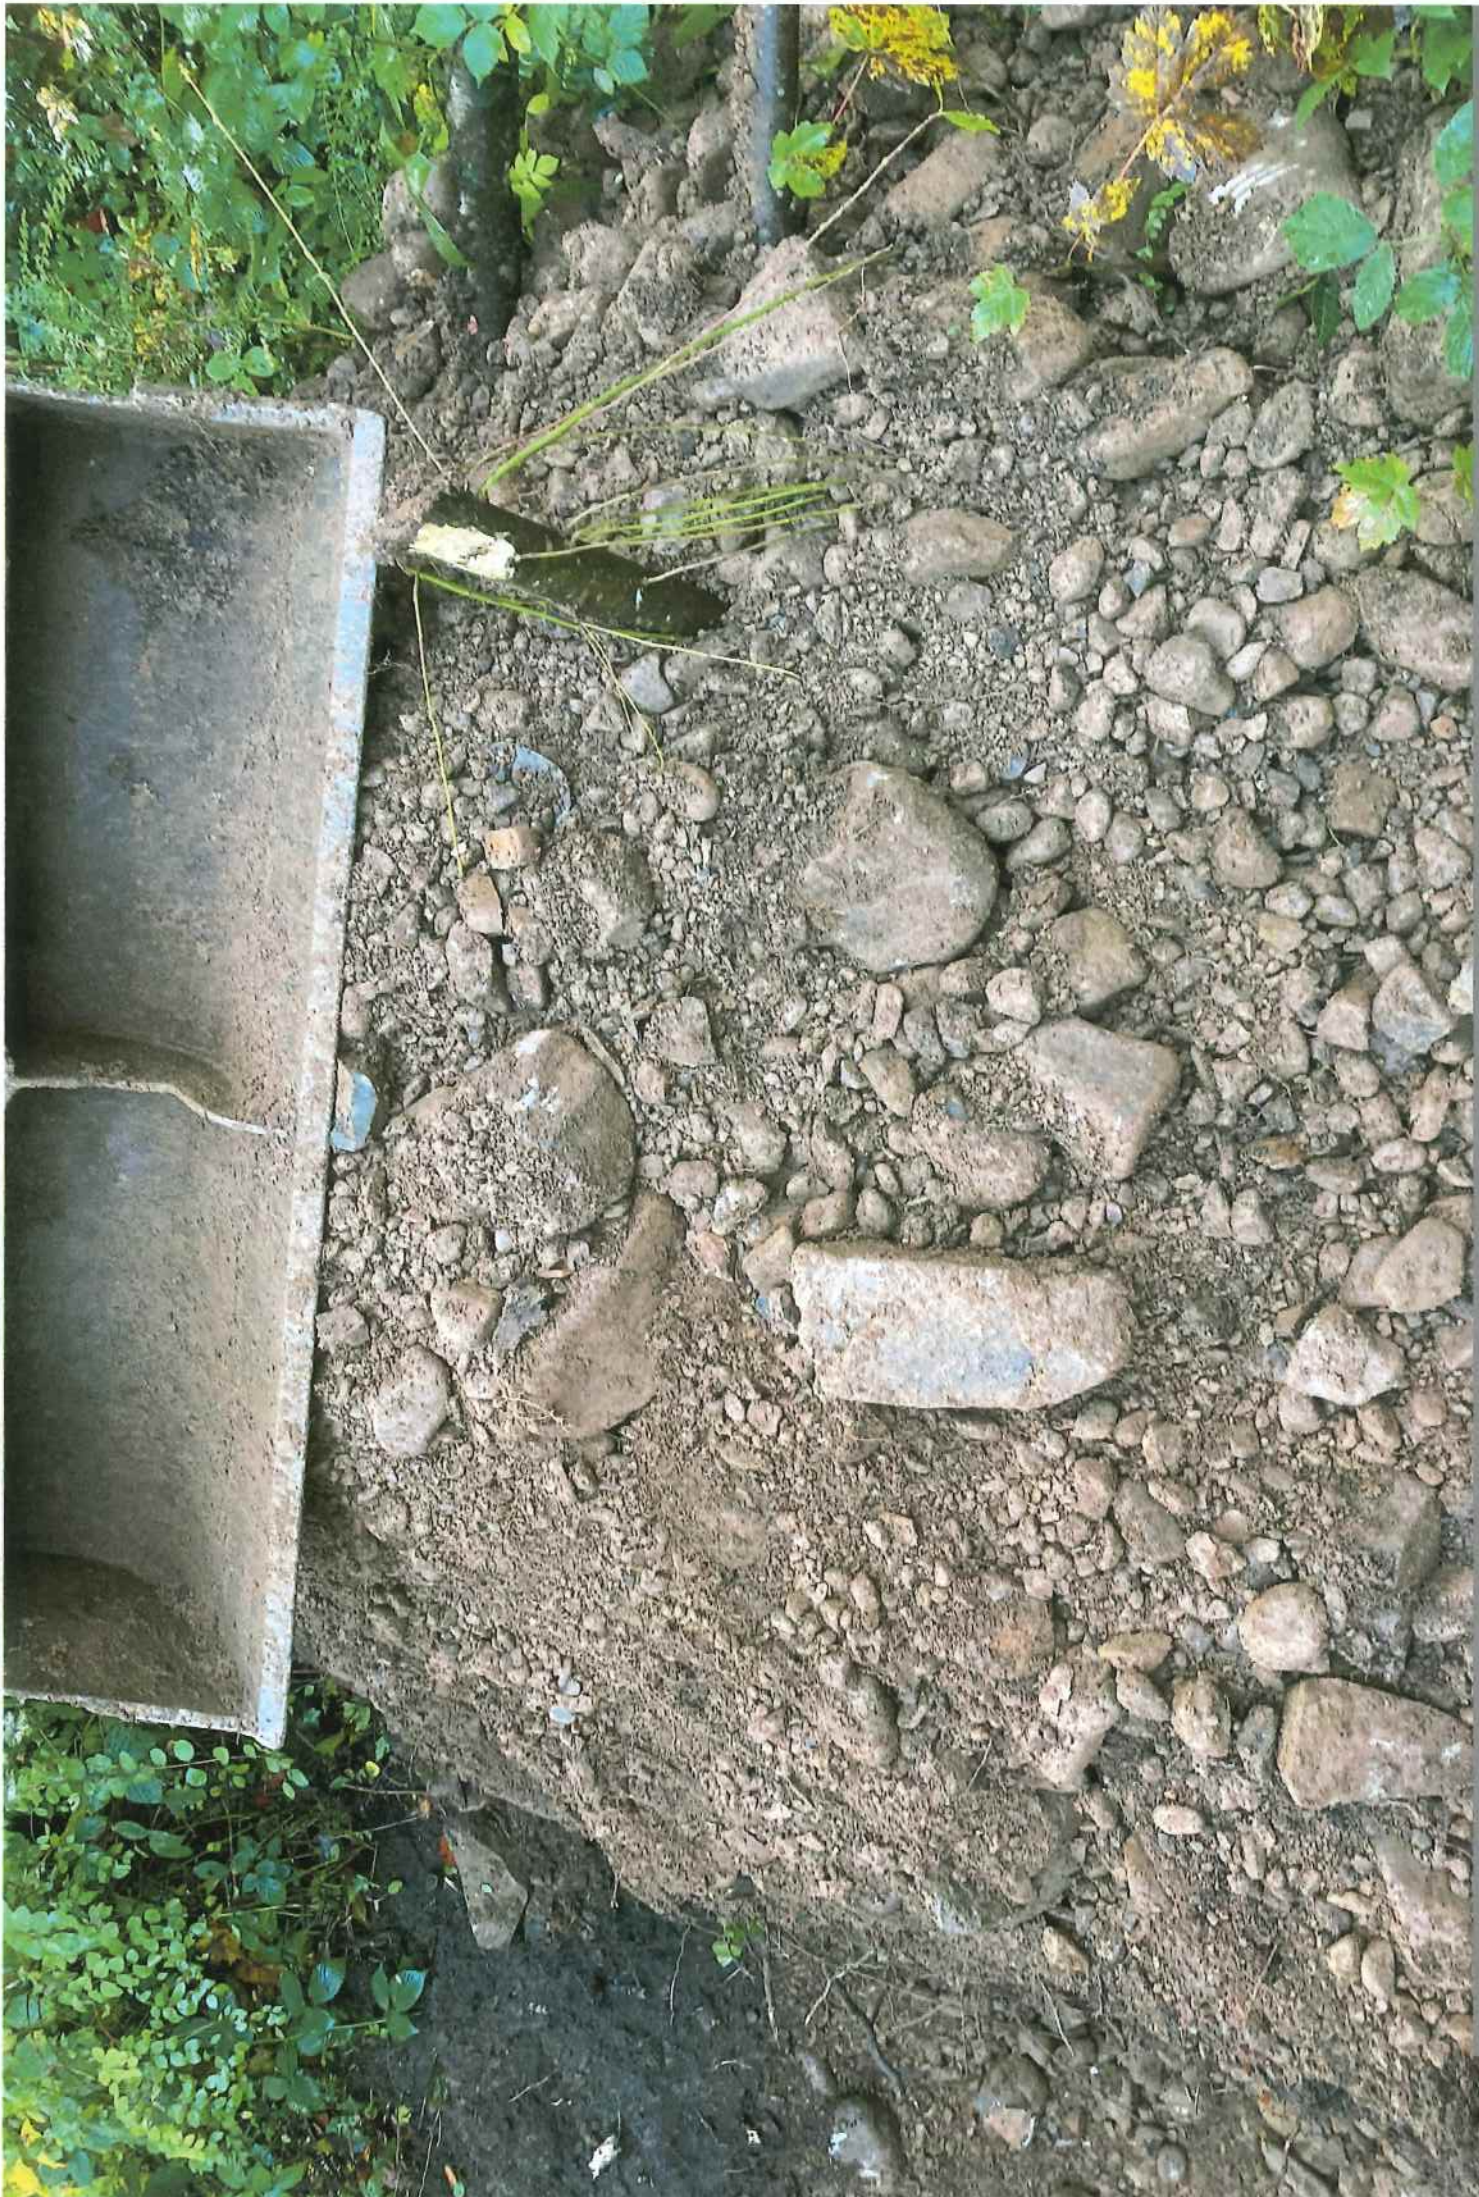
**PHOTOGRAPHS.**

- 4) The development site is a rectangular [albeit it a somewhat irregular] area of land some 0.6ha It is at present disused and considerably overgrown. [See Photographs]

- 5) The site contains a now derelict “Georgian Mansion” which in its time would have been of some substance. However, it is now derelict having suffered fire damage in [it is understood] c 2012 and has been the subject of a structural survey. The results of this survey show that the building is not capable of being restored and consequently it is not considered in these report to be an issue which requires attention other than that associated with its removal. [see Drainage Report and Main Report Photographs] The remainder of the land is now an historic garden area but completely overgrown.

14) The attached photographs give some indication of the current layout of the site and its access.
