# **Gellinudd Care Home, Swansea**

## **Ground Investigation Report**

Rhodos Properties (No 14) Ltd

P1188/CC-1206

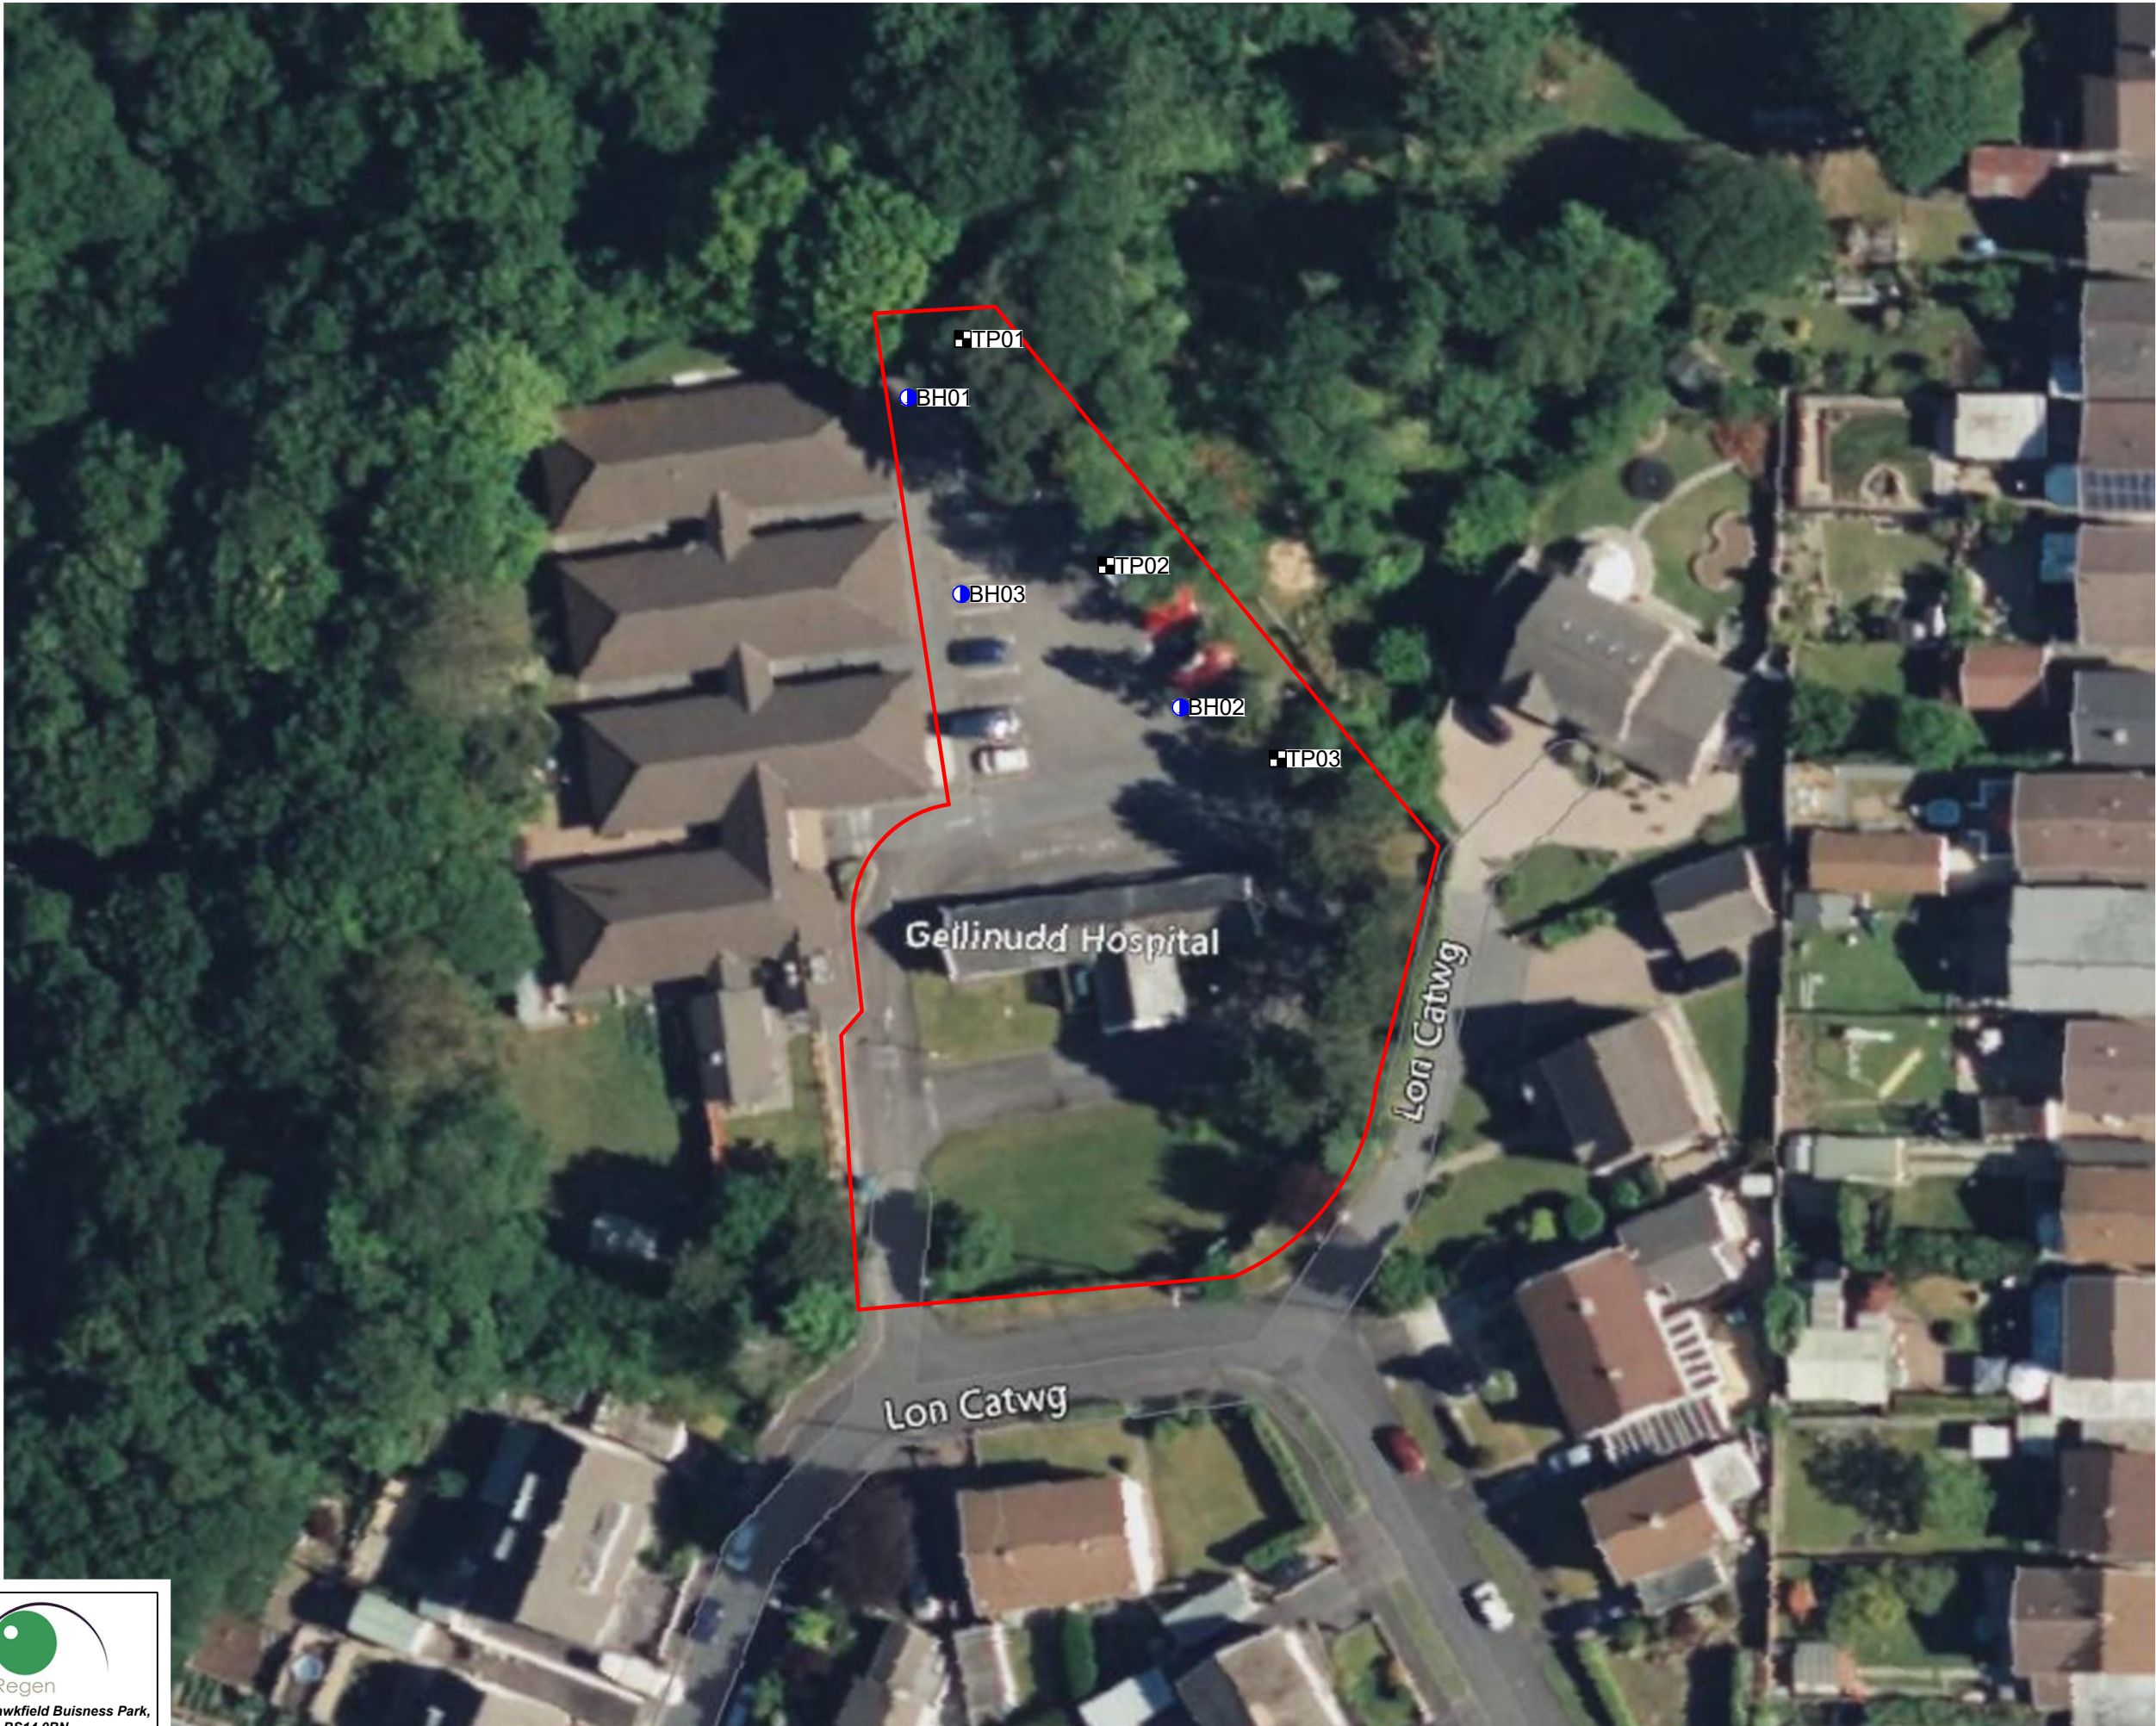
- Site Boundary
- T&P Investigation**
- Trial Pit Locations  
(TP01 - TP03)
- Cable Percussive Locations  
(BH01 - BH03)

The trial pits were positioned as per the exploratory hole location plan contained within Appendix A. Infiltration tests were not completed in areas of the site where made ground was encountered.
