**LAND AT CWMGORS, NEATH PORT TALBOT**

**Site Investigation Report**

14301/AG/24/SI

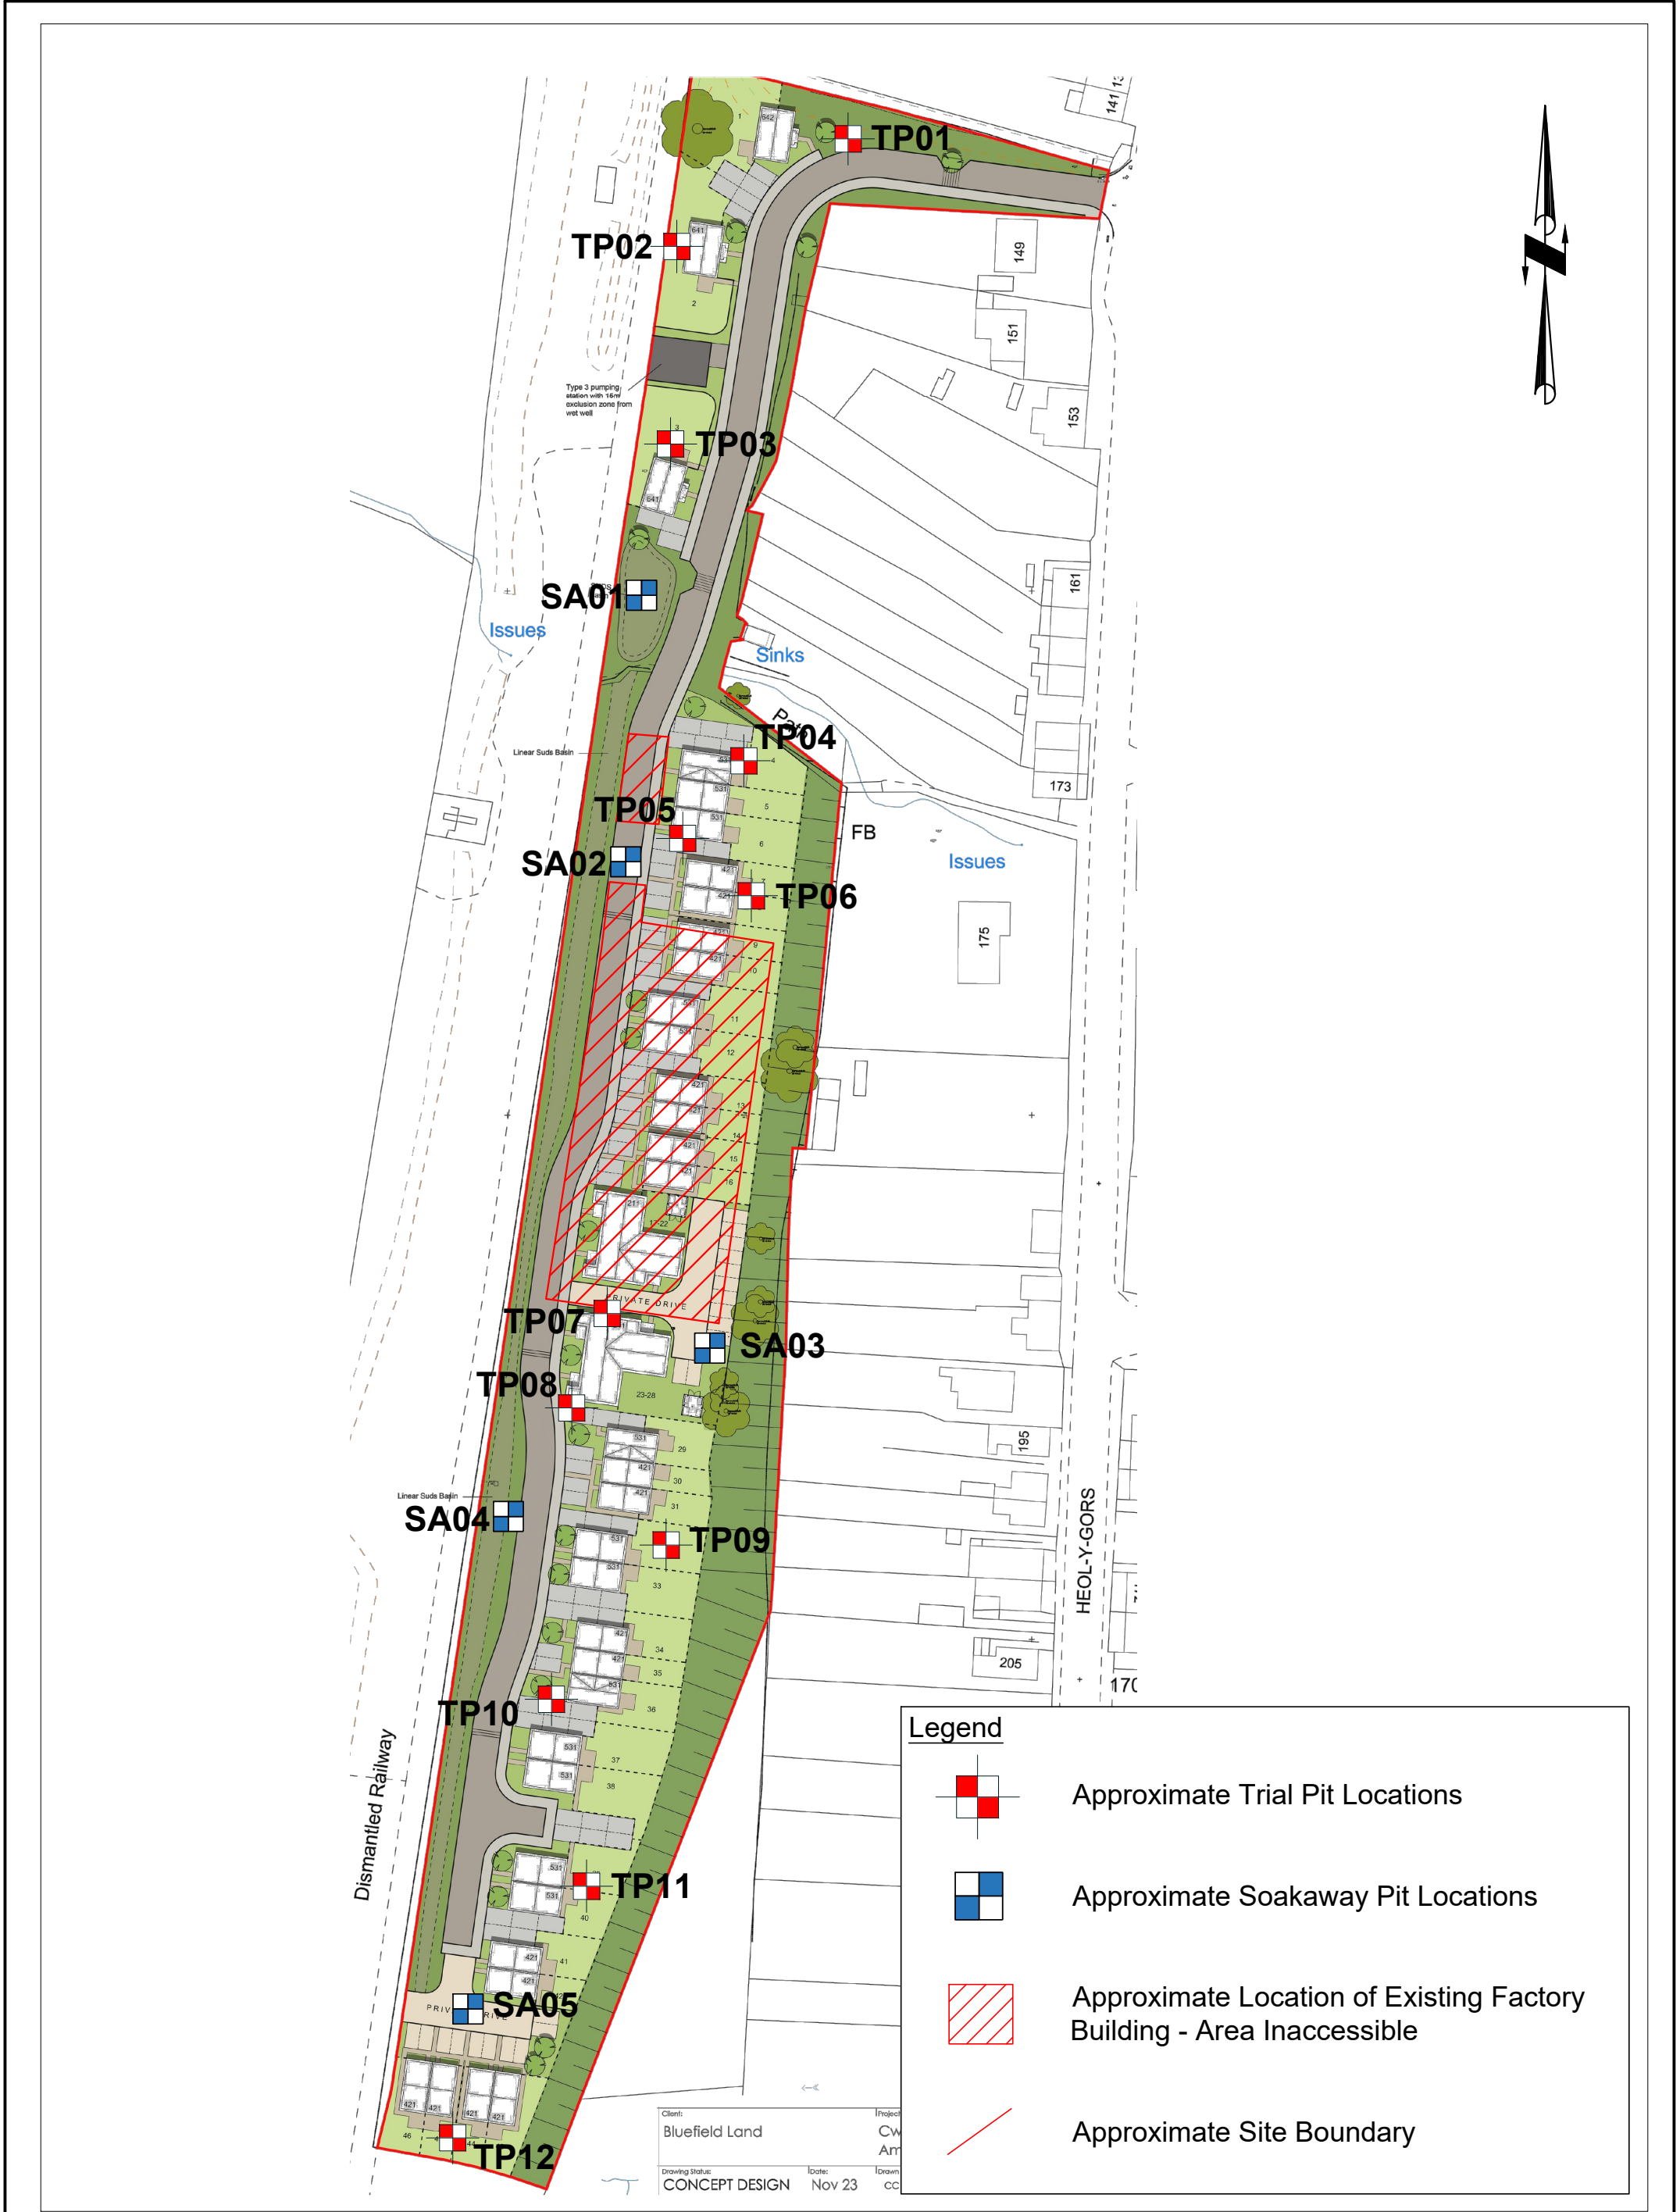
Figure 2: Site Plan

The approximate locations of the trial pits are shown on Figure 2, while their logs are presented in Appendix A. The results of the soil infiltration tests are presented in Appendix B.
