**TAI TARIAN LTD**

**SANDFIELDS PHASE 2, PORT TALBOT**

**UPDATED PRELIMINARY ECOLOGICAL APPRAISAL**

12 June 2024

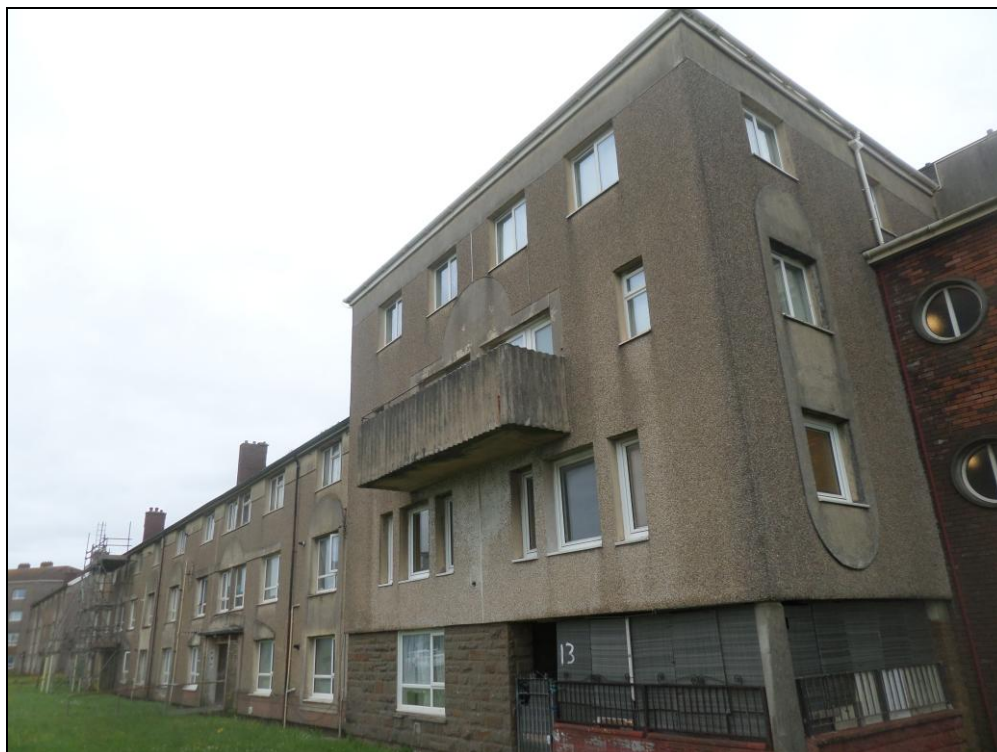
*Photo 1: Southern extent of Carmarthen House (view looking north east).*

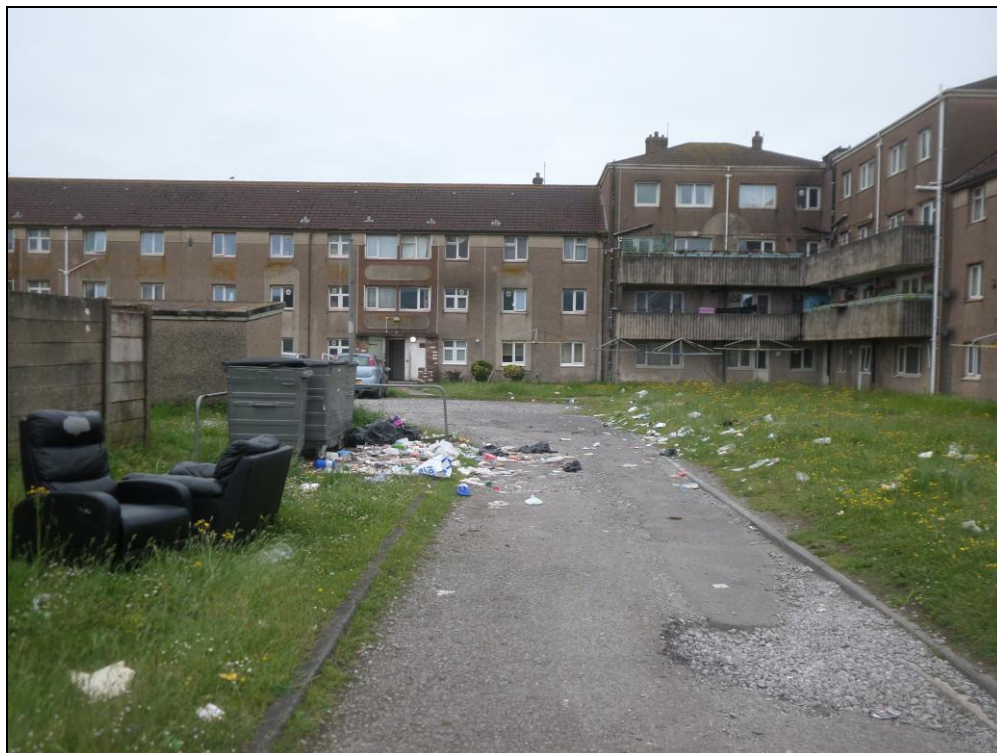
*Photo 2: Rear of armarthen House (view looking south).*

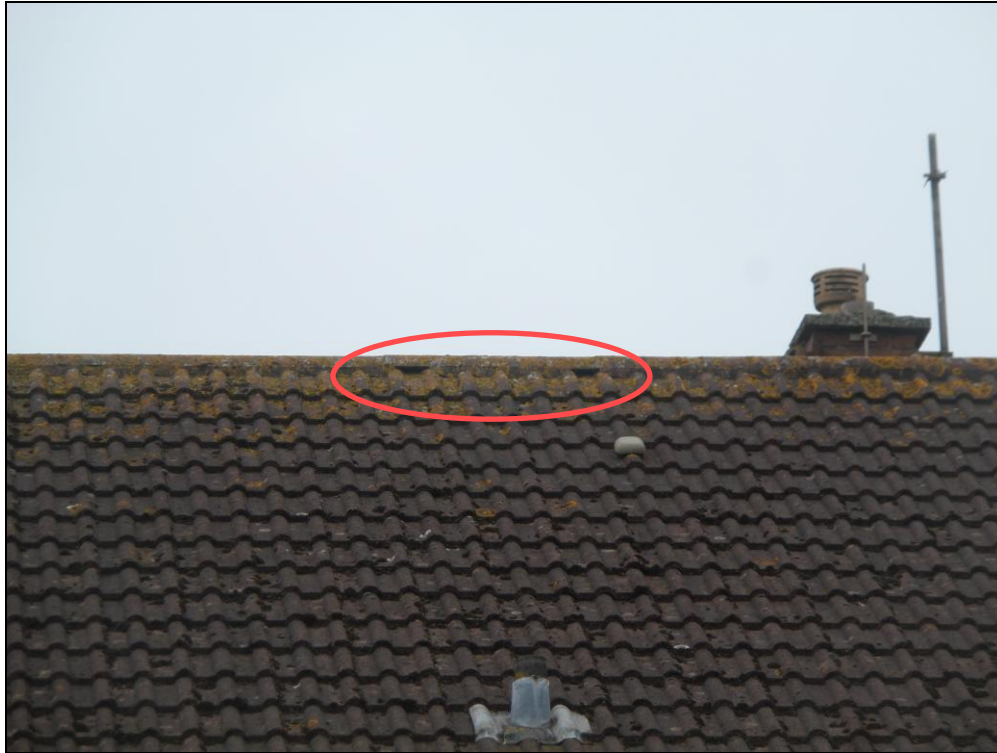
3.6 In the subsequent years post 2022 PEA (BE, 2022) the structure hadn't deteriorated further with the same limited potential bat roosting features associated with missing mortar beneath ridge tiles on the rear roof

aspects (Photo 4), as well as missing pointing between the red brick on the western stairwell block (Photo 5).

*Photo 4: Missing mortar beneath ridge tiles on rear aspects of roofs (view looking north west).*

- 5.4 The results from these surveys are still valid and on this basis, it is considered that the proposed works will not require further surveys or a European Protected Species (EPS) derogation licence. However, it is recommended that a precautionary approach to the roof strip and demolition be adopted given the itinerant nature of some common bat species identified within the bat activity surveys i.e. Pipistrelle species. The possibility that the structure could potentially be utilised by individual bats on an irregular or occasional basis during future bat activity seasons could not be ruled out (highly unlikely) and a precautionary approach as follows would be appropriate:

- Builders advised prior to the start of works of the low risk that bats (or birds) could be present and the action to take should a bat be discovered (see below);

- Removal of roof features to be undertaken by hand or using hand-tools (e.g. crowbars etc.);
  - In the unlikely event that a bat were discovered, all works would cease immediately and Natural Resources Wales (NRW) or the project ecologist contacted for advice on how to proceed.

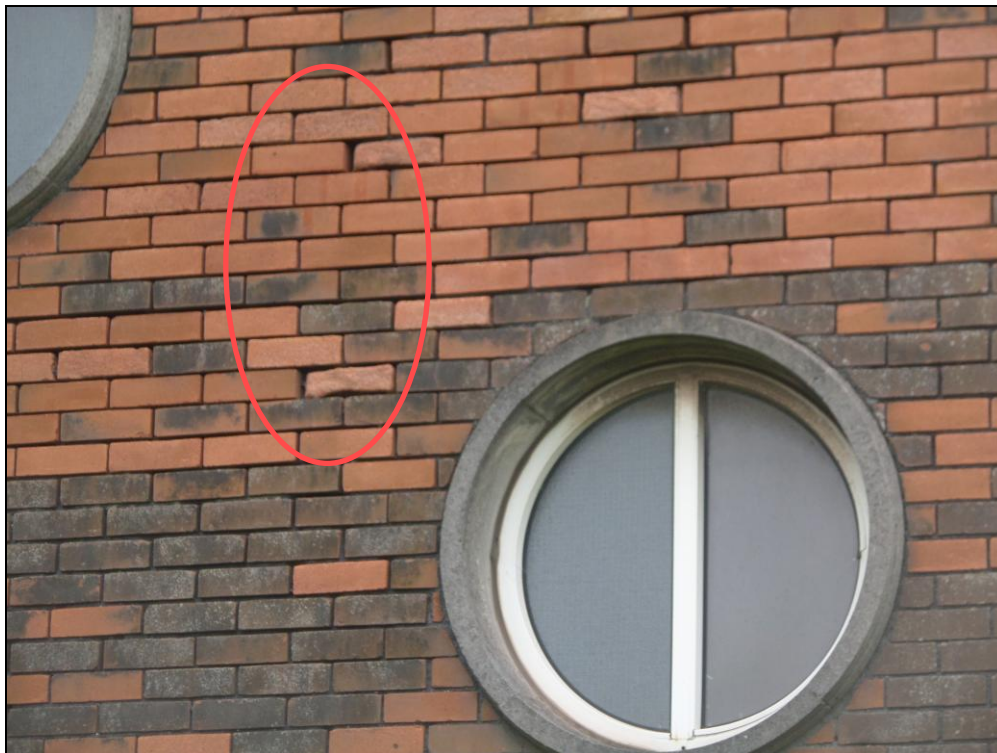
*Photo 5: Missing pointing between red brick on stairwell (view looking south east).*

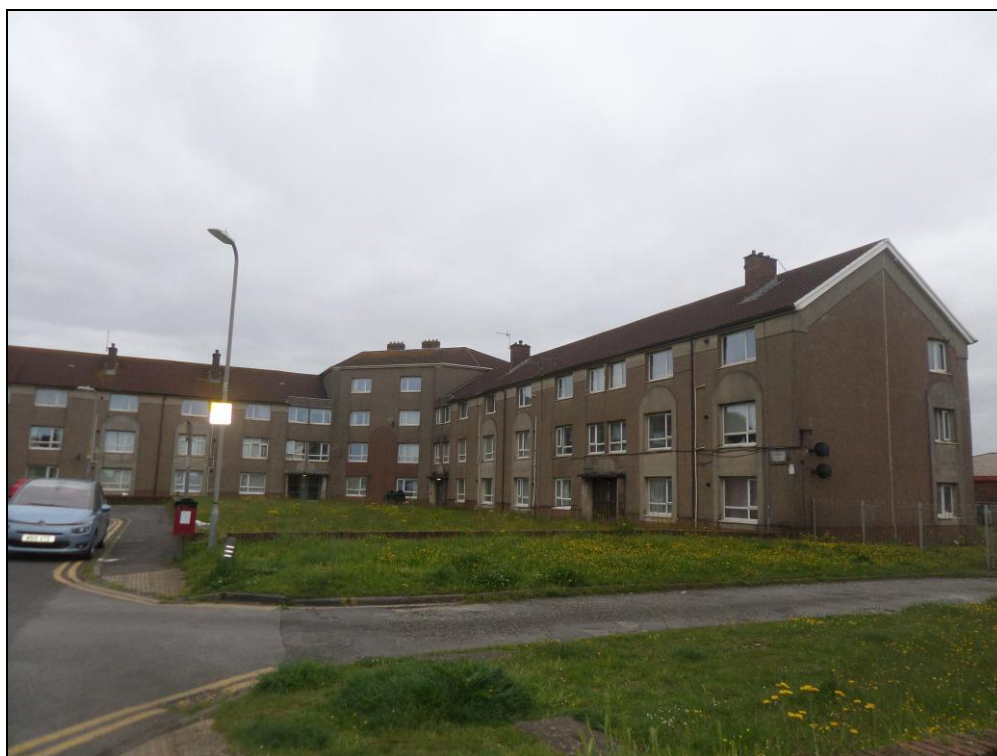
*Photo 6: Coronation House complex (view looking north).*

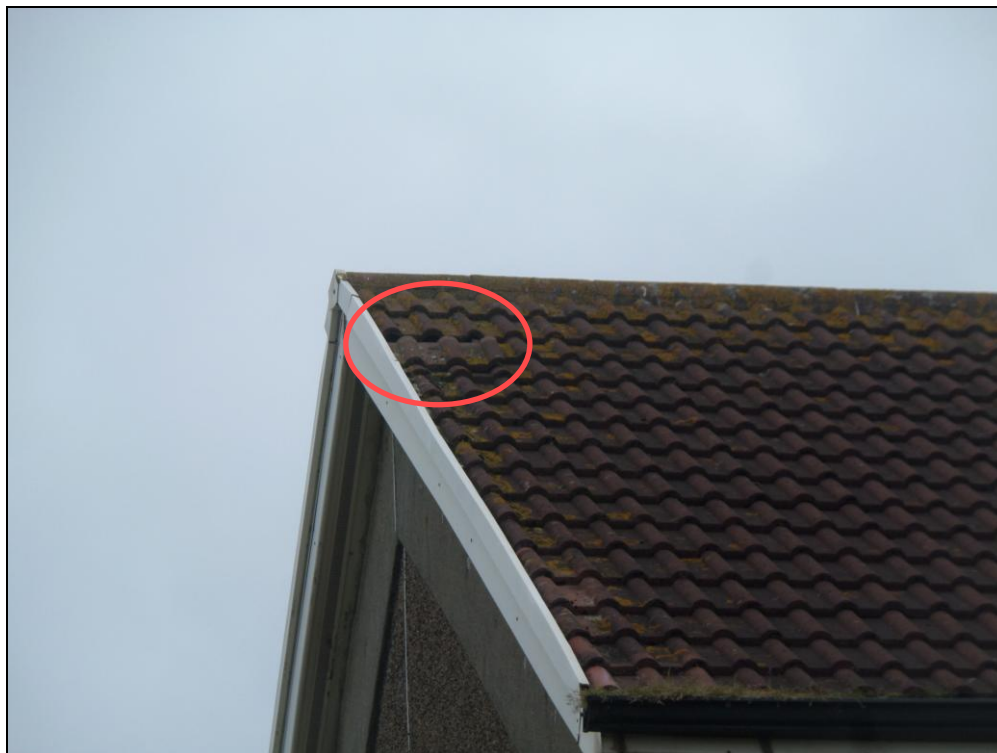
- 3.7 As identified within the 2022 PEA Coronation House was the central residential flat complex, which is an inverted L-shaped with a three storey pebble dashed sections located at the southern and northern extent of the building, with a central four storey central pebble dashed spine located towards the centre of the inverted 'L'(Photos 6).
- 3.8 In the subsequent years post 2022 PEA (BE, 2022) the complex hadn't deteriorated further with the same limited potential bat roosting features that were generally associated with missing and dislodged roof tiles (Photo 7 & 8).

*Photo 7: Dislodged roof tile on eastern pitch of southern complex arm (view looking west).*

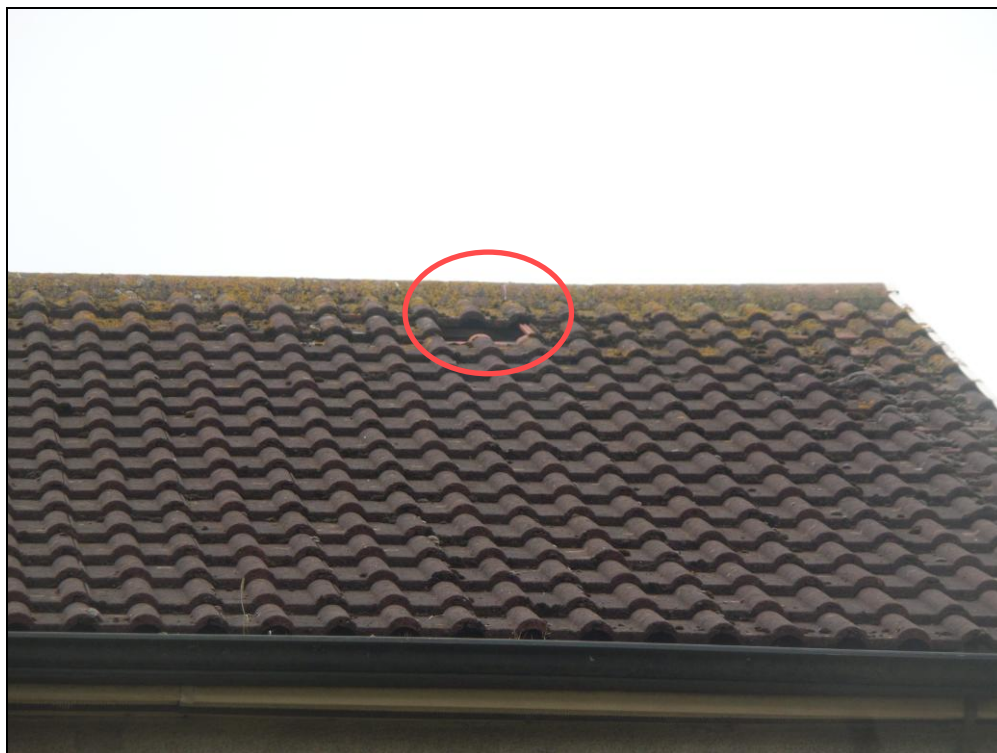
*Photo 8: Missing roof tile on northern pitch of western complex arm (view looking south).*

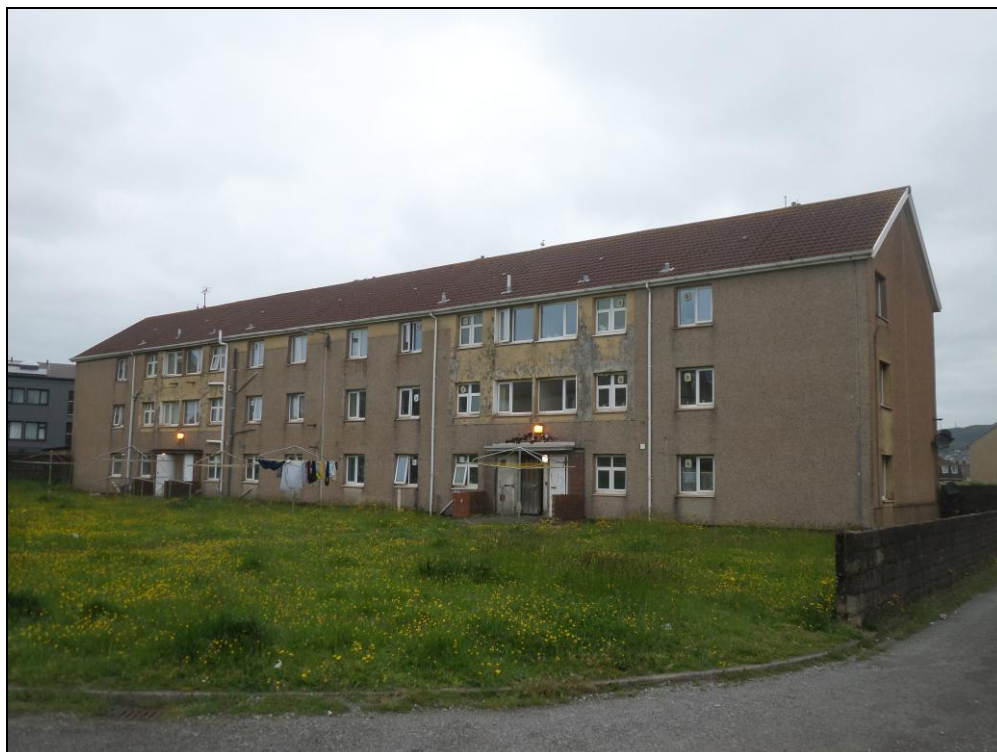
*Photo 9: Cardigan House's southern elevation (view looking north).*

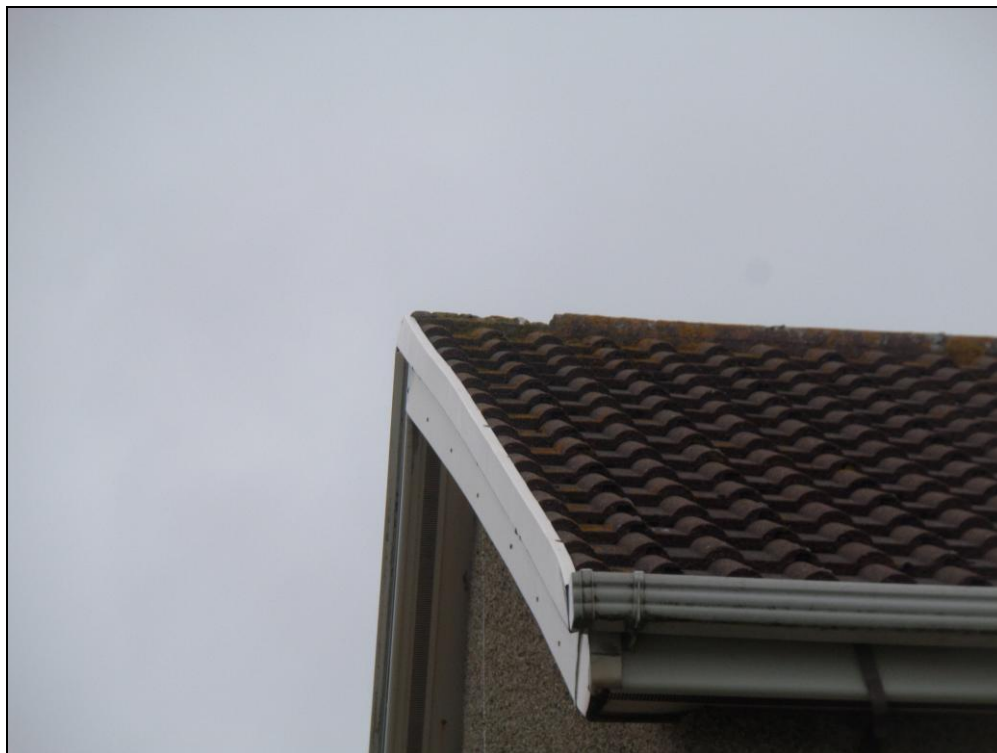
- 3.9 As identified within the 2022 PEA Cardigan House was the northernmost residential block of flats that is a three storey pebble dashed rectangular structure with a pitched roof and red brick chimneys (Photo 9).
- 3.10 In the subsequent years post 2022 PEA (BE, 2022) the complex hadn't deteriorated further with the same limited potential bat roosting features that were generally associated with missing roof tiles (Photo 10).

*Photo 10: Missing ridge tile located on western gable end of Cardigan House (view looking north).*

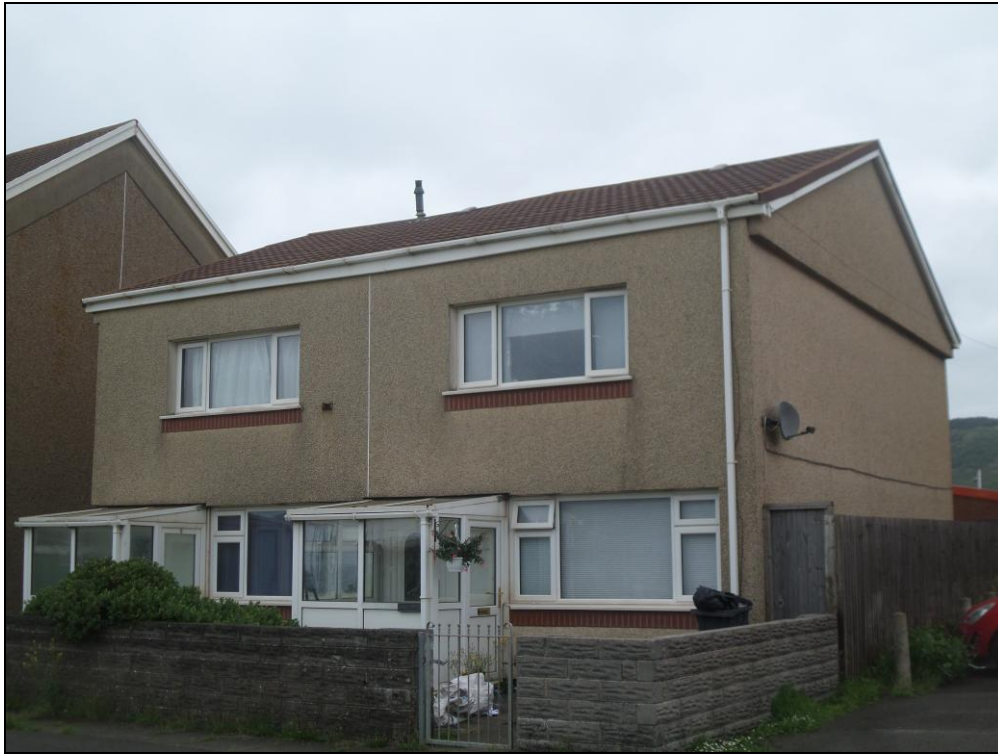
- 3.11 As identified within the 2022 PEA the two semi-detached houses were located at the south eastern extent of site located adjacent to Carmarthen House (Photo 11). The two storey structures were pebble dashed with rubber roof sheeting and uPVC front porch (south western elevations), window frames, doors, fascias and rainwater goods.
- 3.12 In the subsequent years post 2022 PEA (BE, 2022) the complex hadn't deteriorated with no obvious potential bat roosting features evident.

*Photo 11: Southern elevation and eastern gable end of semi-detached properties (view looking north west).*

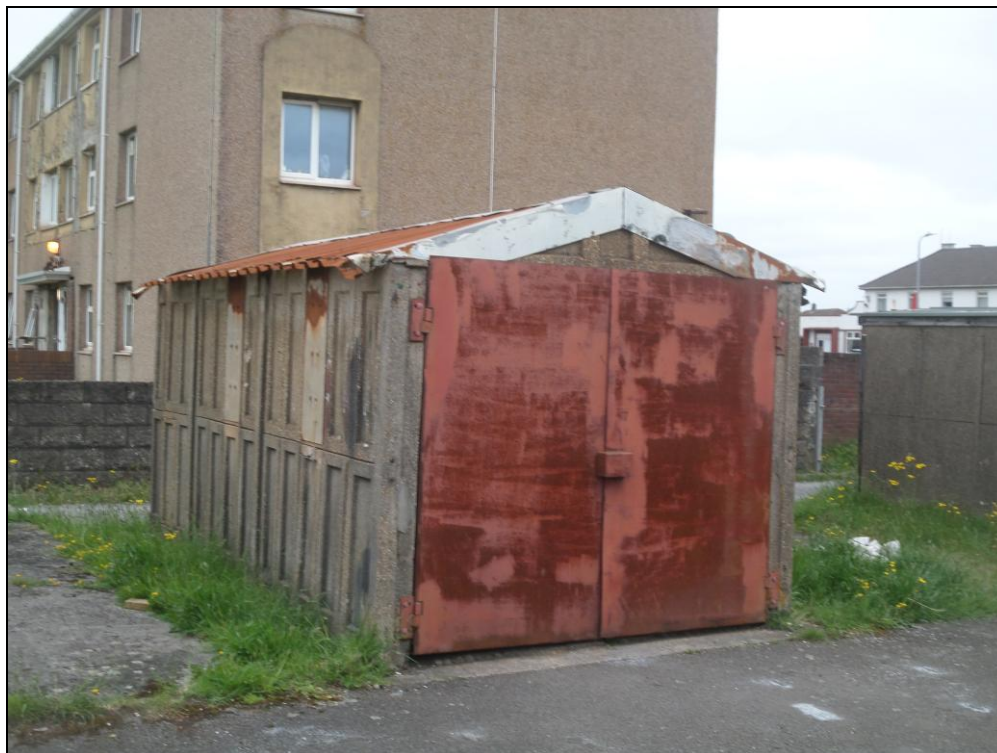
- 3.13 As identified within the 2022 PEA a number of detached garages were located along the eastern extent of site at the rear of Coronation and Cardigan House (Photos 12). The garages were of varying construction which included prefabricated concrete panels and breeze block & brick walls all of which had mono pitched roof with varying asbestos and corrugated metal roof sheets.

- 3.14 In the subsequent years post 2022 PEA (BE, 2022) the structures had not appeared to deteriorate further with potential access points still evident beneath the roofs were evident on all of the structures.

*Photo 12: Detached garage located at rear of Cardigan House (view looking west).*

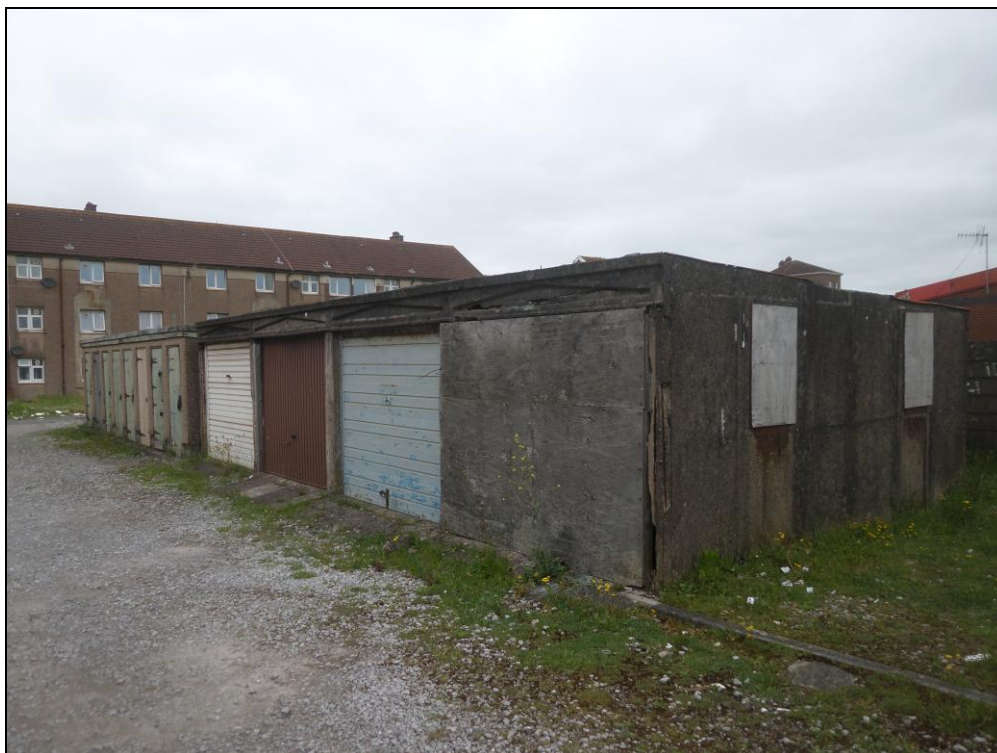
- 3.15 As identified within the 2022 PEA a row of garages and storage units was located at the rear of Carmarthen House (Photo 13). The rendered single storey structures possessed wooden and metal garage doors, with a combination of corrugate metal and fibreglass roofs with wooden fascias.

- 3.16 In the subsequent years post 2022 PEA (BE, 2022) the garages hadn't deteriorated further with gaps still located beneath the fascias and access points. However, the eastern broken windows had been boarded up.

*Photo 13: Row of garages and storage units at rear of Carmarthen House (View looking north west).*

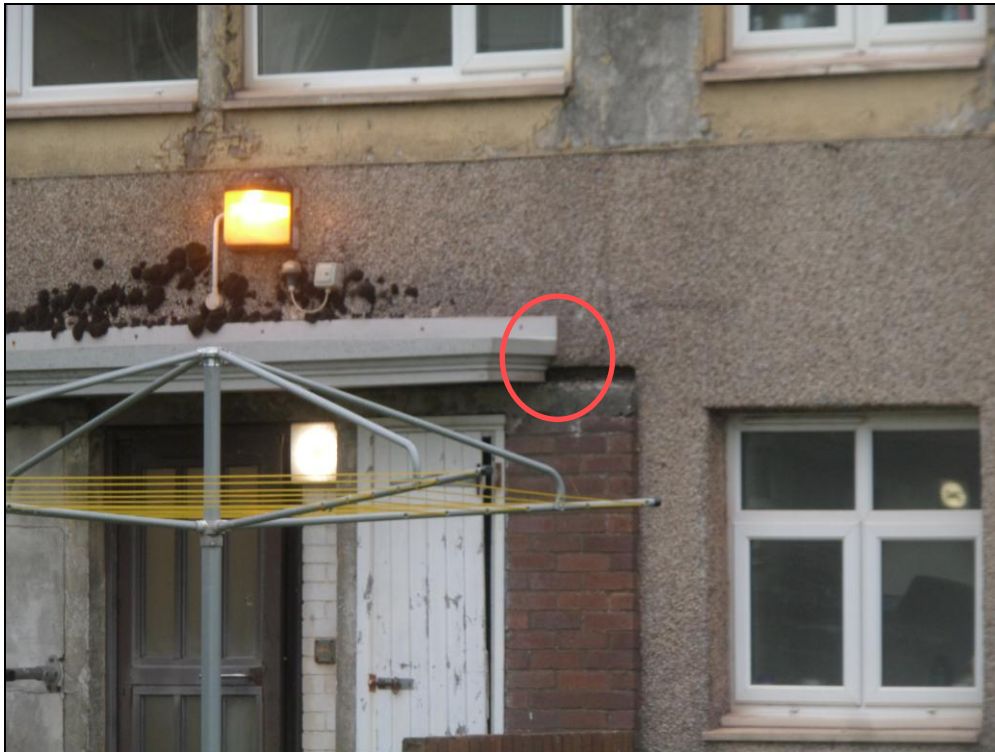
3.18 During the survey multiple active Starling *Sturnus vulgaris* (Photo 14) and House Sparrow *Passer domesticus* (Photos 15 & 16) nests were identified on each of the structures with young Starlings also identified being fed by their parents in the site curtilage. Starling and House Sparrow are listed as Red and Amber on the Birds of Conservation Concern Wales 4 (Johnstone et al., 2022).

**Photo 14: Location of Starling nest above porch on Cardigan House.**

- 5.7 Multiple nesting Starling and House Sparrow were recorded in the structures; whilst the marginal scrub was also considered to be potentially suitable nesting bird habitat. Given The proposed refurbishment, demolition and vegetation clearance works should be undertaken outside the bird-breeding season (i.e. clearance between September and March inclusive) or preceded by a visual check for nesting birds. All wild birds are protected against killing and injury under the Wildlife and Countryside Act 1981 (as amended) and their nests against damage or destruction whilst in use or being built. To offset the loss of nesting bird habitat it is proposed that at least 22 No. Starling Boxes and 22 No. House Sparrow Terraces will be placed on the northern and eastern elevations of the structures (Appendix III).

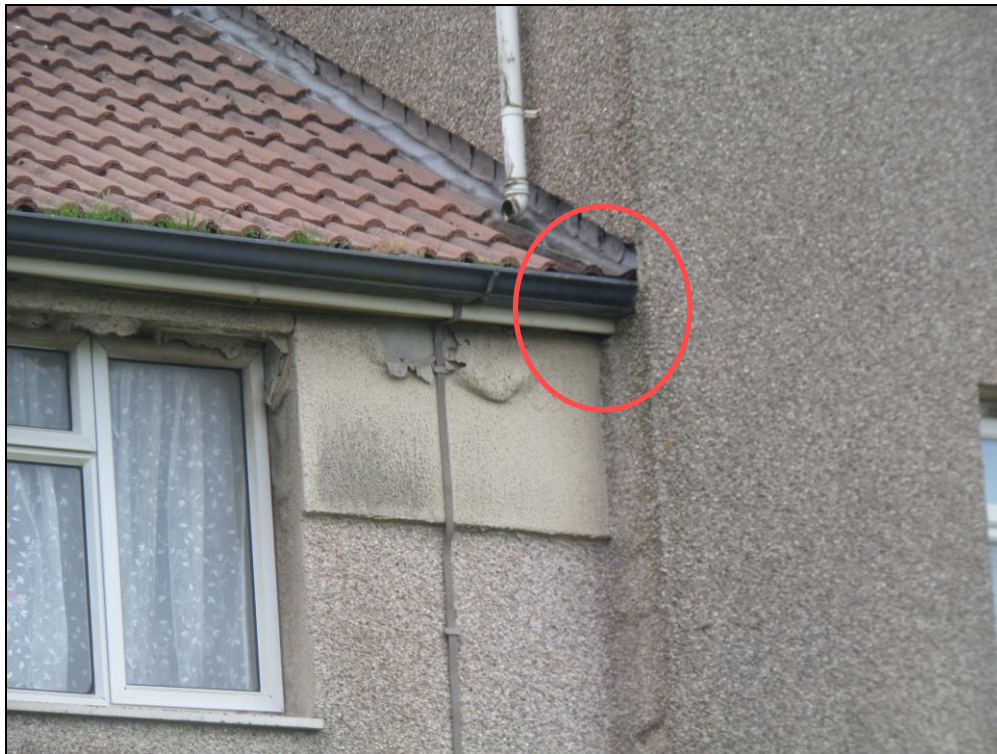
***Photo 15: Location of House Sparrow in soffit of Carmarthen House.***

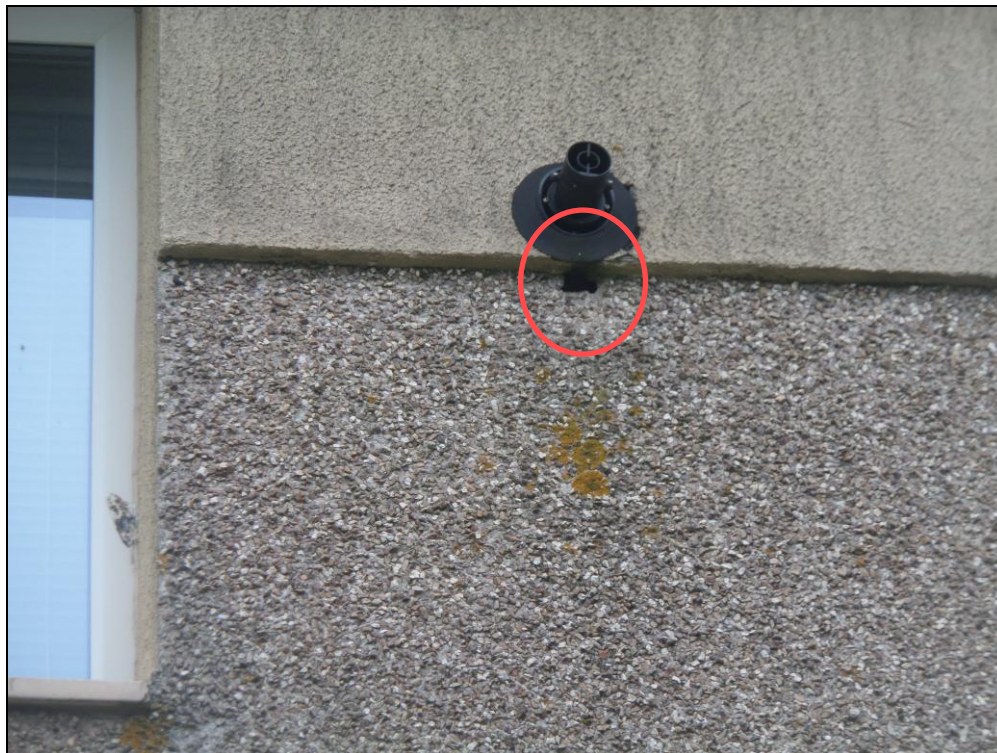
***Photo 16: House Sparrow below flue on Carmarthen House.***

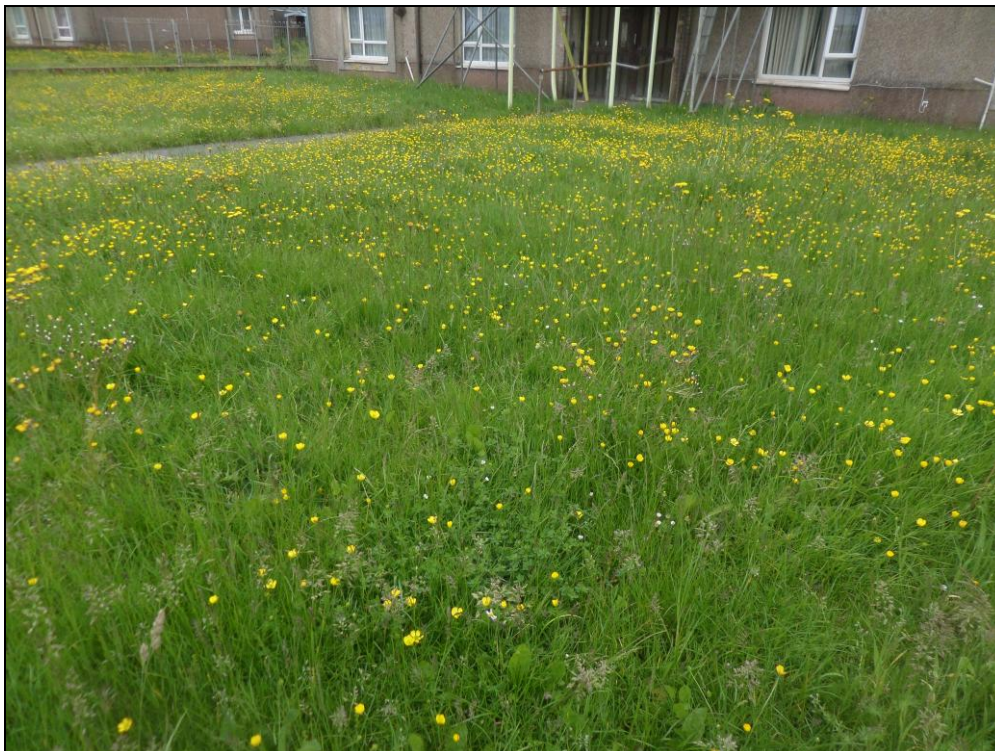
- 3.20 As identified within the 2022 PEA the site footprint was dominated by buildings, hard standing and amenity grassland areas (lawned areas). In the 2022 PEA the survey was conducted during a prolonged dry period of weather and after the grass had been mown resulting in a short sward length. However, the grass had yet to be cut prior to the 2024 updated PEA (Photo 17).

*Photo 17: Amenity grassland areas located west of Carmarthen House (view looking east).*

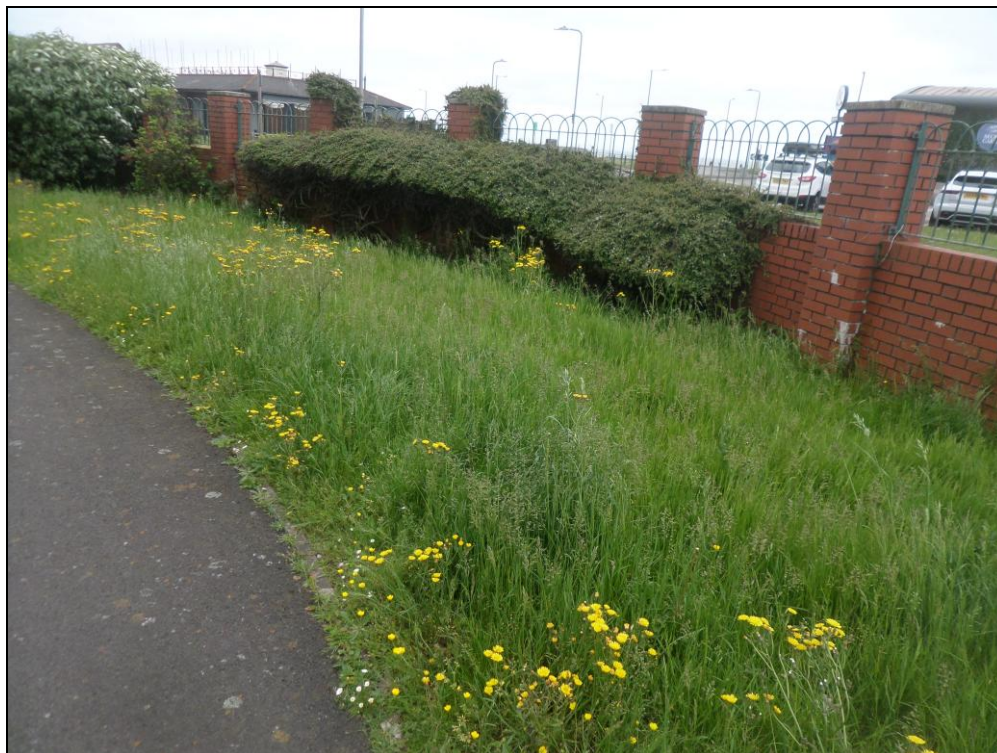
- 3.21 The grassland was generally of limited botanical interest and was comprised of such species as Annual Meadow Grass *Poa annua*, Yorkshire Fog *Holcus lanatus*, Ribwort Plantain *Plantago lanceolata*, Creeping Buttercup *Ranunculus repens*, Hawkbit *Leontodon* sp. and Yarrow *Achillea millefolium*. However, the margins were becoming more diverse with species such as Soft Brome *Bromus hordeaceus*, Common Bent *Agrostis capillaris*, *Brassica* sp. and Black Medick *Medicago lupulina*. In the sandier areas of soil in the margins coastal species such as Buck's-horn Plantain *Plantago coronopus* and Wall Barley *Hordeum murinum* were evident. The amenity grassland located in the front curtilage of Carmarthen House was bordered by ornamental shrubs (Photo 18).

Photo 18: Ornamental shrubs located south of Carmarthen House (view looking south).
