## Public Toilet and Car Park, Pontneddfechan Proposed Leisure Development Exploratory Investigation

Report Reference: ESP.8715.03.4351

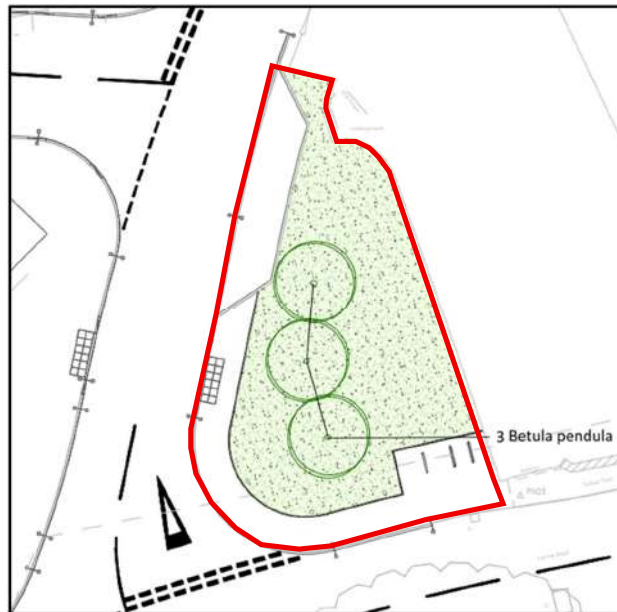
Insert 1 - Insert 1: Proposed Development Layout. Ref: DLA-2228-L-02-RevP13 (2024)

The proposed redevelopment in this area will comprise the demolition of the existing WC block and replacement of the existing hardstanding with a layby, pavements and soft landscaping. It is understood that there will be no significant changes to the current ground levels. The proposed development layout is presented as Insert 1.

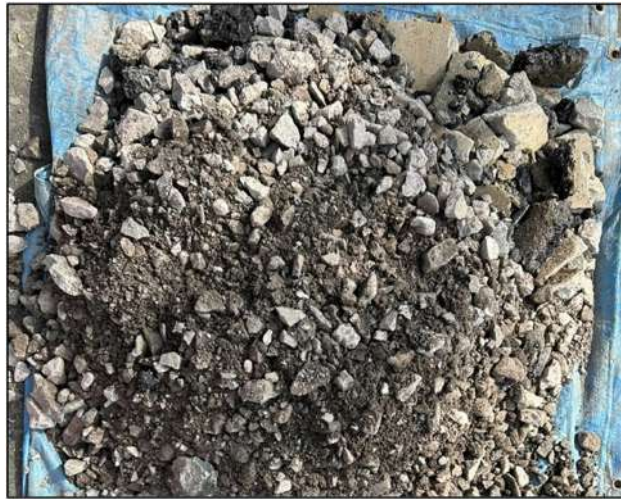
**Made Ground (Probable Sub-base):** encountered to depths between 0.15m – 0.2m and 0.4m – 0.5m in HP202 – HP204 as a medium dense, grey, sandy fine to coarse, sub-angular to angular gravel of mudstone, with low to high cobble content.

Insert 3 – Probable Sub-base encountered in HP202 to HP204 beneath the paving slabs

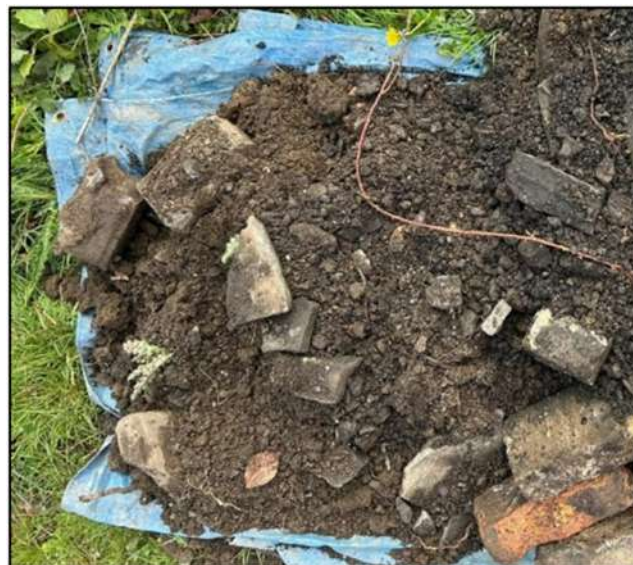
**Made Ground:** encountered to a maximum depth of 0.4m in HP201 as a soft black gravelly SILT with rare coal fragments and occasional brick and concrete.

Insert 4 - Made Ground encountered in HP201

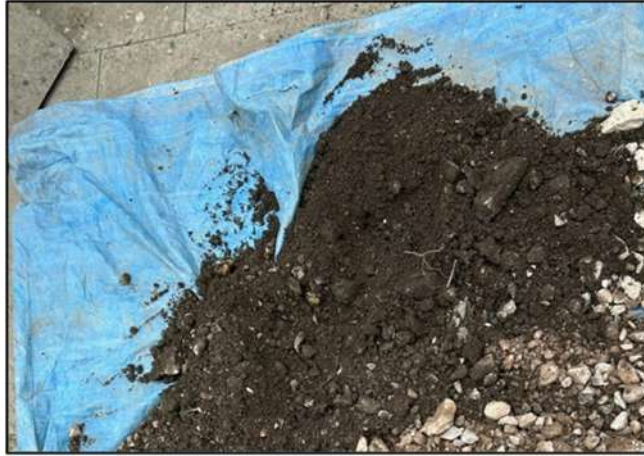
Encountered in all pits (including beneath the sub-base) to depths of 1m as a loose to medium dense, dark grey to black silty sandy sub-angular to very angular gravel of mudstone, brick and concrete, with occasional ceramic fragments, and low to medium cobble content.

Insert 5 - Made Ground encountered in all hand pits

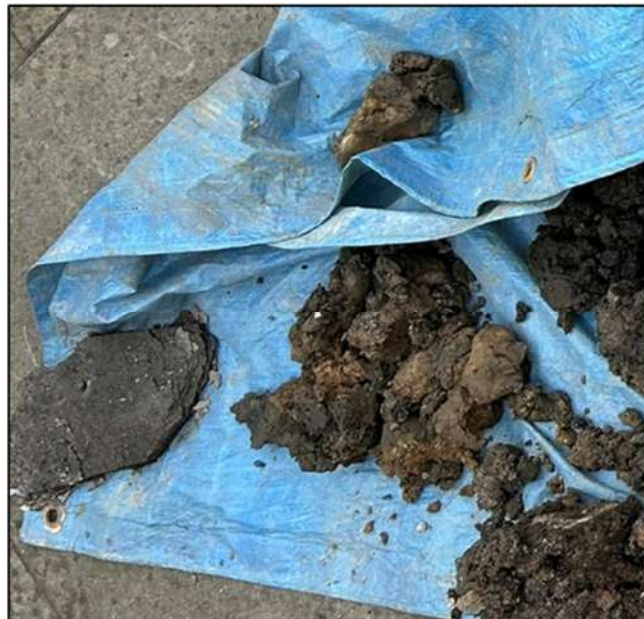
**Possible River Terrace Deposits:** encountered in HP203 between 0.75m – 0.85m as very stiff, brown mottled dark brown gravelly clay. It cannot be discounted that this consists of re-worked natural soils.

Insert 6 - Possible River Terrace Deposits encountered in HP203

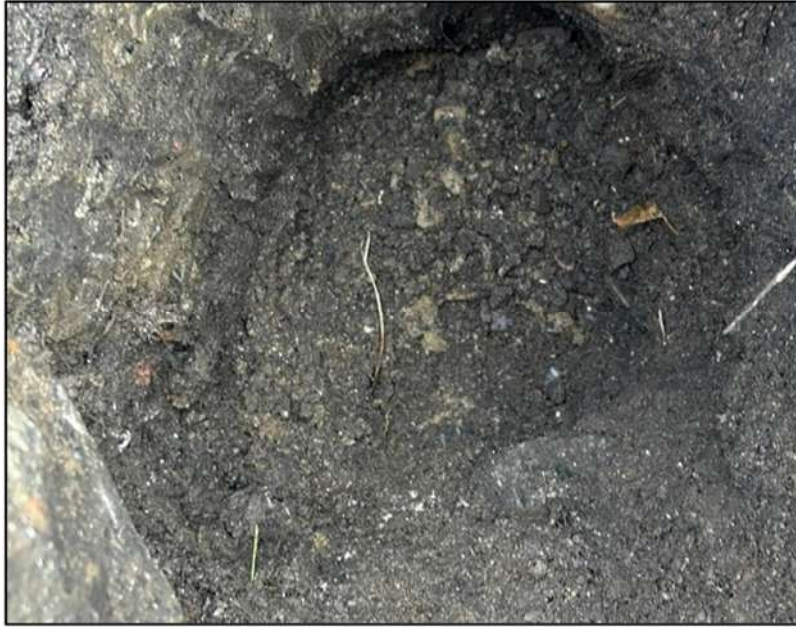
**Possible Weathered bedrock:** encountered in HP201 and HP202, at depths of between 0.85m – 1.0m and 0.9m – 1.05m respectively, recovered as very dense gravel and cobbles of very angular sandstone/mudstone. We cannot discount that these strata could represent re-worked natural soils.

Insert 7 - Possible weathered bedrock encountered in HP201 and HP202. (Note: ground conditions within this stratum were too difficult to extract samples via hand excavation)
