# FORMER CLUN PRIMARY SCHOOL, CLYNE, NEATH, SA11 4BW

## Verification Report

Report No. Q0320-12/VR

May 2025

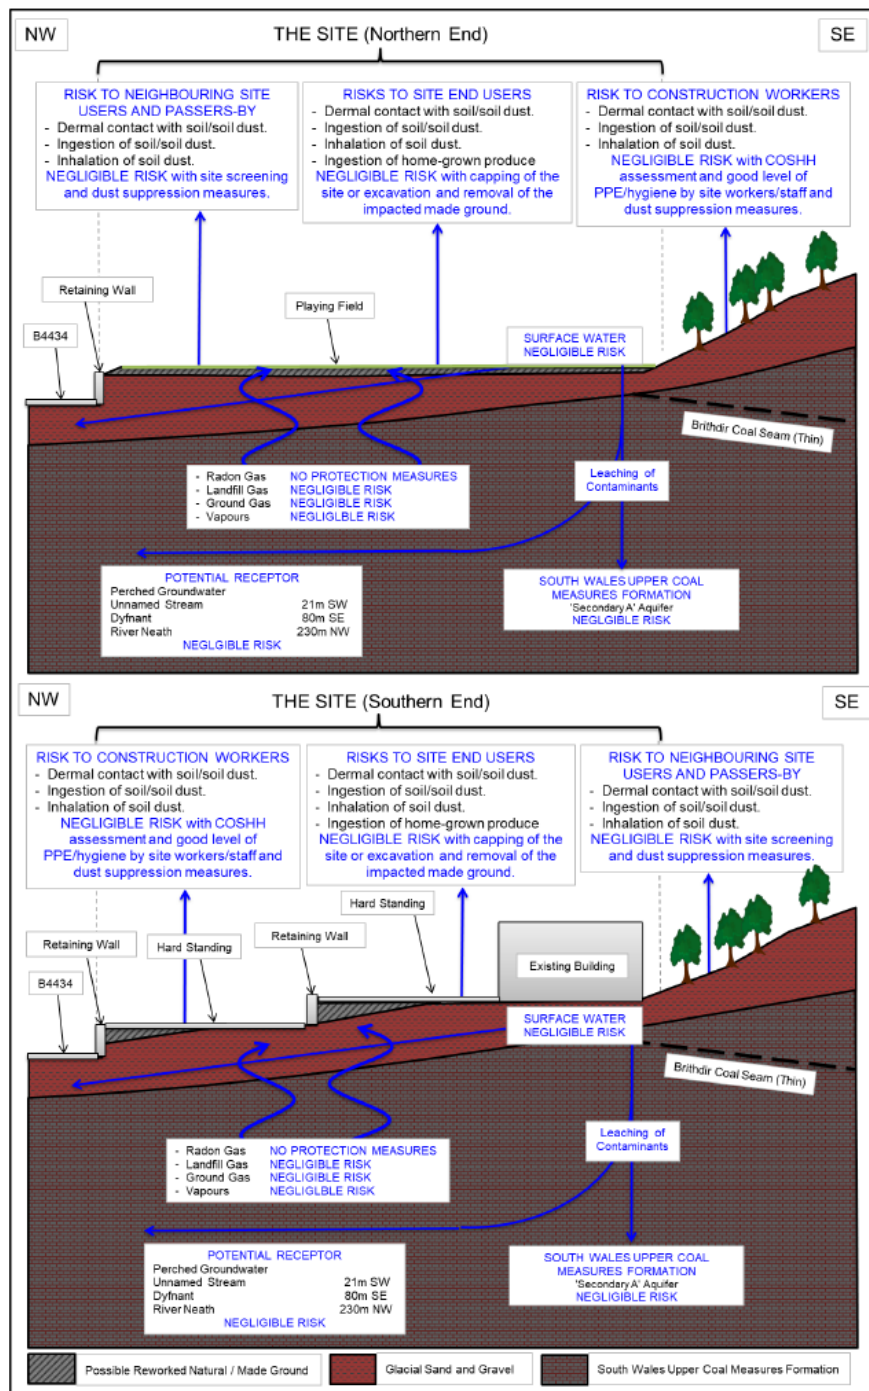
Figure 6.1: Refined Illustrative Site Conceptual Model (not to scale)

The report included an illustrative Site Conceptual Model (as Figure 6.1 in TF1) as below.

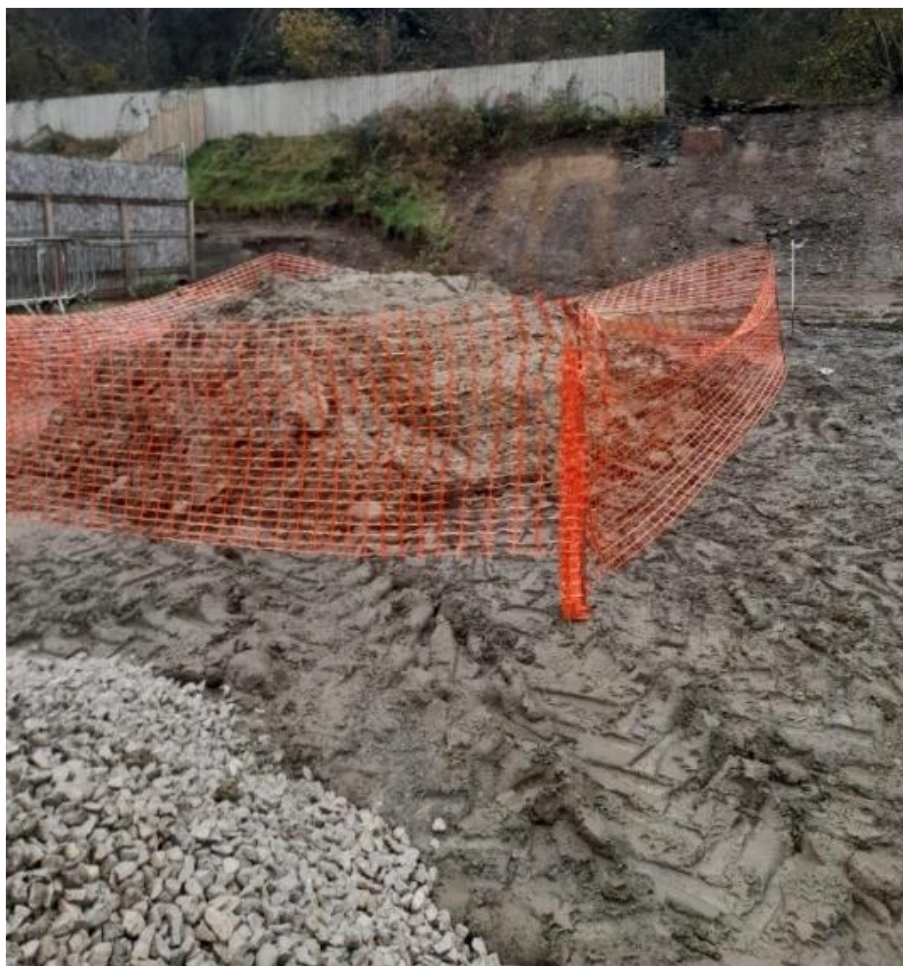
In order to satisfactorily carry out the necessary remediation of the PAH hotspot (at TP-A identified in Report TF2) Sterling UK Construction initially delineated the area of the hotspot, as shown in the following site photograph.

The area of impacted contaminated soil was transported by a licenced waste transfer contractor from site. Copies of the waste transfer note are included in Appendix 3.

The soil was transported and disposed of at a suitably licenced waste disposal site. A copy of the Waste Transfer Note showing successful disposal is presented in Appendix 3.

As required by the remediation strategy detailed in TF2, two soil samples were taken from the excavation sides in the in the impacted area. The soil samples were tested for the suite of PAH to determine concentrations particularly of Naphthalene. The test results certificates are presented in Appendix 4.

The test results show all concentrations of PAH's to be below detectable limits.

**This demonstrates adequately that the impacted soils have been removed, thus severing any pollutant link between source and receptor.**

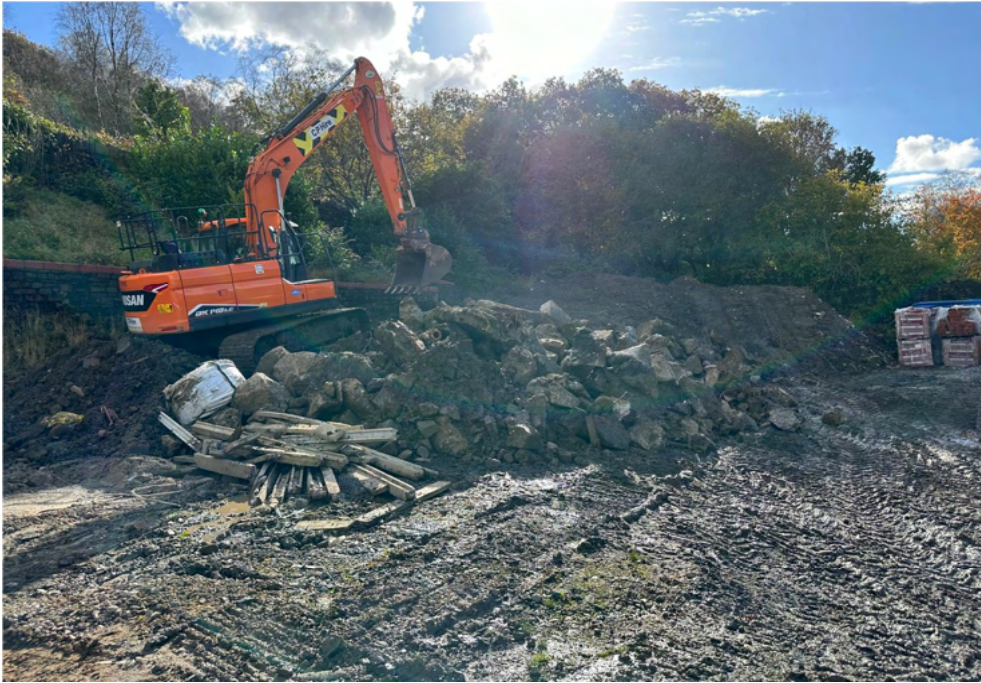
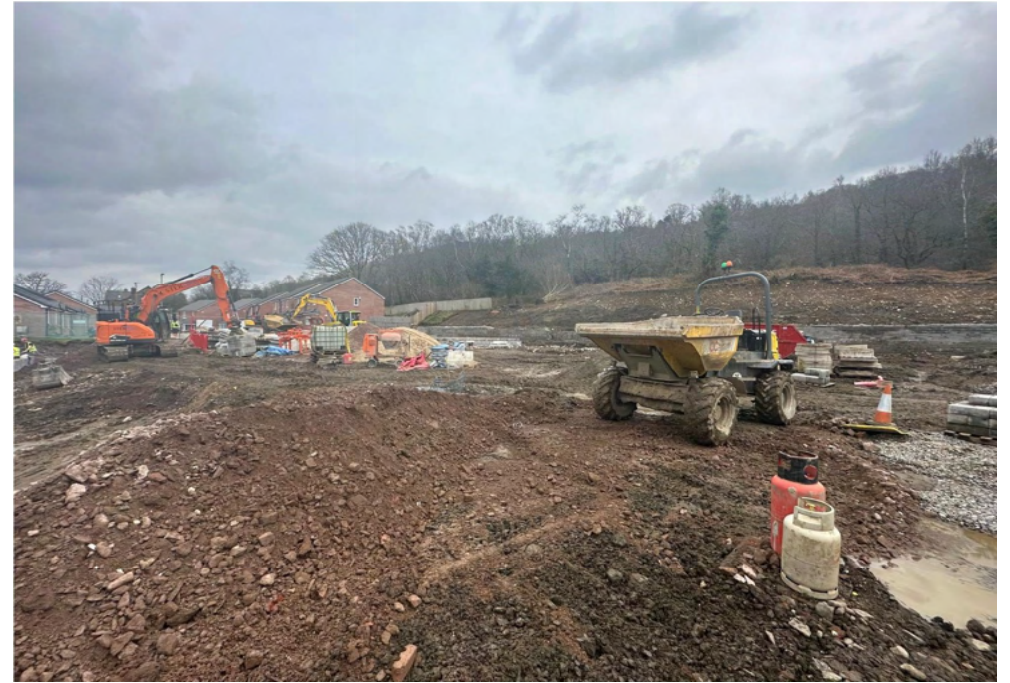
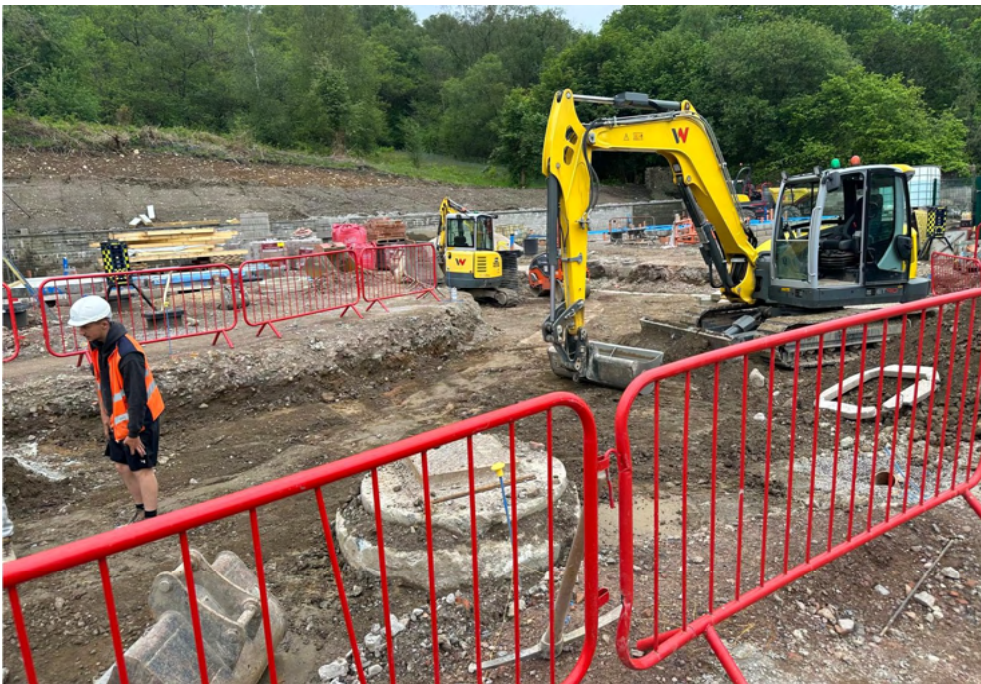
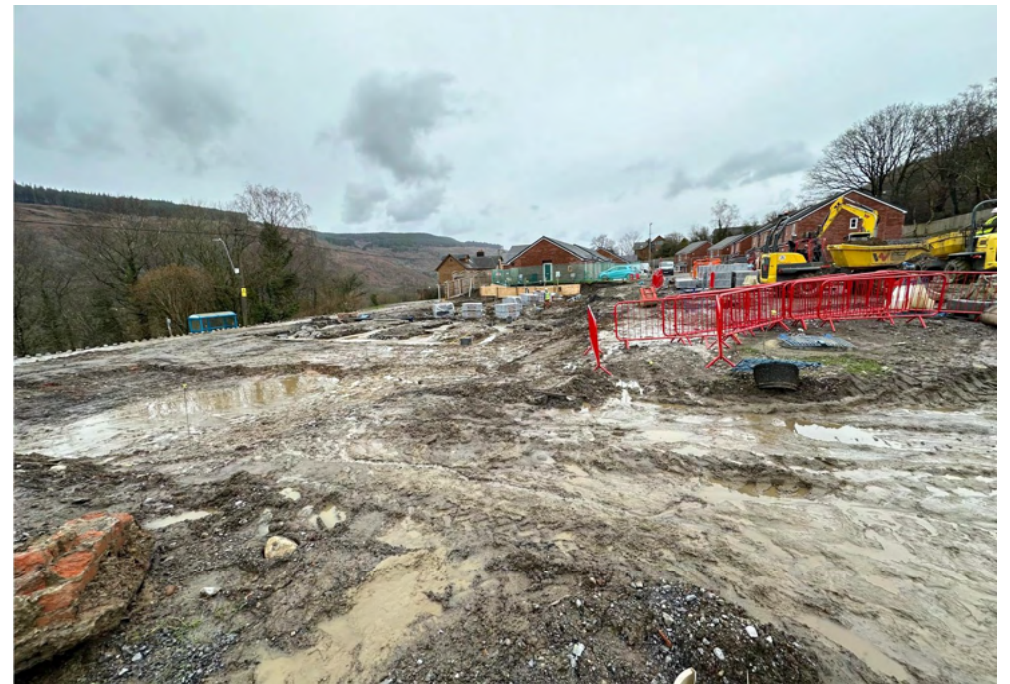
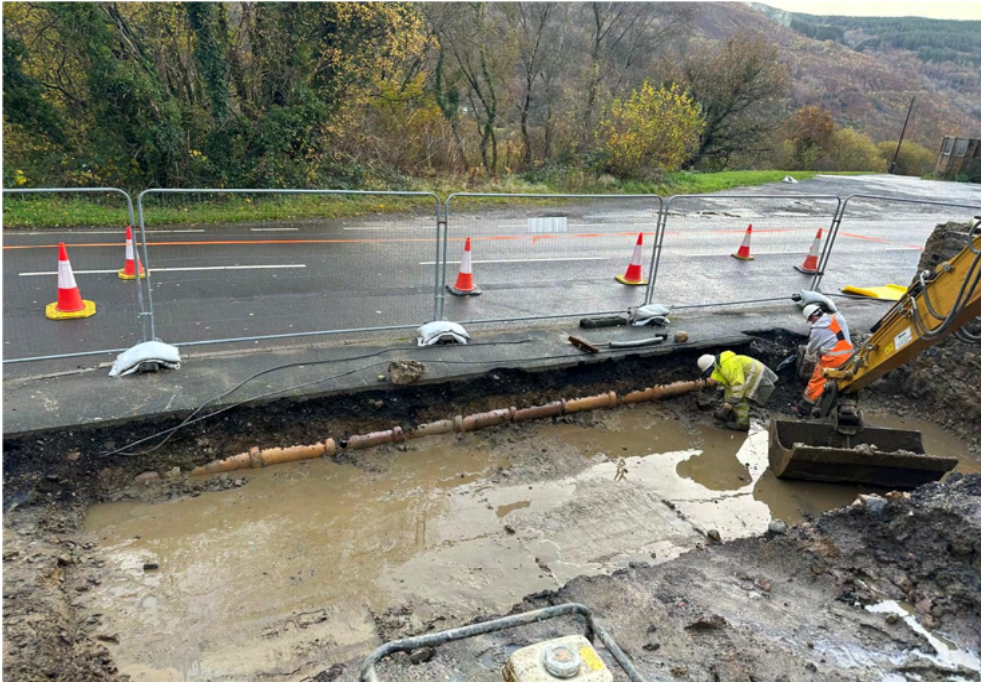
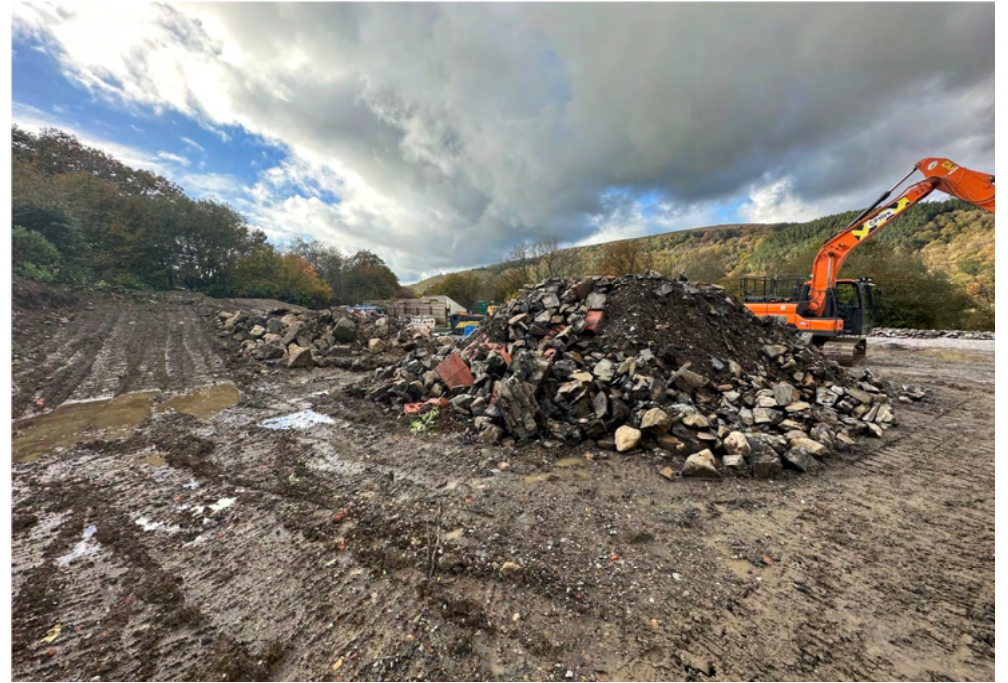
**Record Photographs of Reduced Level Dig**

A series of site photographs showing the reduced level excavation situation. A second series of photographs show the capping cover in various stages of placement, with the separating membrane in place.

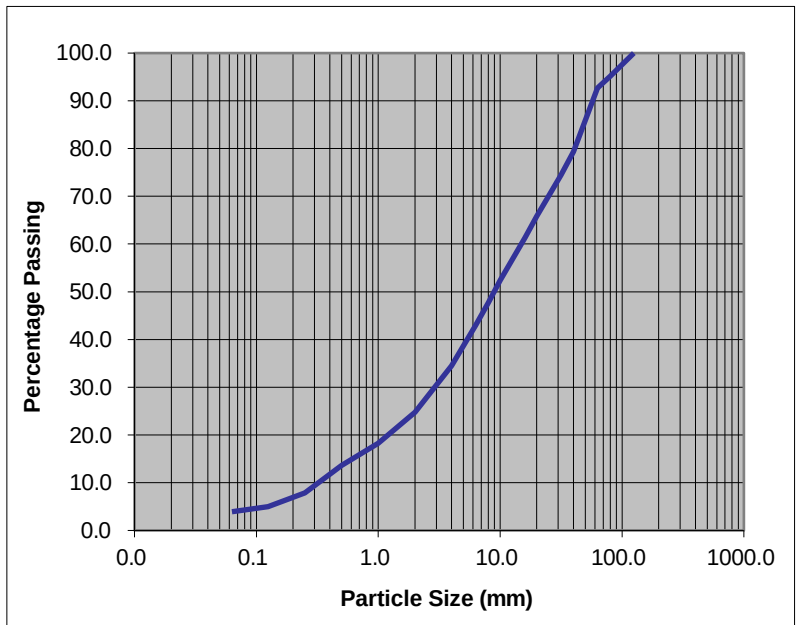
Remarks: Material complies with 6F5 grading requirements.
