# **LLANGATWG SCHOOL, CADOXTON, NEATH PORT TALBOT SA10 8DB HISTORIC BUILDING RECORDING**

REPORT NO. 2025-02  
EVENT RECORD NO. E008746

**LLANGATWG SCHOOL, CADOXTON, NEATH PORT  
TALBOT, SA10 8DB:  
HISTORIC BUILDING RECORDING**

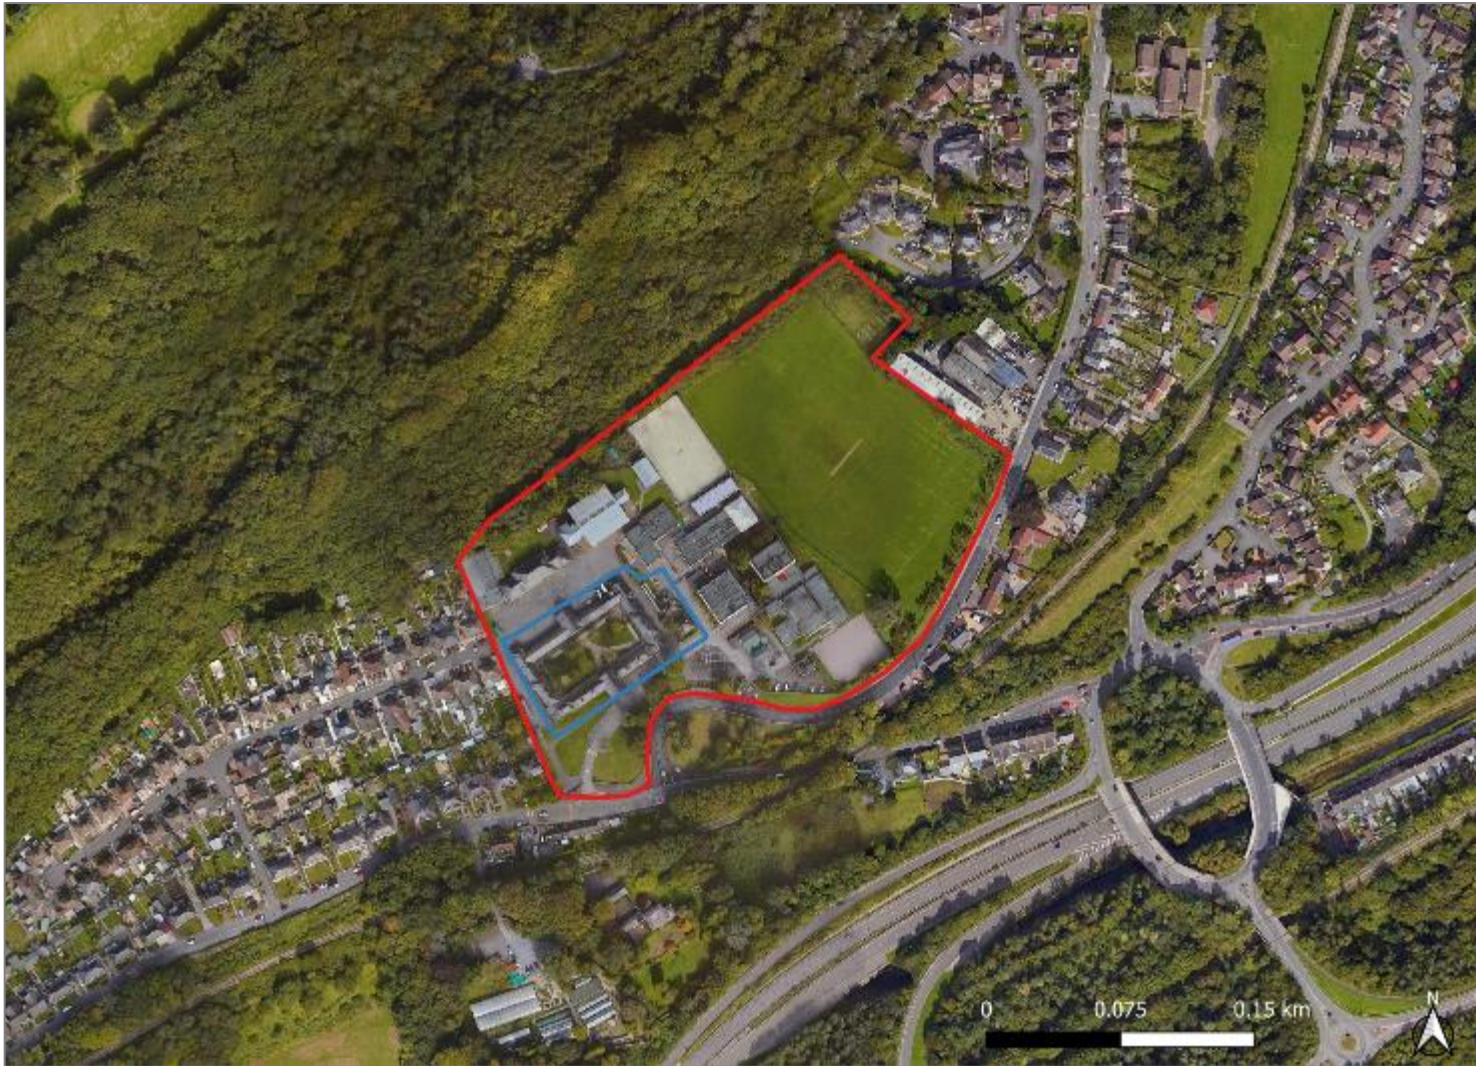
**Figure 2:** Site location detail. The red shows the outline of the school grounds, the blue shows the historic old block and caretakers house buildings.

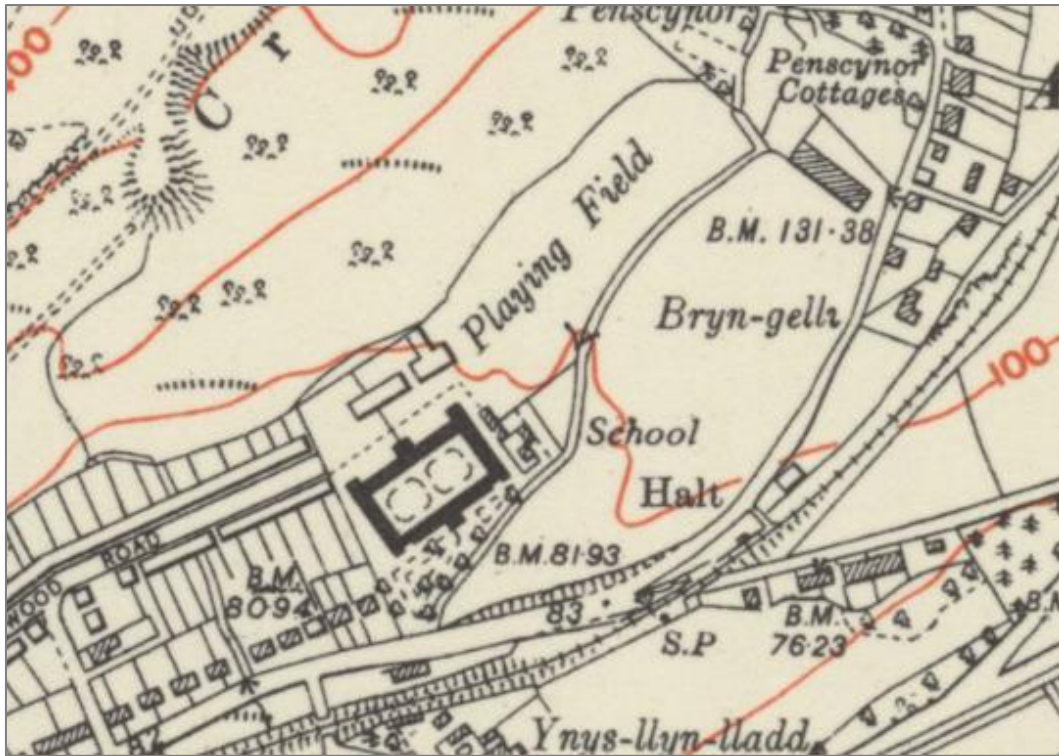
**Figure 4:** An extract from the Ordnance Survey 6-inch map of 1951 showing the school, with the gym and old canteen buildings now visible to the north of the quadrangle. Reproduced with the permission of the National Library of Scotland.

- 3.5 In 1938 a gymnasium was added to the north of the quadrangle, which is probably also when the adjacent canteen building was constructed, although it had certainly been built by 1951 (figures 4 and 5).

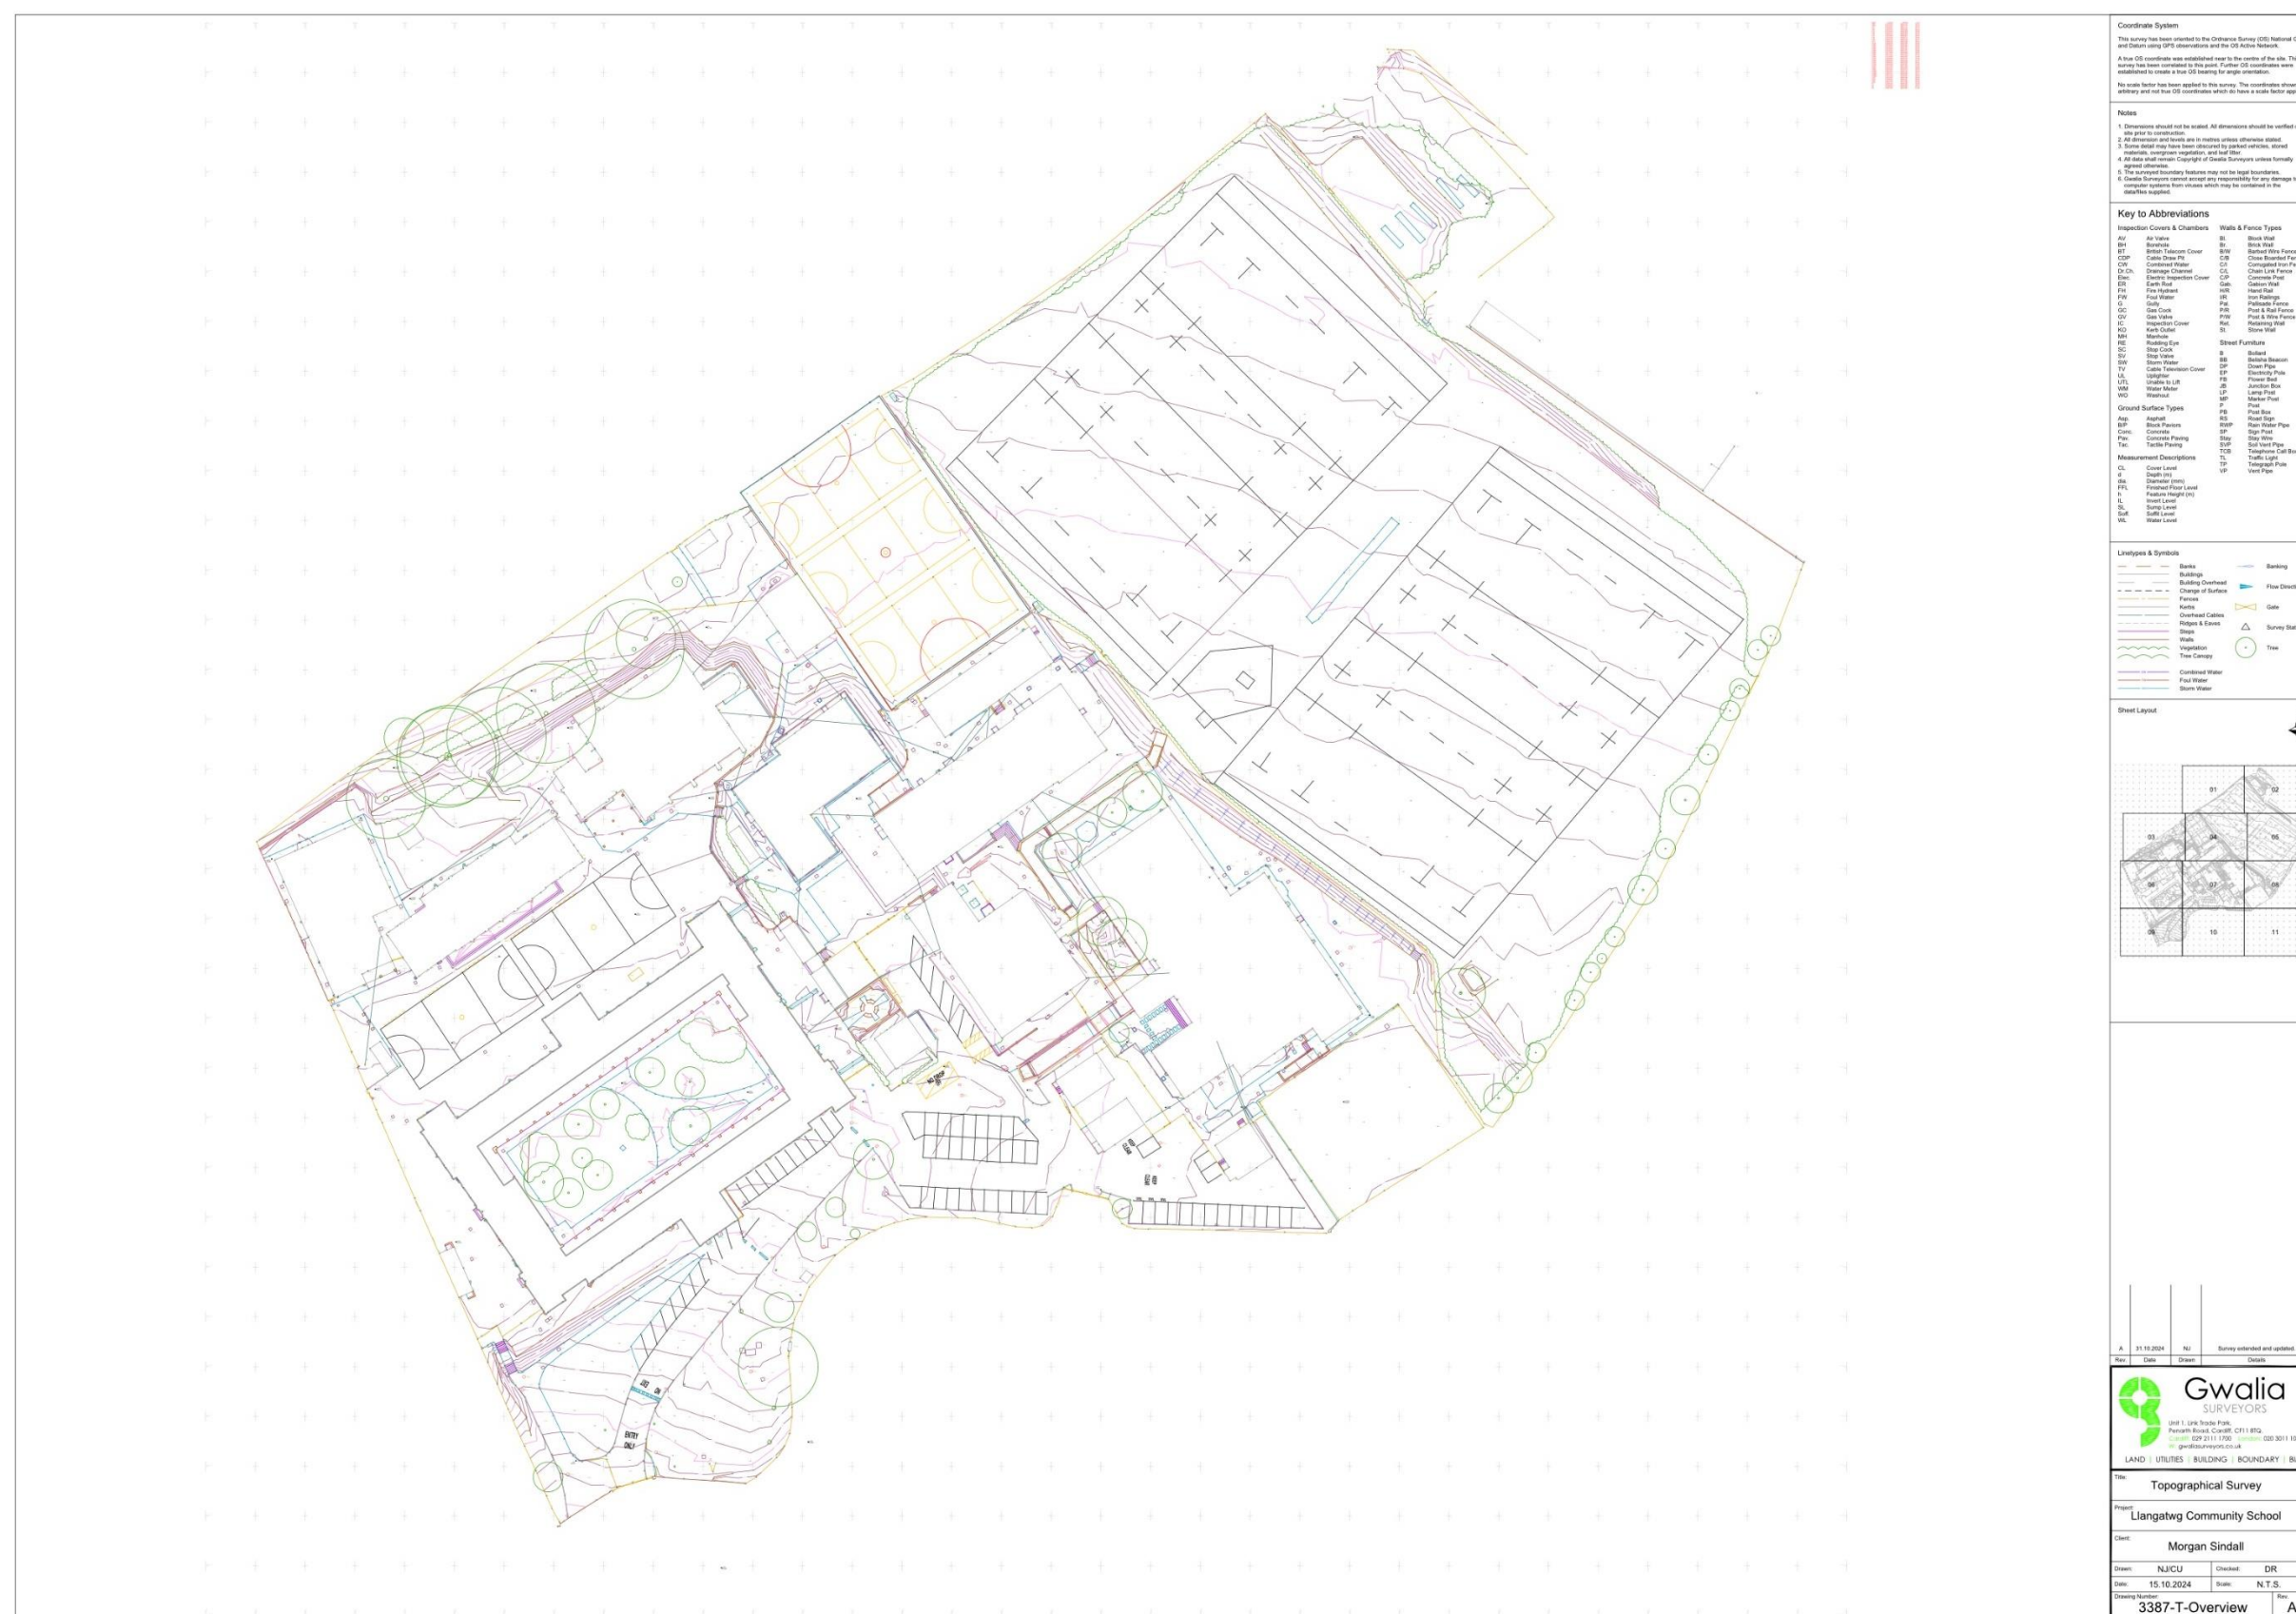
**Figure 7:** Topographical survey of the Llangatwg School site. Survey undertaken by Gwalia surveyors, provided by the client. Not reproduced to scale.

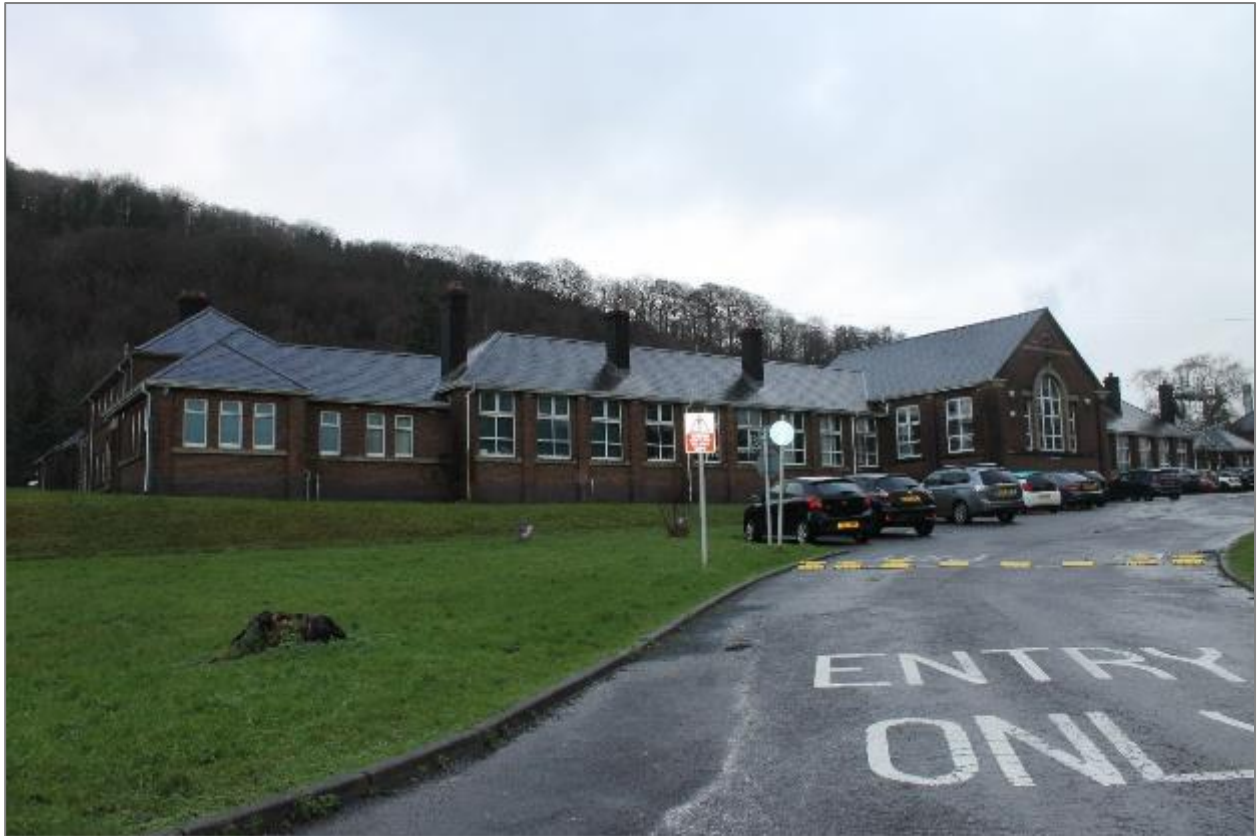
**Photo 1:** Southeast facing façade. Facing north.

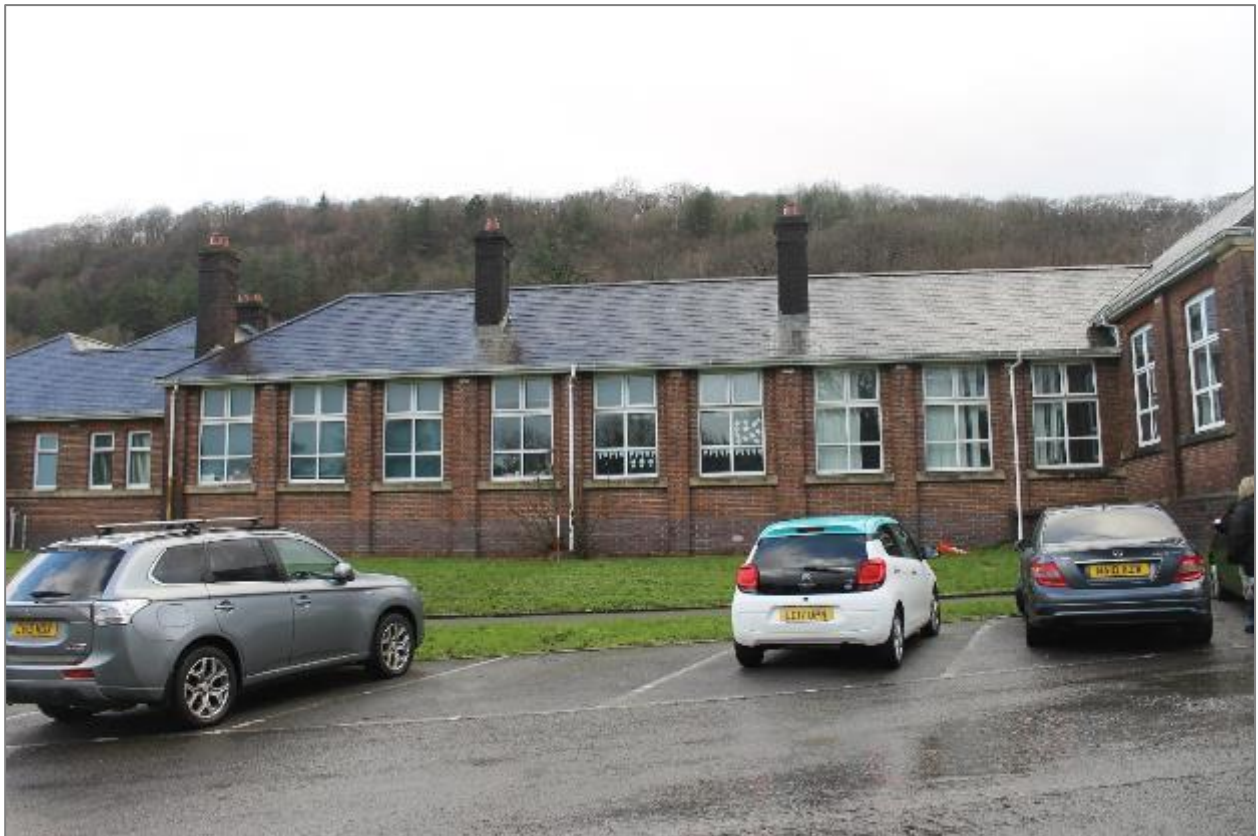
**Photo 2:** Southeast facing façade. Facing northwest. 1 x 1m scale.

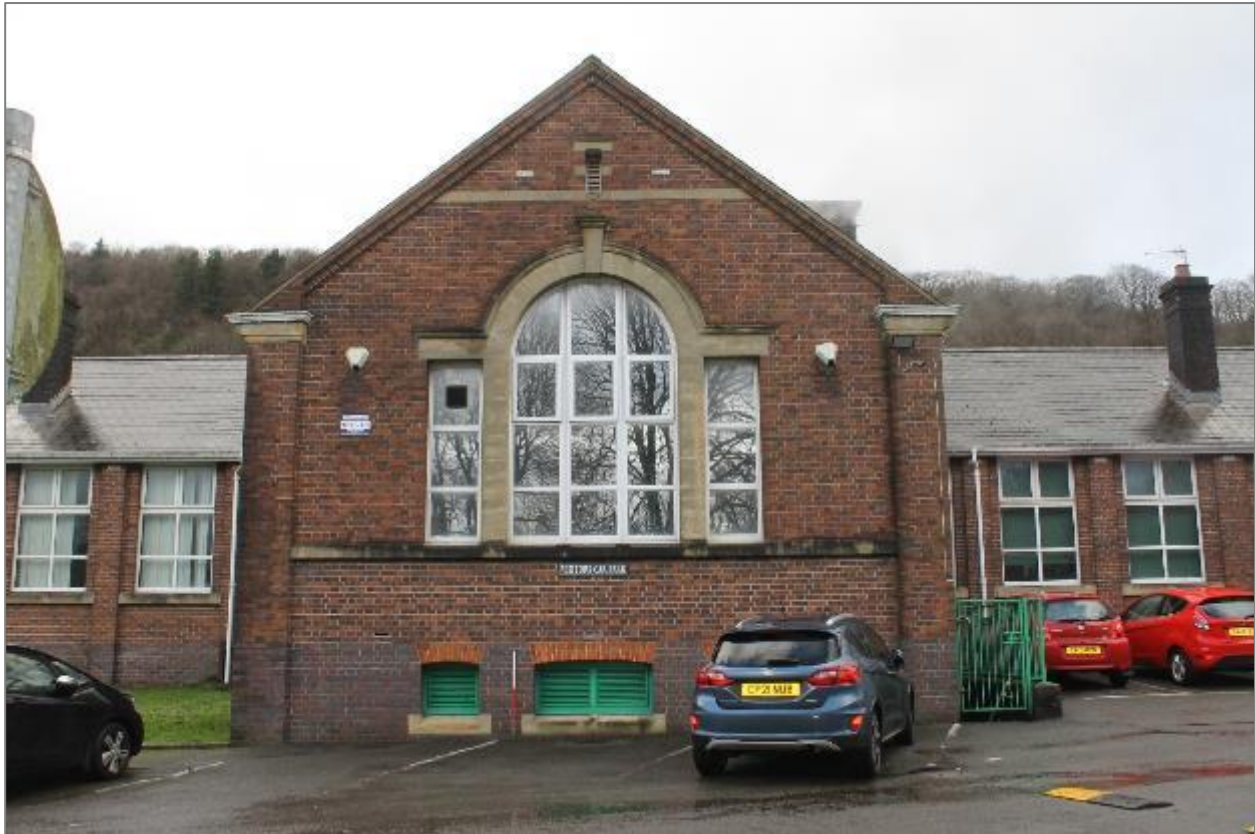
The hall, which protrudes south-eastwards from the centre of the façade, has a gabled slate roof and is of slightly different construction having English brick bonding, however the brick colour is matched, and it also contains the band of darker brick on the lower courses. On the side walls the windows are the same as those of the main façade, with the addition of a flat arch of red brick above. The main southeast facing window is a large arched window, with a smaller rectangular window each side. A decorative oolite arch frames the central window, with a central keystone, all topped with oolite moulding. There is no sill, instead an oolite string course extends almost across the full width of the façade until it meets the buttress at each end. At the top of each buttress is further moulding. The gable wall is framed with two rows of brick laid on end. Above the window keystone, an oolite string course extends across the wall. Above this is a vent with decorative oolite in the reveal, and a small lintel above. Two smaller vents are present each side. At the base of the façade are three vented openings with sandstone sills and red brick arches above, which internally is at the upper level of the basement boiler room, the stairs and access to which are at the northeast facing wall of the gabled hall (photo 3).

**Photo 3:** Southeast facing façade – extending hall. Facing northwest. 1 x 1m scale.

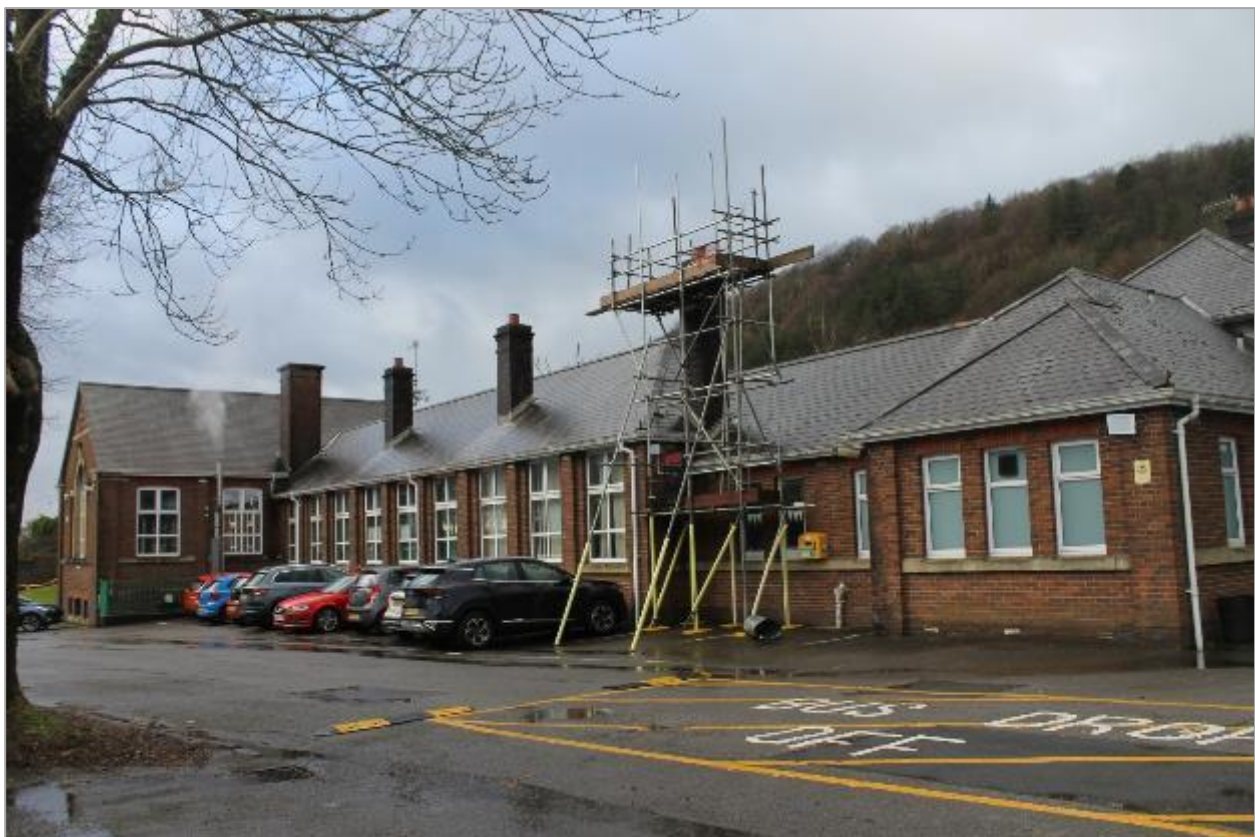
**Photo 4:** Southeast facing façade. Facing west.

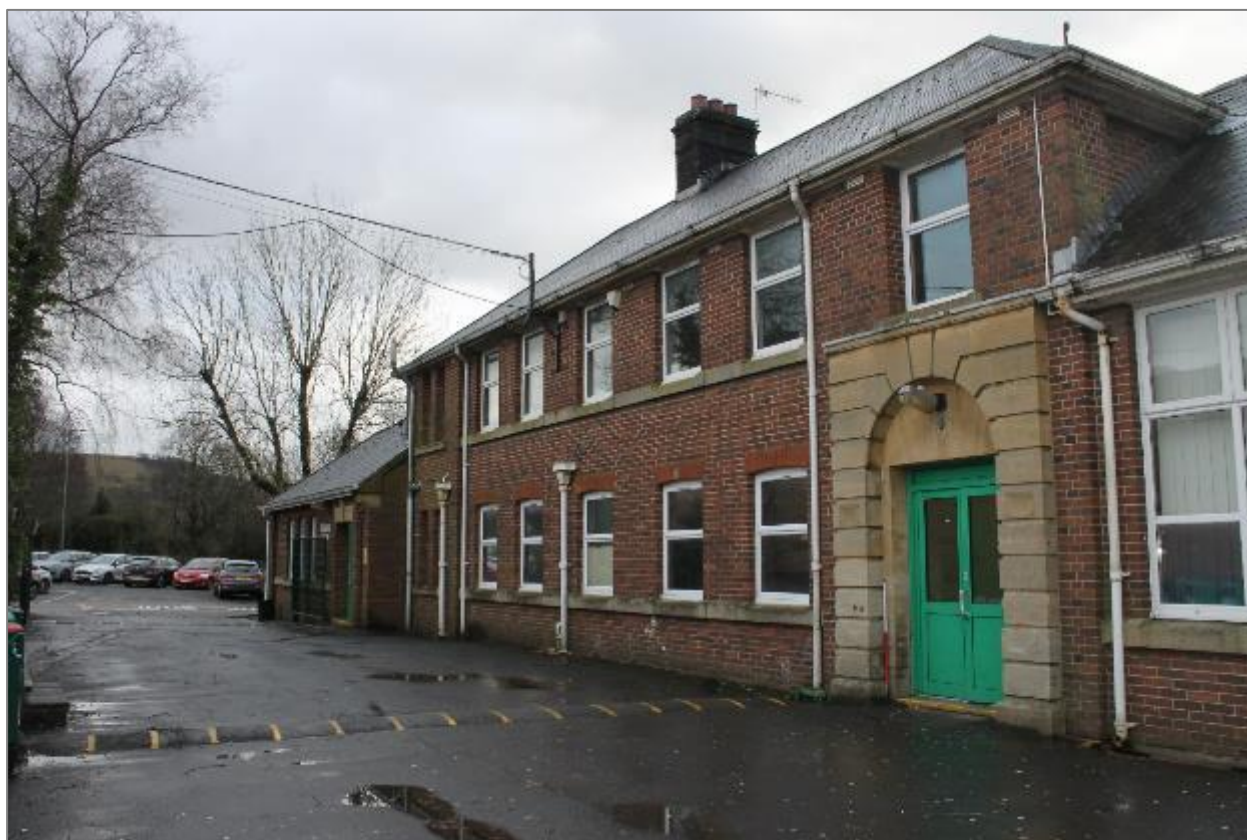
**Photo 5:** Northeast facing façade. Facing southeast. 1 x 1m scale.

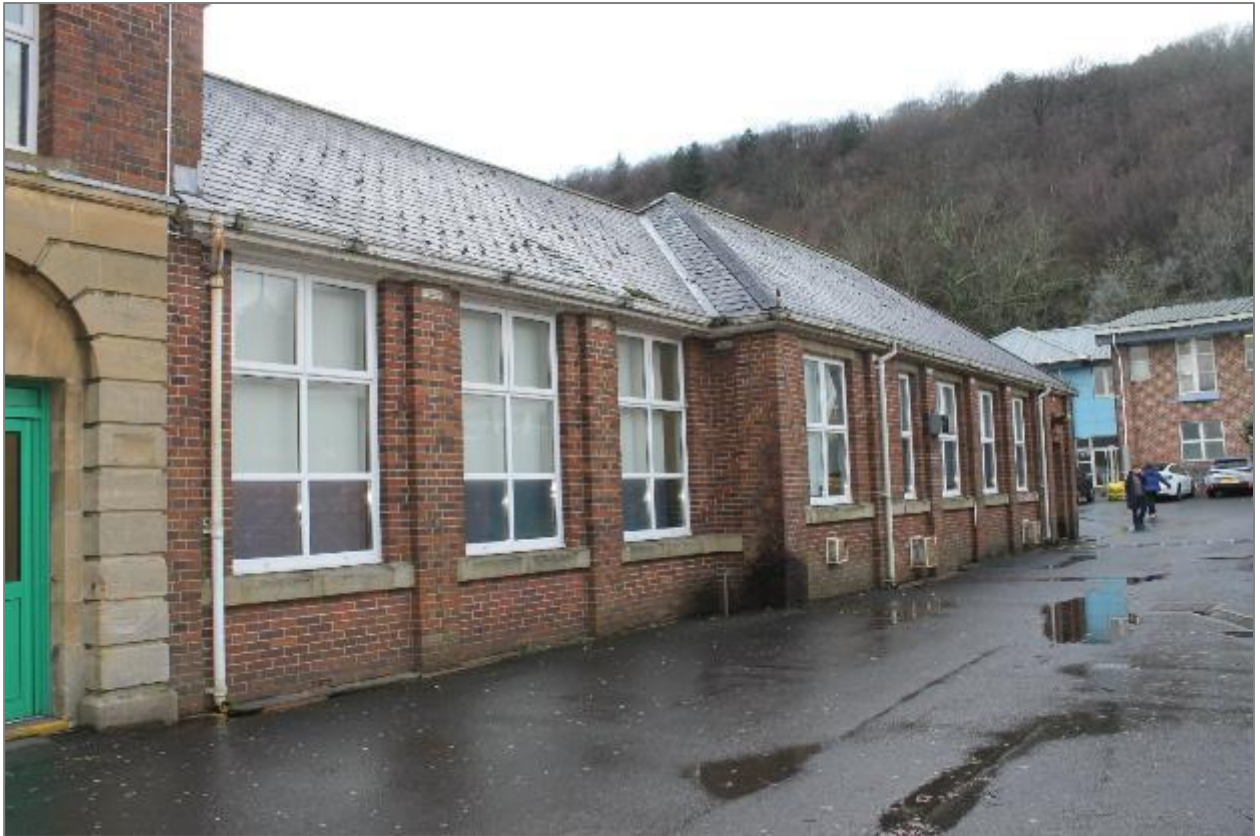
**Photo 6:** Northeast facing façade – north end. Facing northwest.

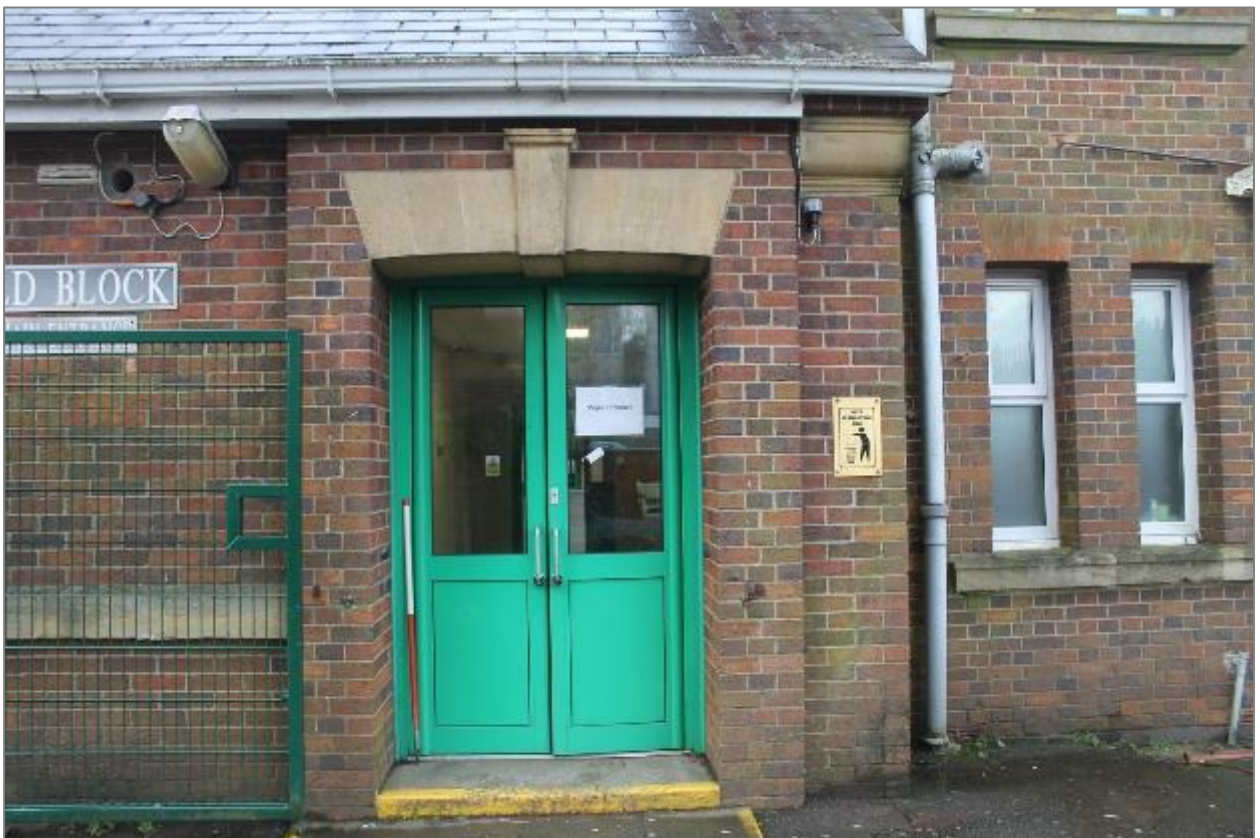
**Photo 7:** Doorway at southern end of northeast facing façade. Facing southwest. 1 x 1m scale.

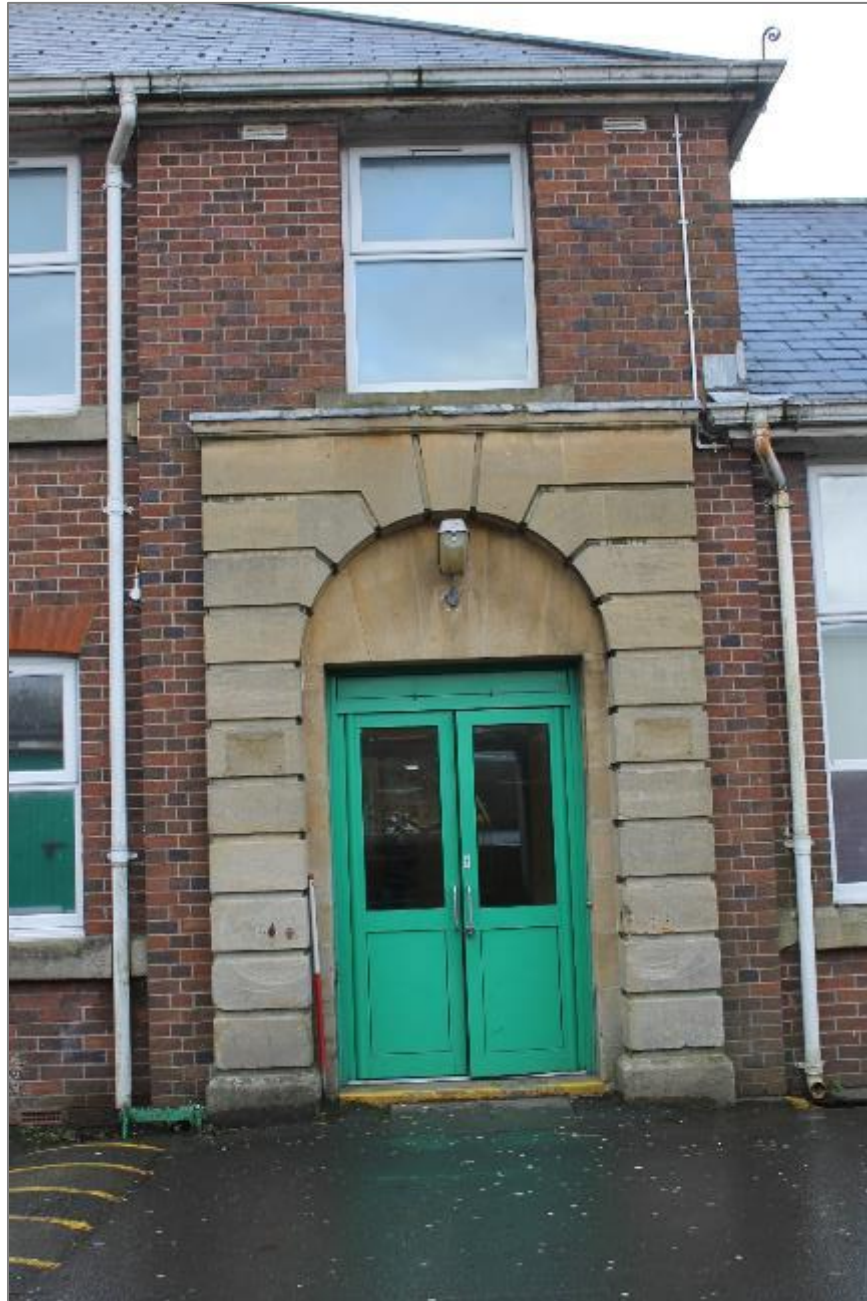
**Photo 8:** Doorway in northeast facing façade. Facing southwest. 1 x 1m scale.

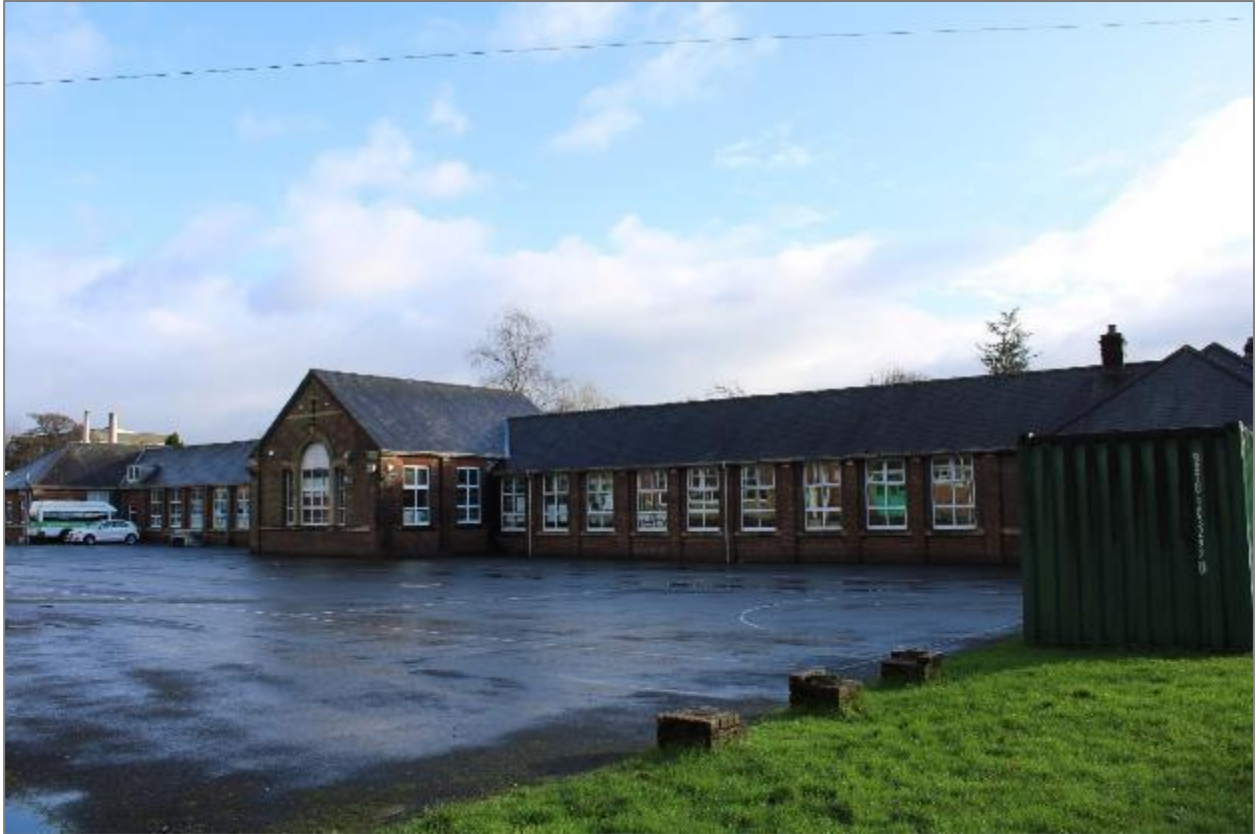
The northwest facing façade shares the same construction and architectural features as the southeast facing façade, save the dimensions of the protruding rooms at the northeast and the southwest corners. There are three windows on the northwest facing side with flat red brick arches above. In place of a sill a string course spans the width of the wall and terminates at the buttresses at each end.

**Photo 9:** Northwest facing façade. Facing east.

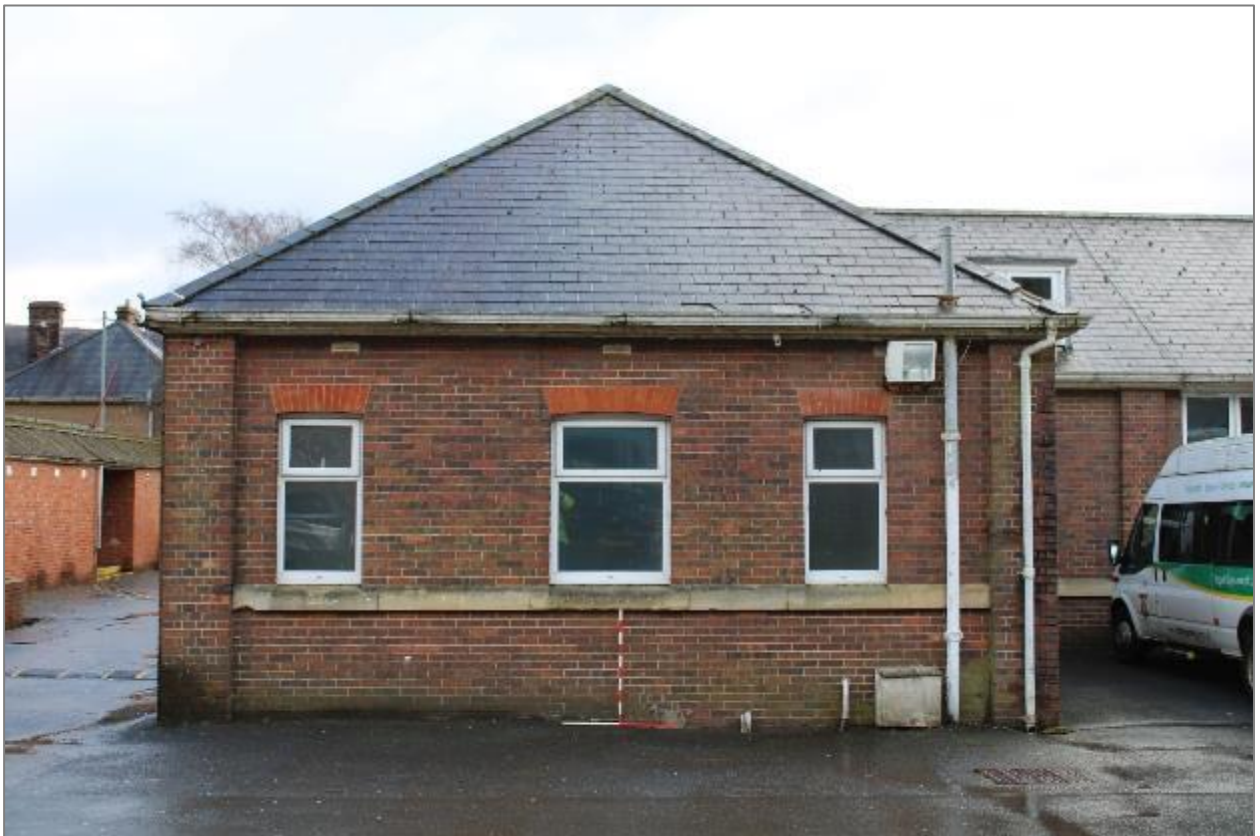
**Photo 10:** Northwest facing façade – northern end. Facing southeast. 2 x 1m scales.

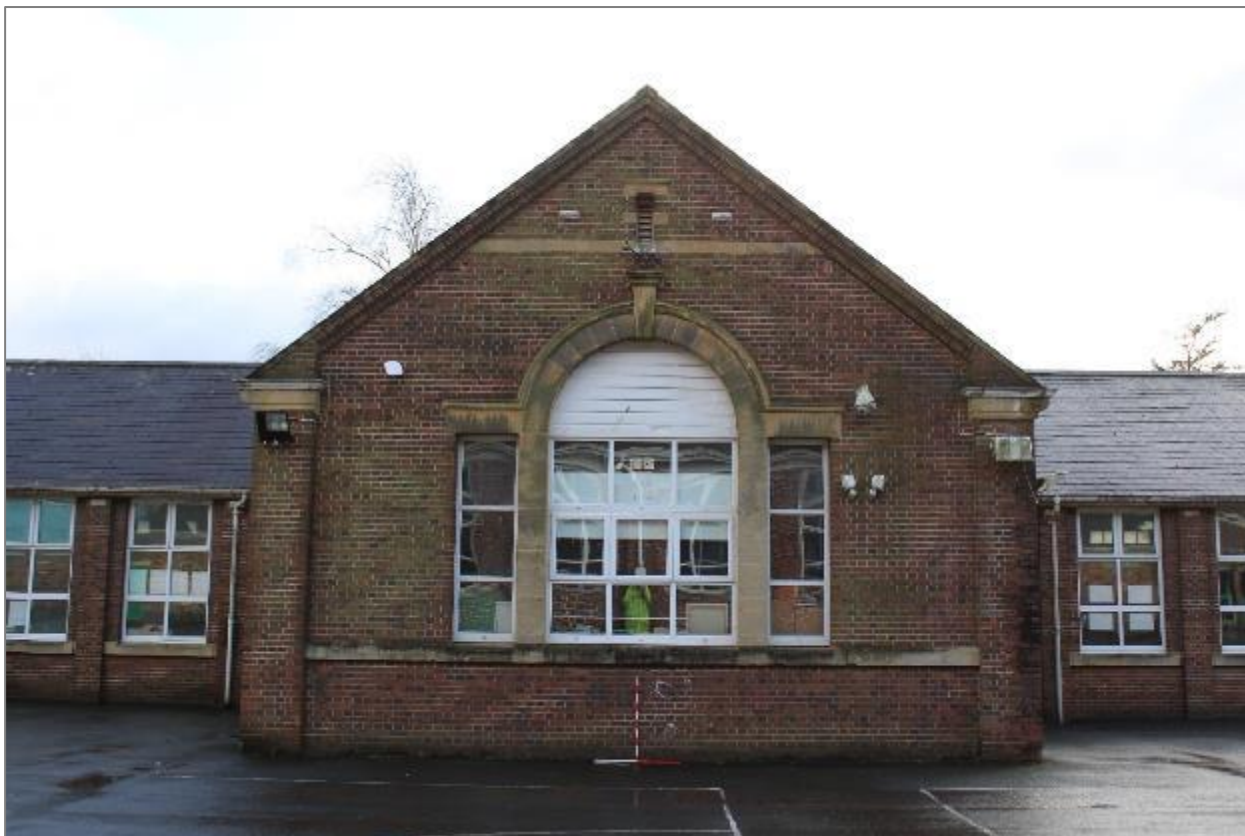
**Photo 11:** Northwest facing façade – central hall. Facing southeast. 2 x 1m scales.

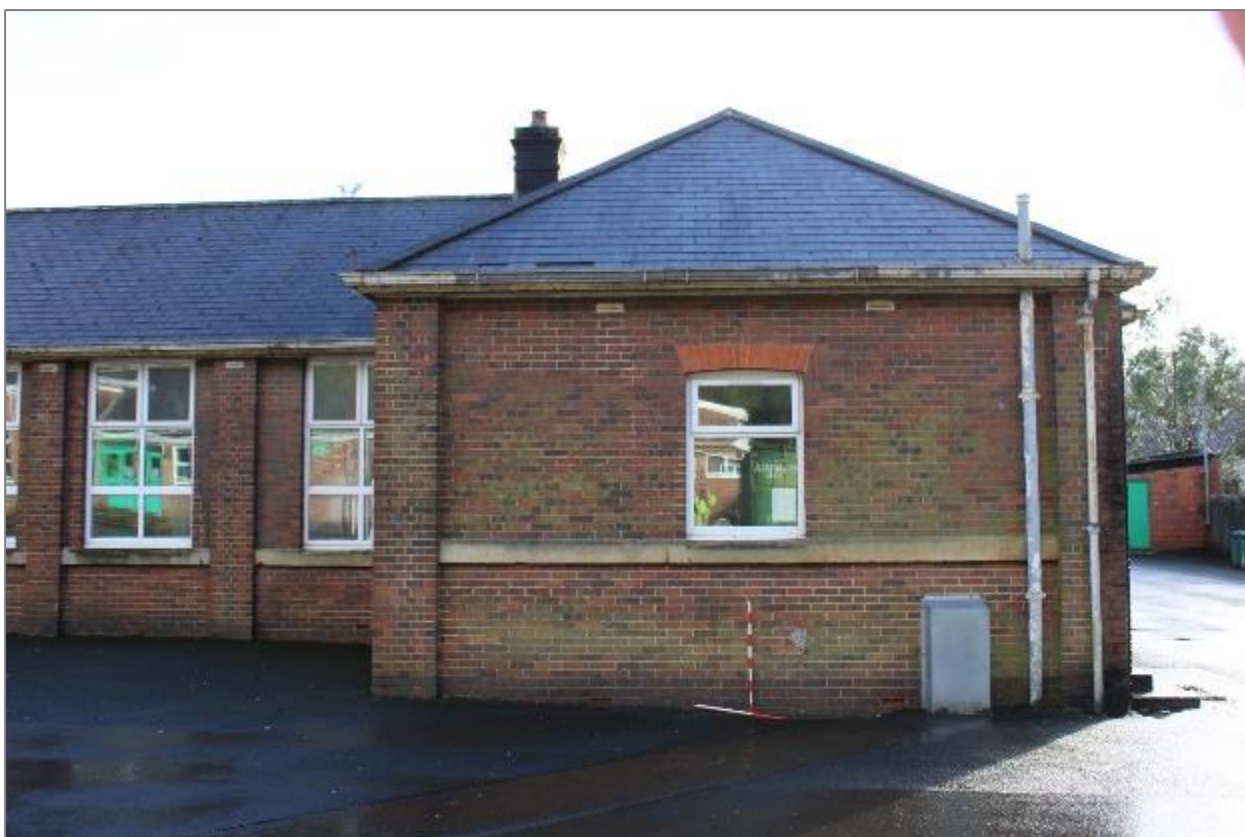
**Photo 12:** Northwest facing façade – western end. Facing southeast. 2 x 1m scale.

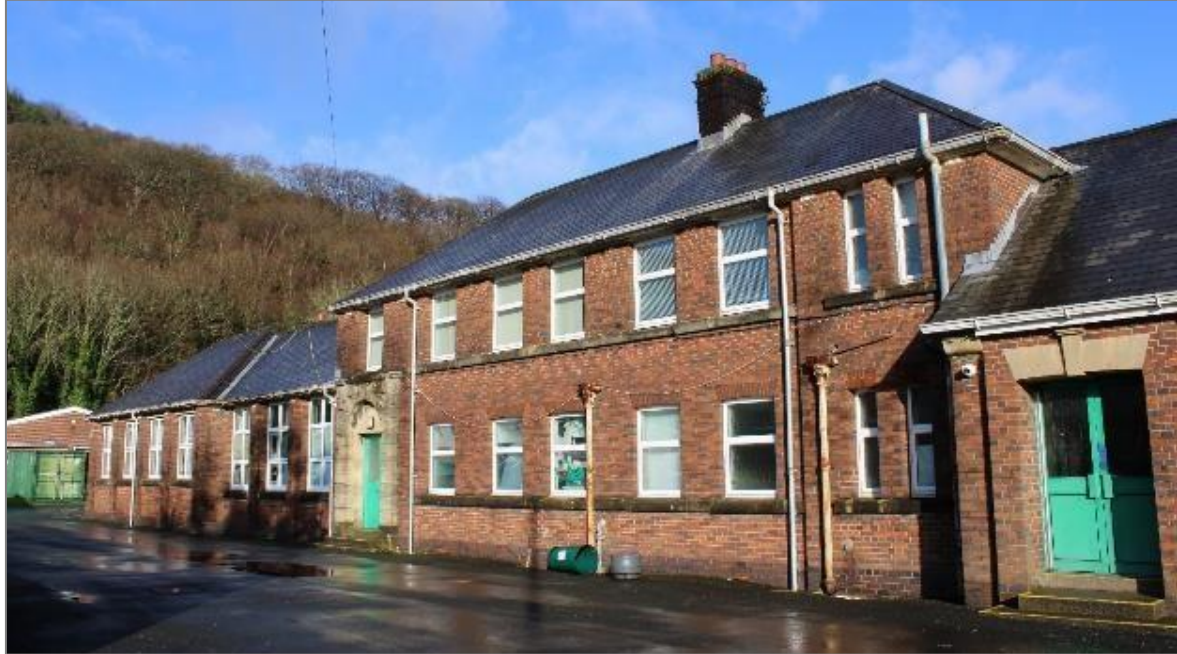
The southwest facing façade shares the same construction and architectural features as that on the northeast save the western end. There are three windows on the northwest facing side with flat red brick arches above. In place of a sill a strong course spans the width of the wall and terminates at the buttresses at each end. As seen on the northeast, there is also a downpipe with decorative features on this façade which may be contemporary with the original construction of the building (photo 15).

**Photo 13:** Southwest facing façade. Facing north.

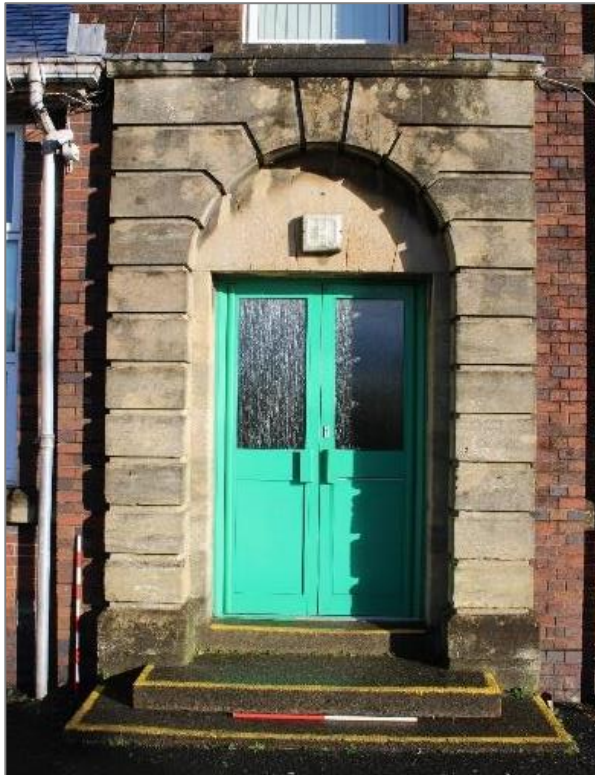
**Photo 14:** Doorway in southwest facing façade. 1 x 1m scale.

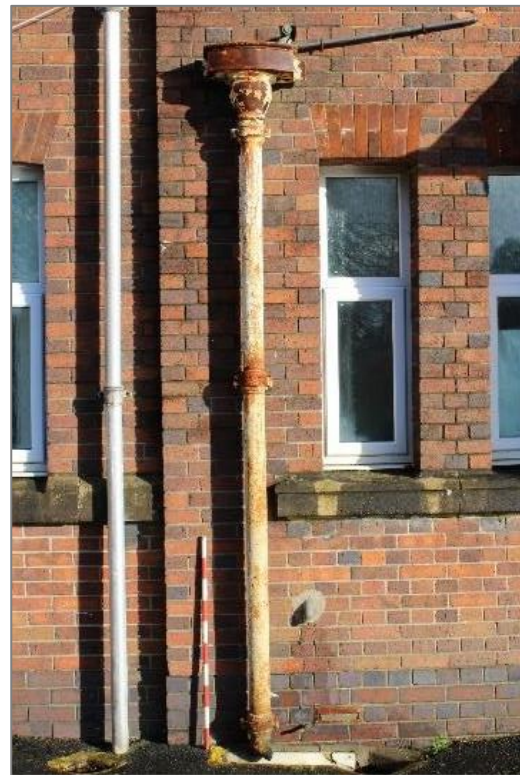
**Photo 15:** Downpipe on southwest facing façade. 1 x 1m scale.

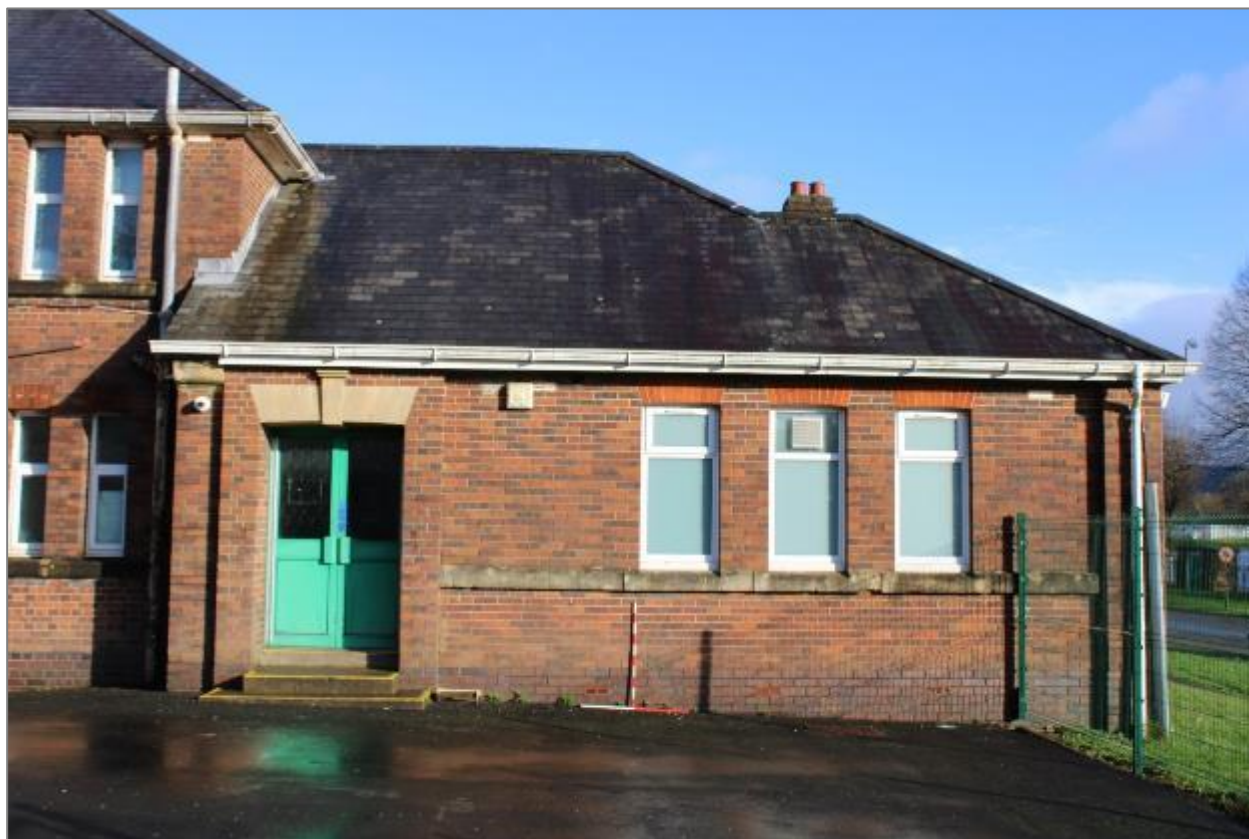
**Photo 16:** Southwest facing façade – southern end. Facing northeast. 2 x 1m scale.
