# **LLANGATWG SCHOOL, CADOXTON, NEATH PORT TALBOT SA10 8DB HISTORIC BUILDING RECORDING**

REPORT NO. 2025-02  
EVENT RECORD NO. E008746

**LLANGATWG SCHOOL, CADOXTON, NEATH PORT  
TALBOT, SA10 8DB:  
HISTORIC BUILDING RECORDING**

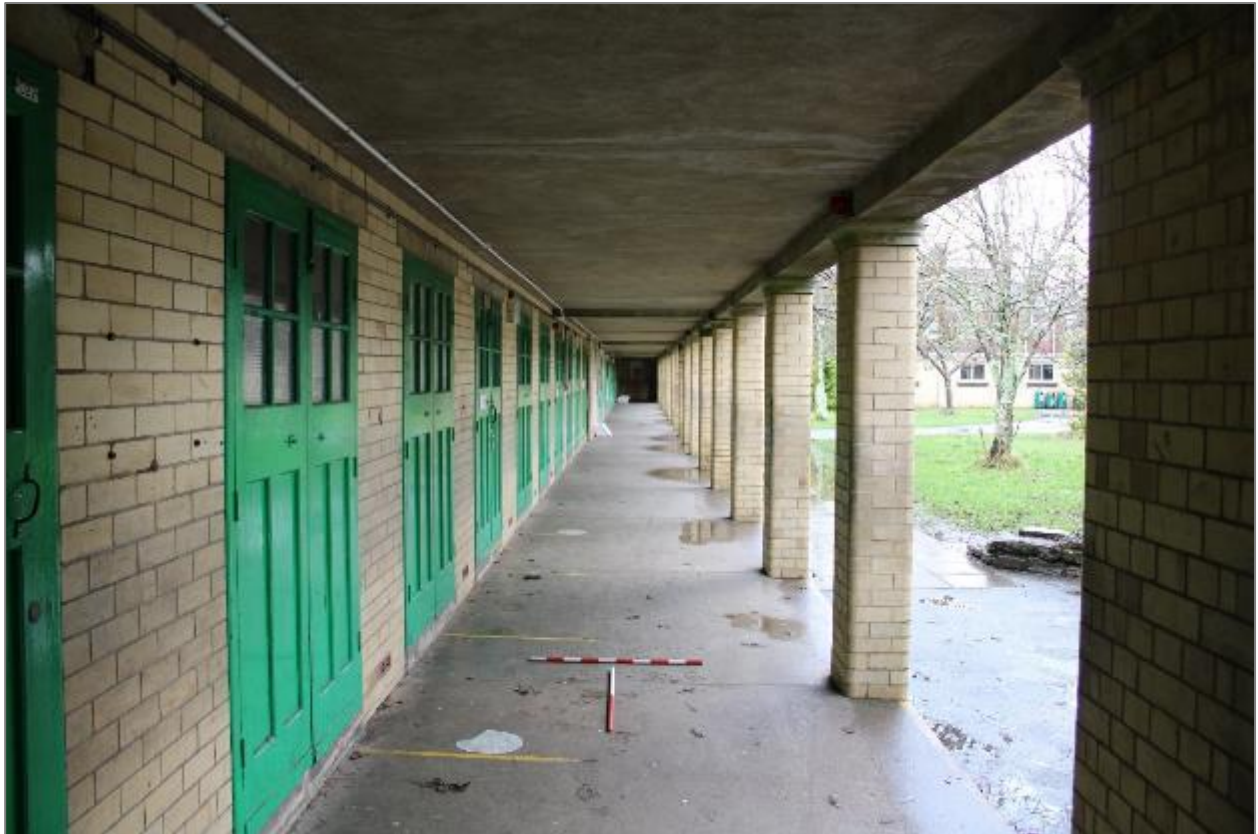
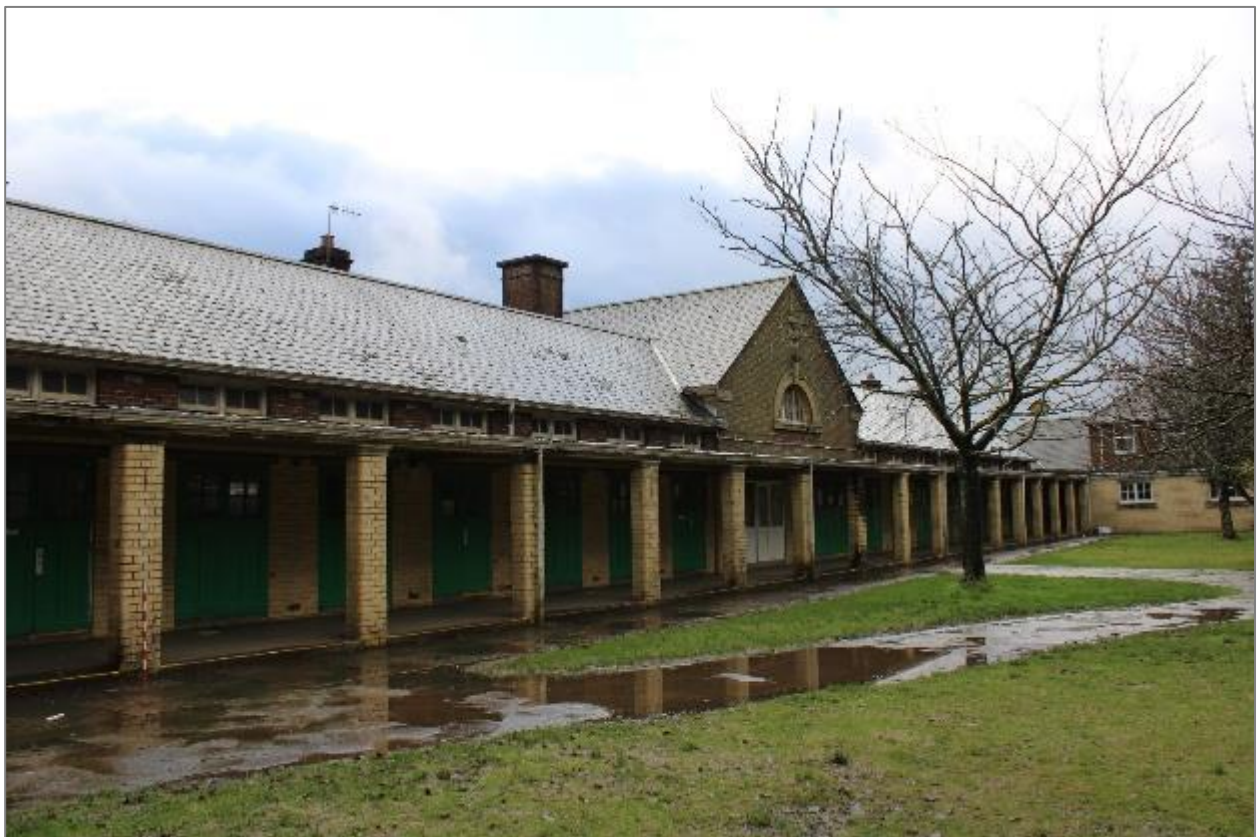
The northwest and southeast ranges of the quadrangle, and a small length of the remaining two sides on their northwest end, consist of covered walkways which provide access to the classrooms (photos 17 & 18). The walkways have concrete floors and ceilings. The external face of the classroom walls is constructed of yellow brick with a smooth finish laid in a stretcher bond. Each of the doorways has a concrete lintel/step, the doorways themselves comprising half-glazed timber panelled double doors. Along the outside of the walkways are a series of support pillars (36 in total) constructed of the same brick, but with rounded corners. The pillars have a simple decorative moulding at the top.

**Photo 17:** Walkway along the northwest range of the quadrangle. Facing northeast. 2 x 1m scales.

**Photo 18:** Walkway along the southeast side of the quadrangle. Facing south.

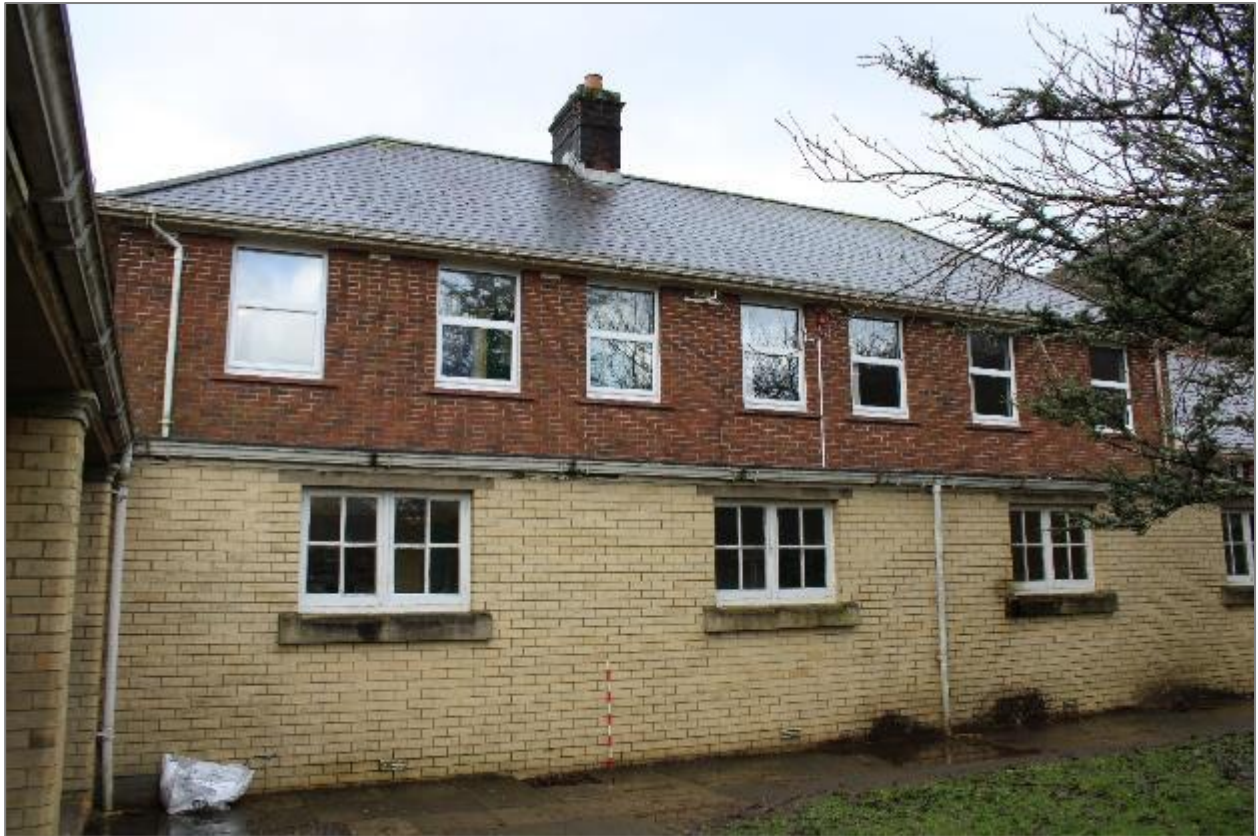
The ground floor of the two-storey northeast and southwest ranges are also constructed of the same yellow brick (photo 19). The windows here have oolite sills. The first floors above are constructed of red brick. The roofs are slate, with a brick chimney with three ceramic pots visible above the first-floor classrooms.

**Photo 19:** The two storeys on the southwest range of the quadrangle. Facing southwest. 1 x 1m scale.

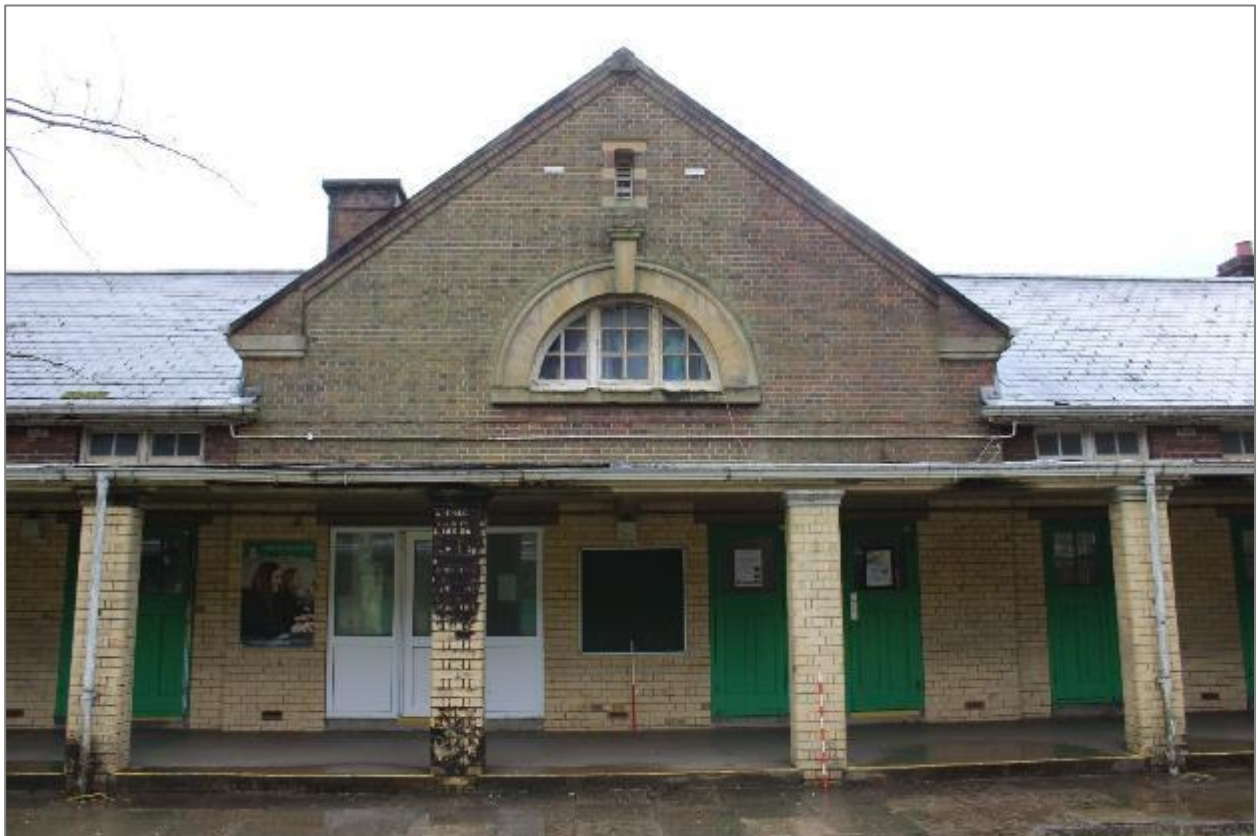
**Photo 20:** The central classroom on the southeast range of the quadrangle. 1 x 1m scale.

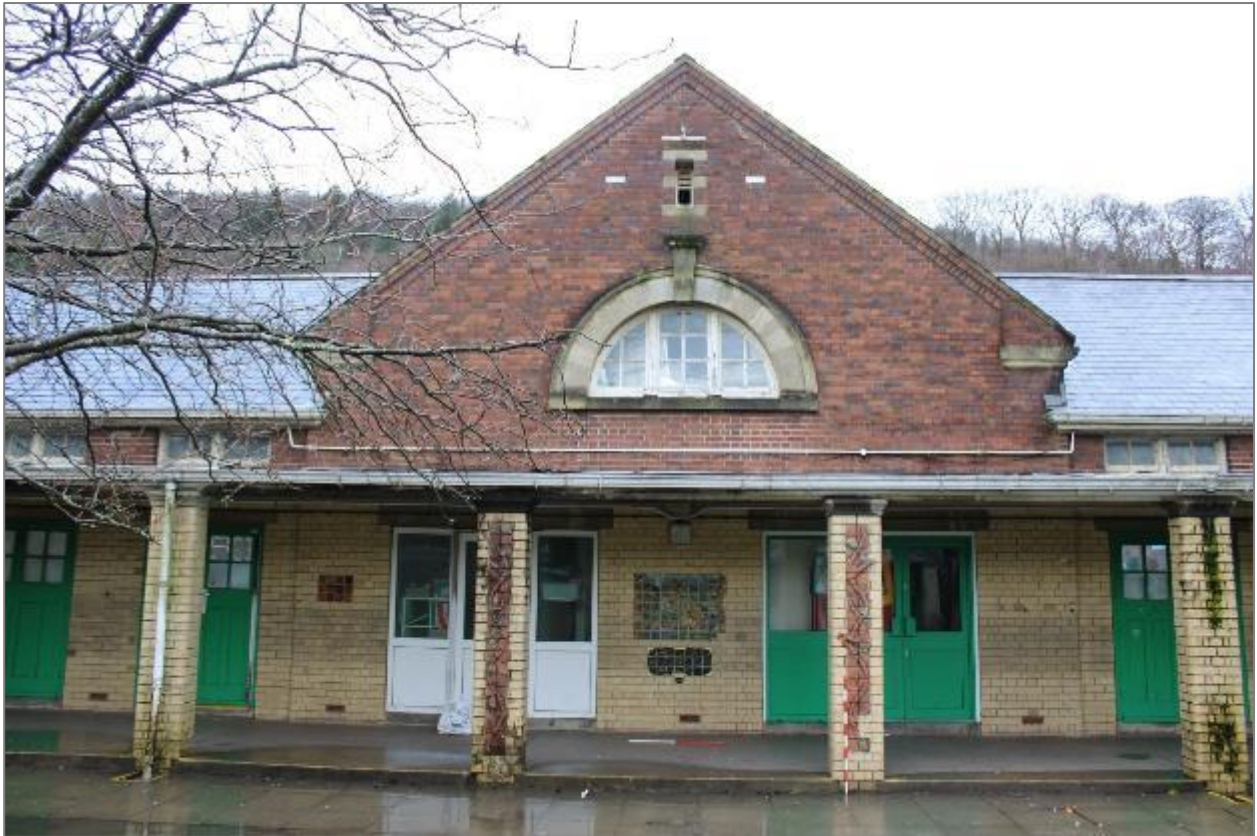
**Photo 21:** The central classroom on the northwest range of the quadrangle. 2 x 1m scale.

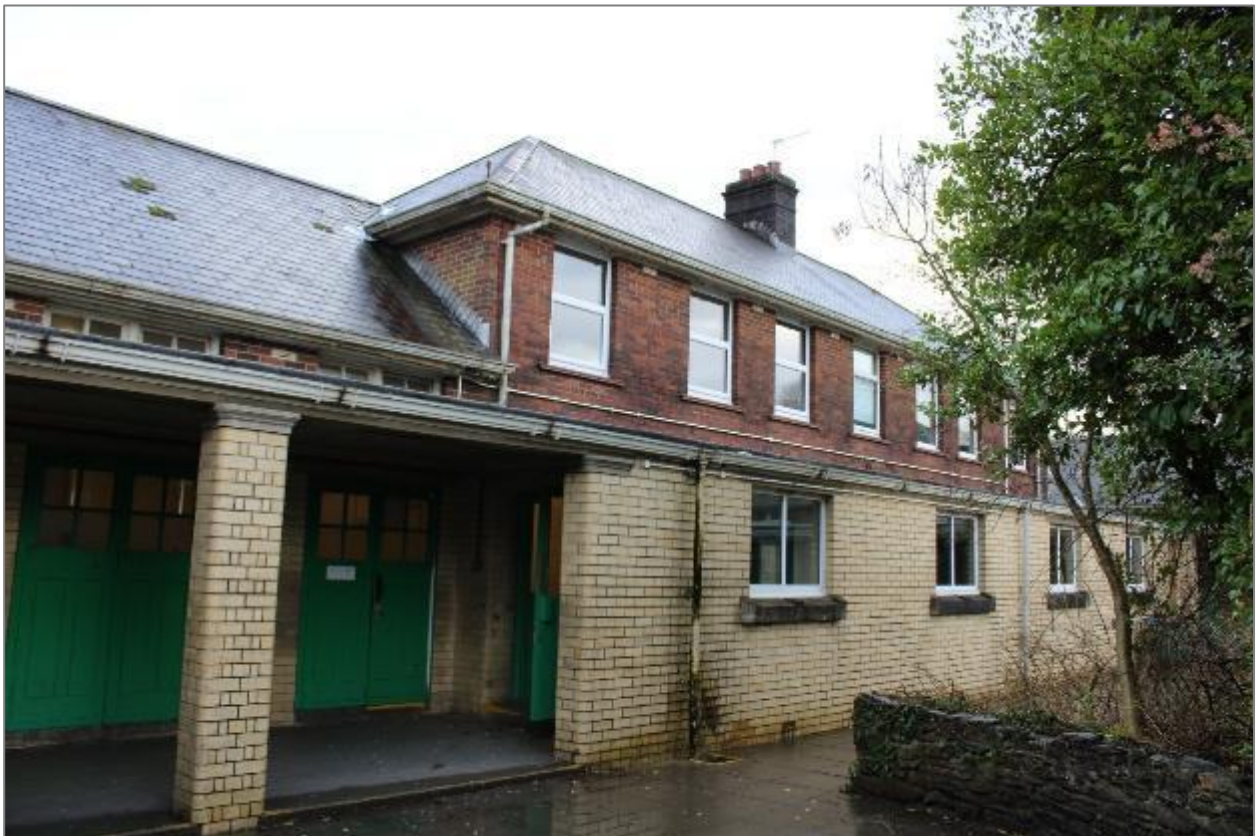
**Photo 22:** The two storeys on the northeast range of the quadrangle. Facing south. 1 x 1m scale.

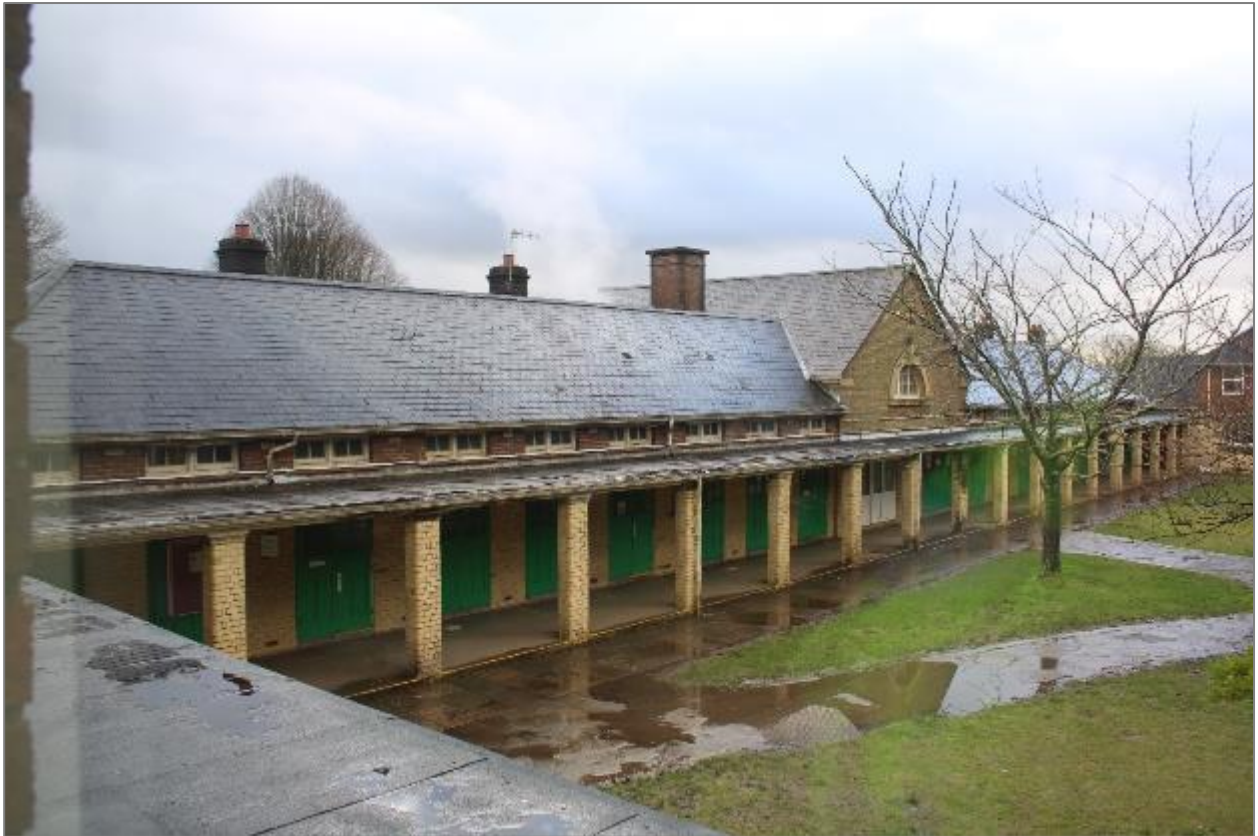
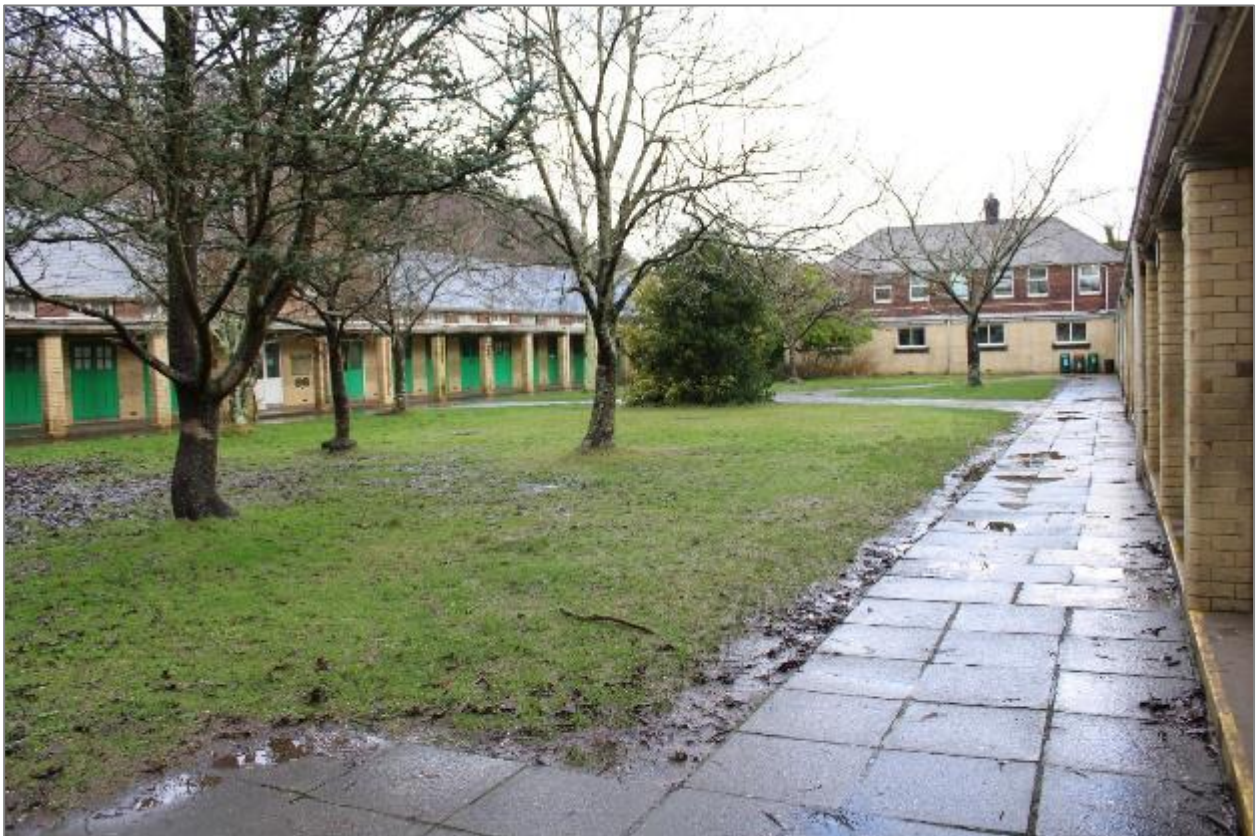
The centre of the quadrangle has paving stones, both rectangular and random in shape, along the edges, with three winding paths crossing the centre. The area in between the paving and paths is under grass with several mature trees and shrubs (photos 23 & 24).

**Photo 23:** Interior of the quadrangle. Facing north.

**Photo 24:** Interior of the quadrangle. Facing north.

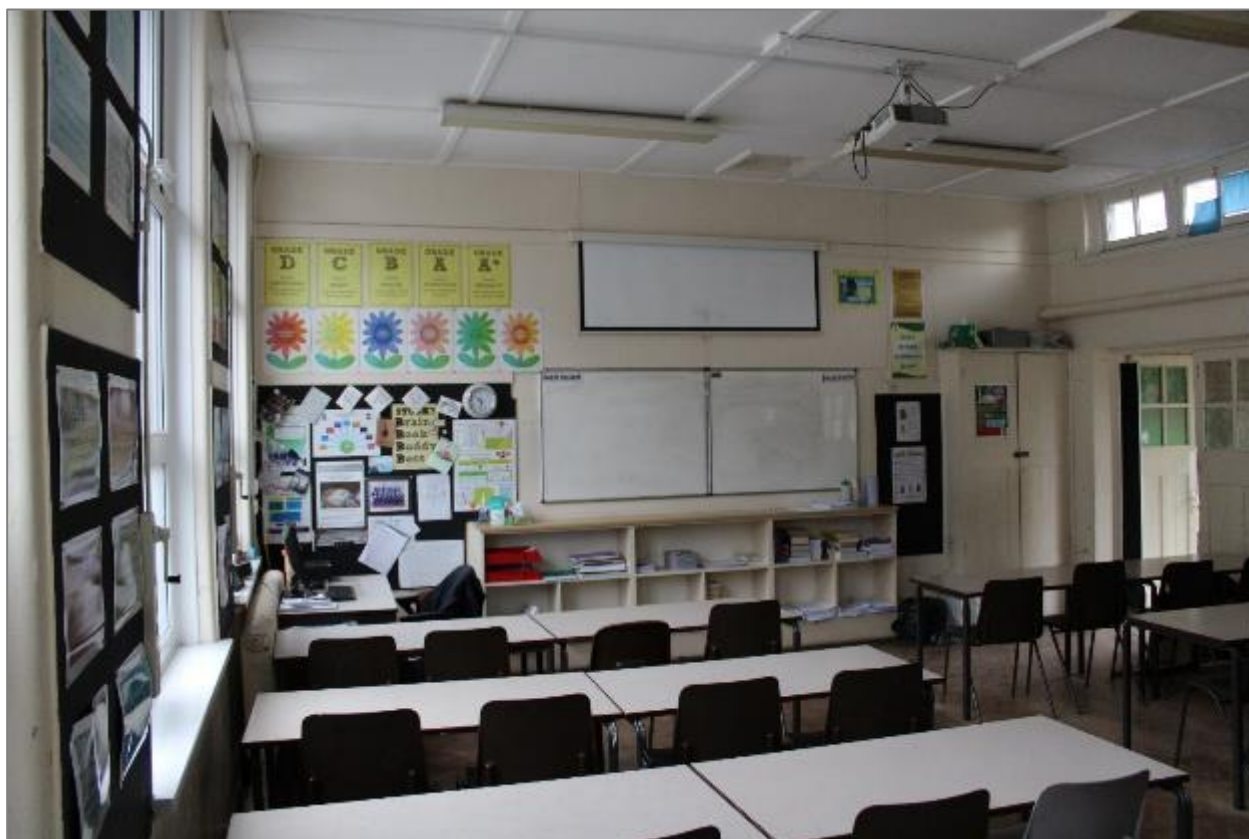
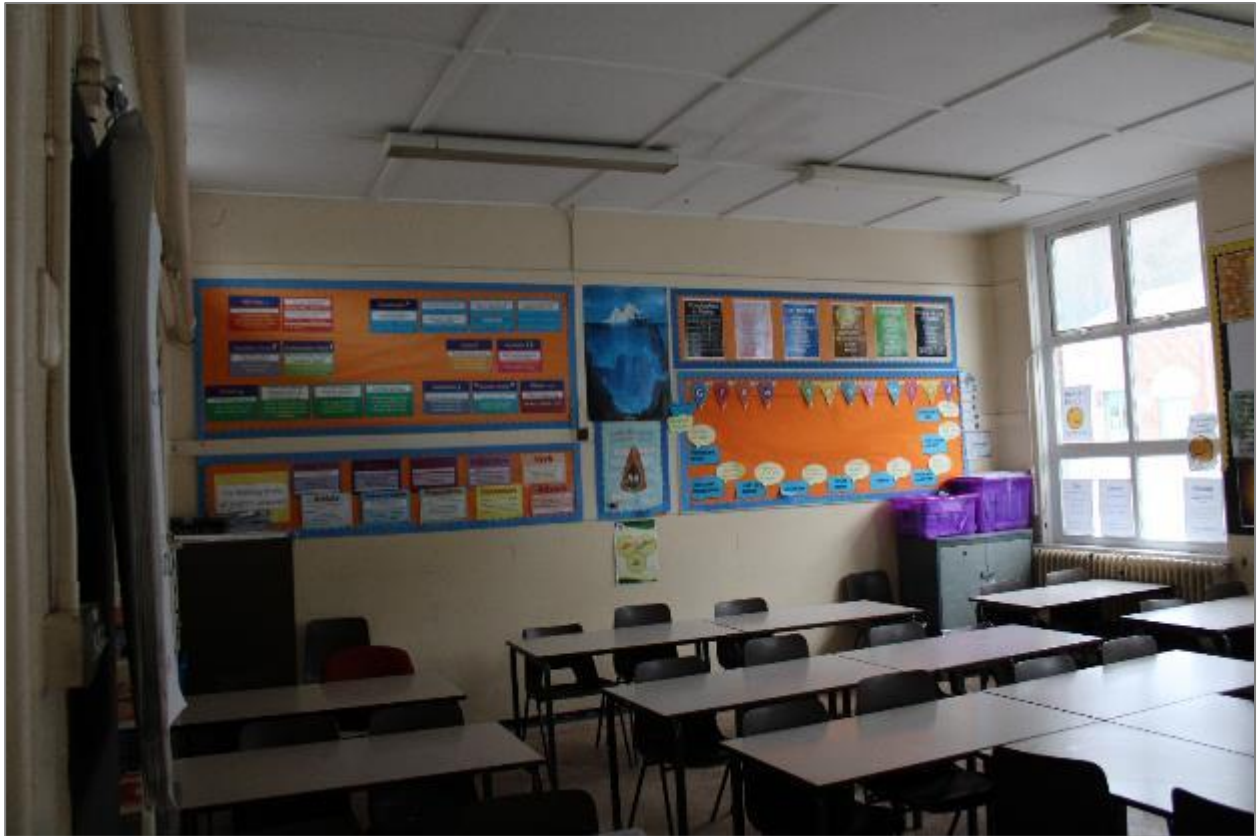
The rooms measure approximately 7.25m by 6.10m, with walls in a painted finish (photos 25 & 26). The floors are parquet flooring in a herringbone pattern, with evidence of small repairs throughout. At the floor edges is a decorative pattern which finishes the floor, consisting of a band of single red tiles laid on end beyond which are three courses laid in a stretcher pattern (photo 27).

**Photo 25:** southwest wall of standard classroom.

**Photo 26:** Northeast wall of a standard classroom.

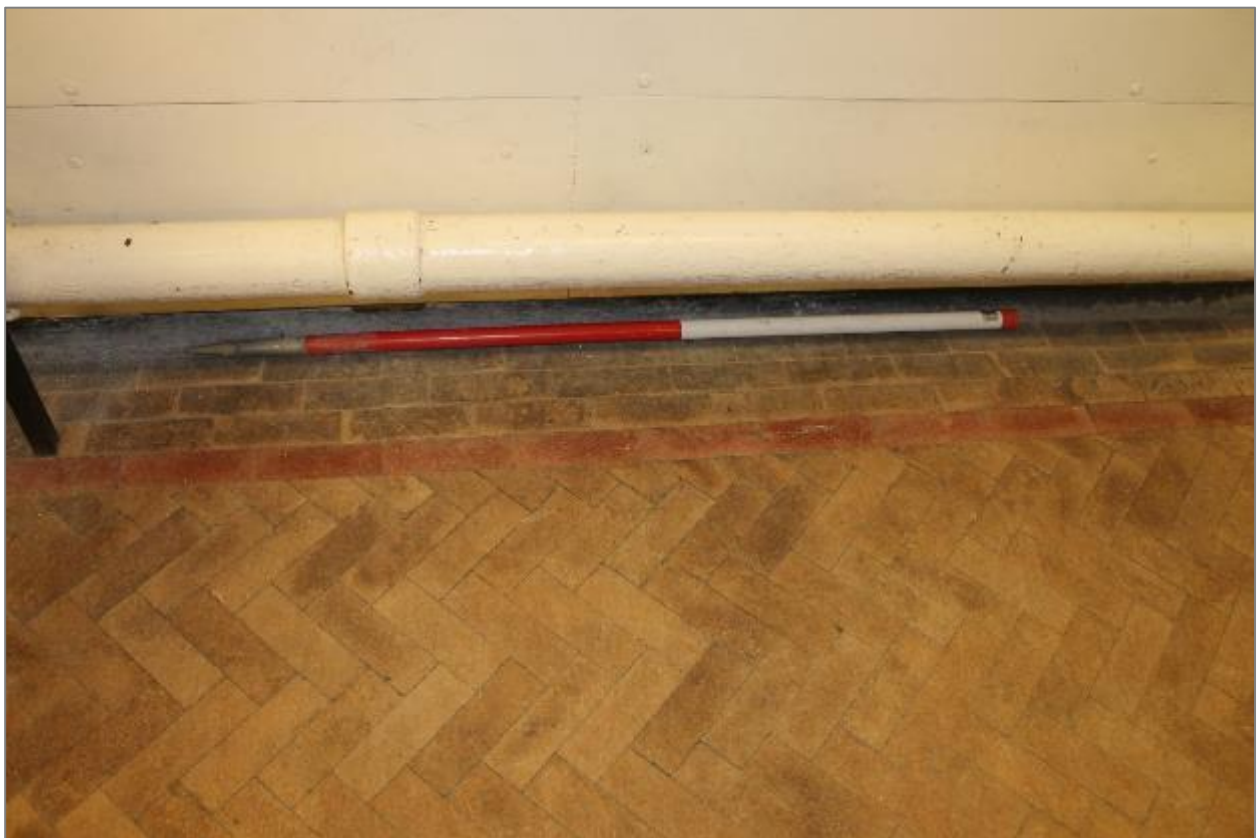
**Photo 27:** Floor in standard classroom. 1 x 1m scale.

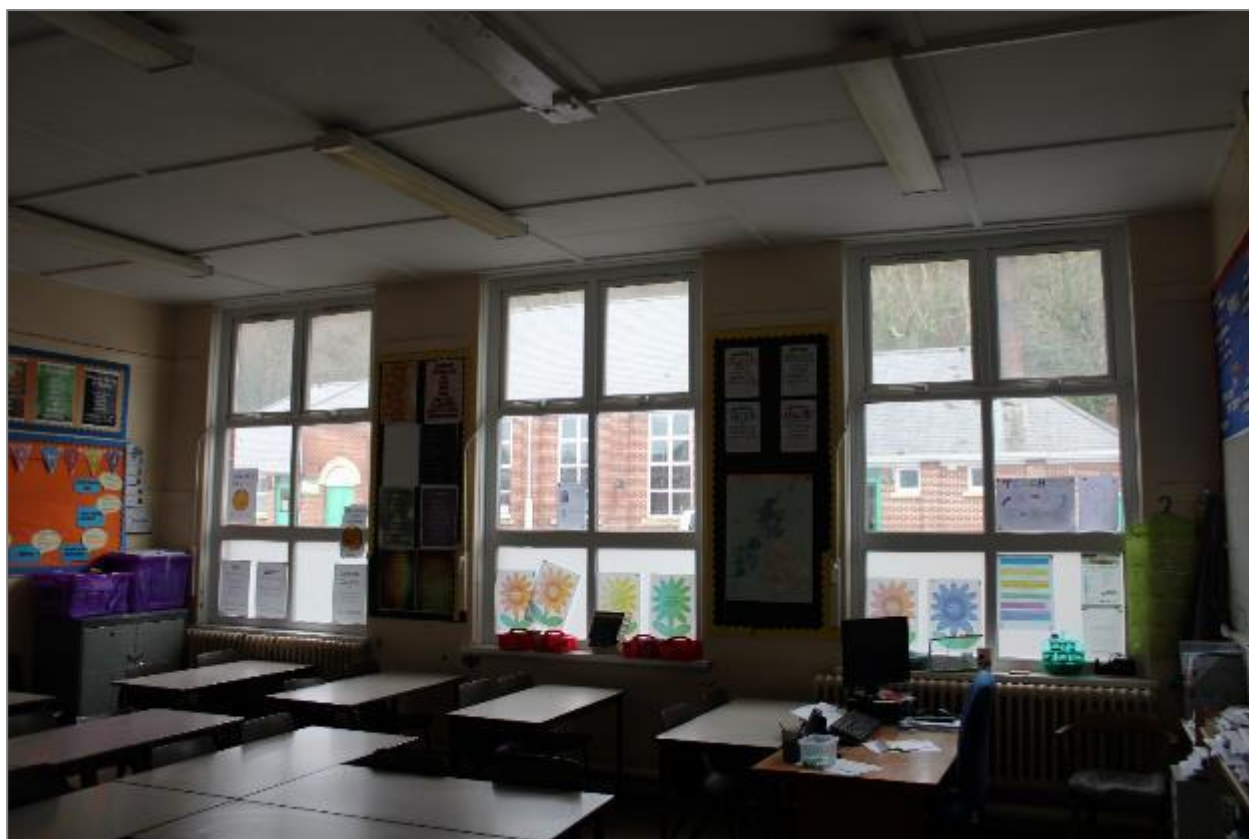
There are three large windows to the outside walls with modern uPVC frames (photo 28). Below the two end windows are cast iron radiators (photo 29). The cast iron heating pipework is exposed along the walls of each of the classrooms (photos 30 & 31).

**Photo 28:** External wall of a standard classroom. Facing northwest.

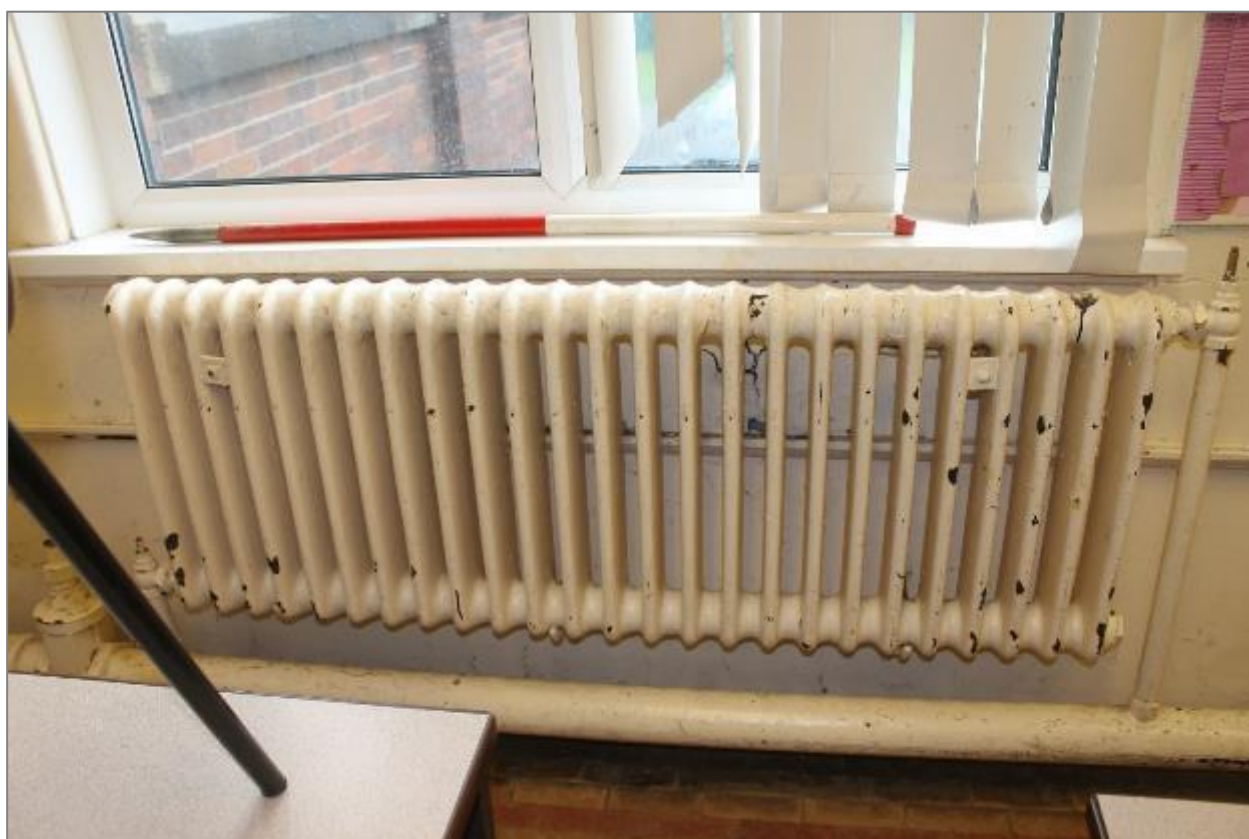
**Photo 29:** Example of a cast iron radiator in a standard classroom. 1 x 1m scale.

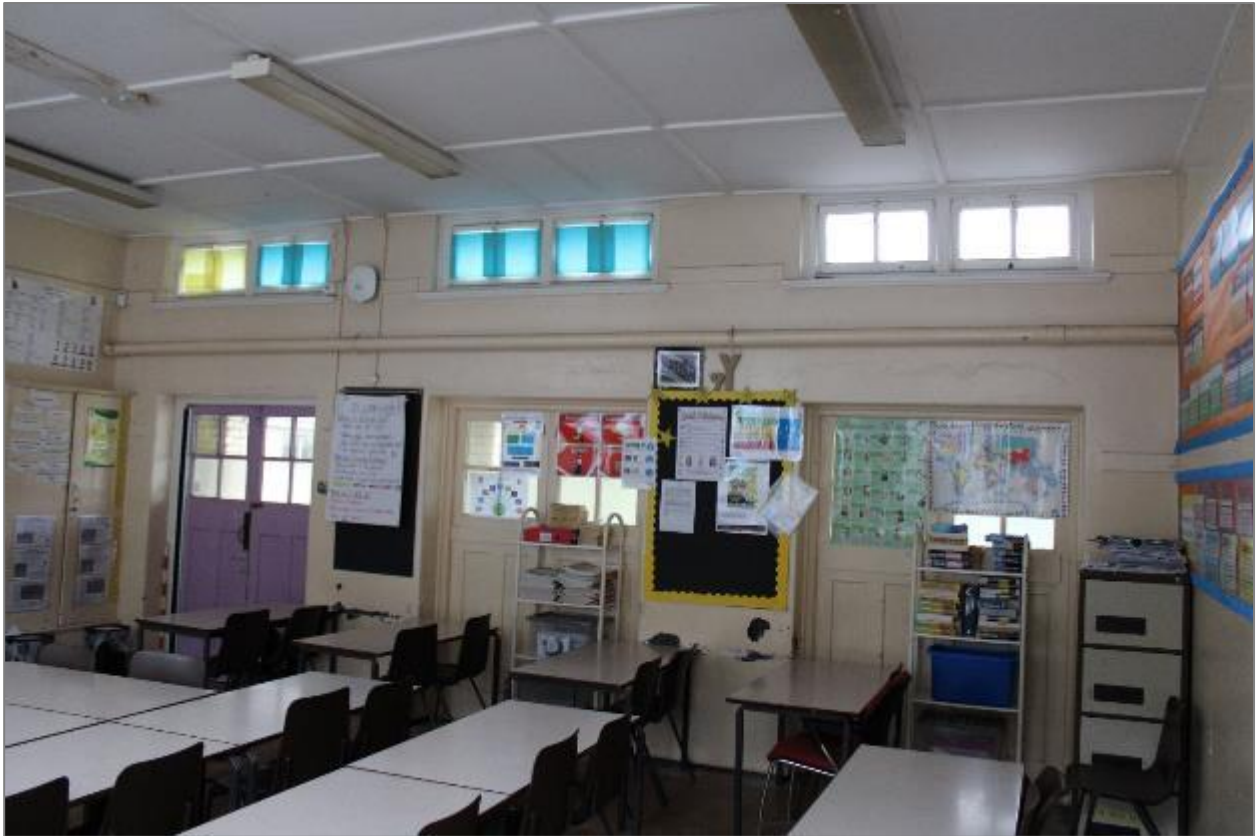
The walls along the inside walkway contain three sets of double doors which open out. The doors are panelled wood below, with a four light window above (photos 30 & 31). One set of doors is used as the main entrance to the classrooms. Adjacent to the entrance on the internal wall is a built wooden cupboard with double doors (photo 32).

**Photo 30:** Internal wall in a standard classroom adjacent to covered walkway.

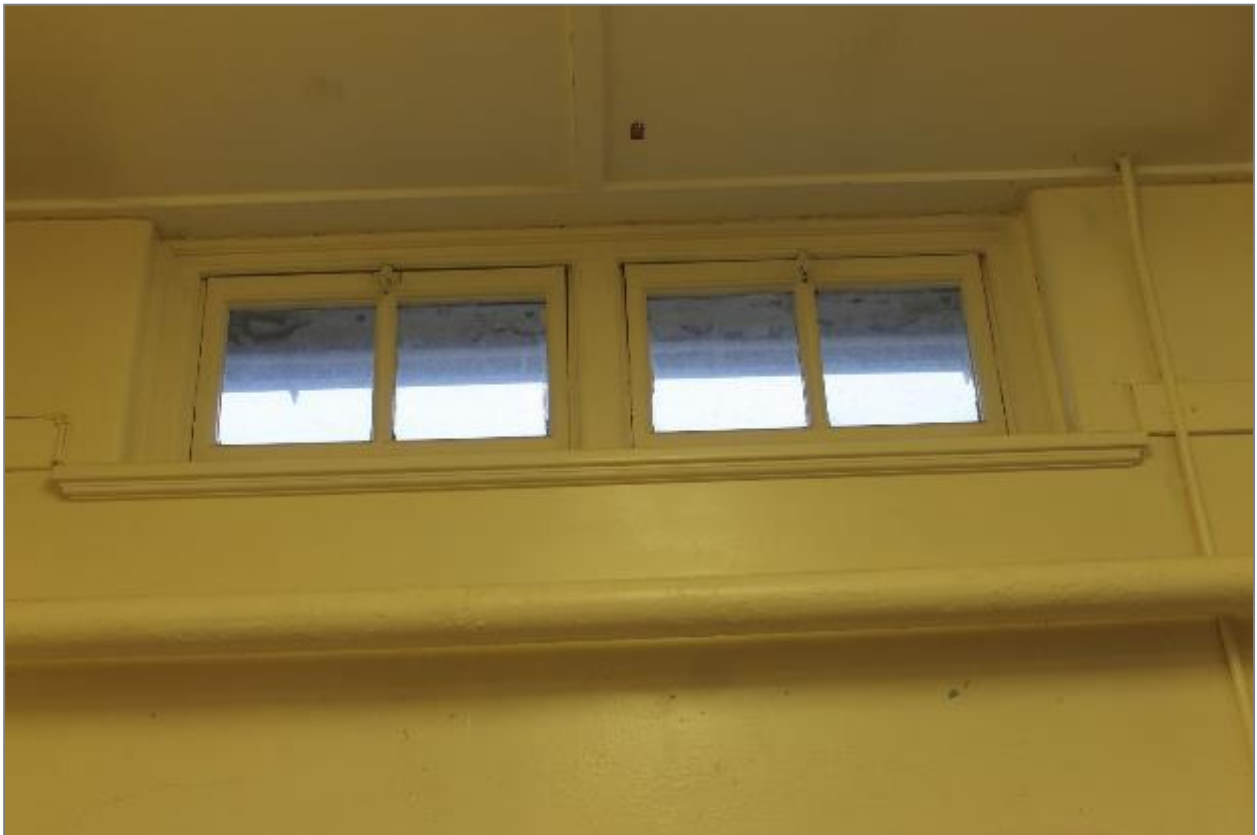
Above each set of doors, just below the ceiling are two sets of double light hopper windows framed in wood. The ceilings are painted and have wood battening laid out in a grid pattern.

**Photo 31:** Windows and exposed pipework above double doors in a standard classroom.

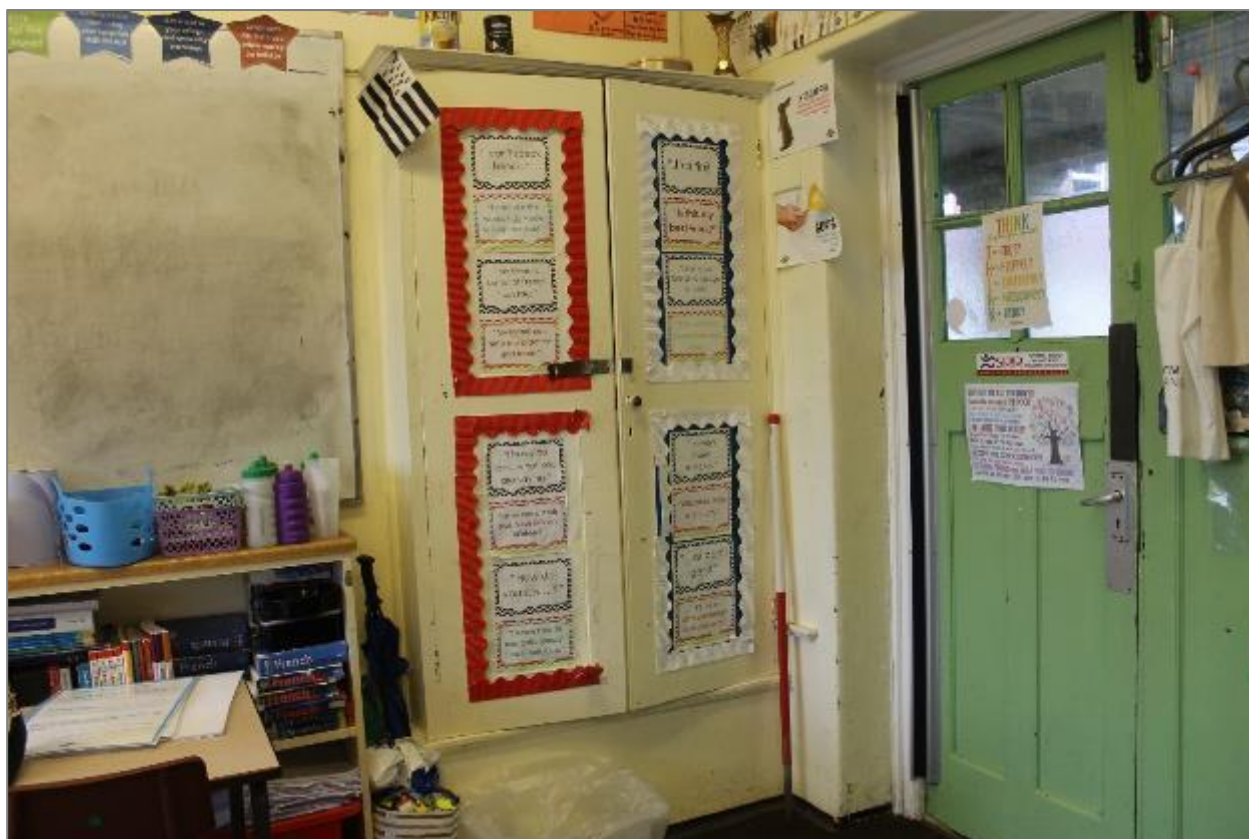
**Photo 32:** Example of the built-in cupboard in the standard classrooms.

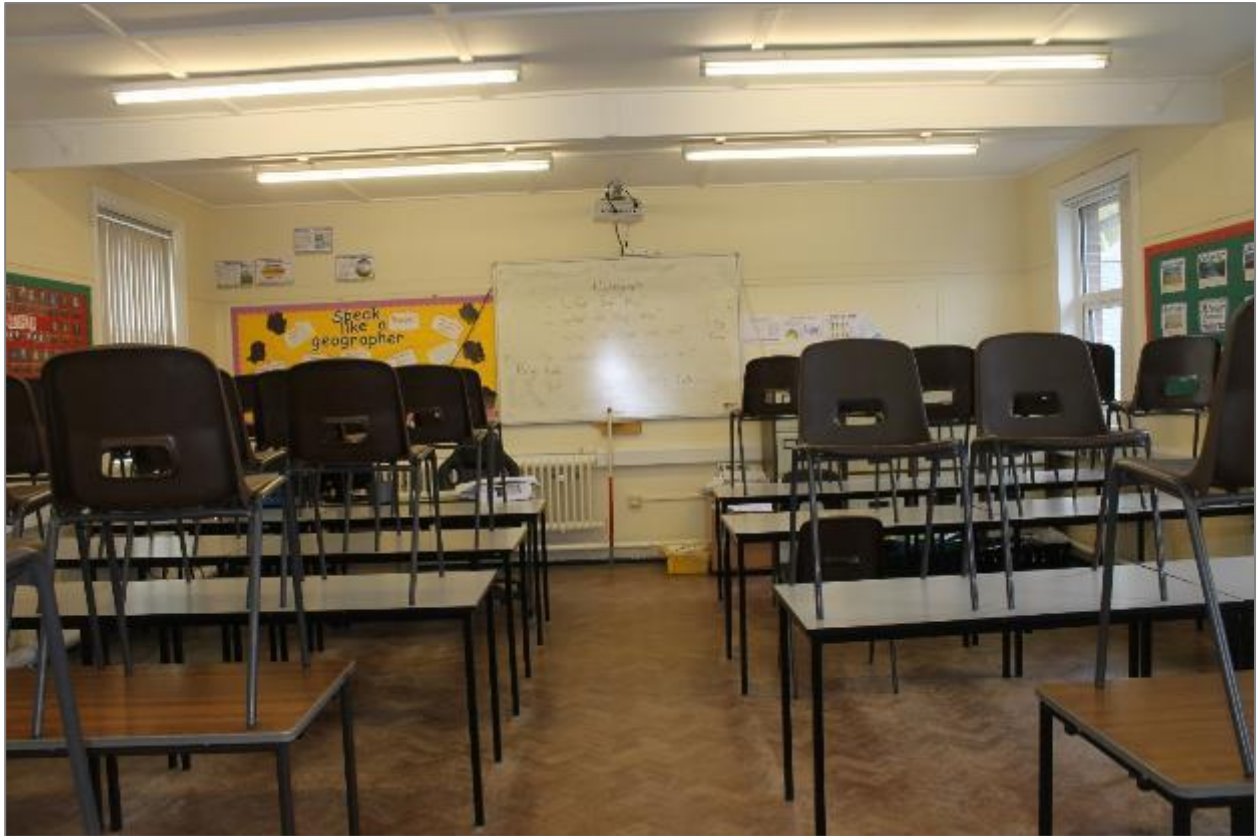
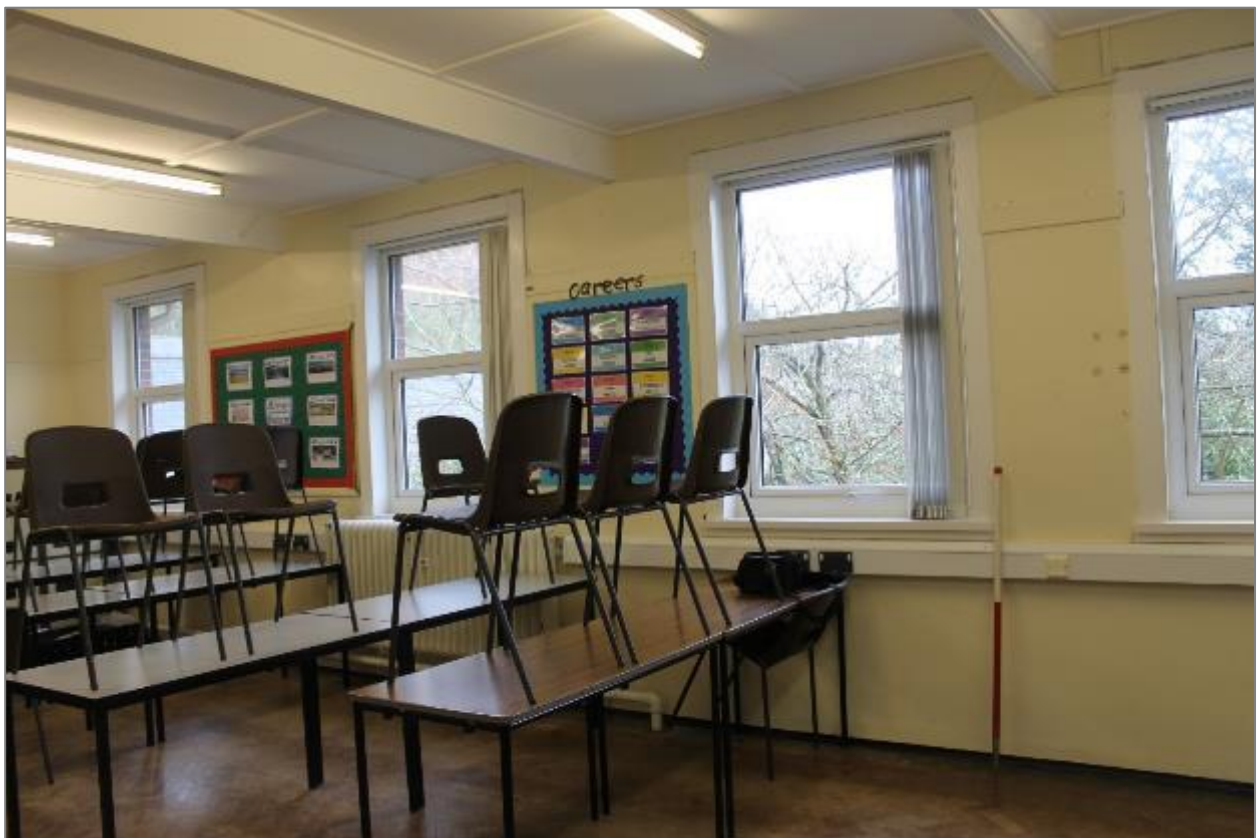
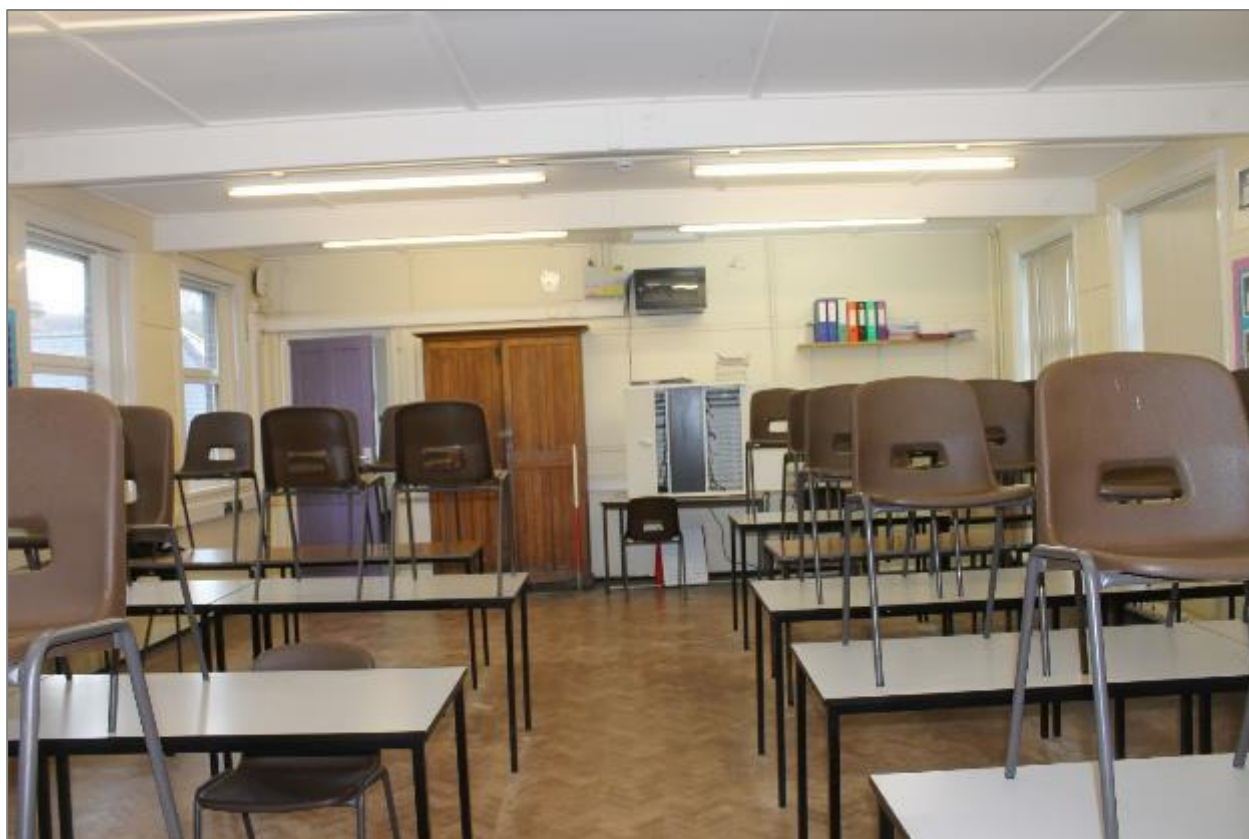
The rooms measure approximately 9m by 6m. The herringbone parquet flooring is continued through these rooms. The ceilings are painted with wood battening laid out in a grid pattern, between exposed painted steel supports. The entrance door is of panelled wood.

There are four windows on the outside wall and four windows overlooking the quadrangle, all with modern uPVC frames. There is a cast iron radiator on the northwest and northeast walls.

**Photo 33:** First floor classroom. 1 x 1m scale.

**Photo 34:** Wall looking out over the quadrangle in first floor classroom. 1 x 1m scale.

**Photo 35:** First floor classroom. 1 x 1m scale.

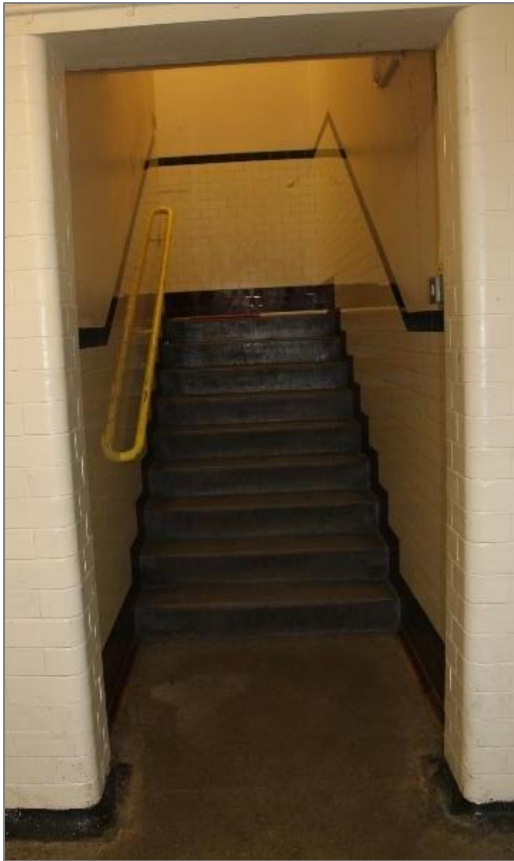
The first-floor classrooms are accessed via a U-shaped stairway with a small interval landing. The steps are finished in polished concrete. The stairway lower walls are decorated in light crème-coloured ceramic tiles, with decorative bandings of dark green tiles laid on end at shoulder level and brown tiles laid in stretcher pattern along the base of the walls. The areas above the tiles are painted.

**Photo 36:** Lower stairway leading to first floor classroom. 1 x 1m scale.
