# **LLANGATWG SCHOOL, CADOXTON, NEATH PORT TALBOT SA10 8DB HISTORIC BUILDING RECORDING**

REPORT NO. 2025-02  
EVENT RECORD NO. E008746

**LLANGATWG SCHOOL, CADOXTON, NEATH PORT  
TALBOT, SA10 8DB:  
HISTORIC BUILDING RECORDING**

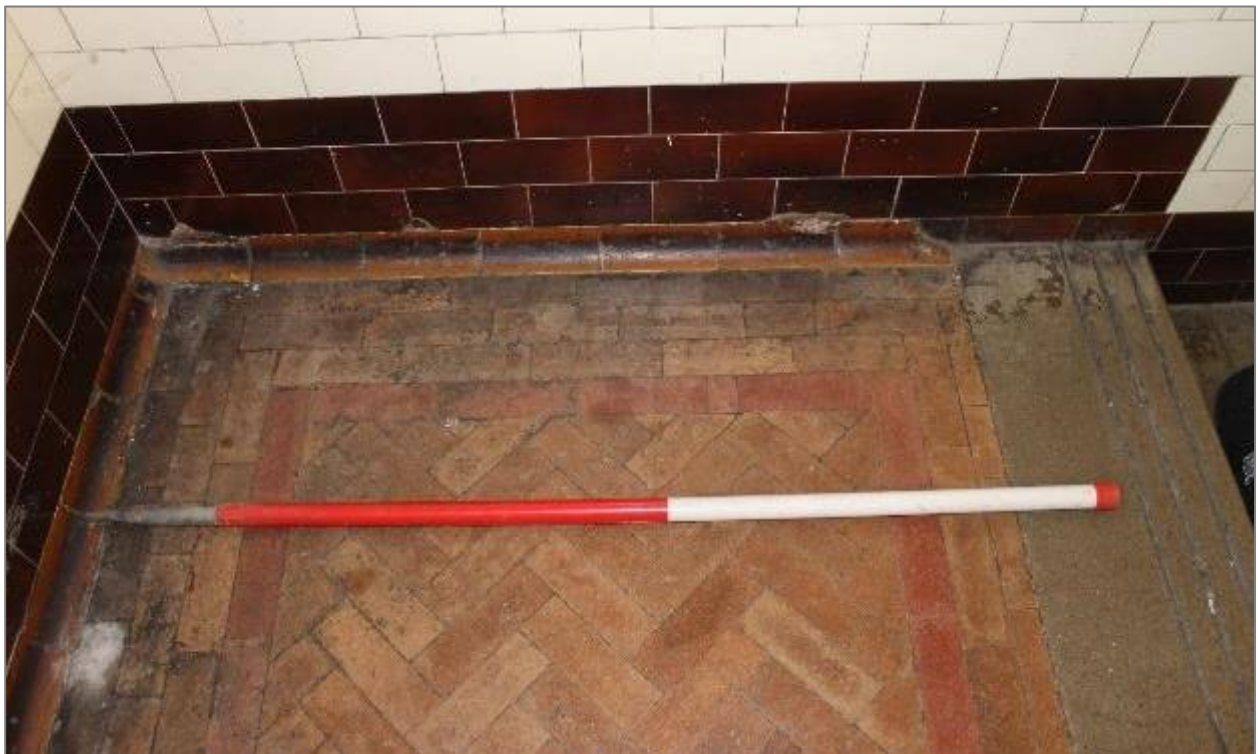
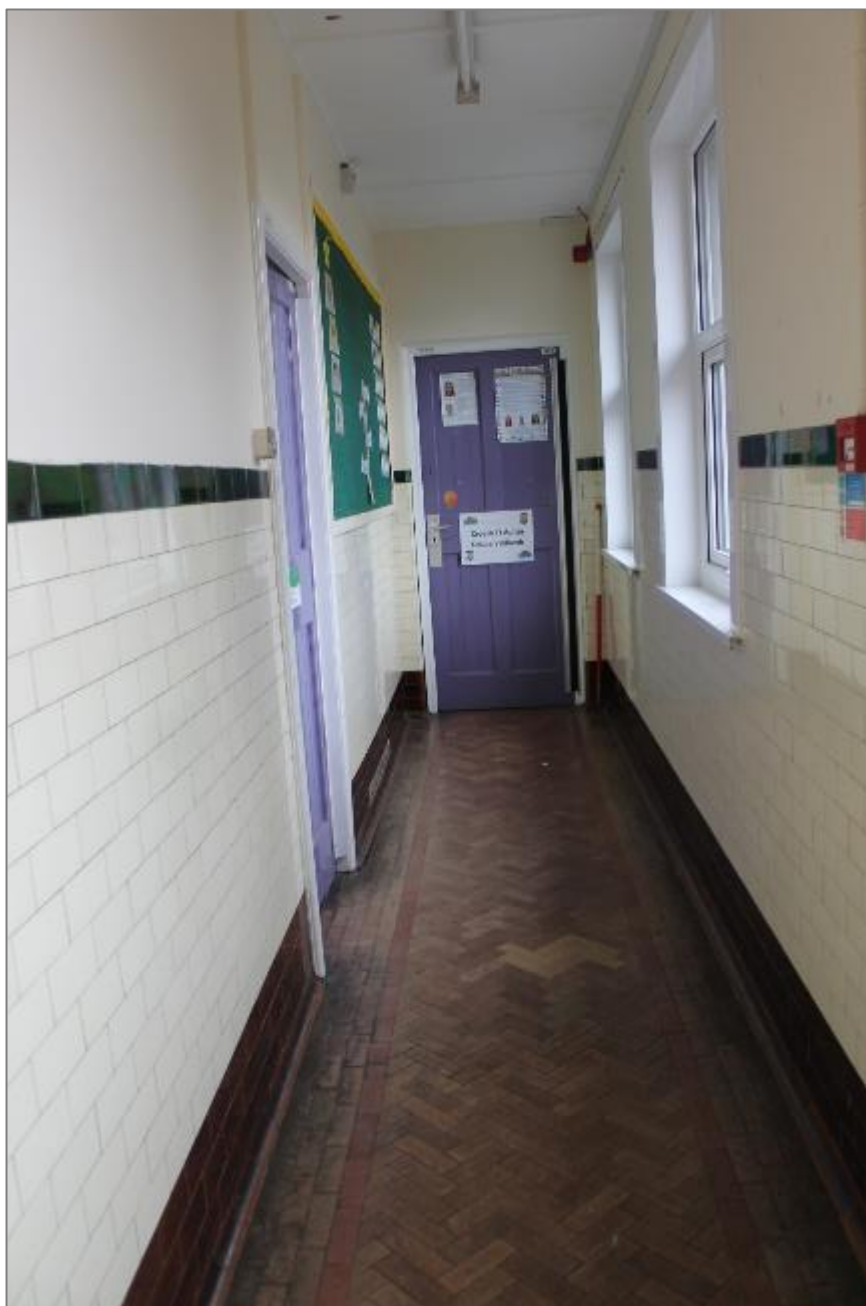
At the top of the stairs and into the upstairs corridor the floor transitions from concrete to the standard parquet flooring. Between the floor and wall edge is a scotia of ceramic brown tiles. The tiling pattern from the stairs is continued along the corridor. In the corridor on are three modern uPVC windows which overlook the quadrant below. There are two wood panelled doors, one which leads into a staff room, the other into the upstairs classroom.

**Photo 38:** Floor detail of corridor leading to first floor classroom. 1 x 1m scale.

**Photo 39:** Corridor leading to first floor classroom. 1 x 1m scale.

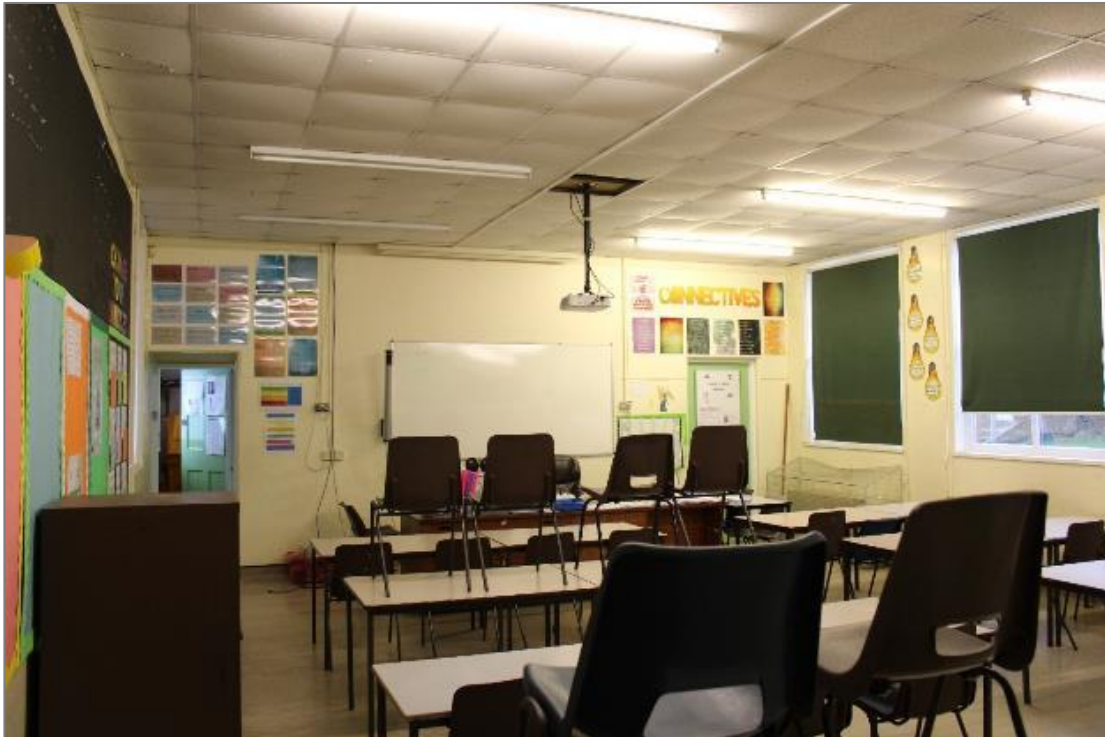
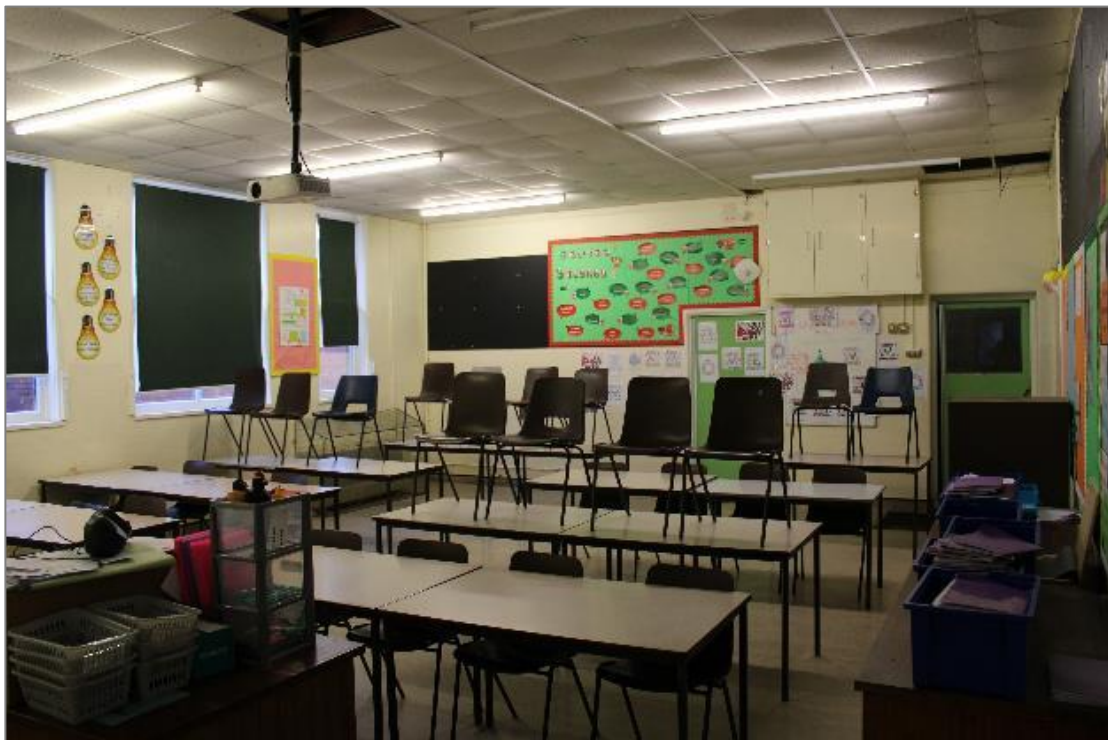
This classroom occupies the extended northern end of the northeast wing. The room is entered via a single timber panelled door in the southwest corner and is a larger room with vinyl flooring, walls of painted brick tile to midway, plain above and a modern suspended ceiling with tiles. Four modern uPVC windows lie on the northeast external wall. There are two wooden panelled doors on the northwest wall which lead to storerooms (photo 40). In one of the storerooms is a ceramic sink by J Duckett and Sons of Burnley which may be an original feature (photo 42) in a former W.C. On the southeast wall is a wooden door which leads to a small room holding IT equipment and a smaller storeroom (photos 41 and 43). On the west wall near the entrance is a doorway which leads to a small foyer with a staircase (photo 44).

**Photo 40:** Corner classroom wall with entrance to storerooms.

**Photo 41:** Corner classroom wall with entrance to storerooms.

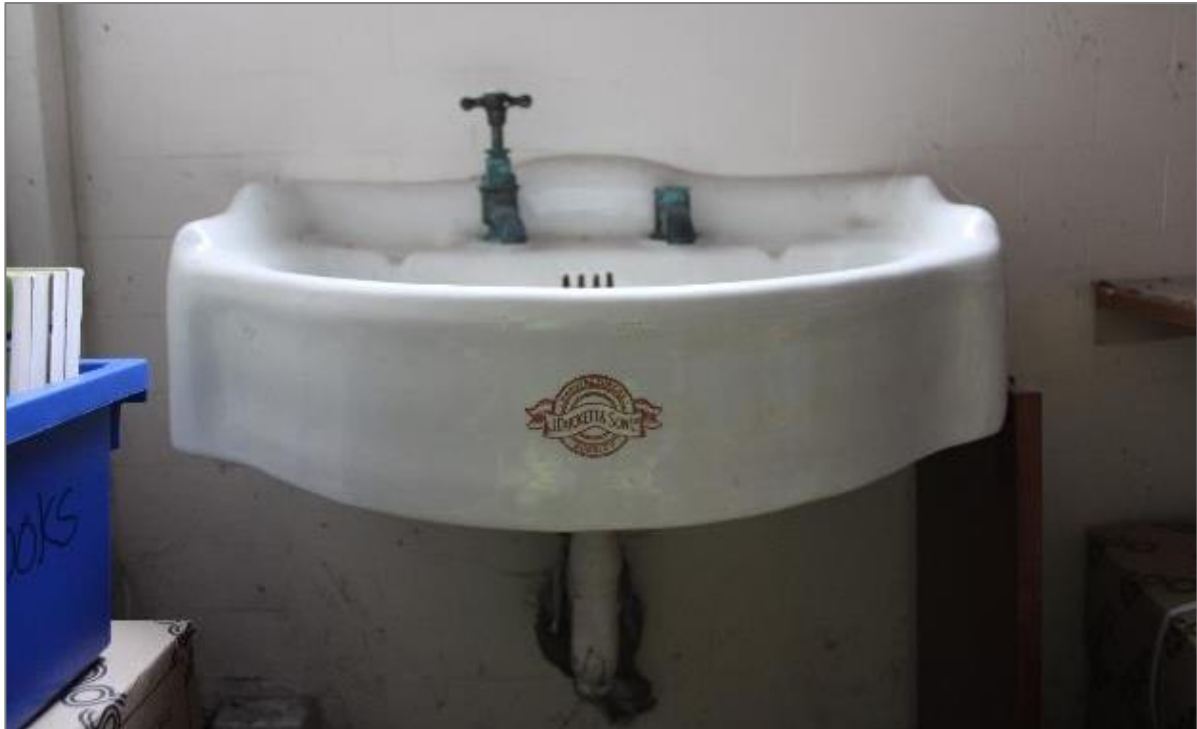
**Photo 42:** J Duckett & Sons ceramic sink in storeroom of corner classroom.

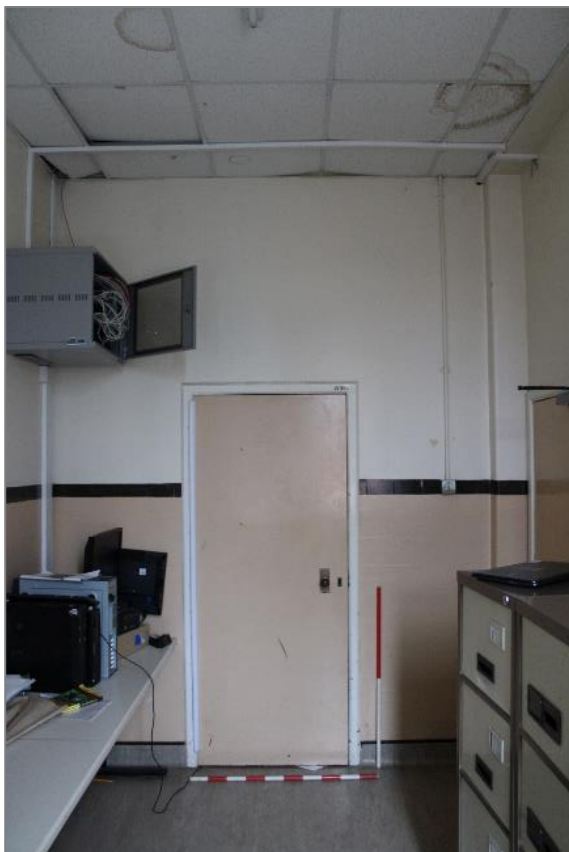
**Photo 43:** Storeroom located off corner classroom. 2 x 1m scales.

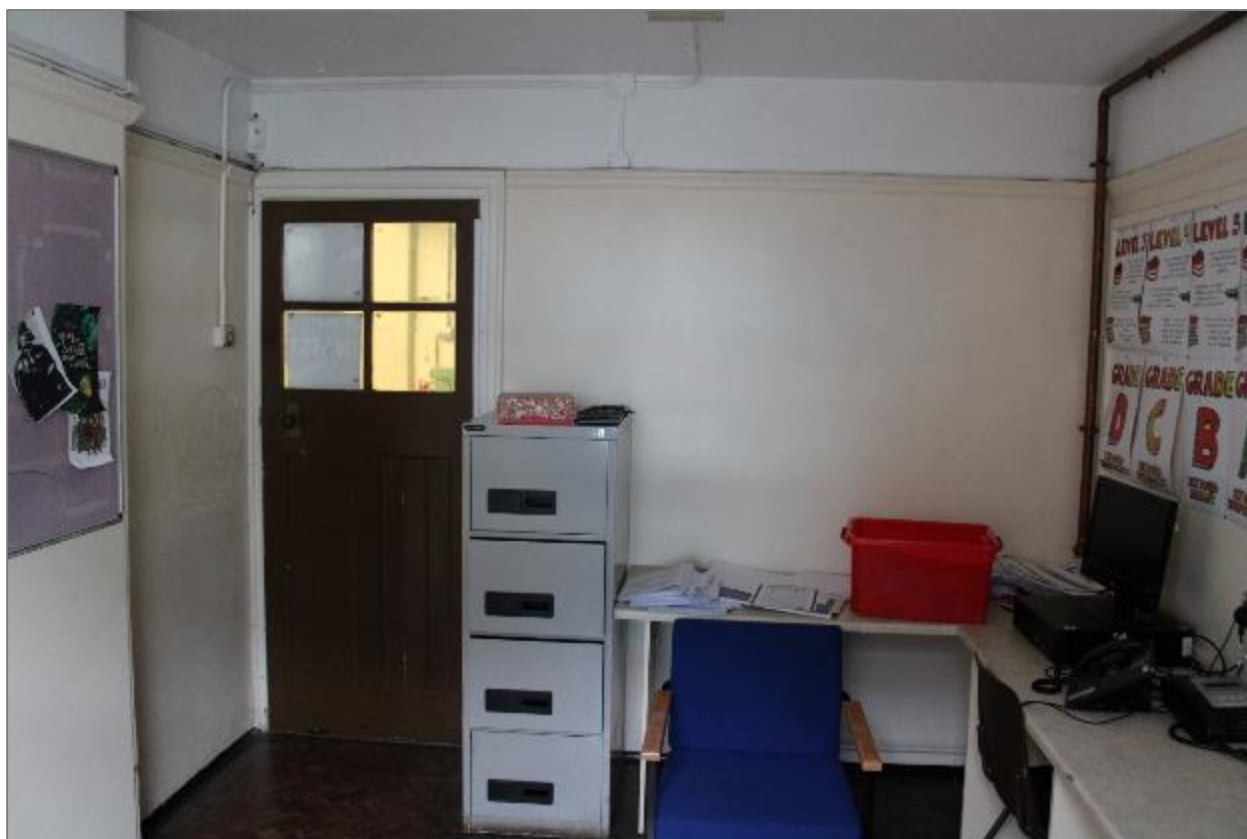
The office door is wood panelled with a four-light window. The walls are painted and have a wooden picture rail around the perimeter with parquet flooring throughout. Against the northeast wall is a rectangular panel of red ceramic quarry tile on the floor, marking the hearth of a blocked fireplace. There is a single window on the northwest wall framed in modern uPVC.

**Photo 45:** Office adjacent to corner classroom accessed via foyer.

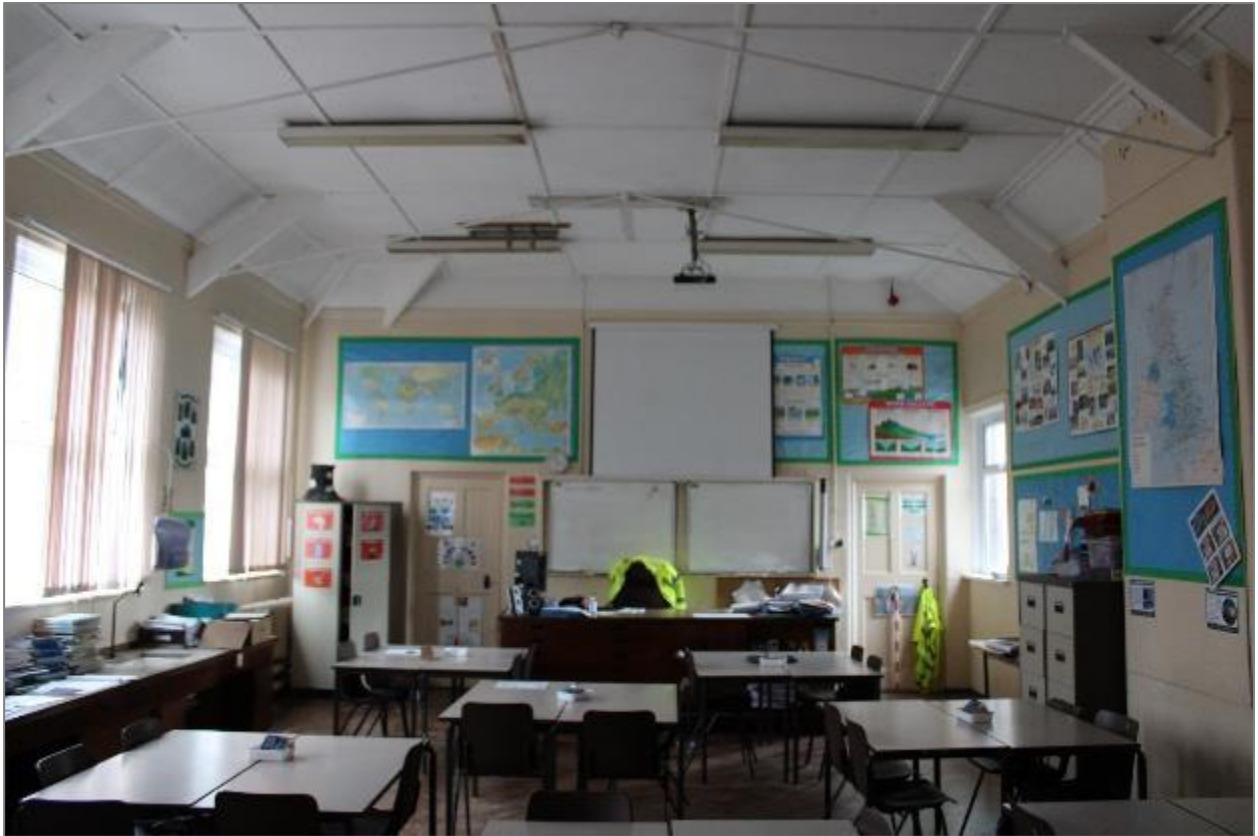
On the outside wall are four windows of modern uPVC and a cast iron radiator. A second radiator is found on the southeast wall. There is a small single light window of uPVC on the northeast wall.. On either side of the platform in the northwest wall are doors which lead to an office in the rear of the classroom.

**Photo 46:** Corner classroom - doors to office visible in the northwest wall. 1 x 1m scale.

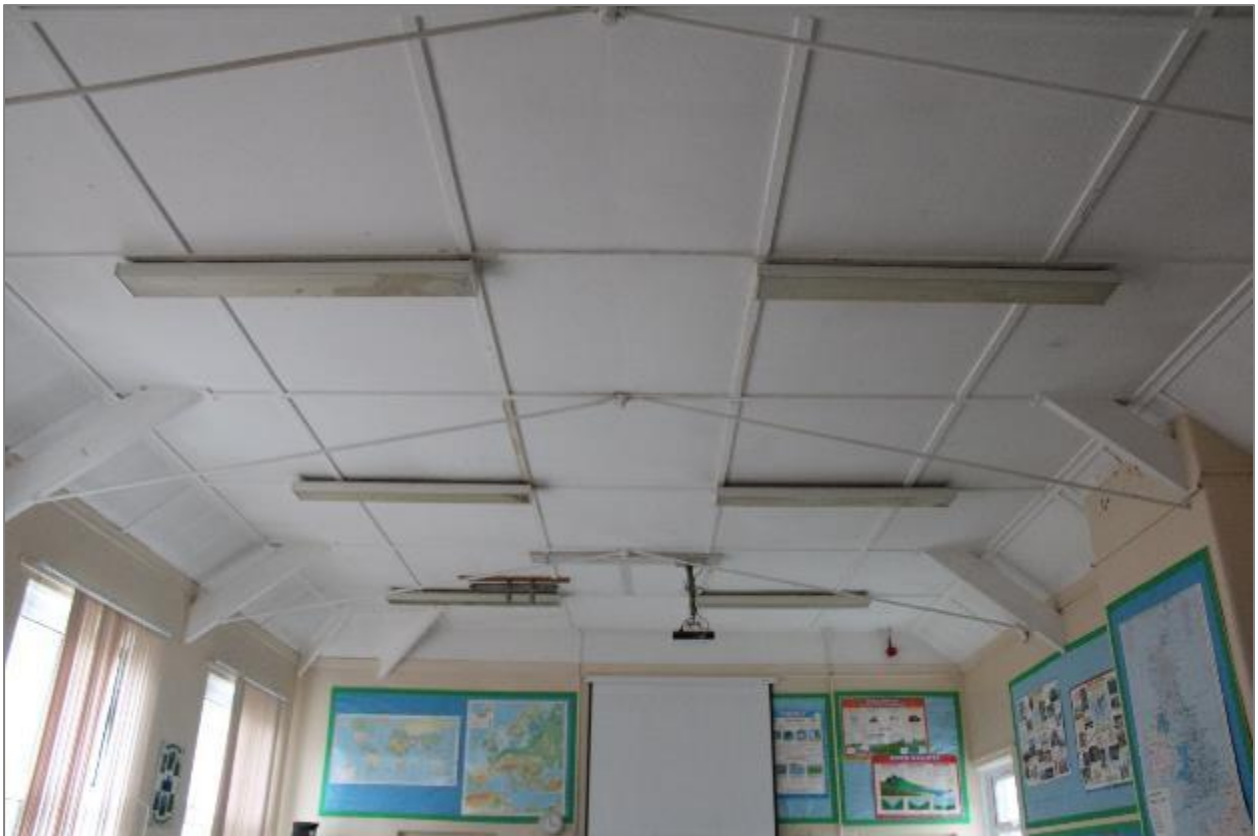
**Photo 47:** Ceiling with visible joists and bracing in corner classroom.

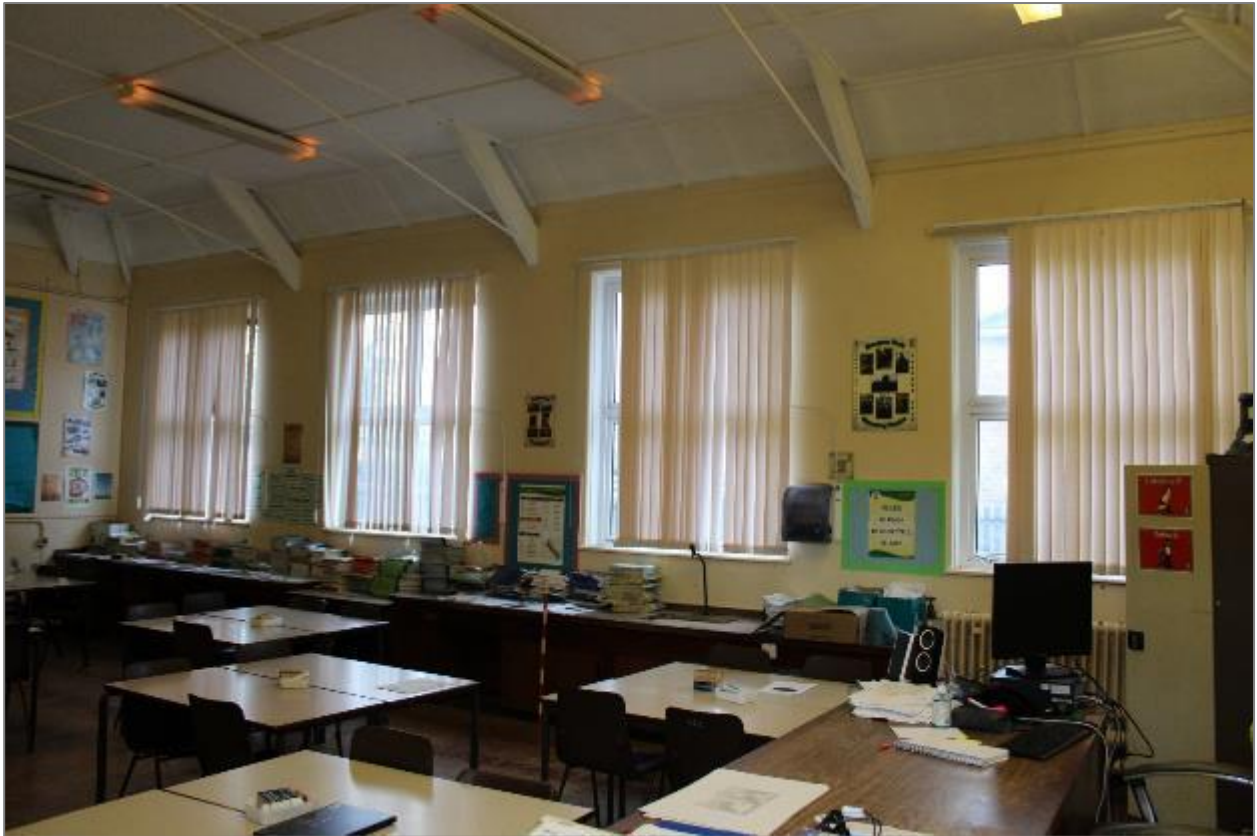
**Photo 48:** External wall of corner classroom.

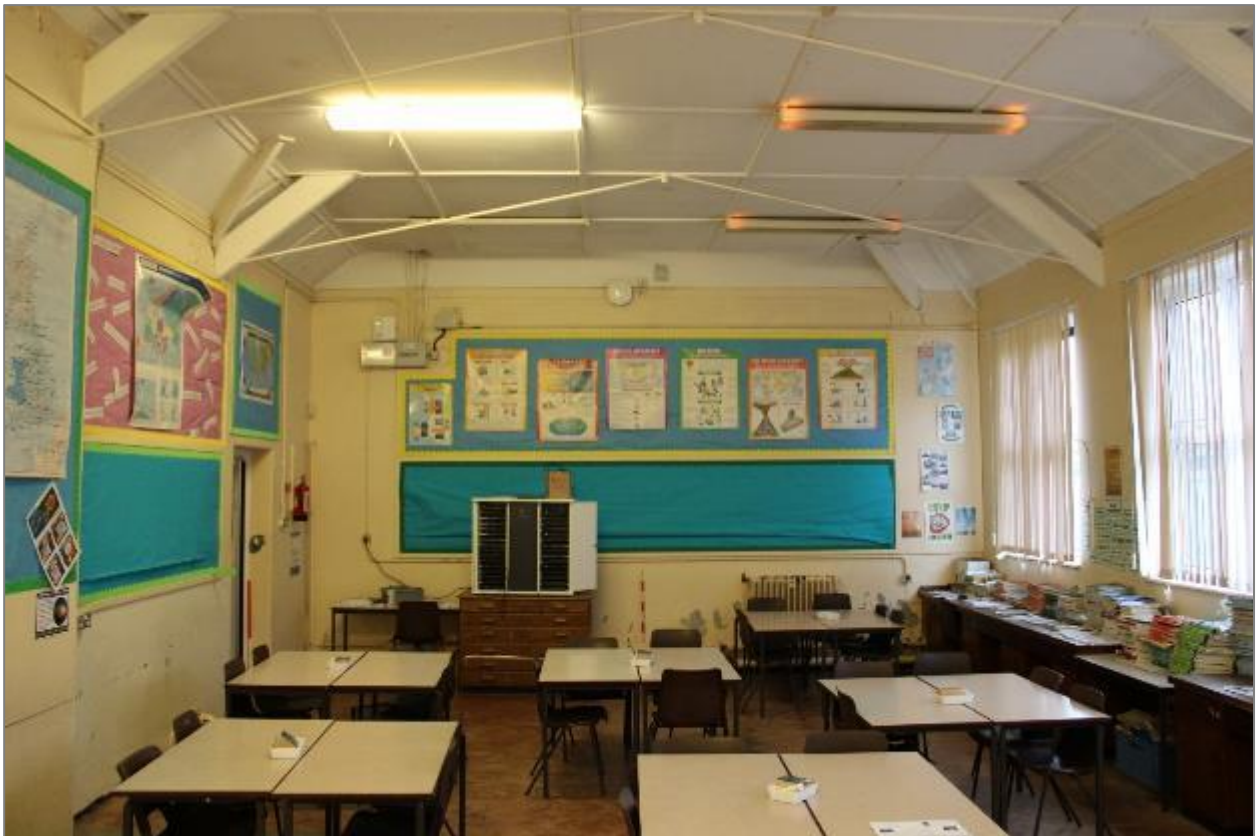
**Photo 49:** Corner classroom – entrance door visible in the left side corner. 2 x 1m scales.

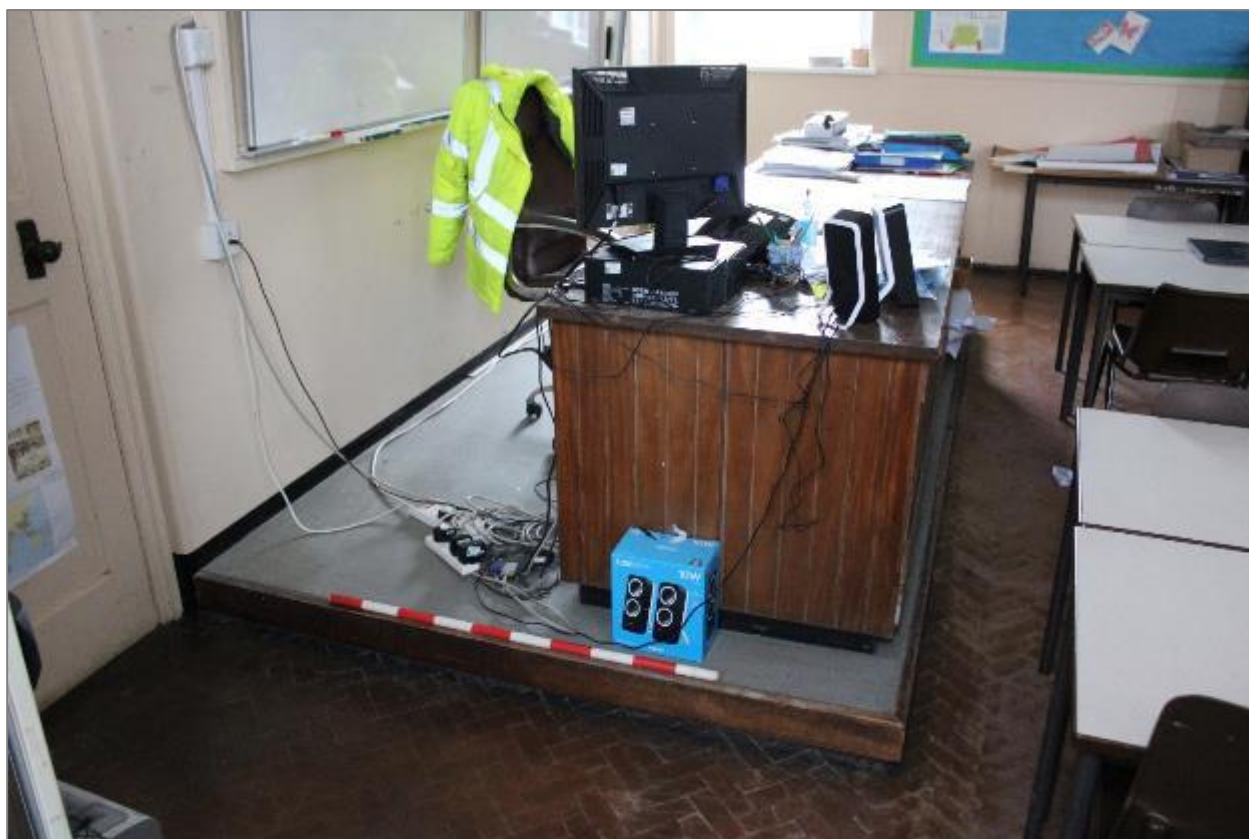
This classroom occupies the extended northern end of the southwest wing. The room is entered via a single door in the southeast corner. The standard parquet flooring is continued through the room, with a low raised platform and teachers' desk against the northwest wall. The walls are plain painted plaster, with a blocked fireplace and chimney column midway along the northeast wall. Wooden sink units are inserted along the southwest wall. This room has the original high panelled timber ceiling with part exposed roof joists supported by metal bracing.

**Photo 50:** Corner classroom –platform at front of classroom. 1 x 1m scale.

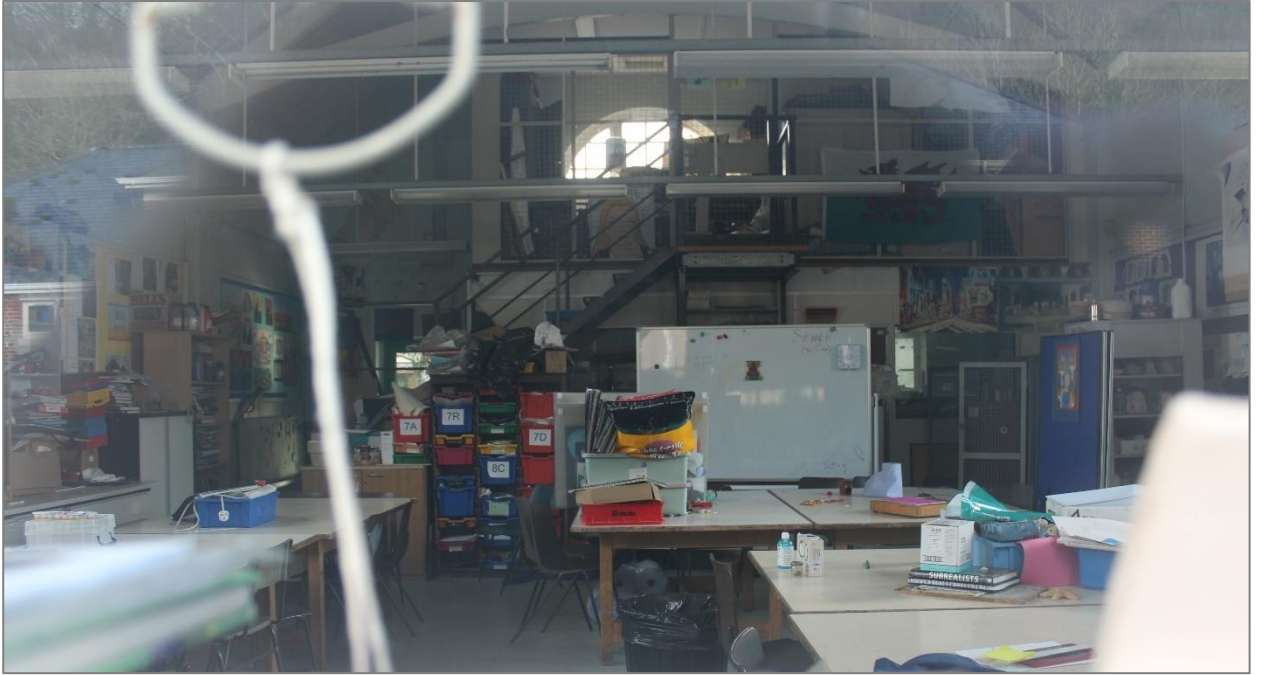
**Photo 51:** Northwest central hall, viewed from the northwest window.

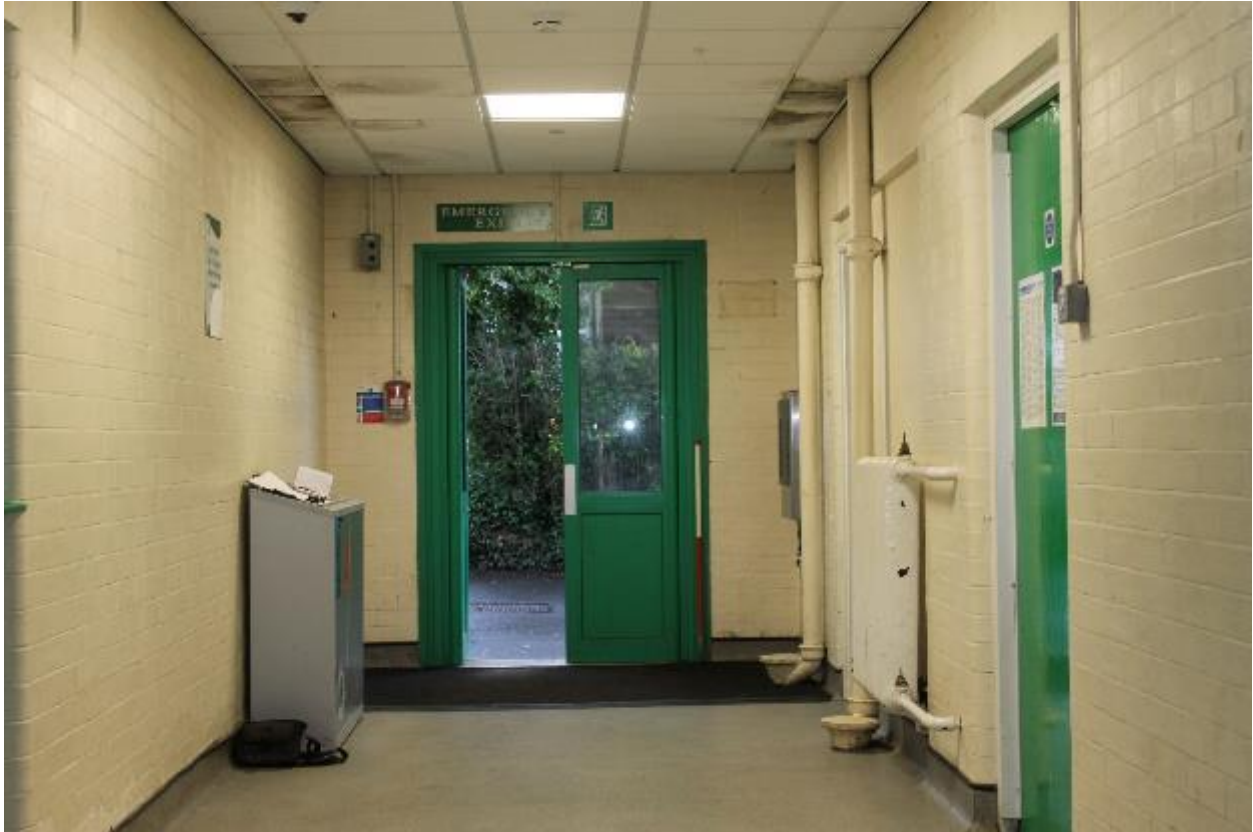
This corridor accesses the old block towards the southern end of the northeast range, via a pair of modern half-glazed doors. The corridor measures approximately 9.4m by 2.4m. On the southeast wall are three modern plain fire doors which lead to a W.C., storeroom, and reprographics room. On the opposing wall are the entrances to another storeroom and the corridor which leads along the northeast range. At the southeast end are double doors which lead out into the open walkway. There is a modern suspended ceiling and polished concrete floor. The walls are painted tile/brick. There is a cast iron radiator on the southeast wall.

**Photo 53:** Entrance corridor. Facing northeast. 1 x 1m scale.

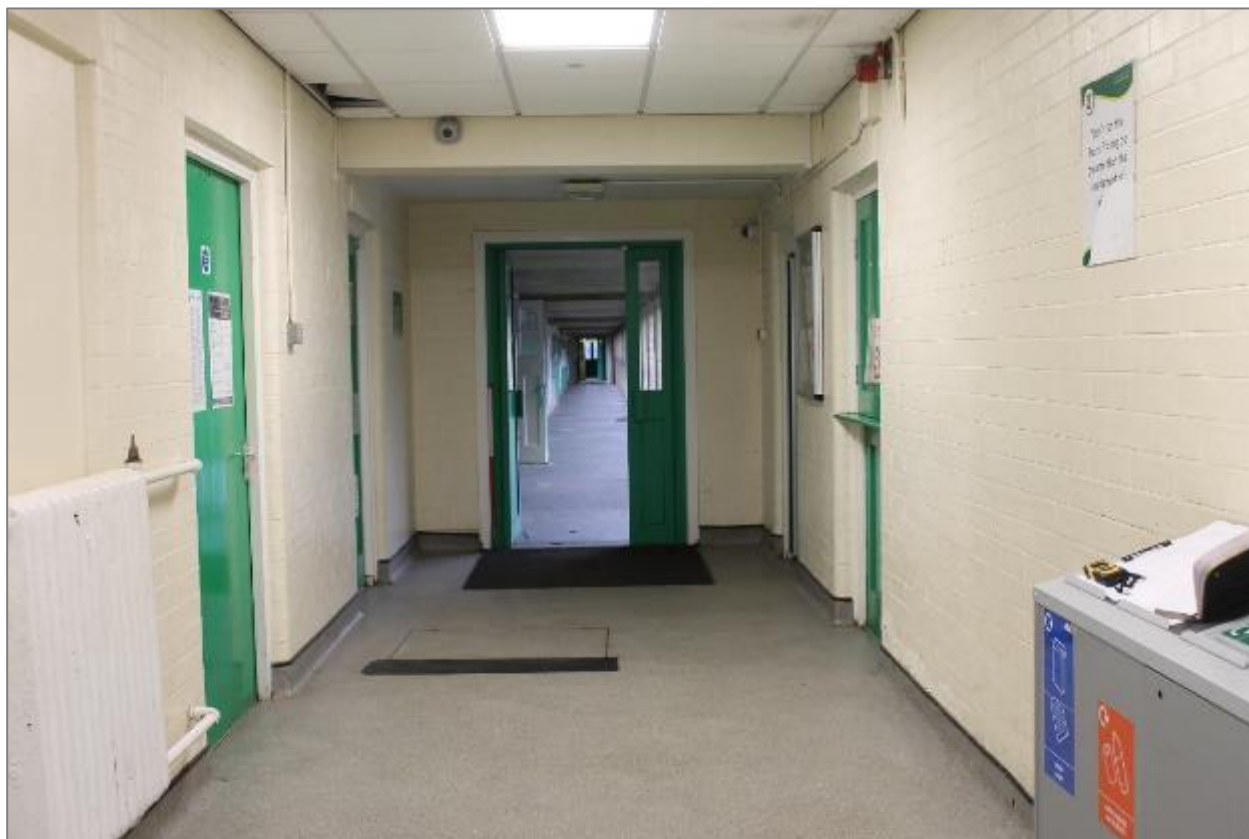
**Photo 54:** Entrance corridor. Facing southwest. 1 x 1m scale.

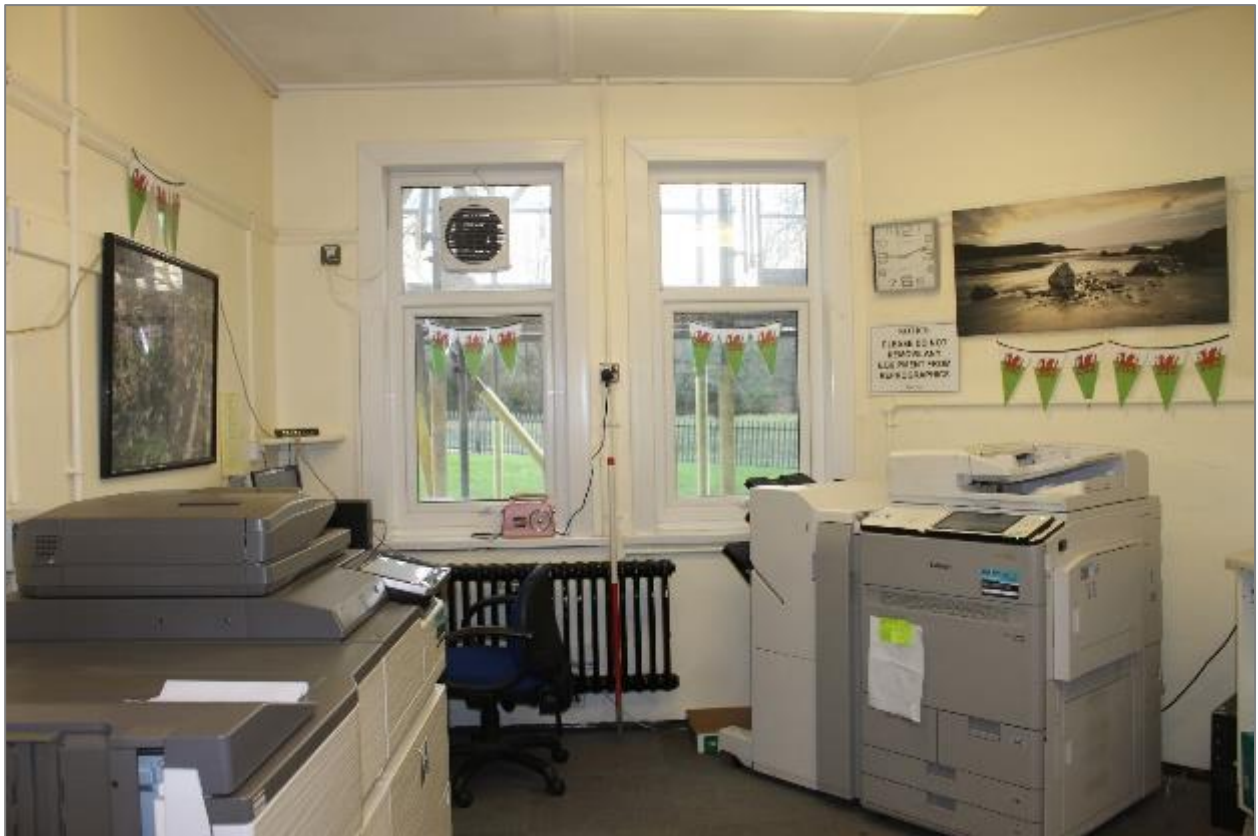
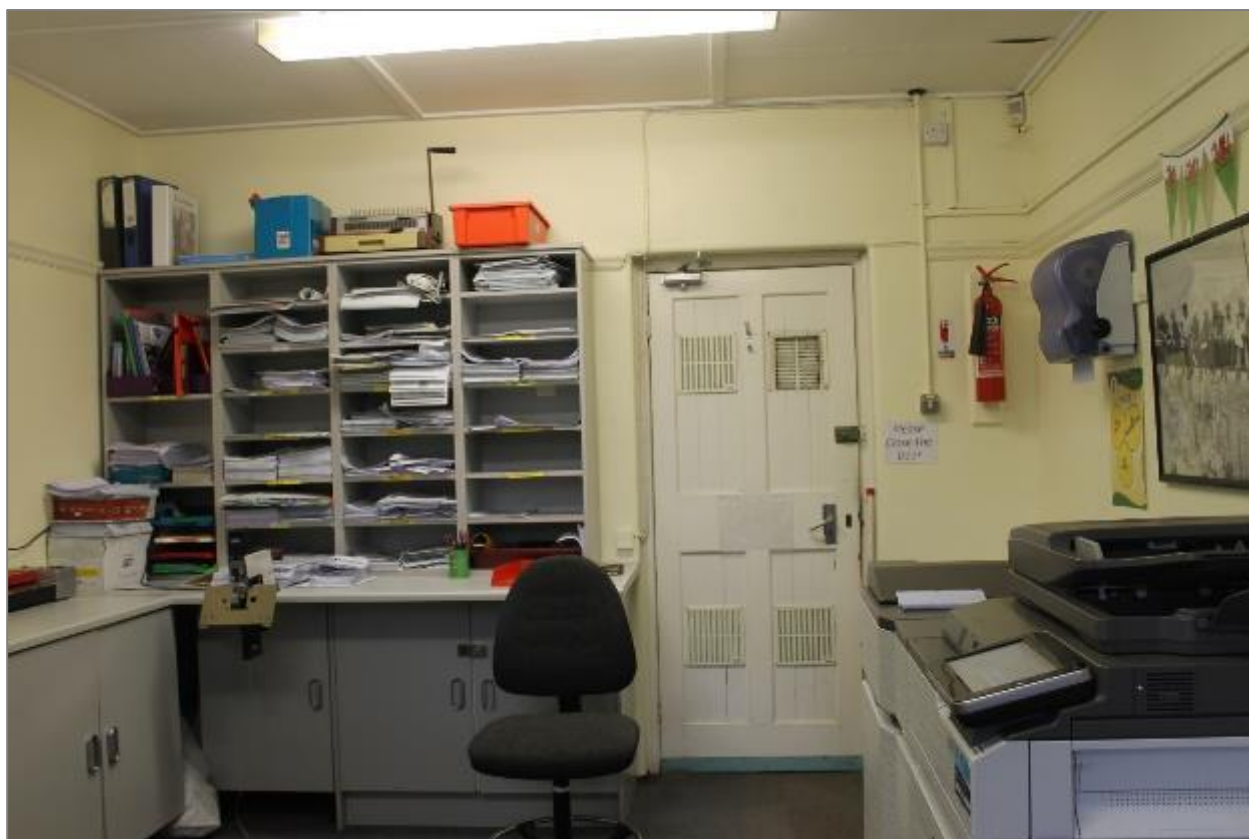
#### **4.3.10 Reprographics room off entrance corridor (photos 56-57)**

The room measured approximately 4.85m by 3.70m at its widest points. The southwest wall runs for 3.60m from the entrance wall before turning approximately 45 degrees and joining the outside wall. There are two windows on the outside wall with modern uPVC frames, with a cast iron radiator below. There is a wooden picture rail around the perimeter of the room approximately two thirds up from the base of the wall. All the walls appear to be painted plaster apart from the small offset section on the southeast wall which is painted tile/brick. the ceilings are painted white with a grid pattern of battened wood, the floor is polished concrete.

**Photo 56:** Reprographics room off entrance corridor. Facing southeast. 1 x 1m scale.

**Photo 57:** Reprographics room off entrance corridor. Facing northwest. 1 x 1m scale.

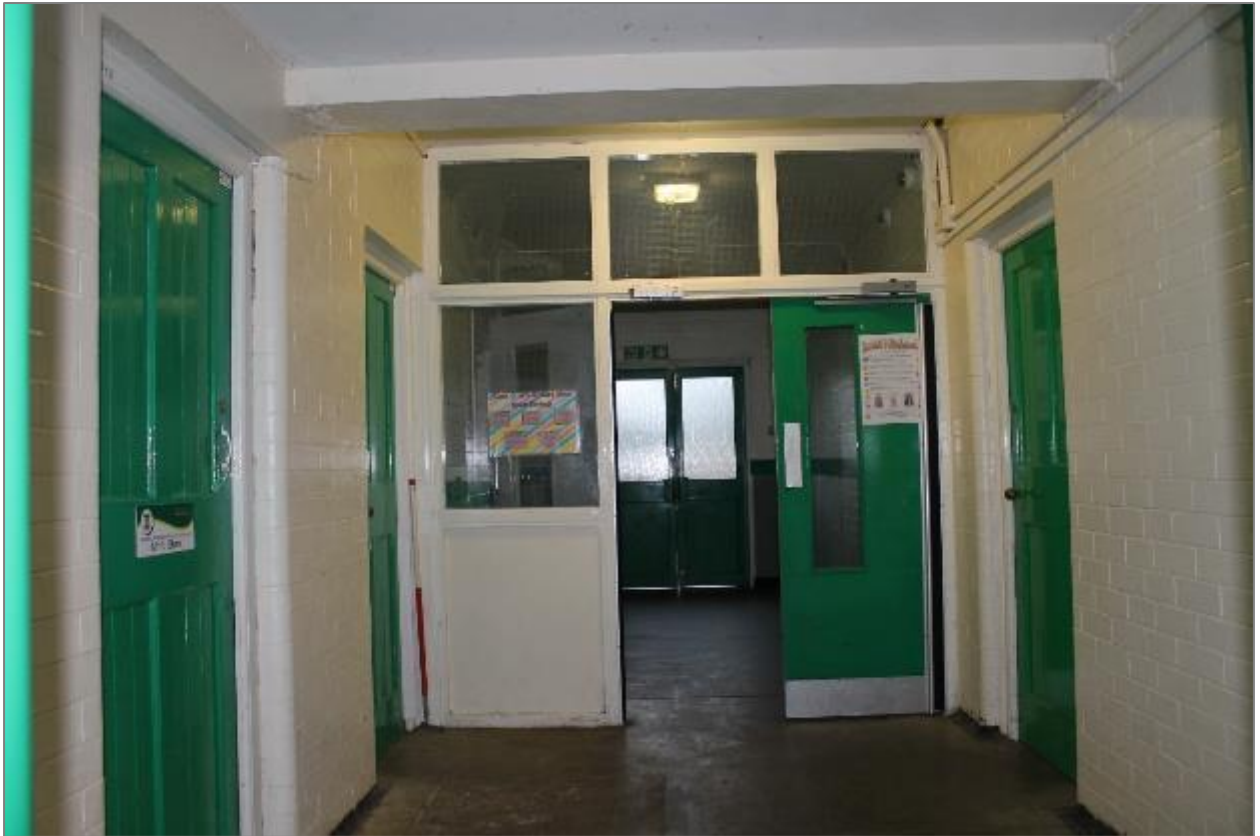
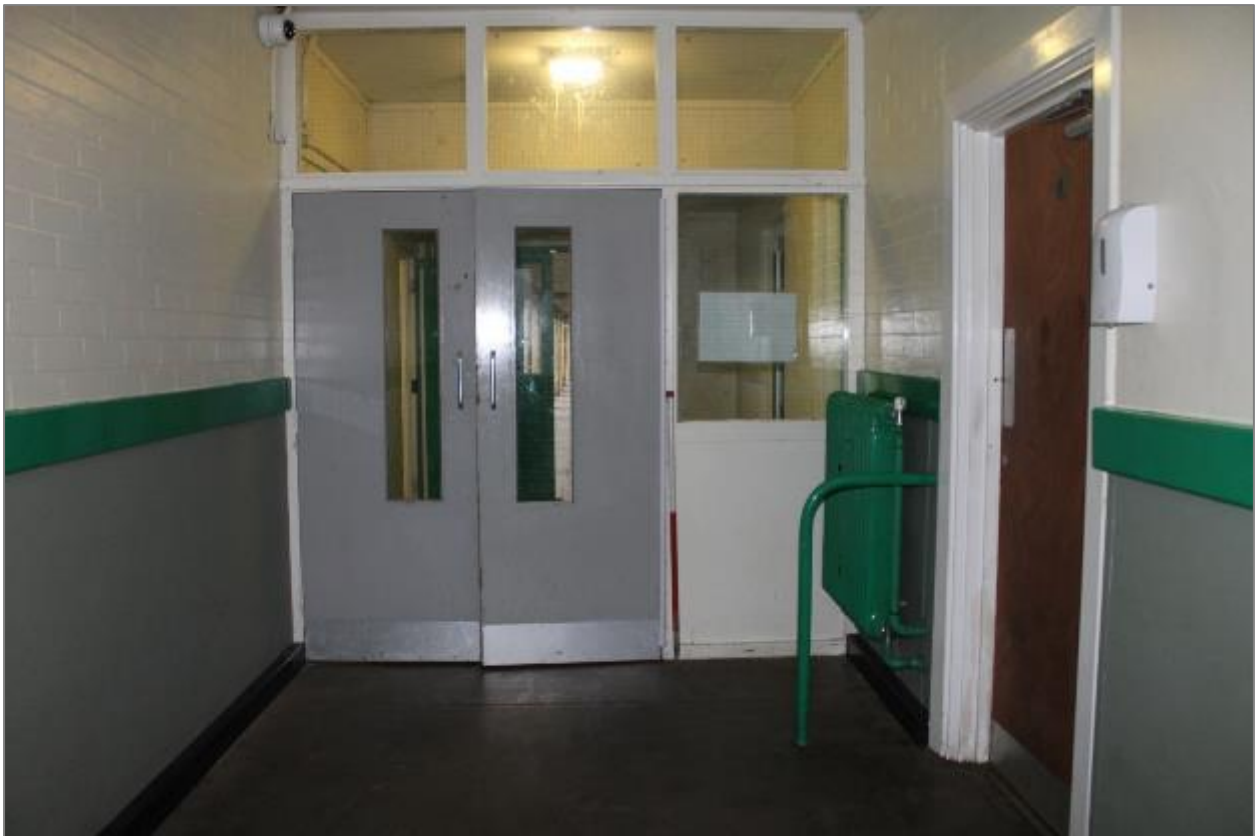
#### **4.3.11 Entrance corridor – southern corner (photos 58-59)**

This entrance corridor lies at the southern end of the southwest range. The corridor measures approximately 9.3m long by 2.4m wide and accessed internally via a set of wooden double doors from the covered walkway. The corridor is divided in the centre by wooden double doors offset to the northwest side, with a wooden panel with single light window to the side, and three single light windows above, all framed in wood. On the southeast wall are two wood panelled doors leading to an office a single W.C., and a modern fire door leading to a larger W.C., outside which is a cast iron radiator. On the opposing wall is a single door leading to the corridor running along the southwest range. The floor is polished concrete, the ceiling is painted plaster. The walls at the northeastern end are painted tile/brick. At the southwestern end the upper walls are painted tile/brick, the lower walls are covered in a modern plastic. There is a thick wooden rail dividing the two areas.

**Photo 58:** Entrance corridor in southern corner of the old block. Facing southwest. 1 x 1m scale.

**Photo 59:** Entrance corridor in southern corner of old block. Facing northeast. 1 x 1m scale.
