# **LLANGATWG SCHOOL, CADOXTON, NEATH PORT TALBOT SA10 8DB HISTORIC BUILDING RECORDING**

REPORT NO. 2025-02  
EVENT RECORD NO. E008746

**LLANGATWG SCHOOL, CADOXTON, NEATH PORT  
TALBOT, SA10 8DB:  
HISTORIC BUILDING RECORDING**

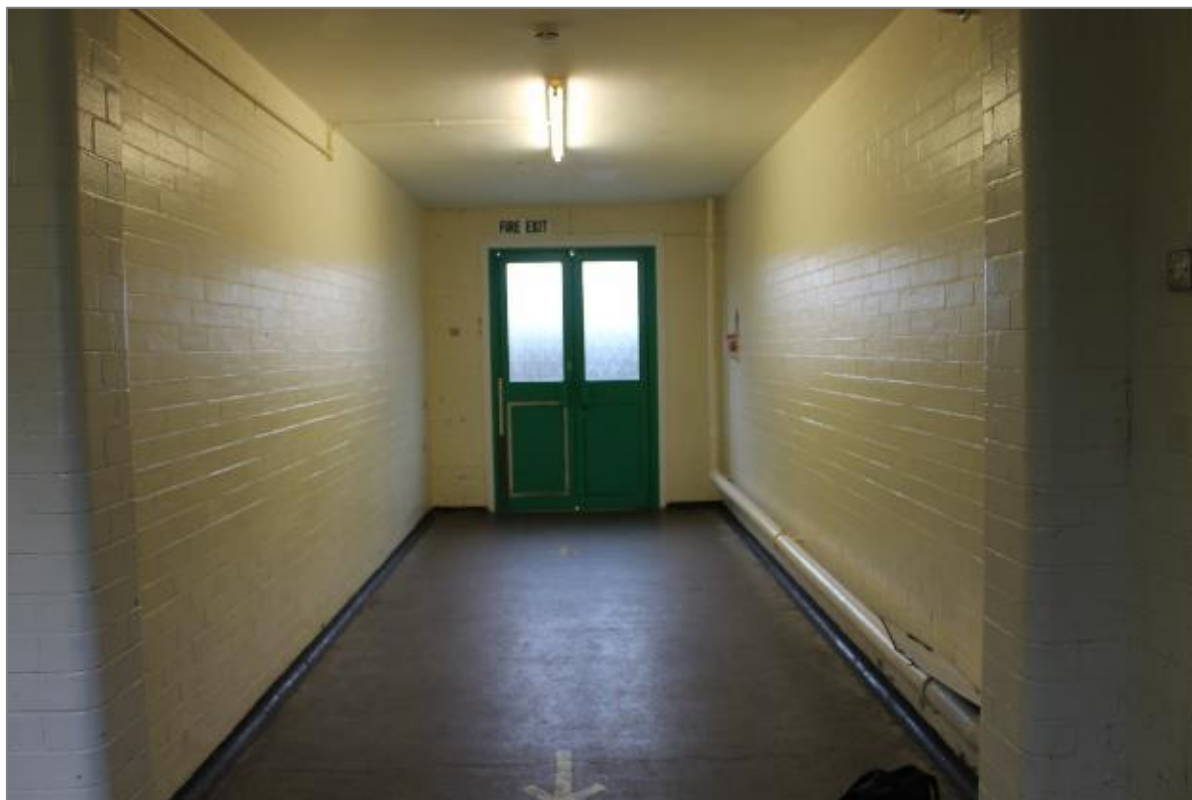
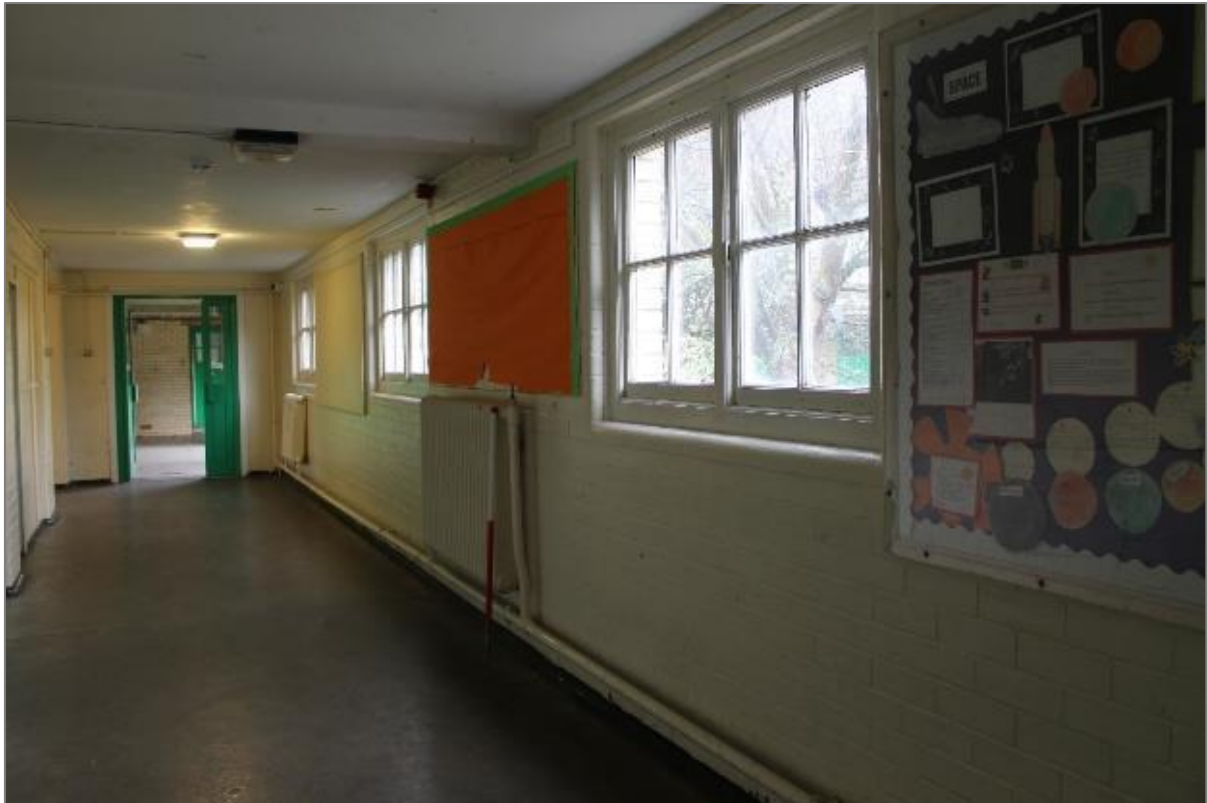
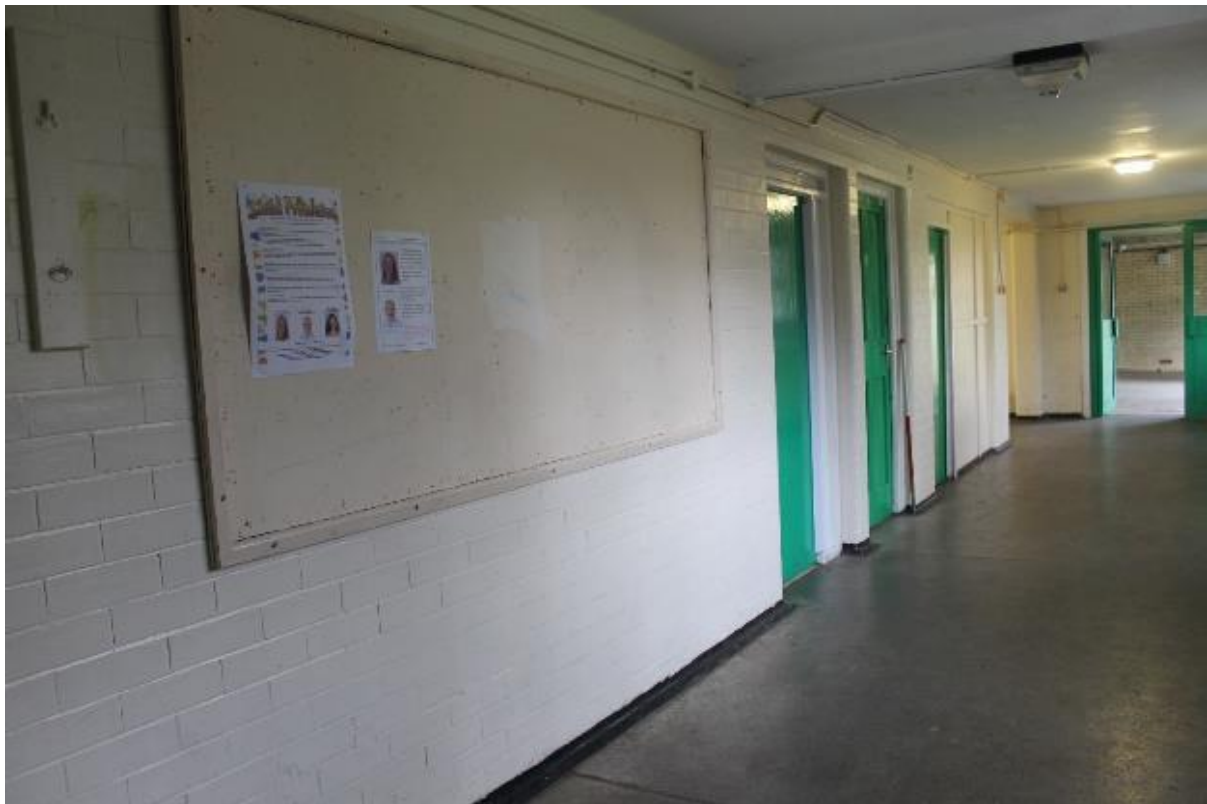
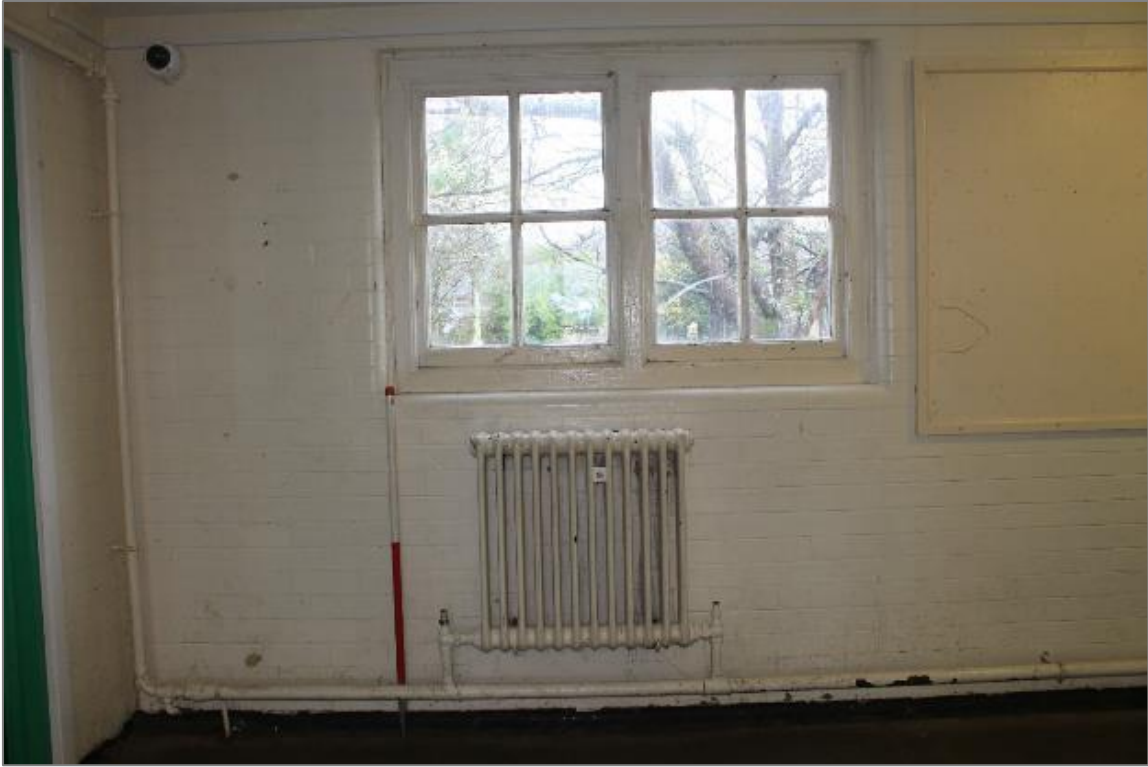
**4.3.12 Central entrance and corridor – southwest range (photos 60-63)**

The original main entrances lie midway along the southwest and northeast ranges. To the southwest a pair of double doors enters a short plain corridor 8.7m long, with polished concrete floor, painted tile/brick walls and plain plastered ceiling.

At the east end of this short entrance corridor a pair of aluminium door lead northwest to the covered internal walkway, with the enclosed corridor turning a right angle to run to the southeast. This corridor is approximately 18.6m long and 2.4m wide. On the northeast wall there are three eight-light wooden framed window which looks out onto the quadrangle. There are also two cast iron radiators. The southwest wall has three doorways to a classroom and storerooms.

At the southern end, where it meets to the entrance corridor in the southern corner, a foyer area leads to the stairway of the upstairs classroom and measures approximately 3.15m by 2.40m. This foyer is enclosed by a set of wooden double doors with a single glass panel in each. On the northeast wall is an eight-light wooden framed window which looks out onto the quadrangle with a cast iron radiator below.

**Photo 60:** Central entrance corridor in the southwest range. Facing southwest. 1 x 1m scale.

**Photo 61:** Corridor in the southwest range. Facing northwest. 1 x 1m scale.

**Photo 62:** Corridor in the southwest range. Facing northwest. 1 x 1m scale.

**Photo 63:** Corridor in the southwest range. Facing northeast. 1 x 1m scale.

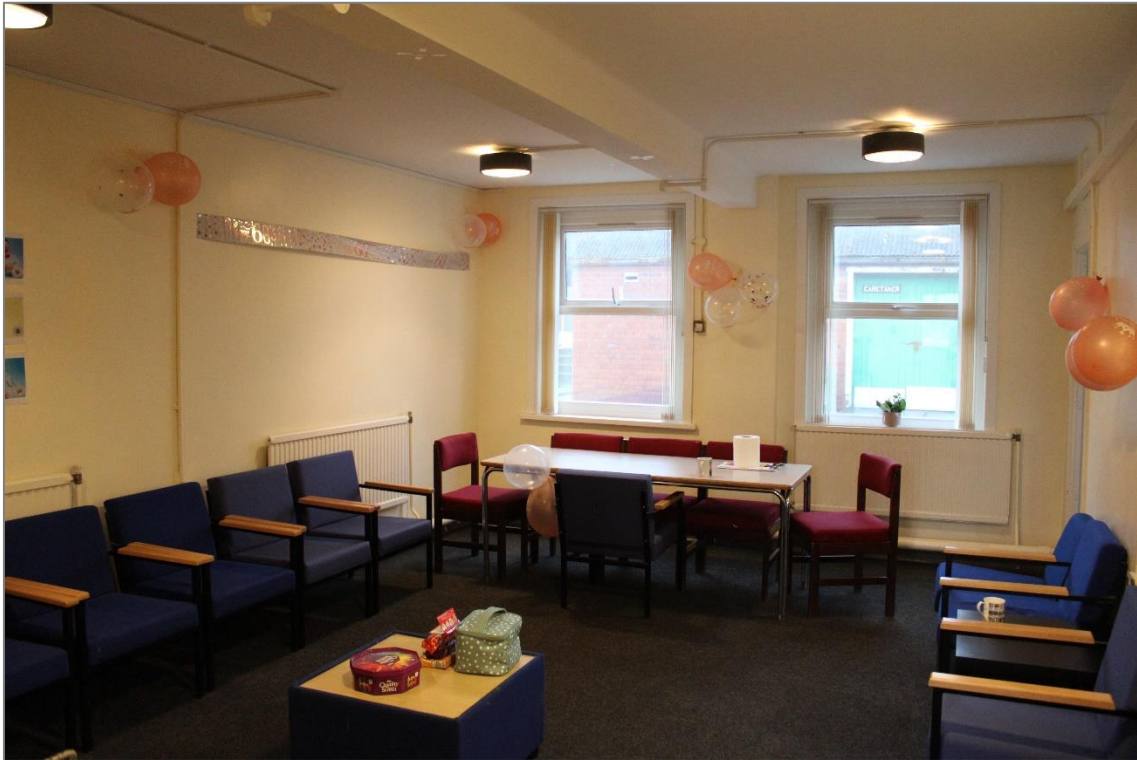
#### 4.3.13 Central entrance and corridor – northeast range (photo 64)

The central entrance and corridor visible in the southwest range (4.3.12) is repeated in the northeast range. The inner corridor accesses an office, kitchen area and staff room/meeting room. These rooms are modernised throughout, with carpeted or vinyl tile flooring, plain walls and ceiling, modern radiators and uPVC windows (photo 64).

**Photo 64:** Staff room/meeting room in the northeast range. Facing northeast.

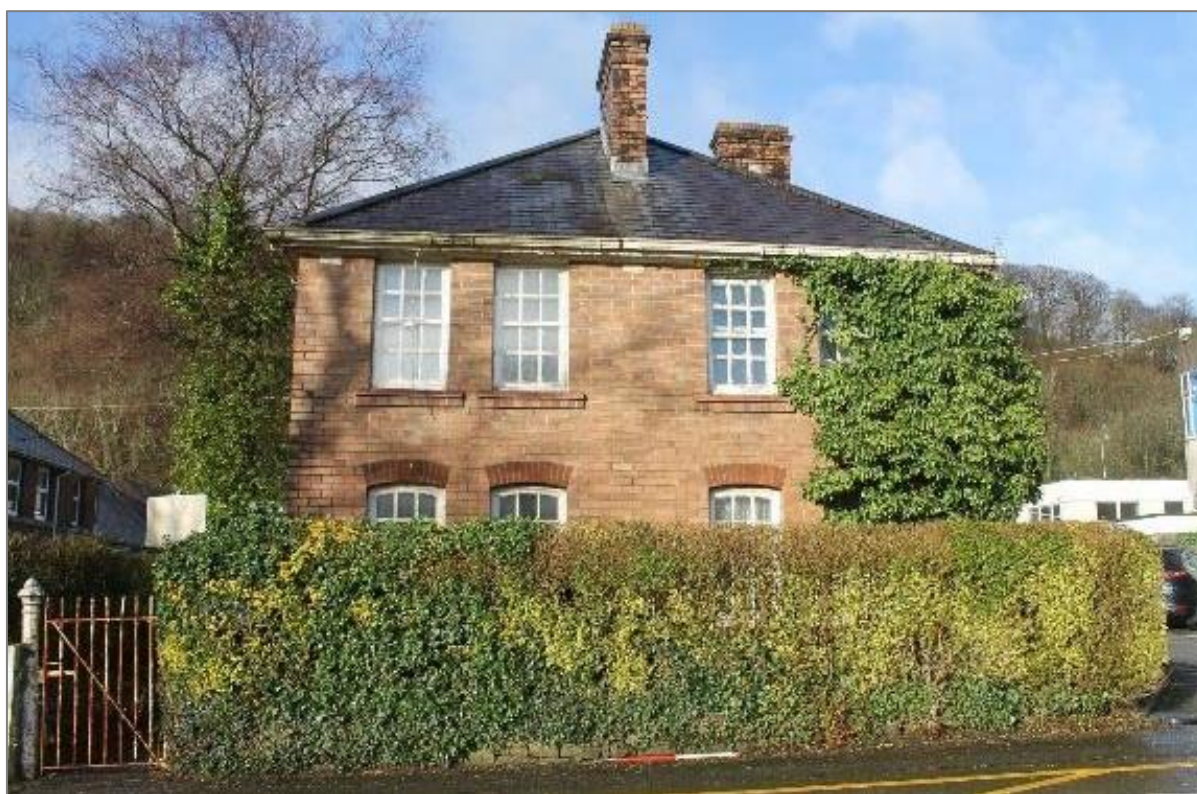
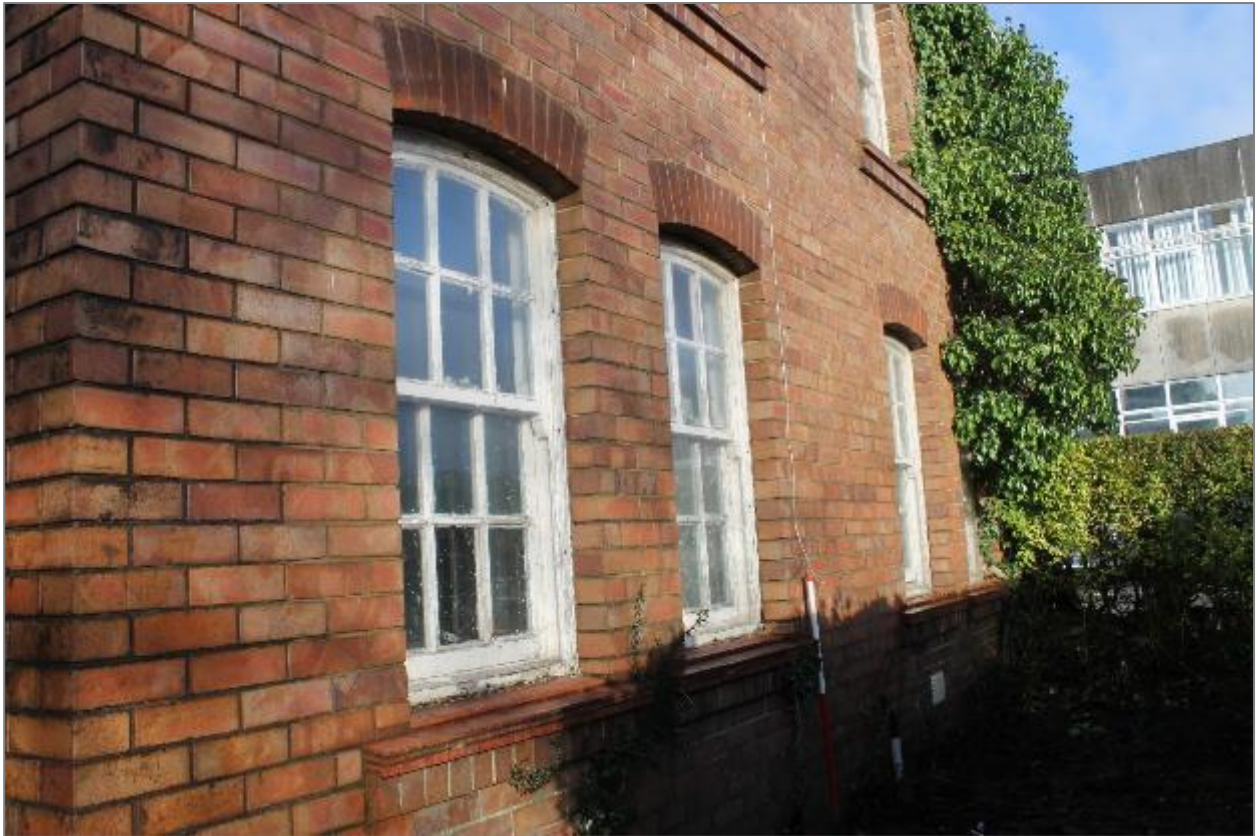
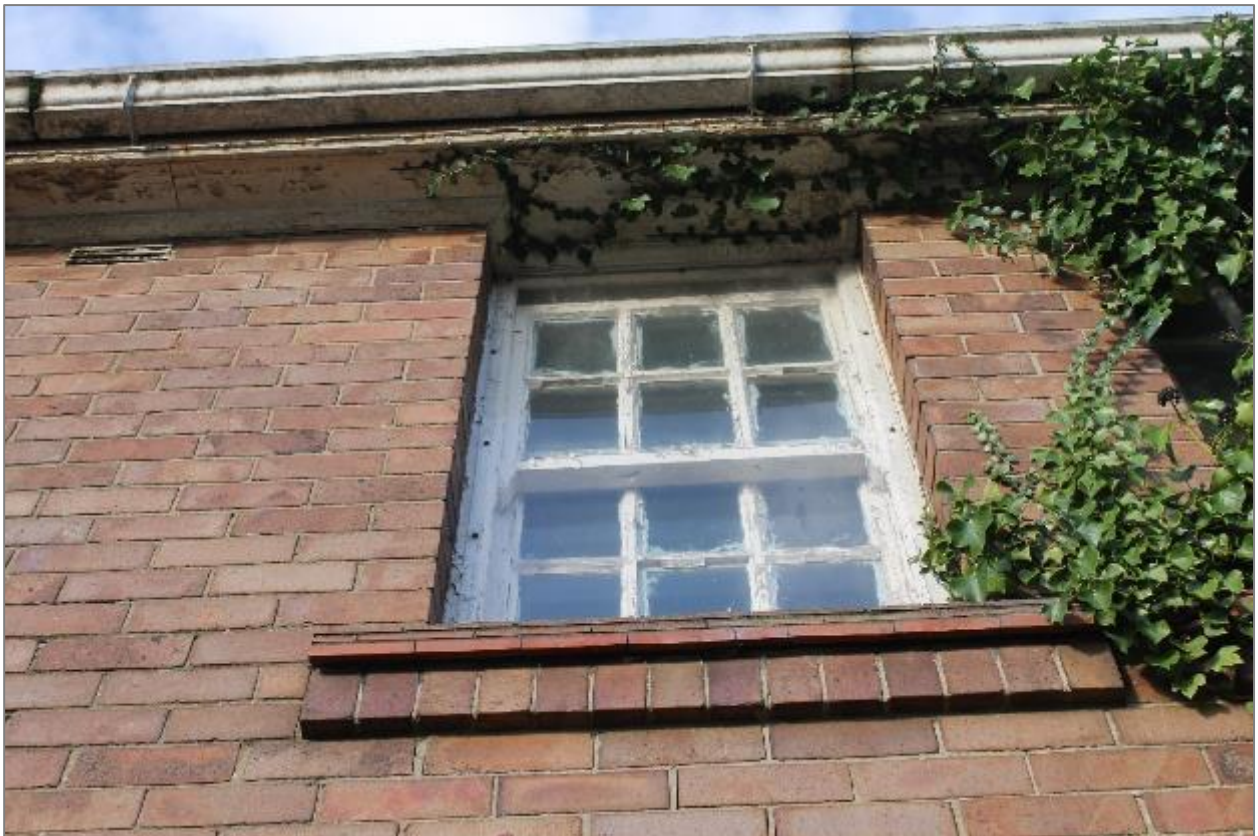
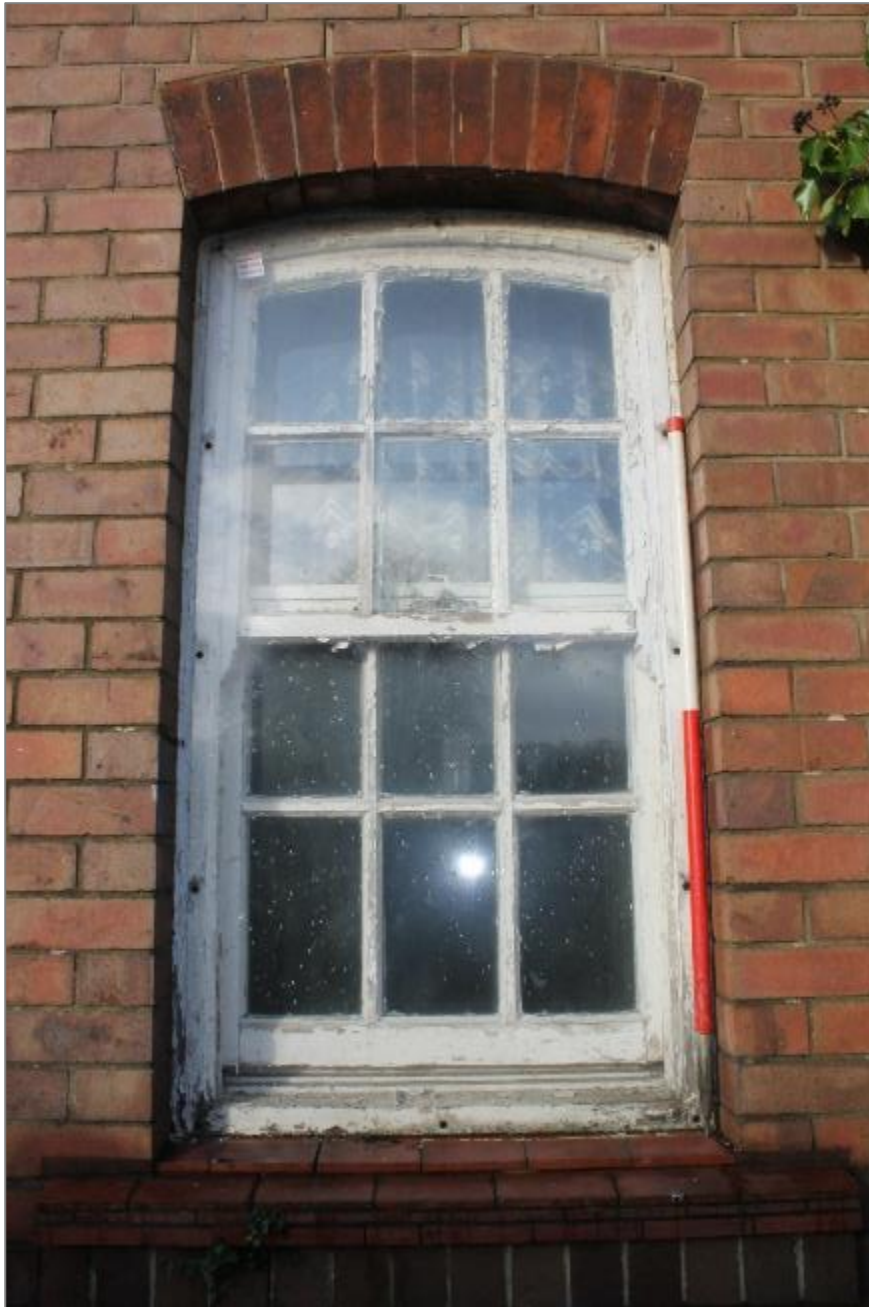
#### 5.2.1 Southeast facing façade (photos 65-68)

The southeast facing façade has a red brick finish laid in stretcher bond. On the slate hipped roof is a brick chimney stack located at the apex of the roof. There are eight wooden framed windows, four at ground floor and four at first floor level. The ground floor windows are twelve light sash windows with decorative red brick and tile sills with a red brick arch above. The first-floor windows are also twelve light sash windows with the same decorative sills, the top of the windows ending where it meets the overhanging eaves.

**Photo 65:** Southeast facing façade of former caretaker's house.

**Photo 66:** Southeast facing façade of former caretaker's house – ground floor. 1 x 1m scale.

**Photo 67:** Southeast facing façade – first floor window.

**Photo 68:** Southeast facing façade – ground floor window.

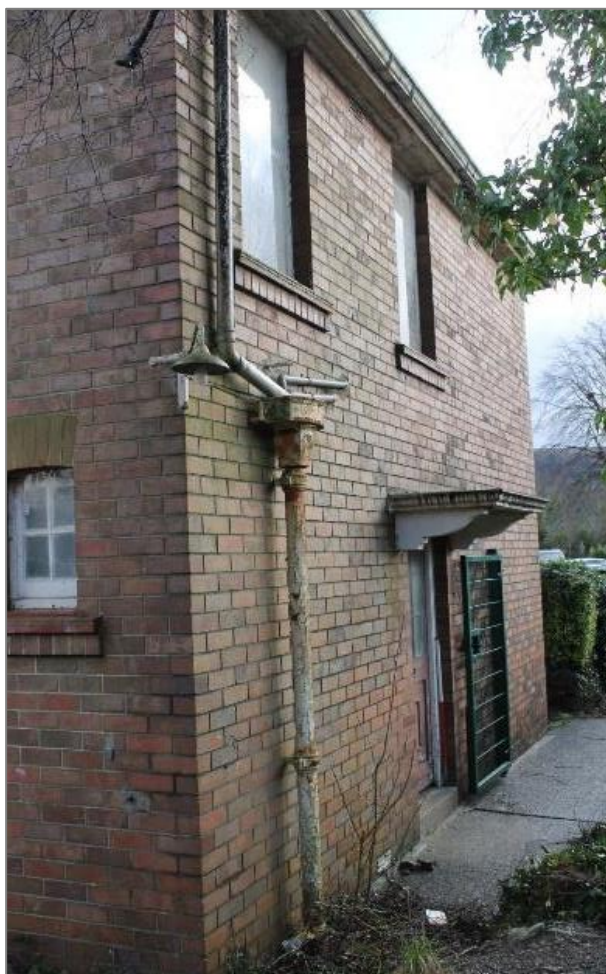
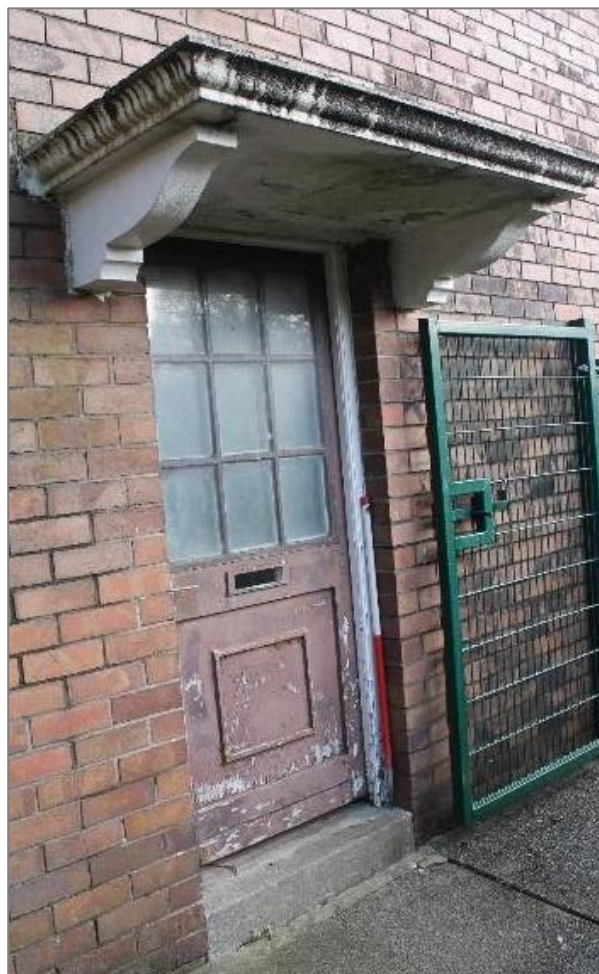
### 5.2.2 Southwest Facing Façade (photos 69-70)

The brick and window detail is continued on the southwest façade. The main entrance lies centrally at ground floor level, comprising a half-glazed wood panel door in a plain surround under a decorative wooden canopy. There are no ground floor windows. At first floor level are two windows, one above the door, which is a wooden twelve light sash window, and one two-pane wooden sash window to the north. There is a cast iron drainpipe which may date to the construction of the house, and with similar seen on the external facades of the Old Block.

**Photo 69:** Southwest facing façade. 1 x 1m scale.

**Photo 70:** Front door detail on the southwest facing façade. 1 x 1m scale.

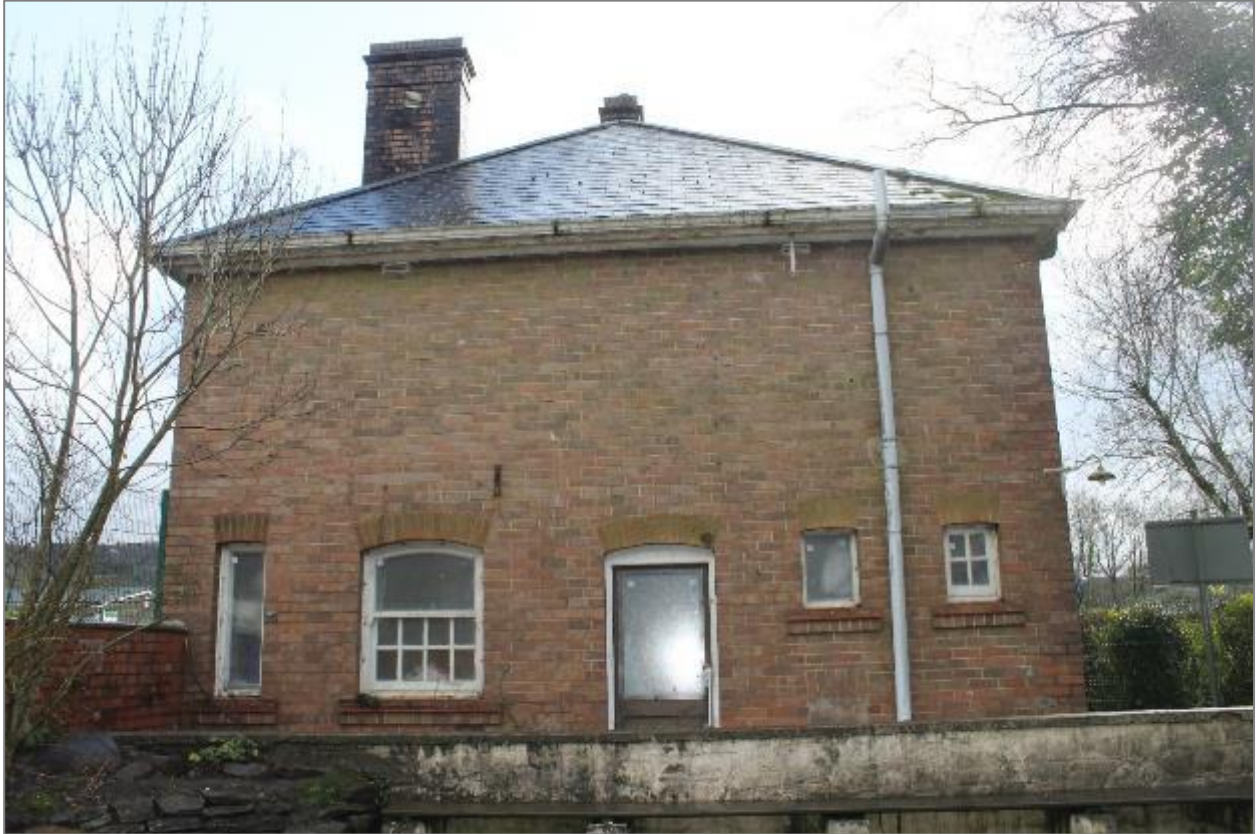
The rear northwest façade has a centrally placed doorway and four windows at ground floor level. The door is half glazed in a single pane of opaque glass, set in a wooden frame under a red brick archway. The window furthest northeast is a tall narrow single light fixed timber framed window. The adjacent window is a wooden sash window, with a single light at the top and an eight-light window below. To the southwest of the door are a pair of smaller windows, one a single pane light window, the other a four light window. All of the windows have red brick arches above and brick and tile sills. Below the single light window to the southwest of the door is small bricked up aperture with red brick arch.

**Photo 71:** Northwest facing façade.

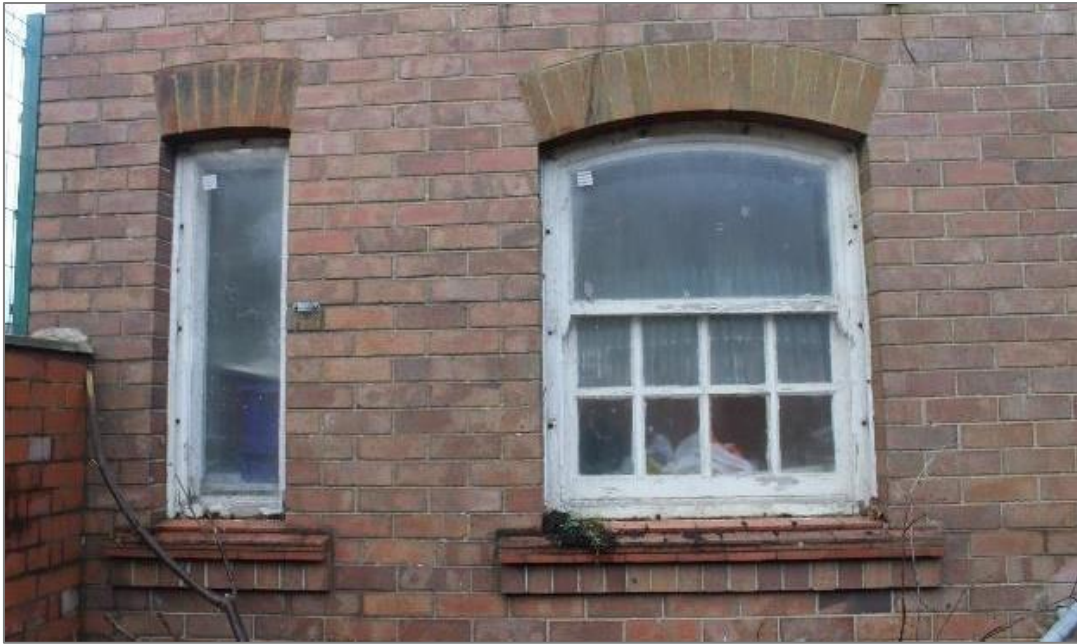
**Photo 72:** Northwest facing façade – ground floor windows.

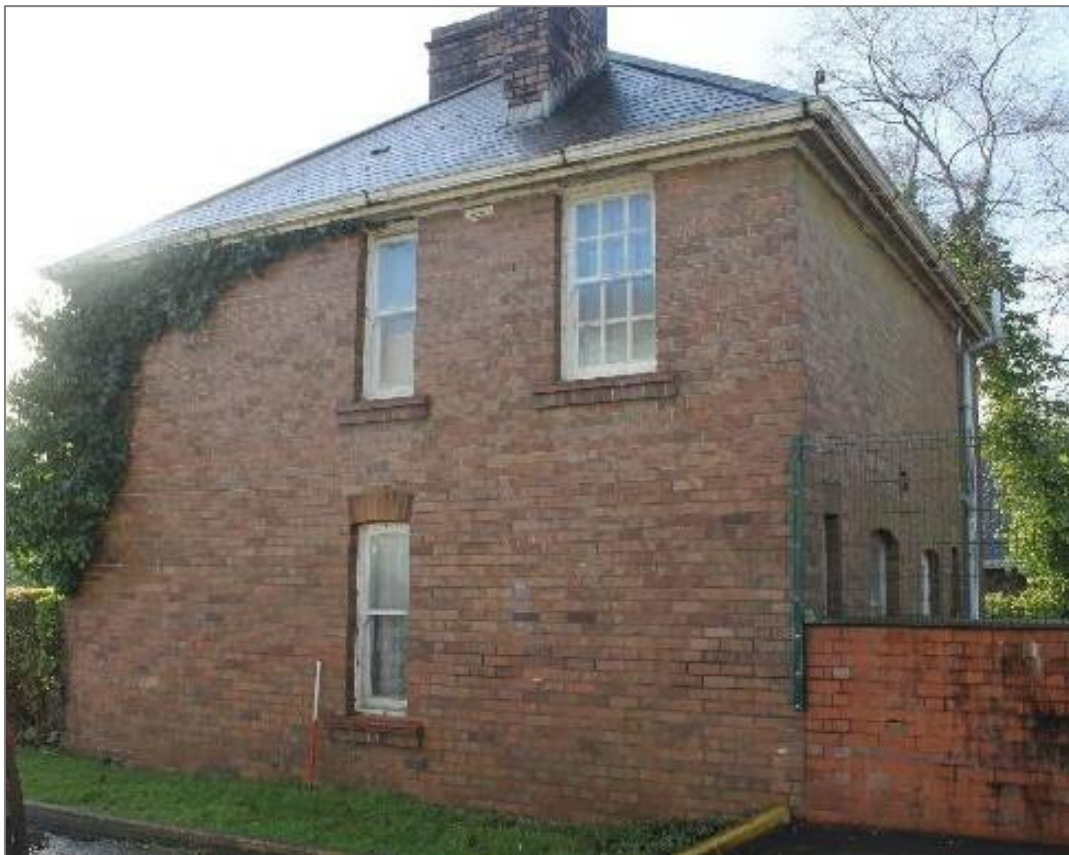
#### **5.2.4 Northeast Facing Façade (photo 73)**

This façade has a narrow timber-framed sash window in the centre at ground floor level with a brick and tile sill and brick arch above. A matching window lies above at first floor level, with a twelve light sash window to the north. Both also have brick and tile sills, and meet the eaves above. A brick chimney stack merges from the hipped roof above.

**Photo 73:** Northeast facing façade. 1 x 1m scale.

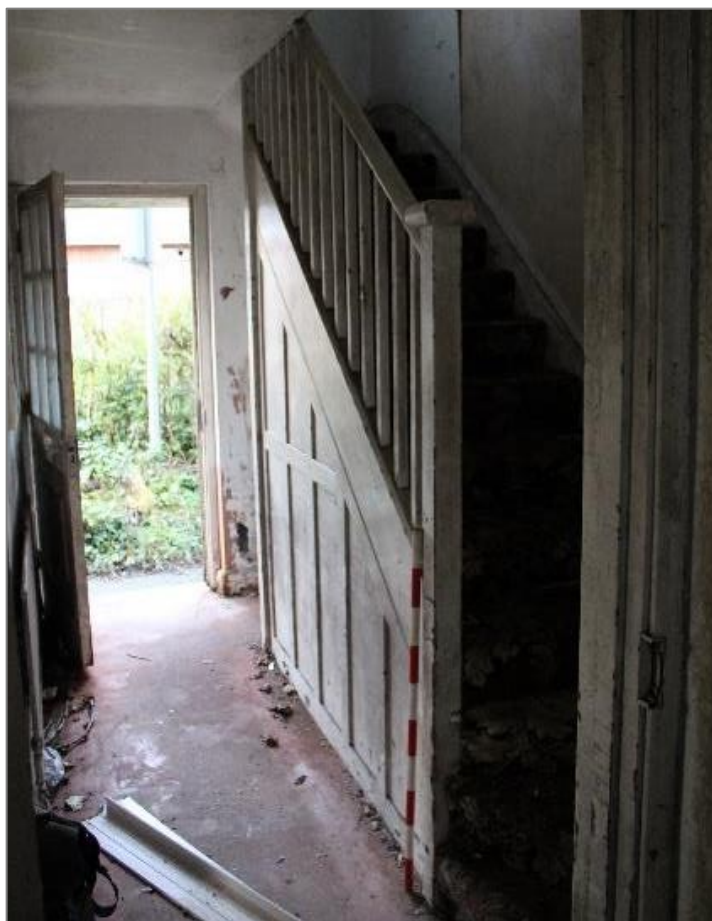
#### 5.3.2 Entrance hall and stairs (photo 74)

The stairs lie adjacent to the entrance hall, with exposed timber steps, plain squared newel and balusters and simple handrail. Painted wood panelling encloses the understairs area, which is accessed via a doorway to the southwest.

**Photo 74:** Entrance hall and stairs, facing southwest. 1 x 1m scale.

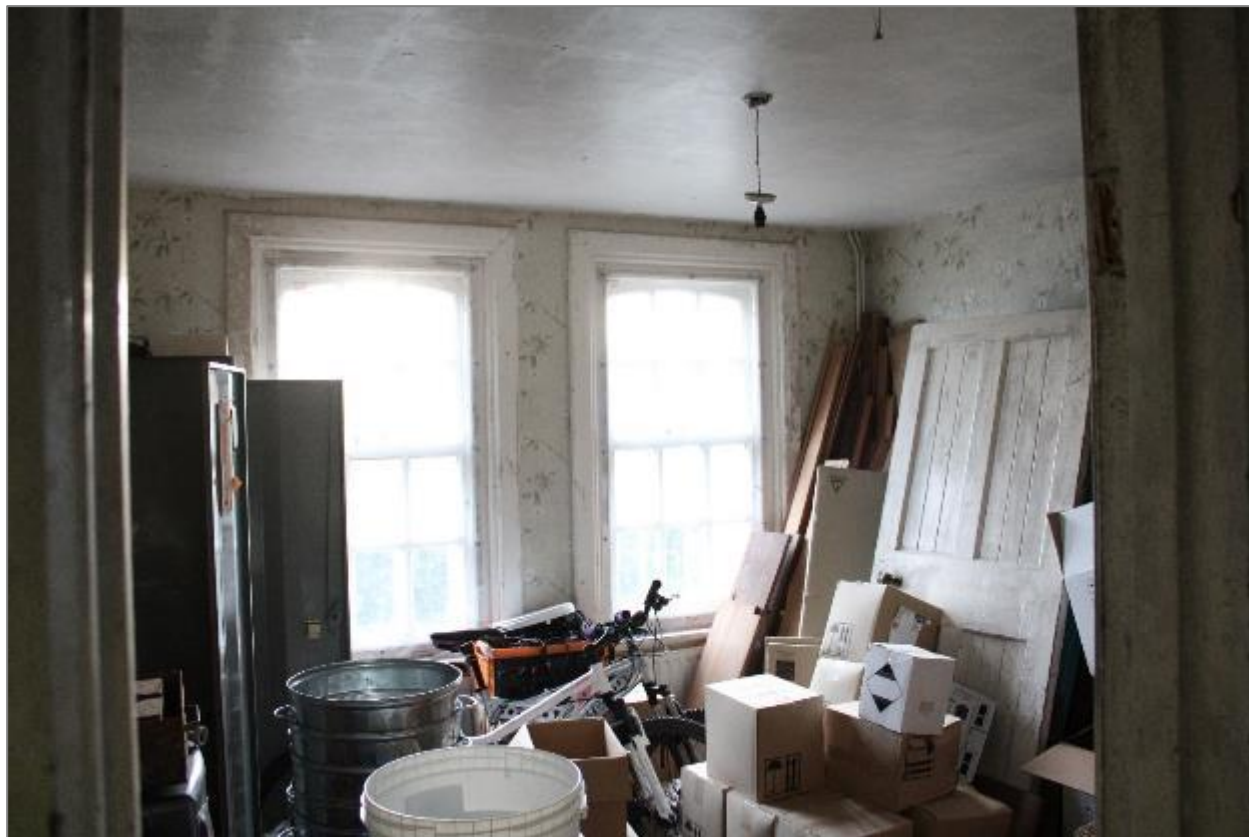
### 5.3.3 Front Room 1 (photo 75)

The former living room, occupying the west corner of the house. Vinyl sheeting covers the floor, the walls covered in a floral wallpaper, with a plain ceiling with central light. The room is lit by a pair of windows in a painted timber surround.

**Photo 75:** Front room 1. Facing west.

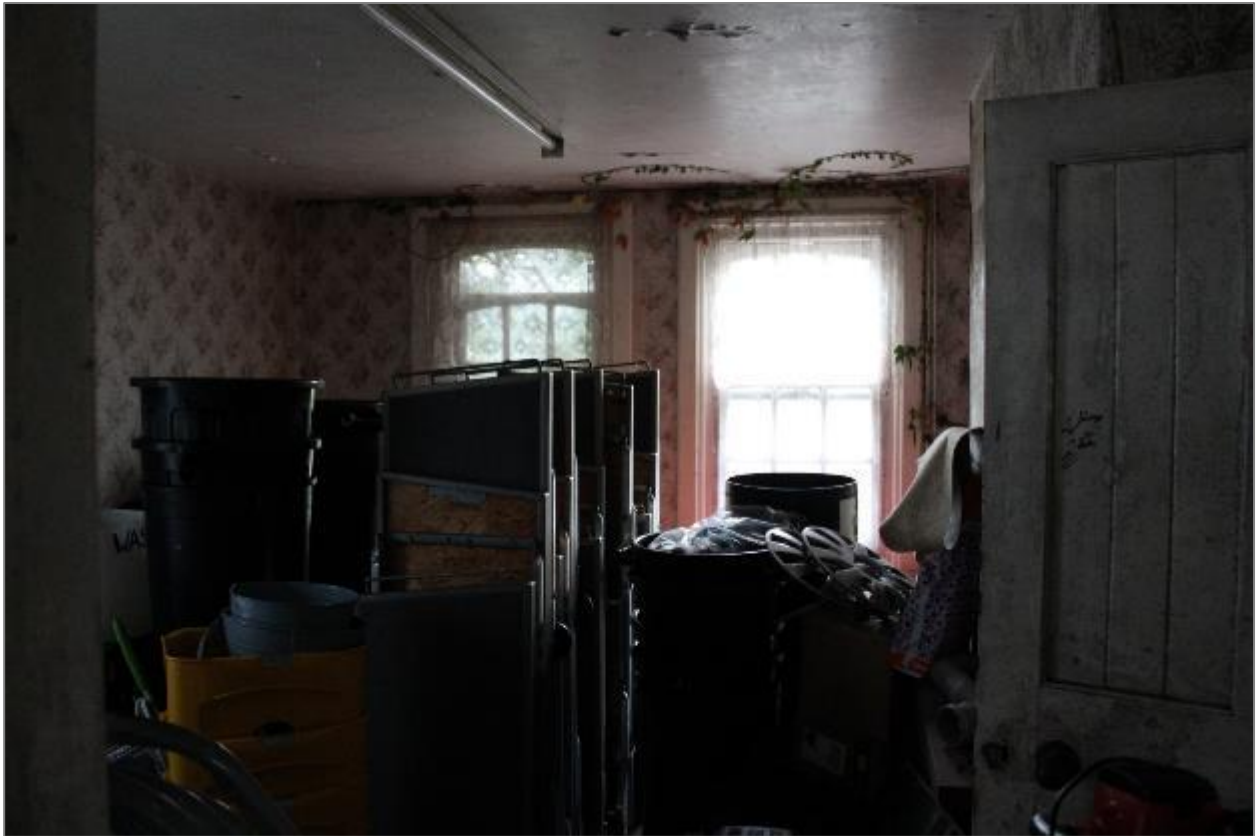
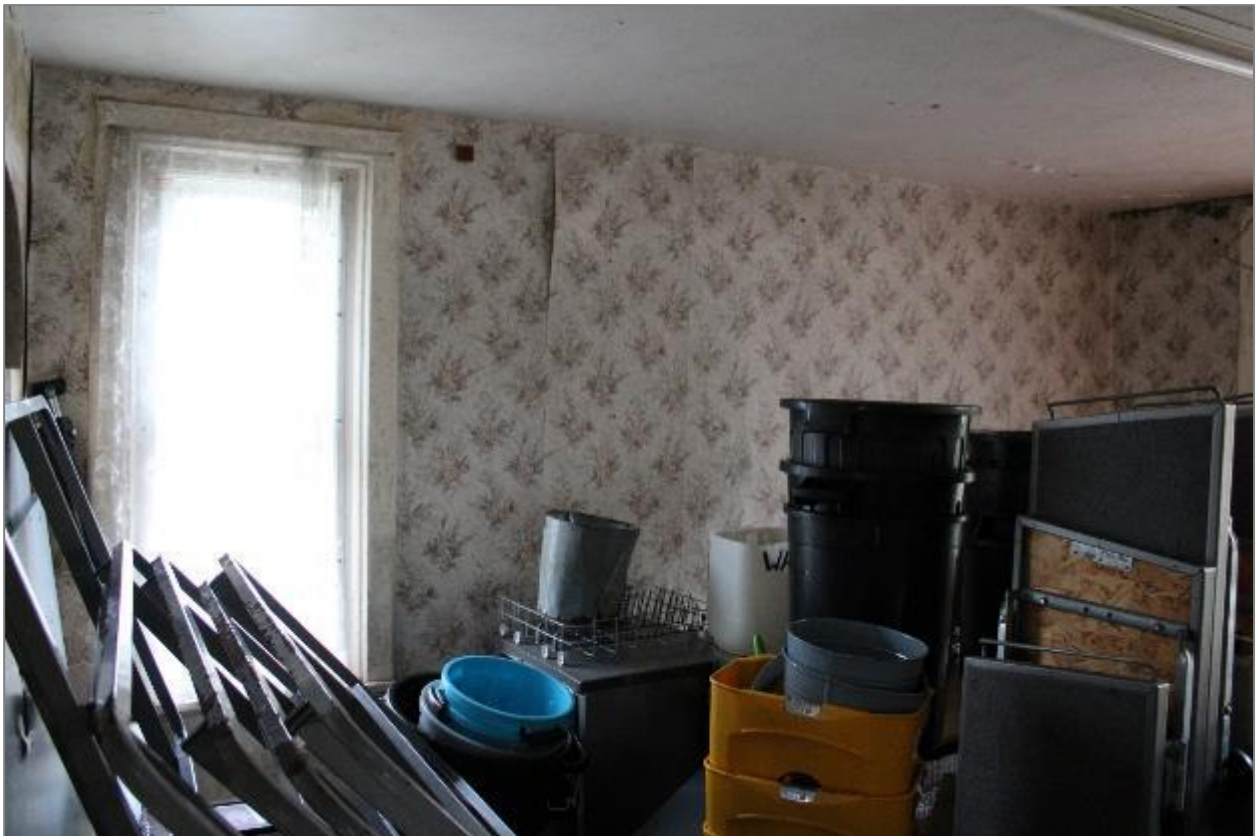
### 5.3.4 Front Room 2 (photos 76 - 77)

The former dining room, occupying the south corner of the house and the larger of the two main rooms as it is not restricted by the entrance hall. The concrete floor is exposed, the walls covered in floral wallpaper with a plain ceiling and central strip light. A fireplace protrudes from the internal northwest wall, blocked but with an electric heater placed in front. The room is lit by a pair of windows in the front southwest wall, and a narrow window in the southeast wall. A doorway to the northeast gives access to the kitchen.

**Photo 76:** Front room 2. Facing southwest.

**Photo 77:** Front room 2. Facing southeast.

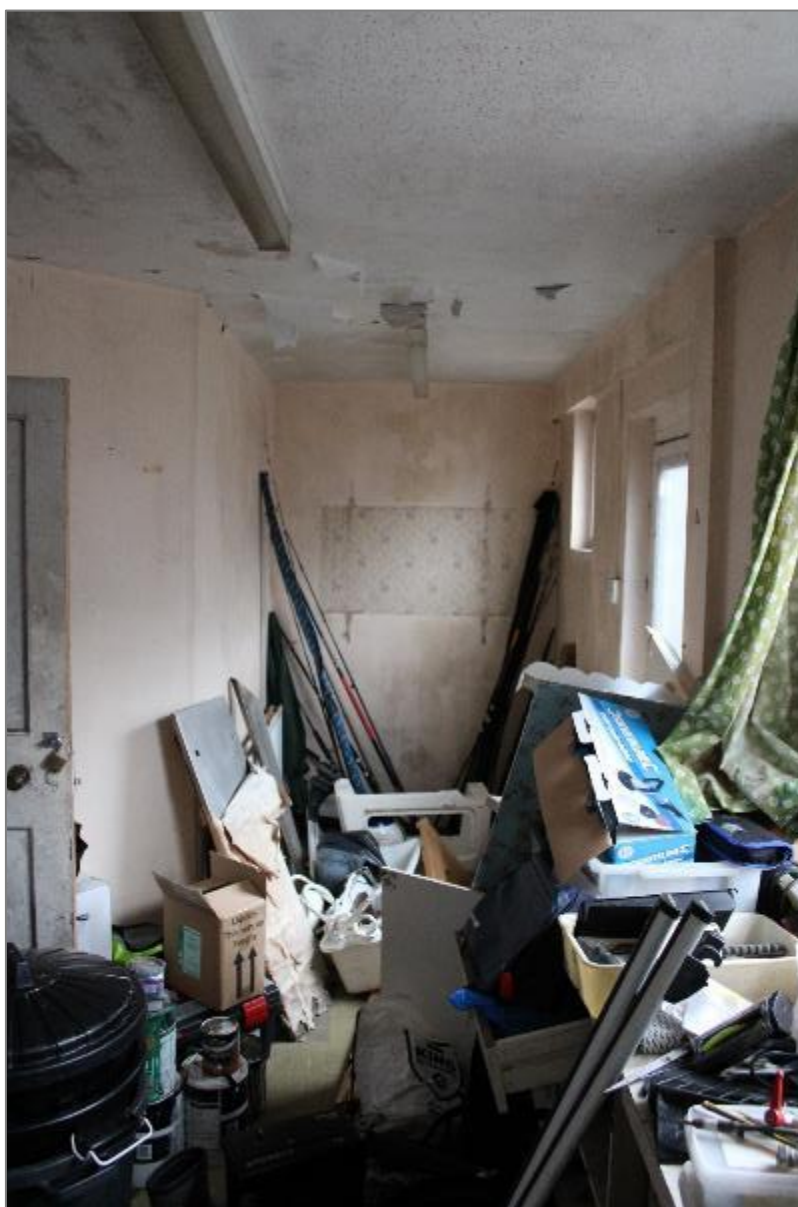
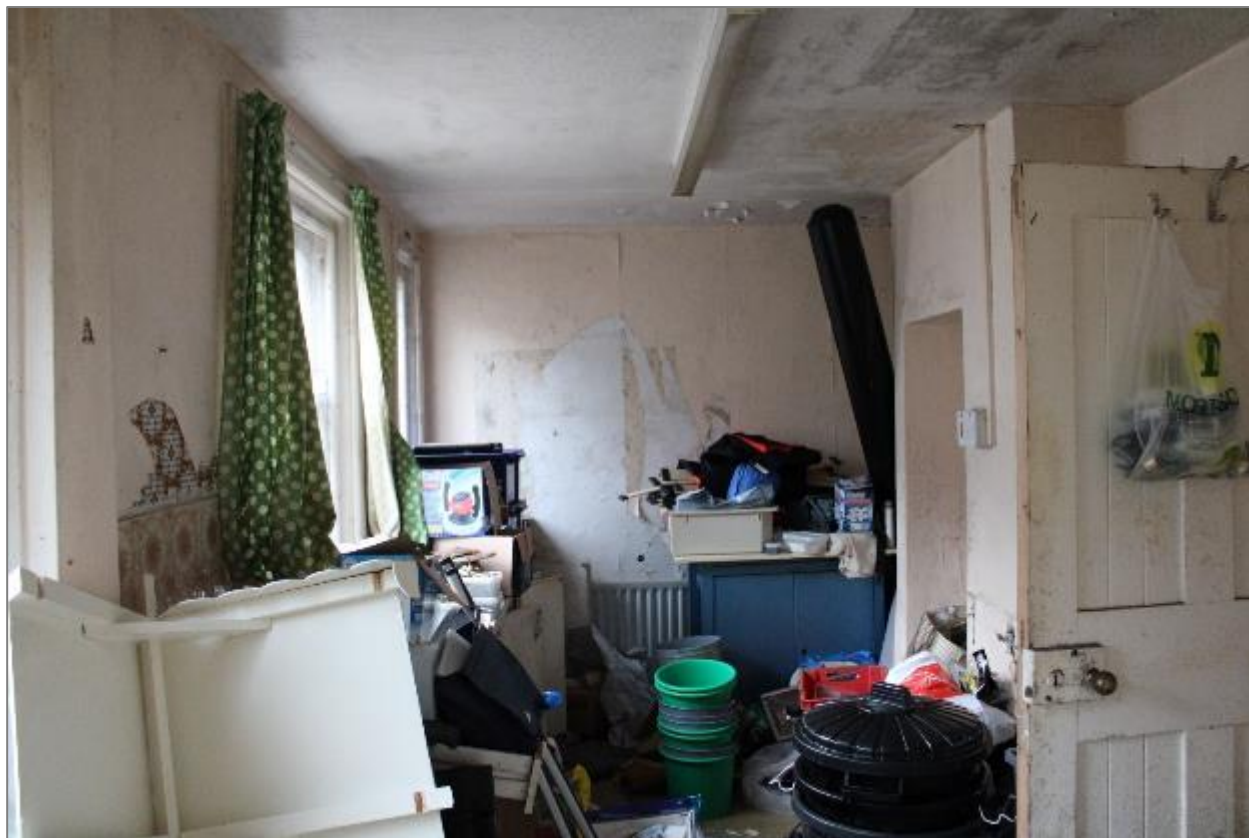
### 5.3.5 Kitchen (photos 78 – 79)

The kitchen occupies almost the full width of the rear of the house, and was probably formerly subdivided with a pantry to the north. Vinyl tiles cover the floor, remnants of wallpaper on the walls, with a panel of glazed tiling above a sink unit on the northeast wall. The ceiling is plain with strip lighting.

A half glazed rear door lies centrally with a small fixed window to the north, and two larger windows to the south, one sash window and one fixed. Kitchen cabinets have been inserted below these two larger windows. A former fireplace lies on the internal southwest wall opposite the larger windows, the fireplace itself having been stripped out and used as a cupboard storage area.

**Photo 78:** Kitchen. Facing northwest.

**Photo 77:** Kitchen, with former fireplace to the right. Facing southeast.

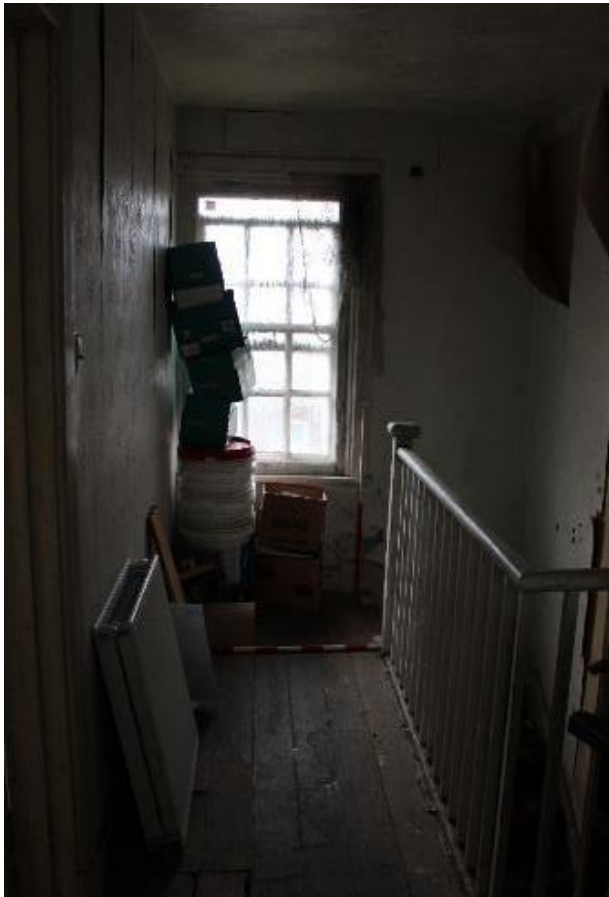
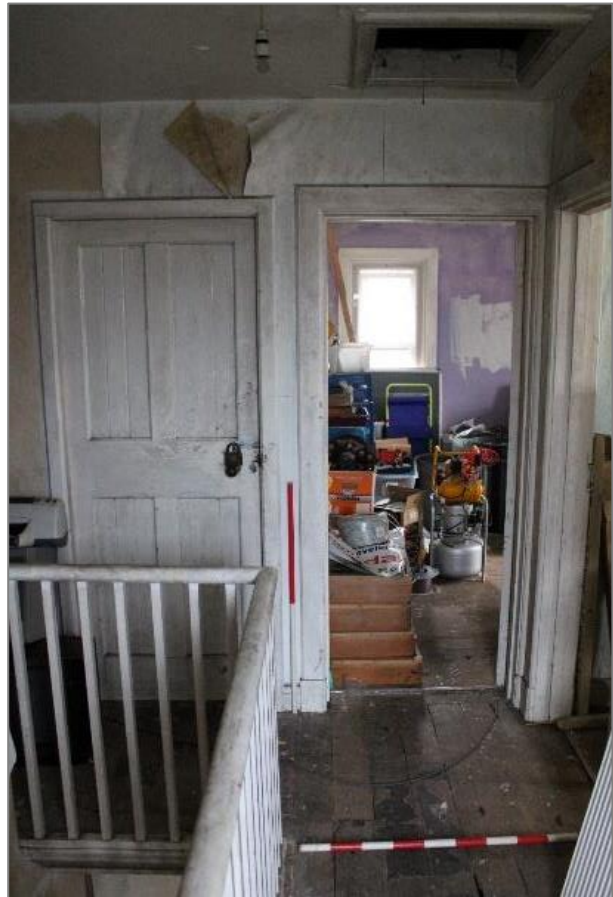
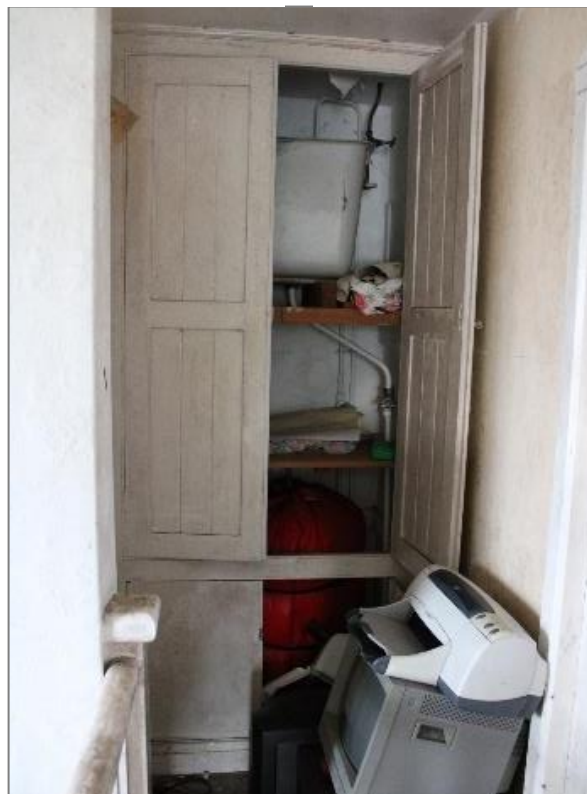
#### **5.3.6 First floor landing (photos 78 – 81)**

Against the northeast wall lies an airing cupboard containing a insulated water boiler with water tank above, enclosed by simple panelled wood cupboard doors.

**Photo 78:** First floor landing. Facing northwest. 1 x 1m scale.

**Photo 79:** First floor landing. Facing southeast. 1 x 1m scale.

**Photo 80:** Airing cupboard on first floor landing. Facing northeast.
