# **LLANGATWG SCHOOL, CADOXTON, NEATH PORT TALBOT SA10 8DB HISTORIC BUILDING RECORDING**

REPORT NO. 2025-02  
EVENT RECORD NO. E008746

**LLANGATWG SCHOOL, CADOXTON, NEATH PORT  
TALBOT, SA10 8DB:  
HISTORIC BUILDING RECORDING**

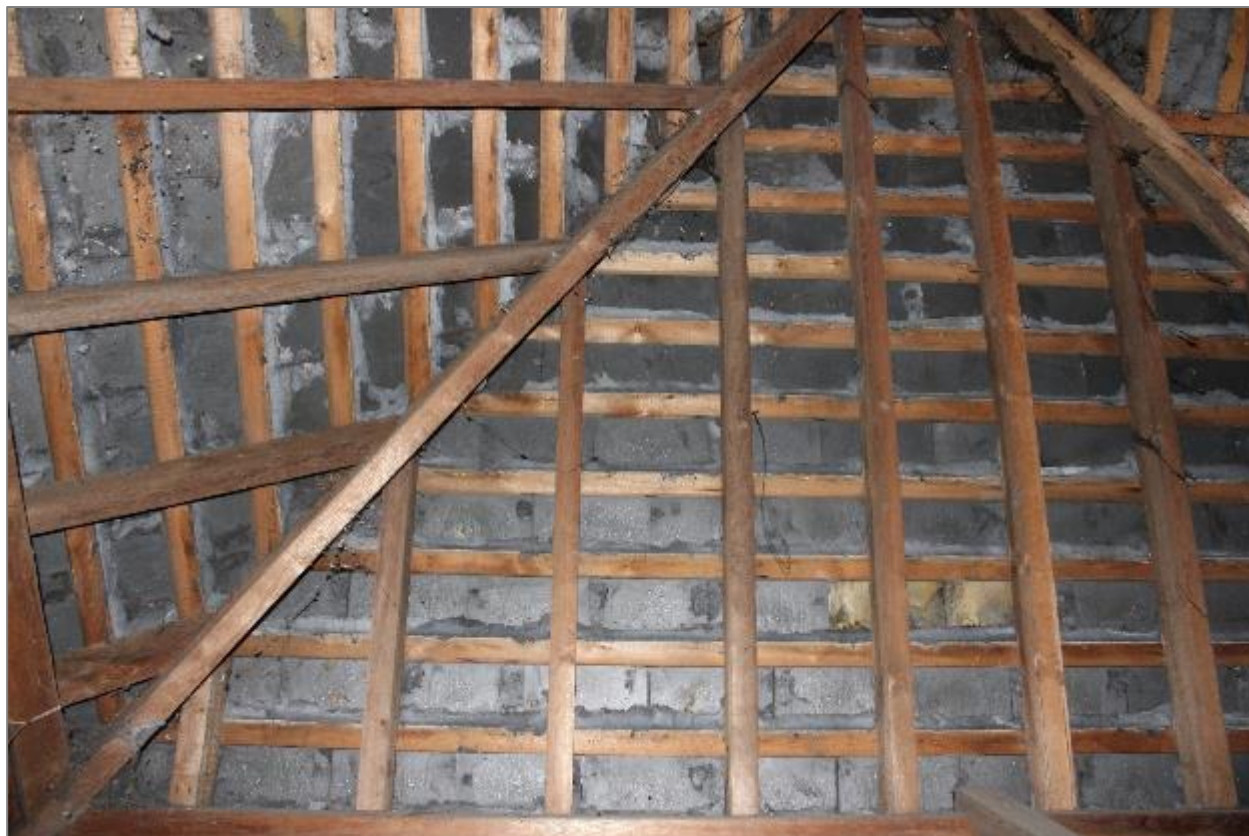
**Photo 81:** Internal roof structure, as viewed through the loft hatch.

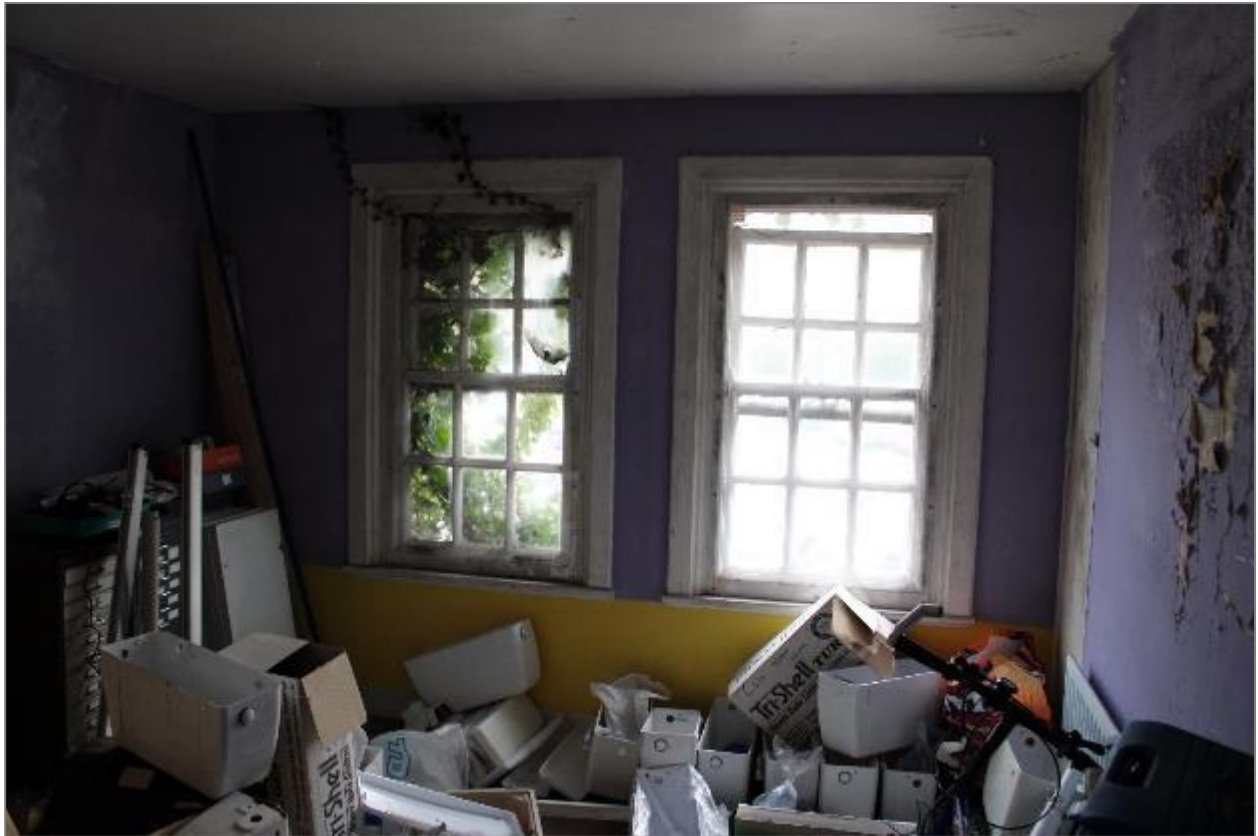
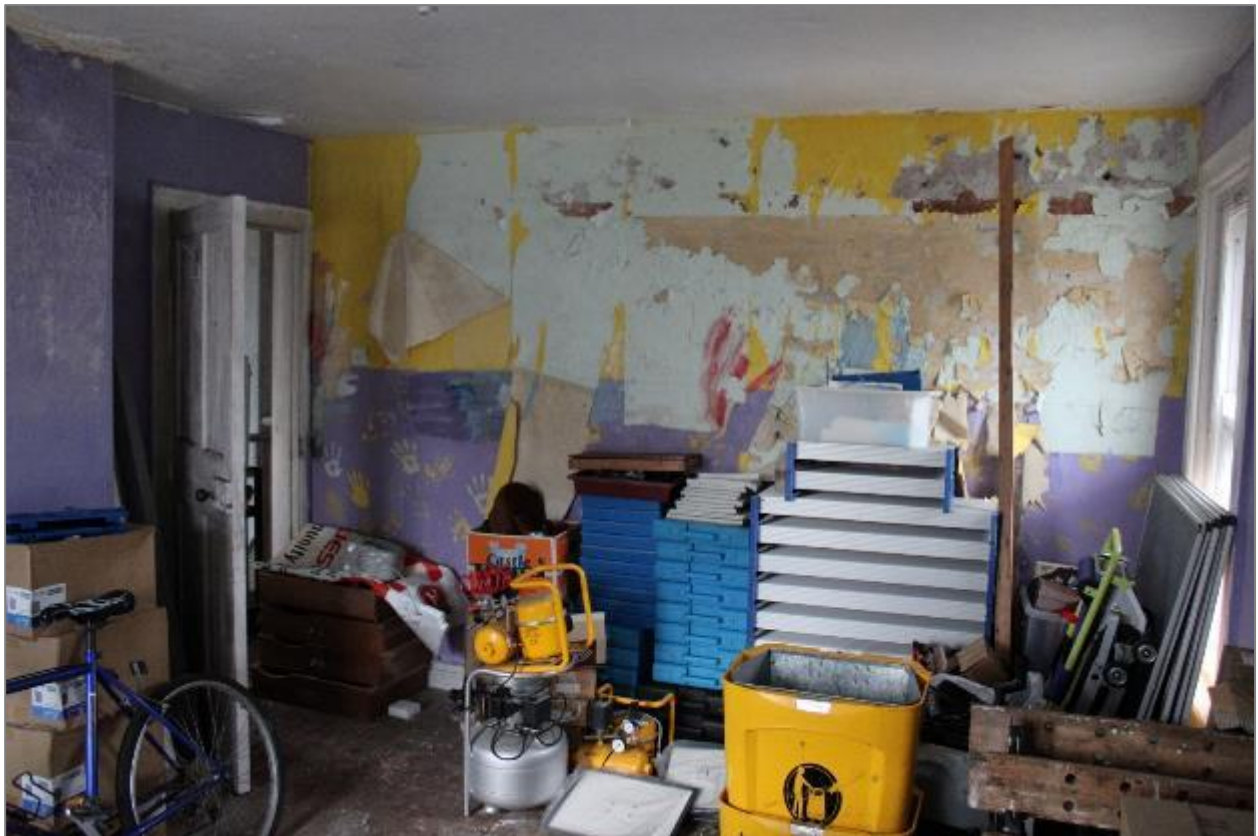
### 5.3.8 Bedroom 2 (photo 82 – 83)

This bedroom occupies the south corner, directly above Front Room 2. The floor boards are exposed, with plain papered walls and a plain ceiling with central light. A blocked fireplace extends into the room from the internal northwest wall, fronted by a modern radiator. The room is lit by a pair of sash windows in the southwest wall, and a smaller opaque-glass sash window in the southeast wall.

**Photo 82:** Bedroom 2. Facing southwest.

**Photo 83:** Bedroom 2. Facing northeast.

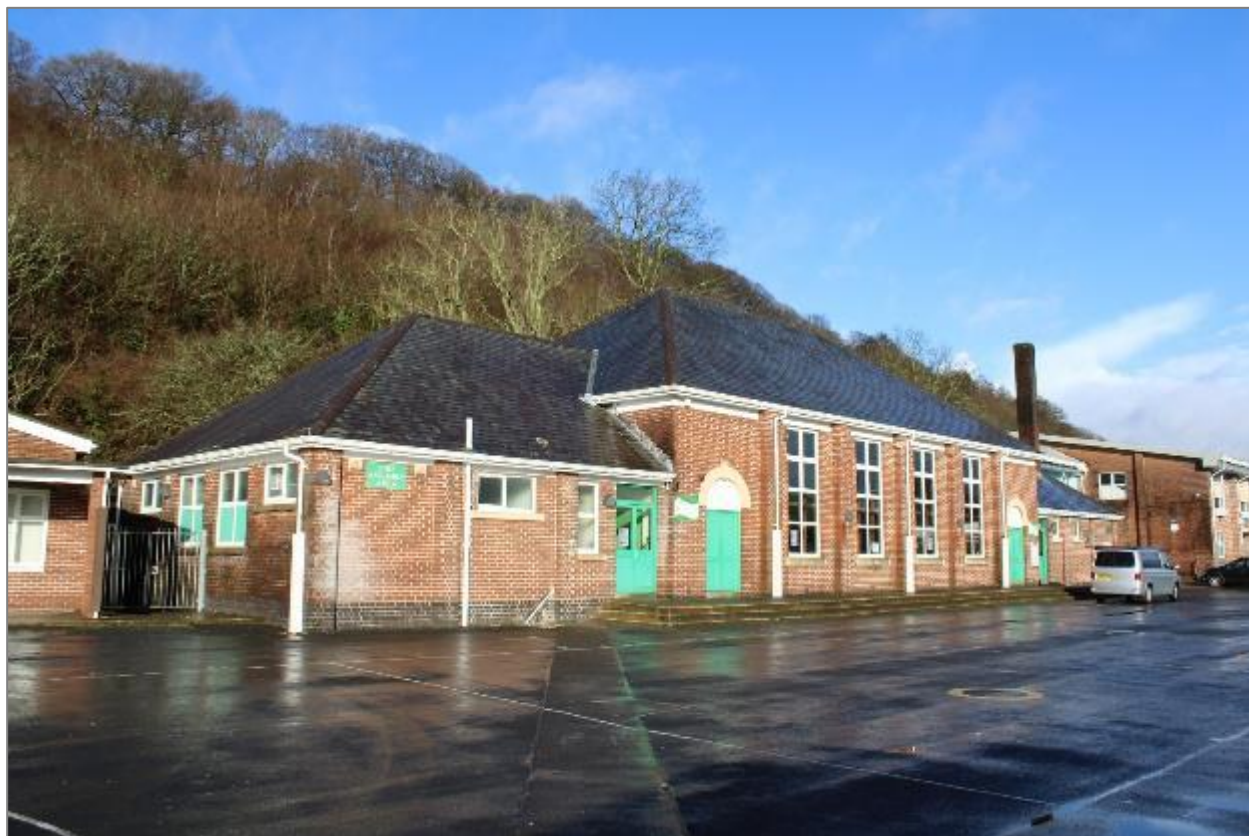
The façade is constructed in red brick in stretcher bond, with a decorative band of grey brick laid on end running along the base. Four tall windows are evenly spaced along the front of the hall, with narrow brick buttresses between. The window frames are modern uPVC replacements. Each of the four windows has an oolite/sandstone sill. Flanking the windows to either side is a double doorway with a oolite/sandstone arch with keystone above. Below the arch is a painted white wood panel. The doorways have a concrete step.

**Photo 84:** Gymnasium, southeast façade. Facing north.

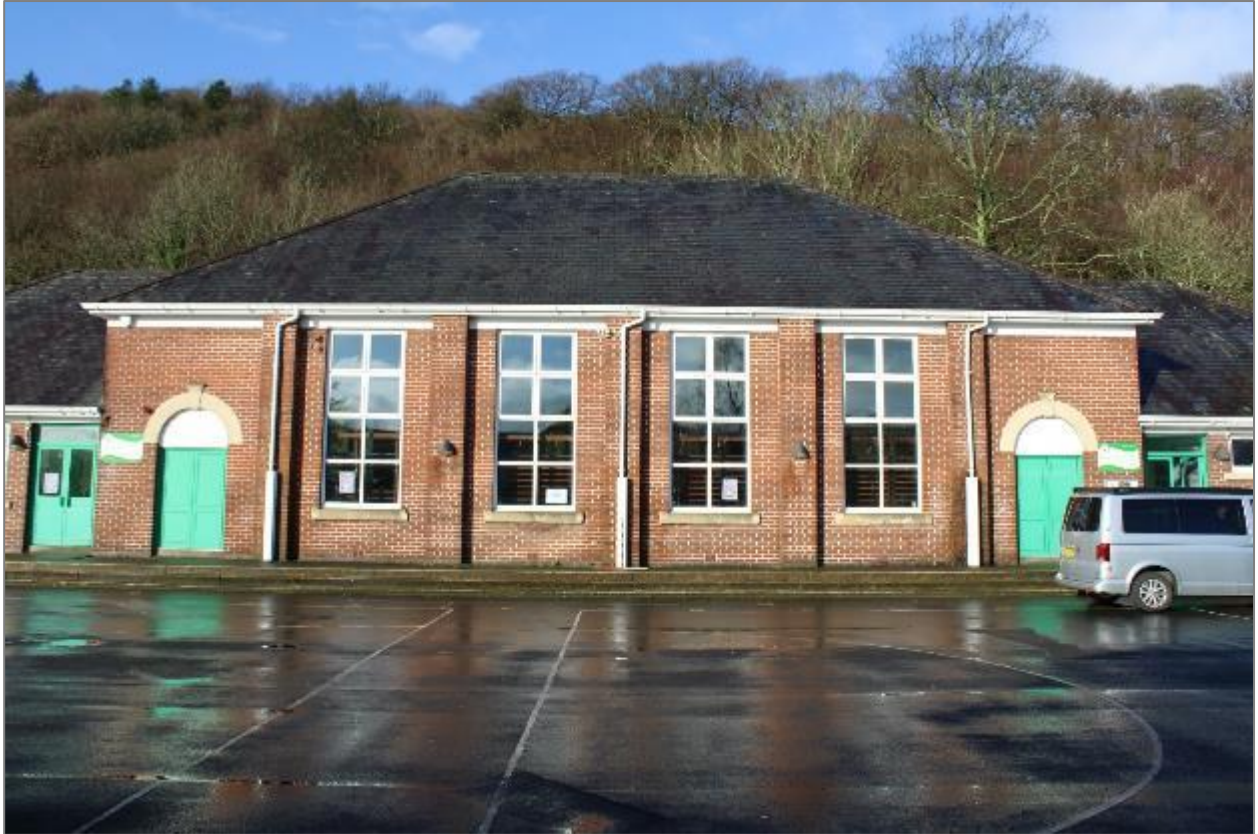
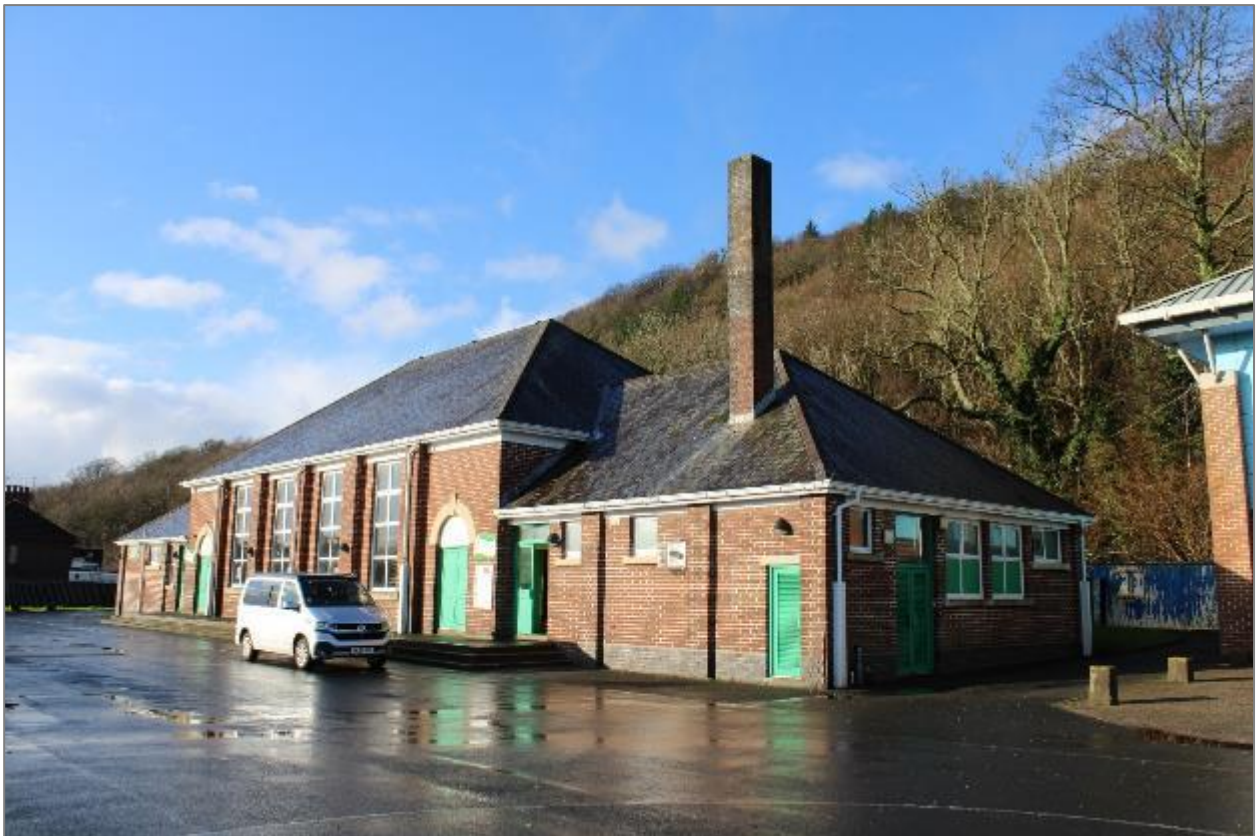
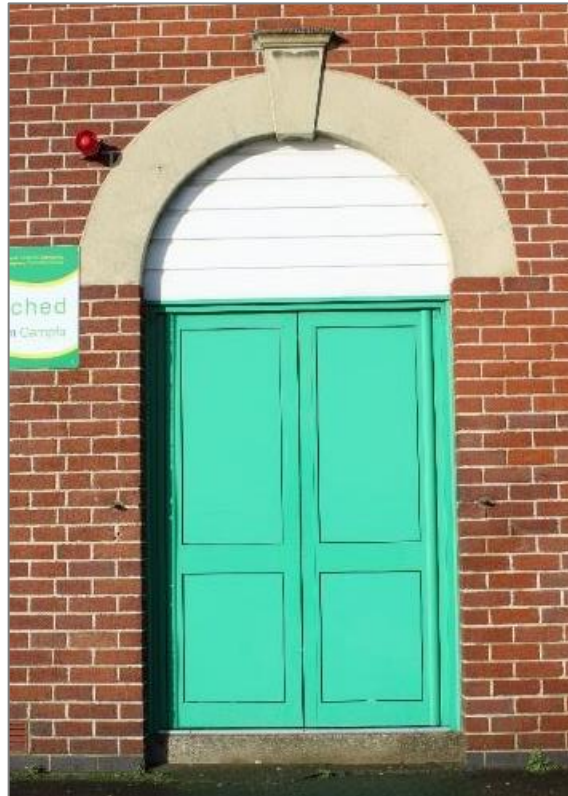
#### 6.2.1 Southeast facing façade (photos 84 – 87)

Each of the flanking changing rooms have modern half-glazed double doors with a single pane light above. Two small square windows are found each side of the double doors, with modern replacement windows. All four windows have oolite/sandstone sills.

**Photo 85:** Gymnasium, southeast façade. Facing northwest.

**Photo 86:** Gymnasium, southeast façade. Facing west.

**Photo 87:** Gymnasium, door detail on the southeast façade.

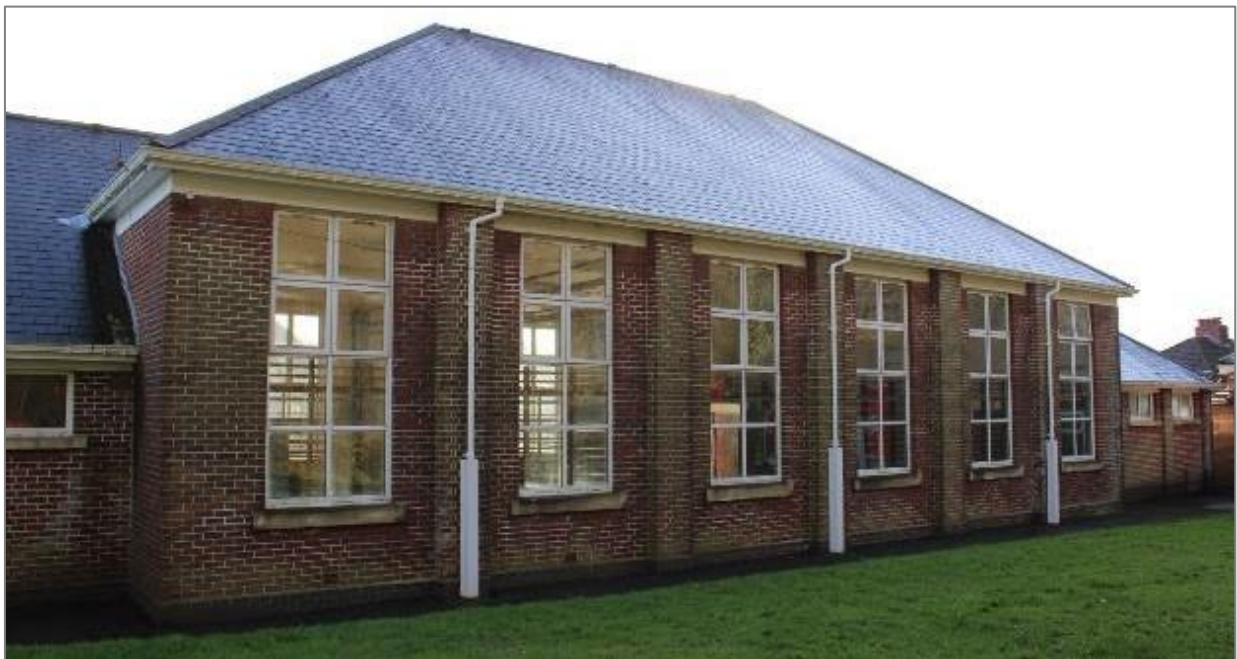
The rear façade mirrors the detail of the front, however in place of the doorways are two additional windows which match the remaining four. All the window frames are modern uPVC replacements.

**Photo 88:** Gymnasium, northwest façade.

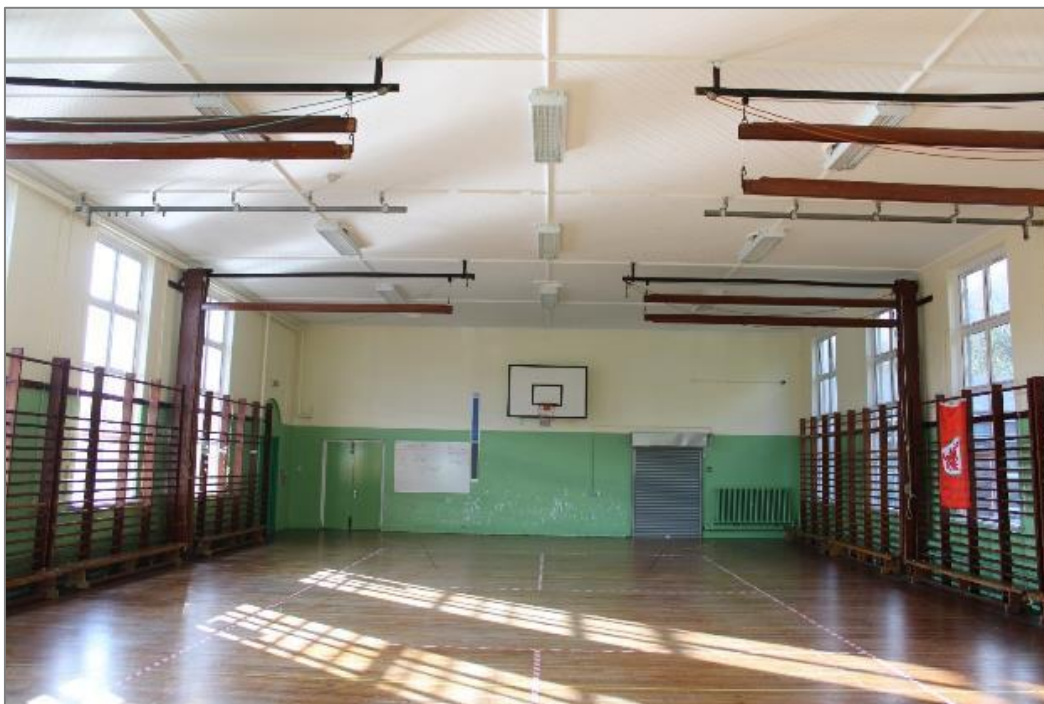
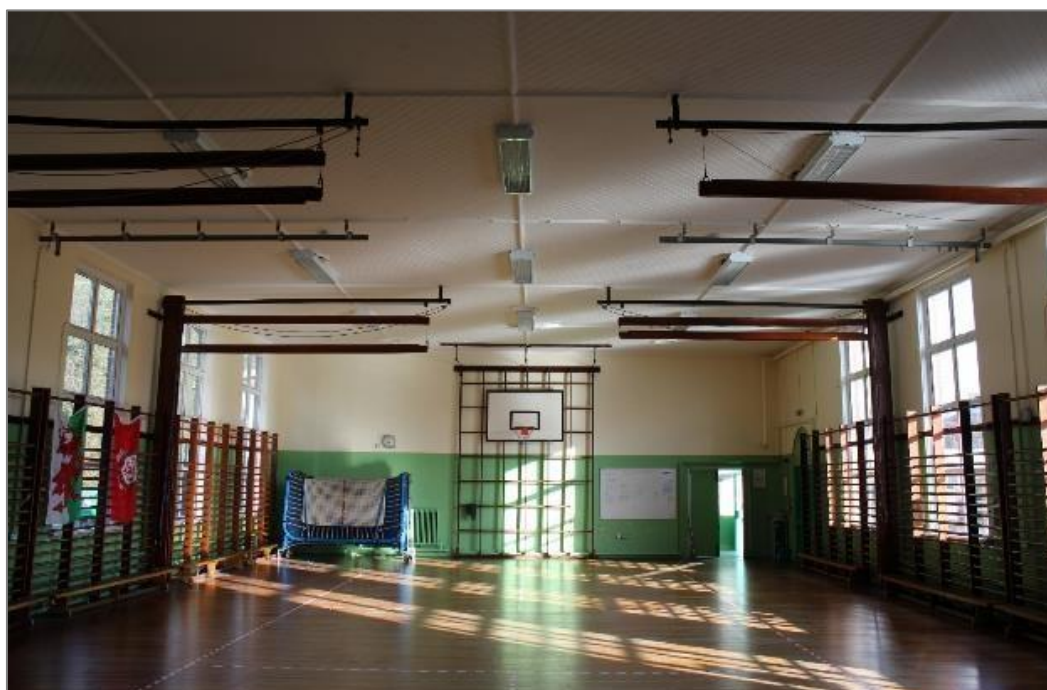
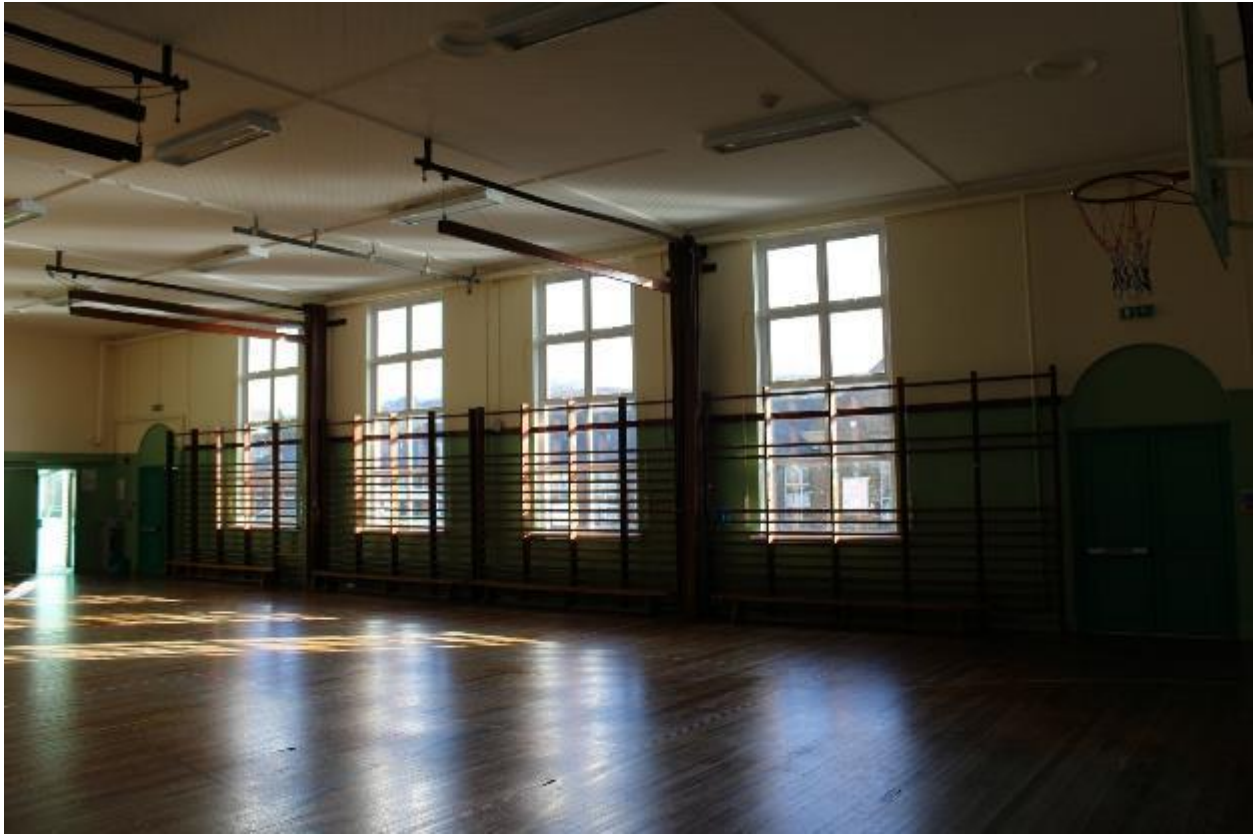
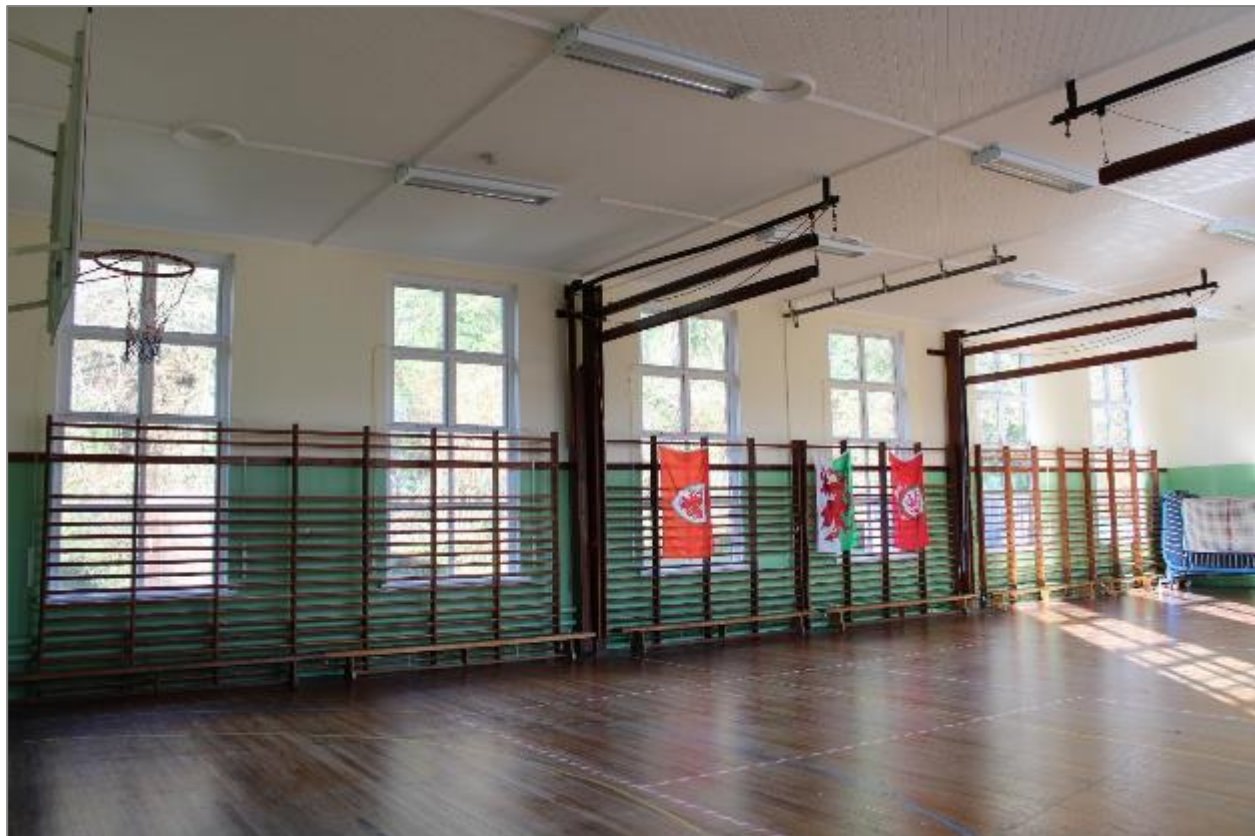
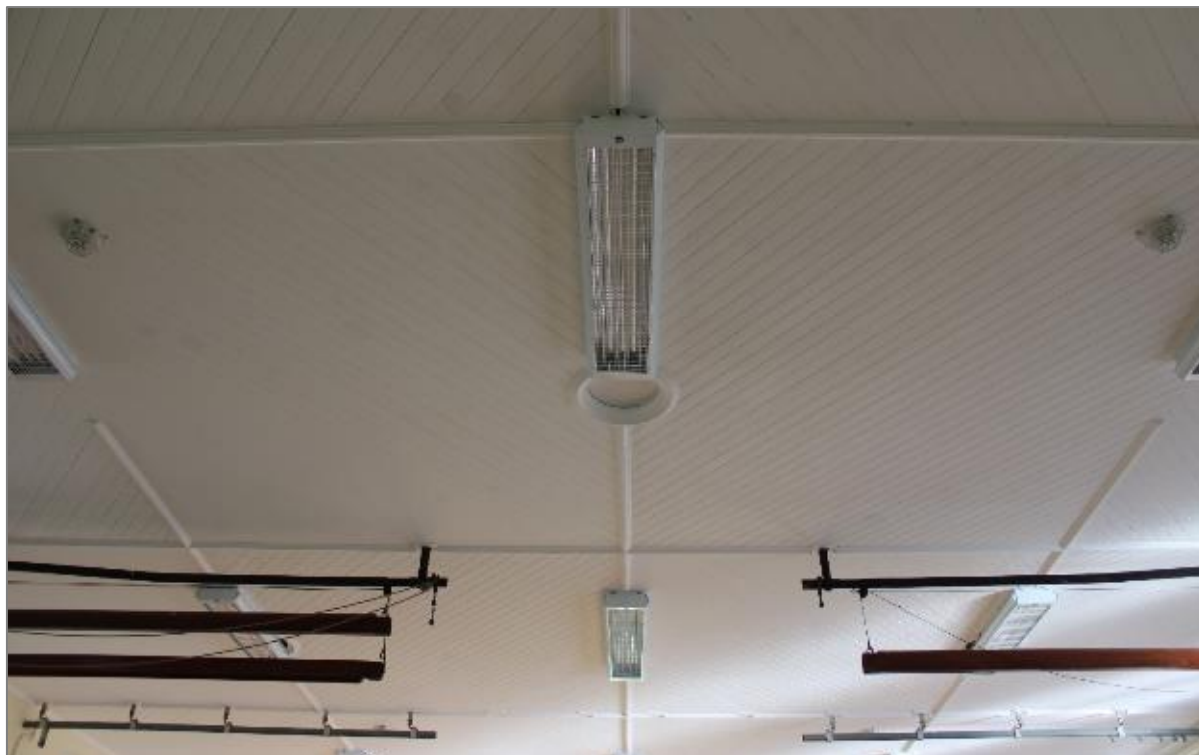
#### 6.3.1 Gymnasium (photo 89 – 93)

The main gymnasium space has a wooden block floor with adhesive strips marking out courts and plain painted plaster walls. The ceiling is clad in wood slats laid in a decorative diagonal pattern in a grided framework, painted white, with modern strip lighting. In the northeast wall was one double doorway and the southwest wall two double doorways which lead into the changing room areas. They also each hold a single cast iron radiator. Wooden climbing and gymnasium apparatus lined each wall with wooden benches arranged in front.

**Photo 89:** Interior of the gymnasium, facing southwest.

**Photo 90:** Interior of the gymnasium, facing northeast.

**Photo 91:** Interior of the gymnasium, facing west.

**Photo 92:** Interior of the gymnasium, facing south.

**Photo 93:** Interior of the gymnasium, ceiling detail.

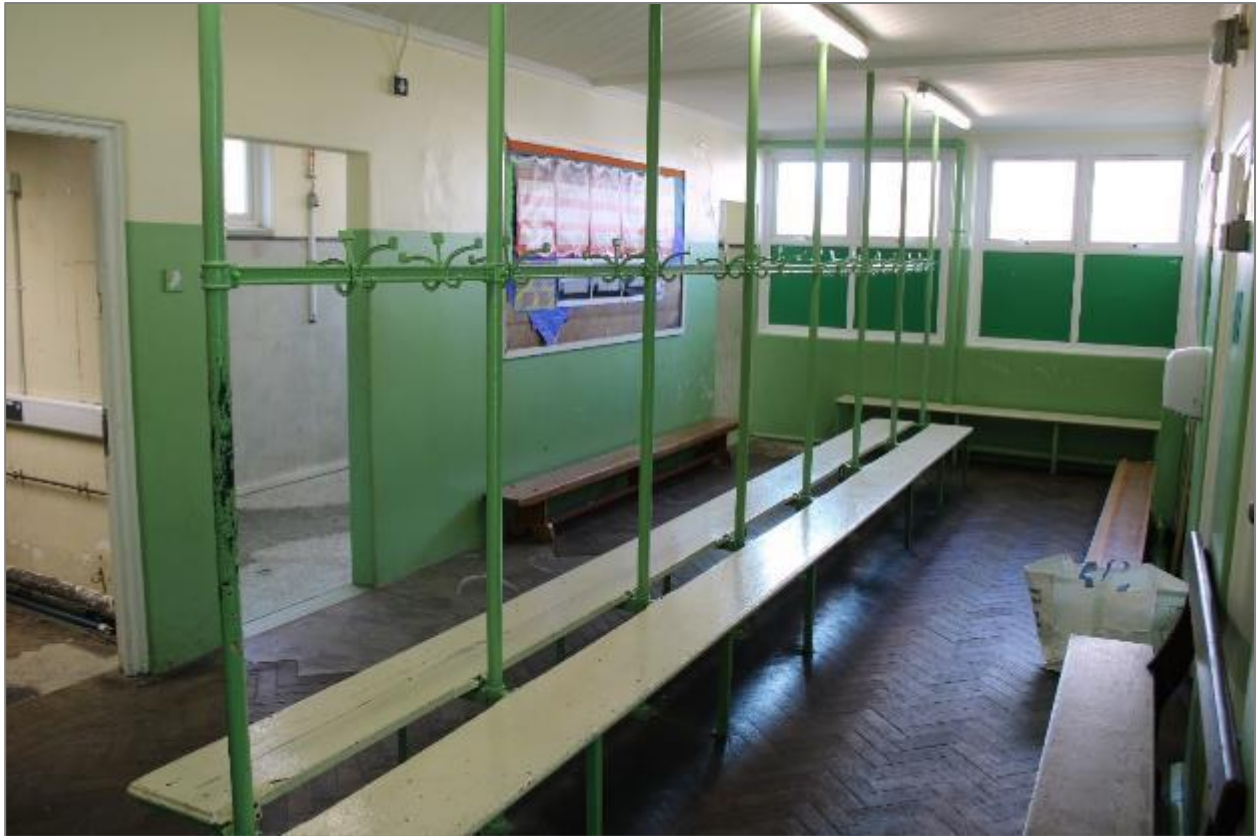
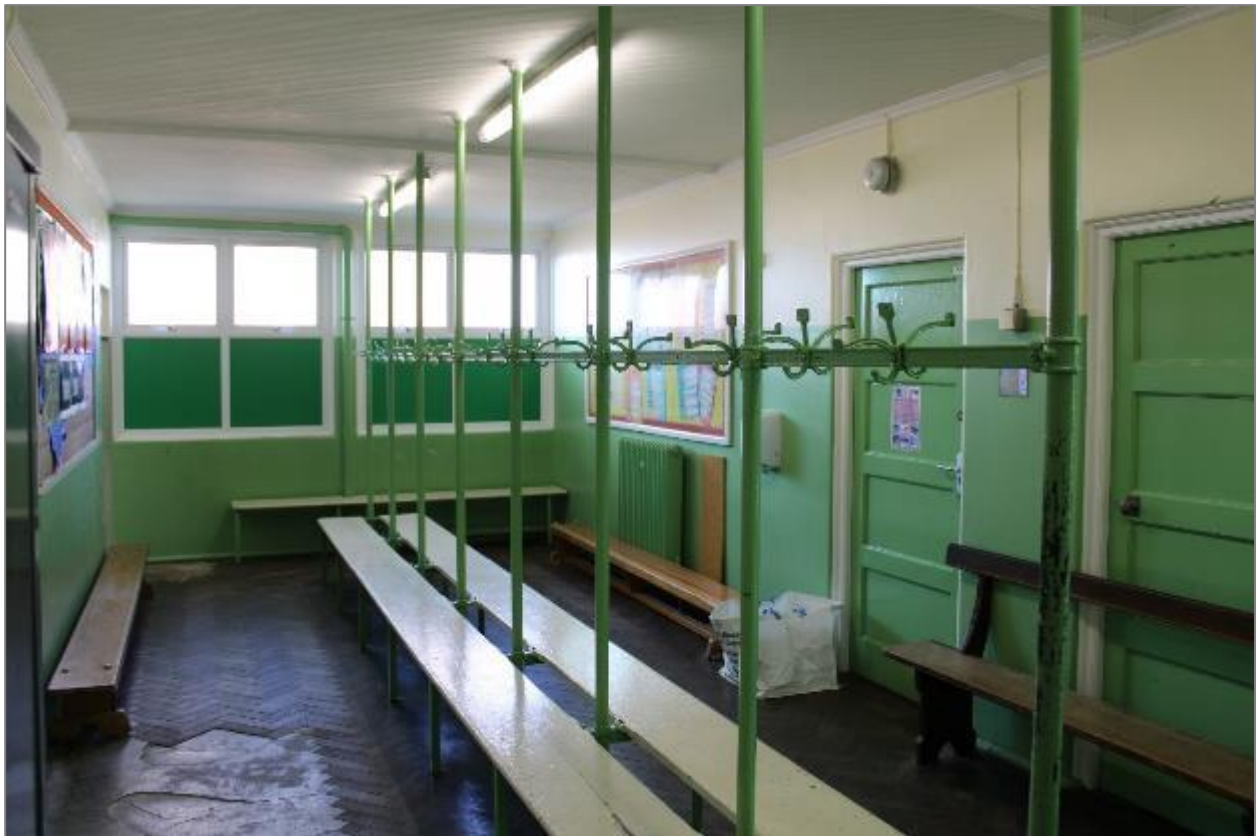
#### **6.3.2 Changing Room (Female) (photos 94 – 95)**

The female changing room lie on the northeast side of the main gymnasium. The male changing rooms on the opposite side were not accessible. Woodblock parquet flooring in a herringbone pattern is laid through the main changing room. The walls are painted, and the wooden ceiling detail is carried through from the main gymnasium. There are two wood panelled doors on the southeast wall, which lead to the store and boiler room, along with a cast iron radiator. There is one wood panelled door in the northwest wall which leads into a small office. Next to this is the shower entrance. There are benches with metal clothes rails running down the centre of the changing room, and benches around the walls.

**Photo 94:** Interior of the gymnasium changing room, facing north.

**Photo 94:** Interior of the gymnasium changing room, facing east.
