# **Unexploded Ordnance (UXO) Risk Assessment**

**Project:** Tata Steelworks

**Project address:** Port Talbot, SA13 2NG

**Report date:** 23<sup>rd</sup> April 2025

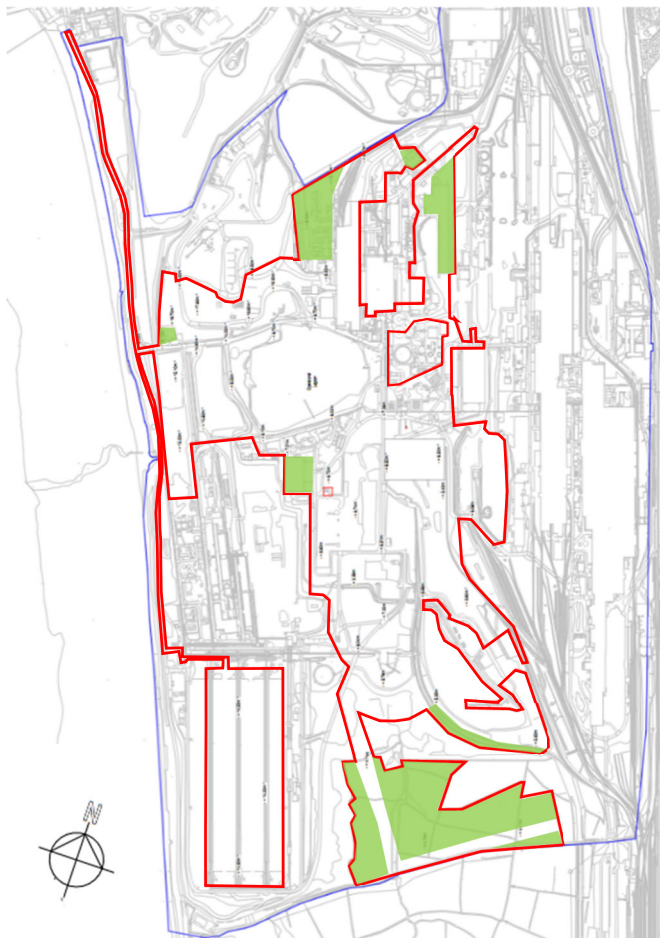
## Section 2.3 Drawing of the existing site & risk assessment boundary (in red)

The red line in this drawing has been reproduced from the boundary described in the planning application specified above. This is slightly larger than the area considered by RSK. The additional areas assessed in this report have been shaded green.

The outer blue line indicates the extent of land in the client's control.

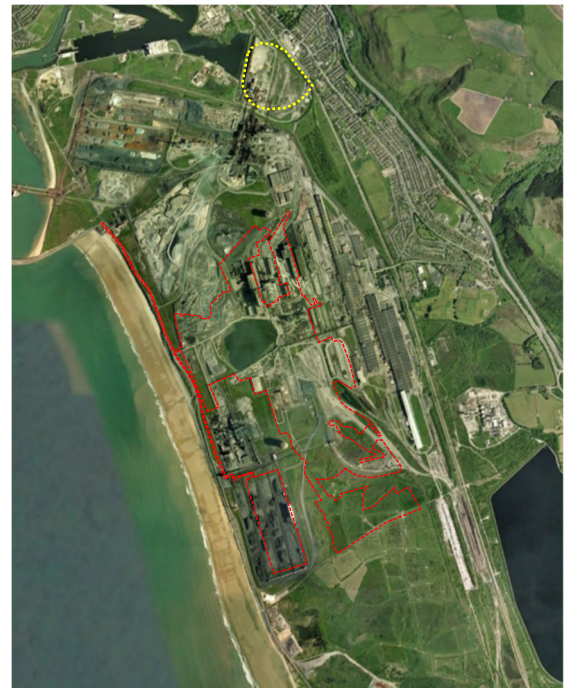
Sept 1940 vs 2006.

The Luftwaffe photo (below left) was included in the RSK report (p.7) and shows targets in the Port Talbot area; note that north is towards the top left corner of the photo. The closest target to the site has been highlighted with a yellow dotted line. This Luftwaffe photo lists facilities within this zone of interest, including gasometers and the *Siemens Martin Ofen steelworks*. The more recent photo (below right) also shows the target area as a yellow dotted line, with the proposed site boundary as a red dotted line. At its closest, this target is 750 metres north of the site, and 3.5km away from the site's most distant point.

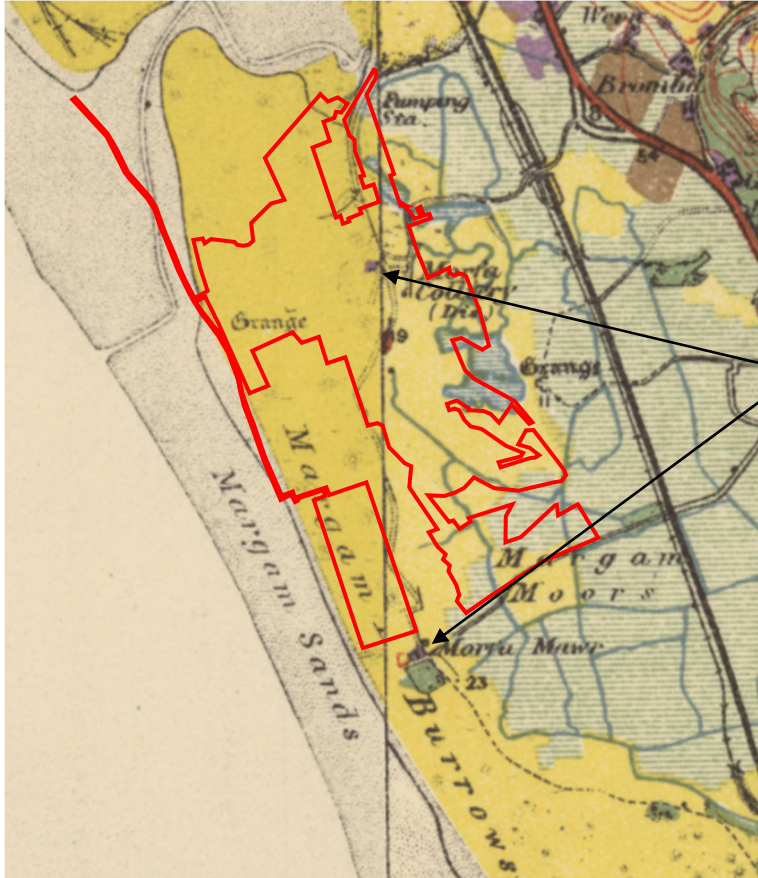
Land usage mapping, revised 1936

Green colouring indicates meadowland or permanent grass; the paler yellow is heath, moorland or rough pasture; the darker yellow is rough marsh pasture; purple indicates housing.

Of note are the two residential areas indicated in purple: former pit buildings to the north and Morfa Mawr to the south.

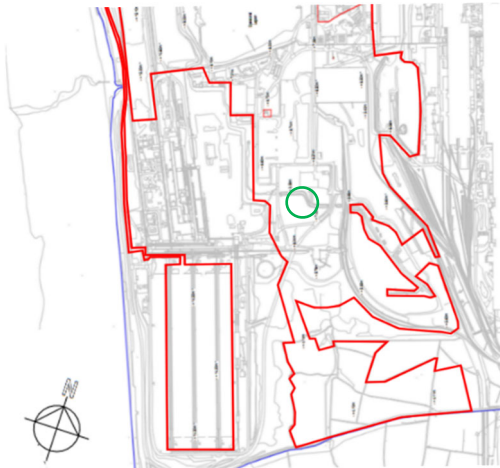
RSK refer to the presence a '*bombing decoy*' on the site (pp. i&7). This potential risk is discussed in more detail later. A map showing the decoy's position based on information available from English Heritage/ CADW data set, is included left. The location of the decoy is identified by a green circle, based on a 6-figure grid reference.

To develop RSK's statements, a single location on the Tata site has been identified in National Archive documents (1) as a dual-purpose decoy. The location is shown as a green circle on the site plan included earlier. No evidence was found to confirm that the decoy was successful drawing away enemy bombers from their intended targets or that it was hit by air dropped bombs during WW2.

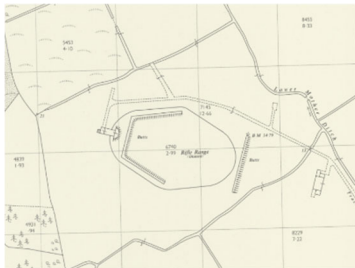
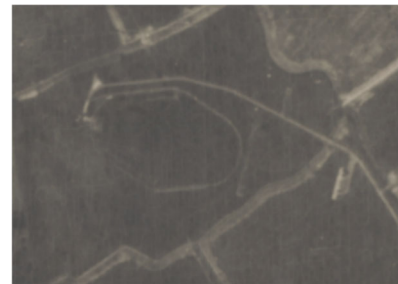
A disused '*rifle range*' is shown on the Ordnance Survey 1:2,500 Series A map, published in 1964 (reproduced left) and the same shape is also visible on the May 1949 aerial photo (right).

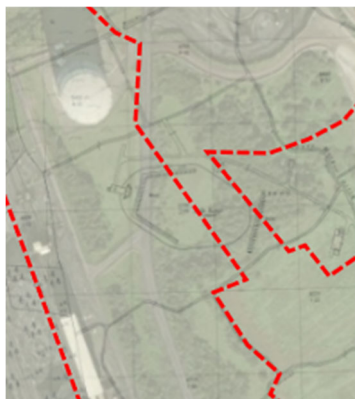
The 1964 map has been overlaid on a modern aerial photo, then the site perimeter has been added (left). The firing range has been identified in green on the plan (right) to provide a clear indication of its location.
