**Job title:** Afen Way, Port Talbot

**Report type:** Phase II Geo-Environmental  
Report

**Prepared for:** Aldi Stores Ltd

| Document Control Form | |
|---|---|
| REPORT NAME | GEO-ENVIRONMENTAL APPRAISAL |

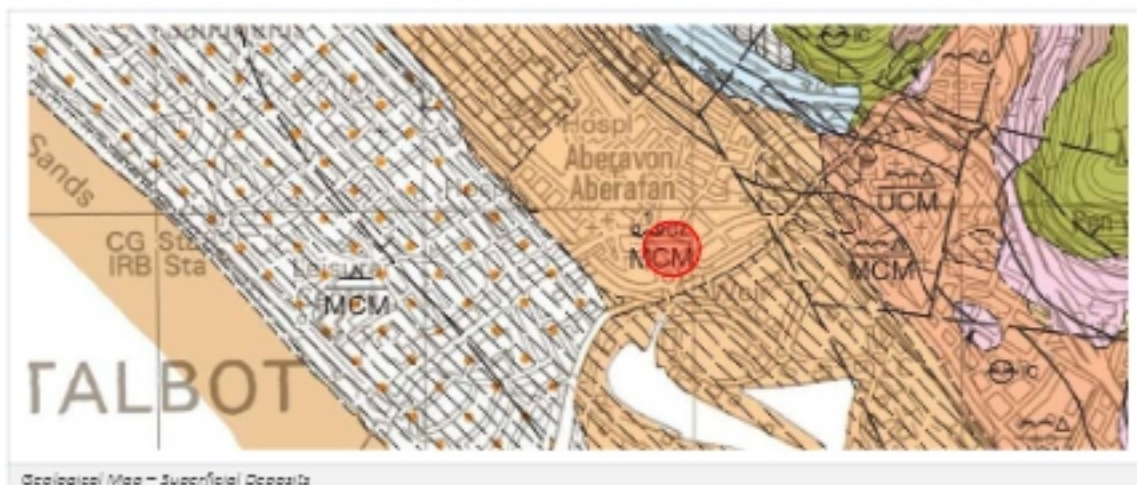
The site is indicated to be underlain by Estuarine Alluvium Deposits which characteristically comprises Clay, Silt and Sand.

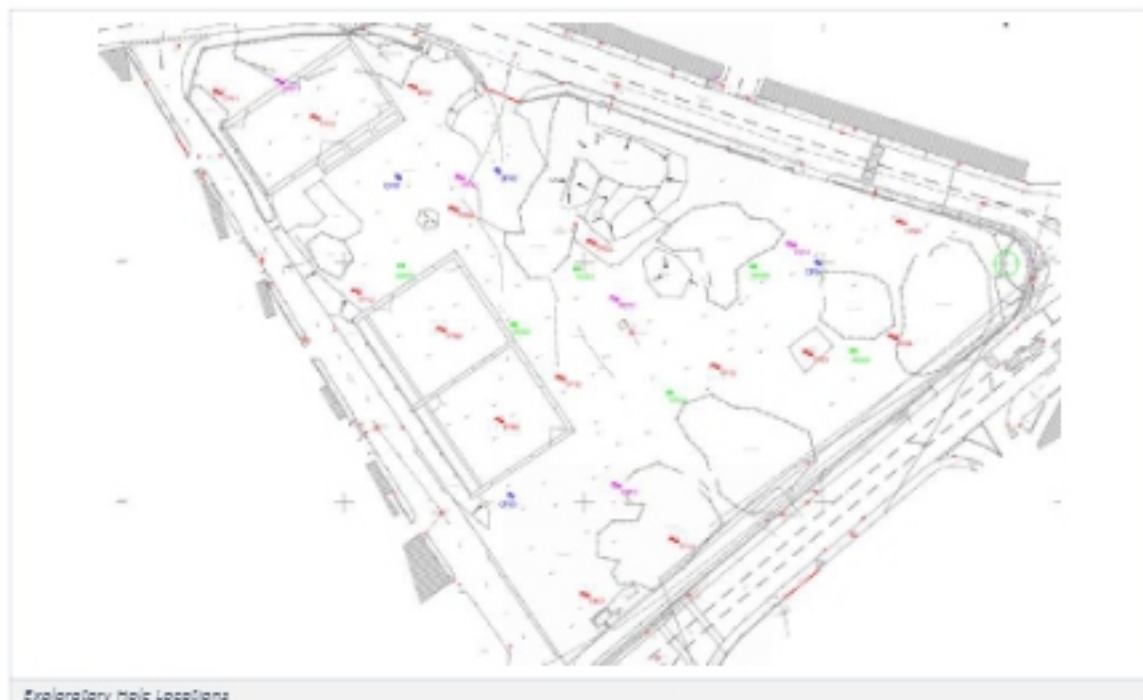
Exploratory Hole Locations

Concrete hardsurfacing was present from ground level within TP02, TP03 and TP05 to a maximum depth of 0.15m bgl – these locations were in the southern and eastern areas. The concrete was underlain by tarmac within TP02 to a depth of 0.2m bgl.

All Made Ground populations that were encountered across the site were granular in nature. Made Ground was found to a maximum depth of 2.9m bgl within CP03 comprising sandy gravel of brick and concrete. This borehole was situated within the footprint of the former Tin Plate Works. Generally, Made Ground was recorded to depths between 1.3m and 2.0m bgl.

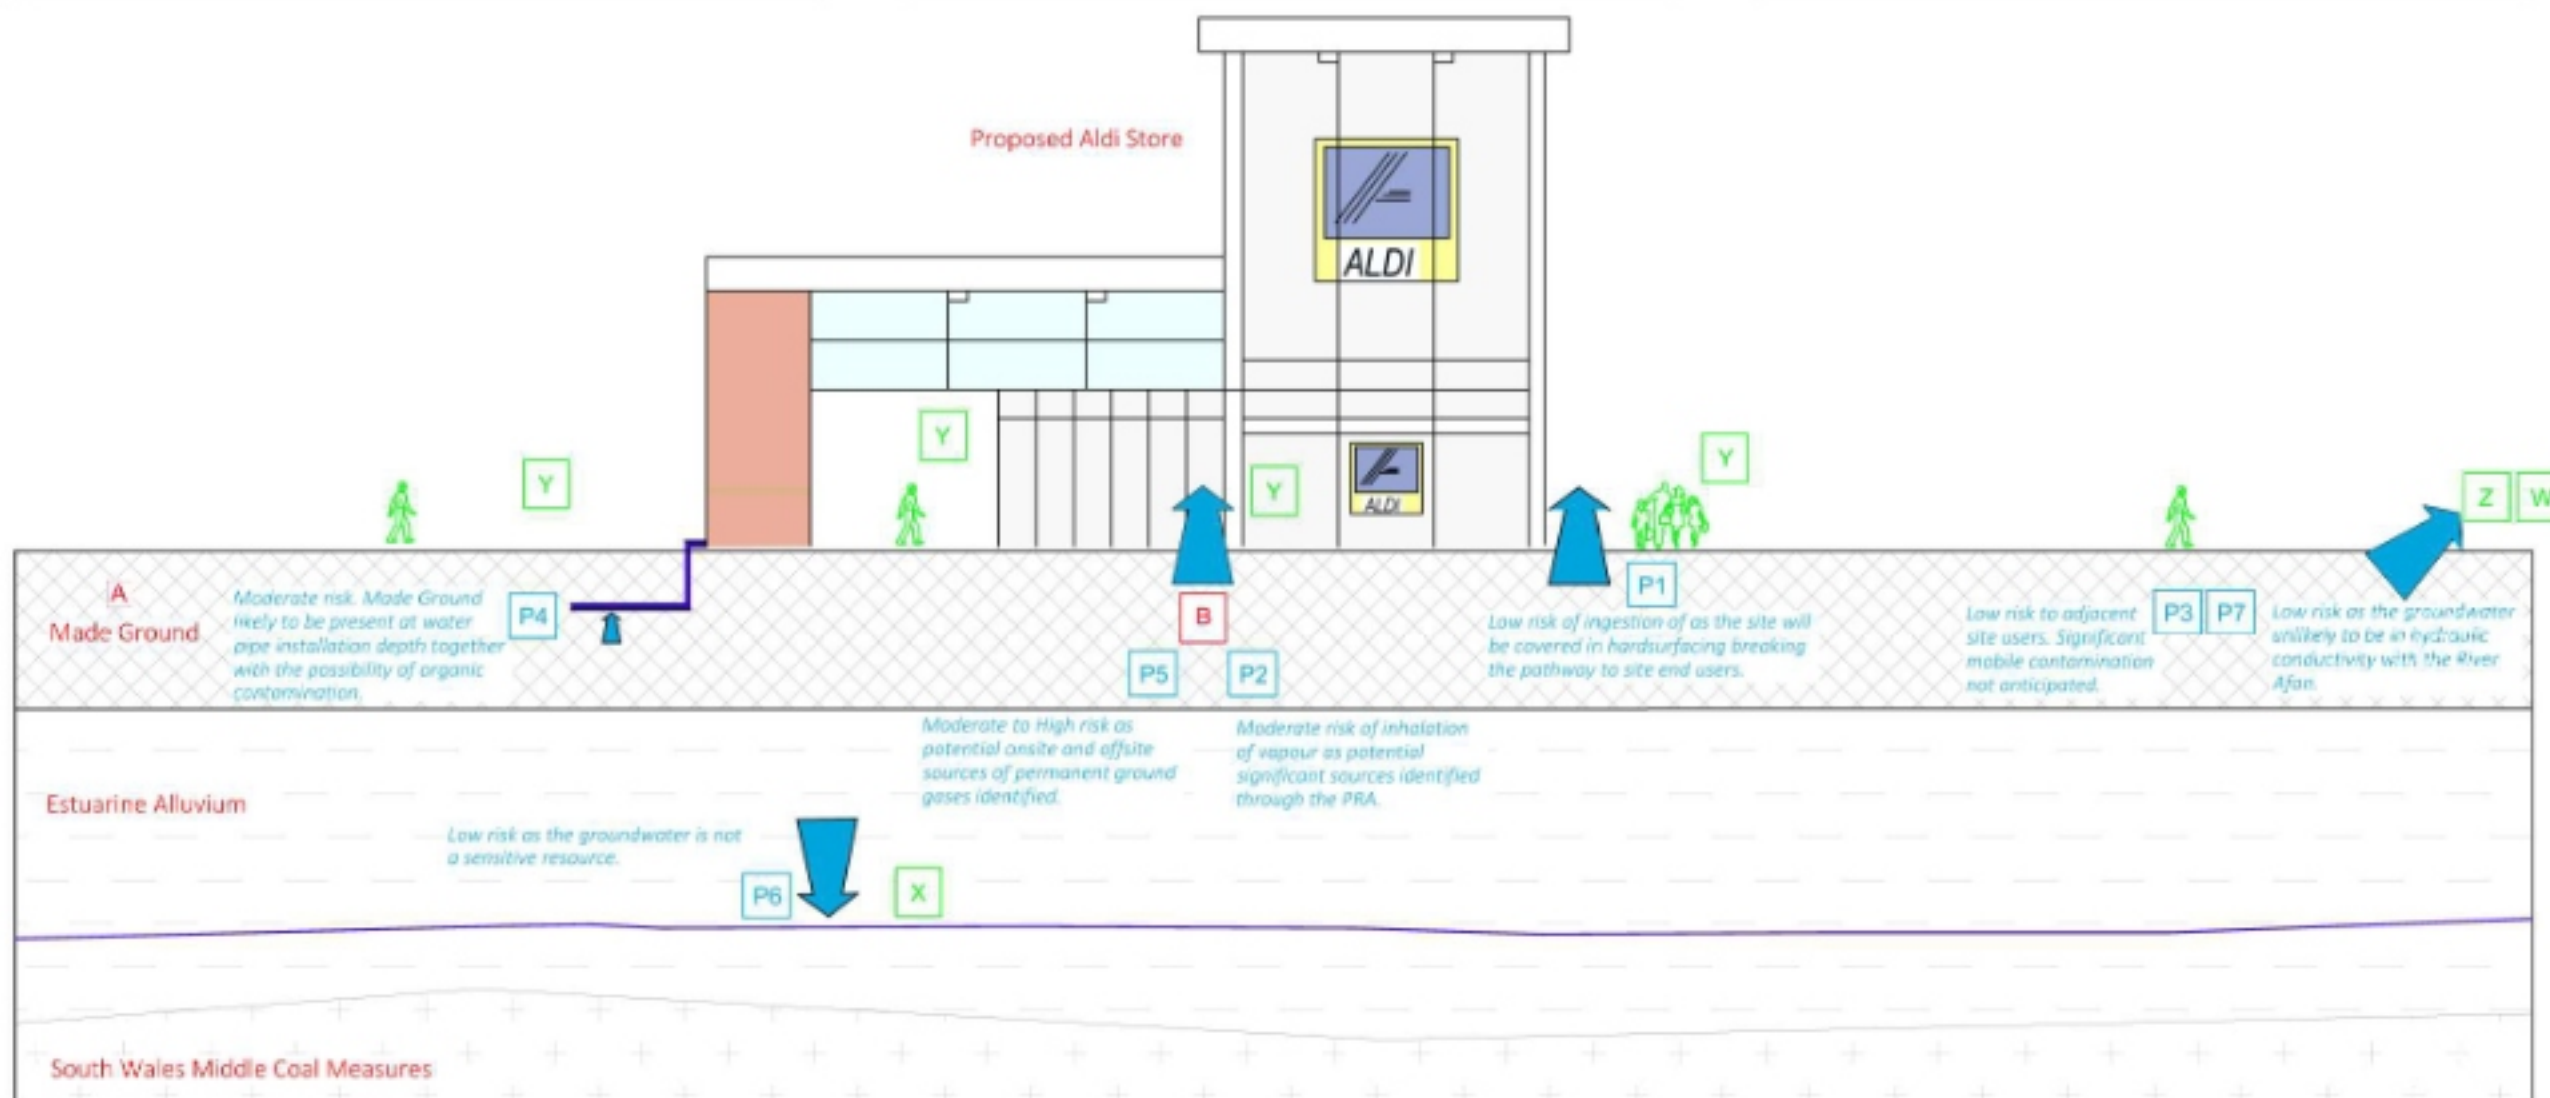
- P1. Ingestion of soil and dust.
- P2. Inhalation of vapour.
- P3. Inhalation of soil dust by adjacent site users.
- P4. Attacking of potable water supply pipe.
- P5. Migration and accumulation of ground gas in internal places.
- P6. Impaction of groundwater from soil contamination.
- P7. Migration of soil and groundwater contamination impacting surface waters.

W. River Afan c.86m south.  
X. Groundwater within the underlying Secondary A Aquifers.  
Y. Site end users.  
Z. Adjacent site users.
