## Geology 1:50,000 scale - Artificial and made ground

### 15.2 Artificial and made ground (50k)

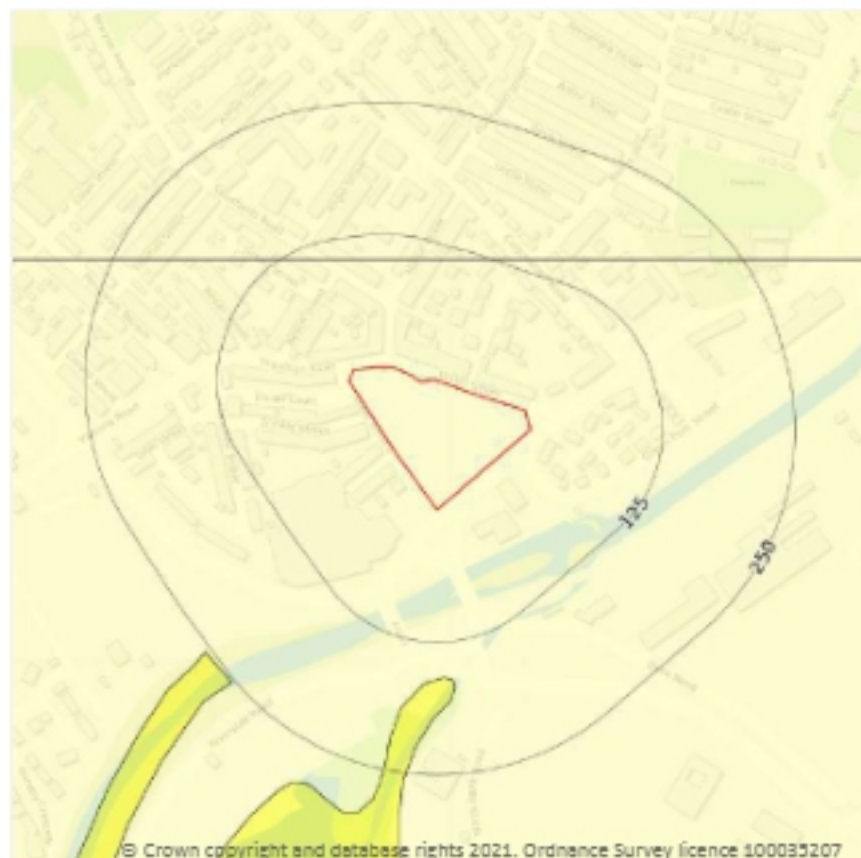
## Natural ground subsidence - Collapsible deposits

The potential hazard presented by natural deposits that could collapse when a load (such as a building) is placed on them or they become saturated with water.

Features are displayed on the Natural ground subsidence - Collapsible deposits map on [page 127](#)

| Location | Hazard rating | Details |
|---|---|---|
| On site | Negligible | Deposits with potential to collapse when loaded and saturated are believed not to be present. |

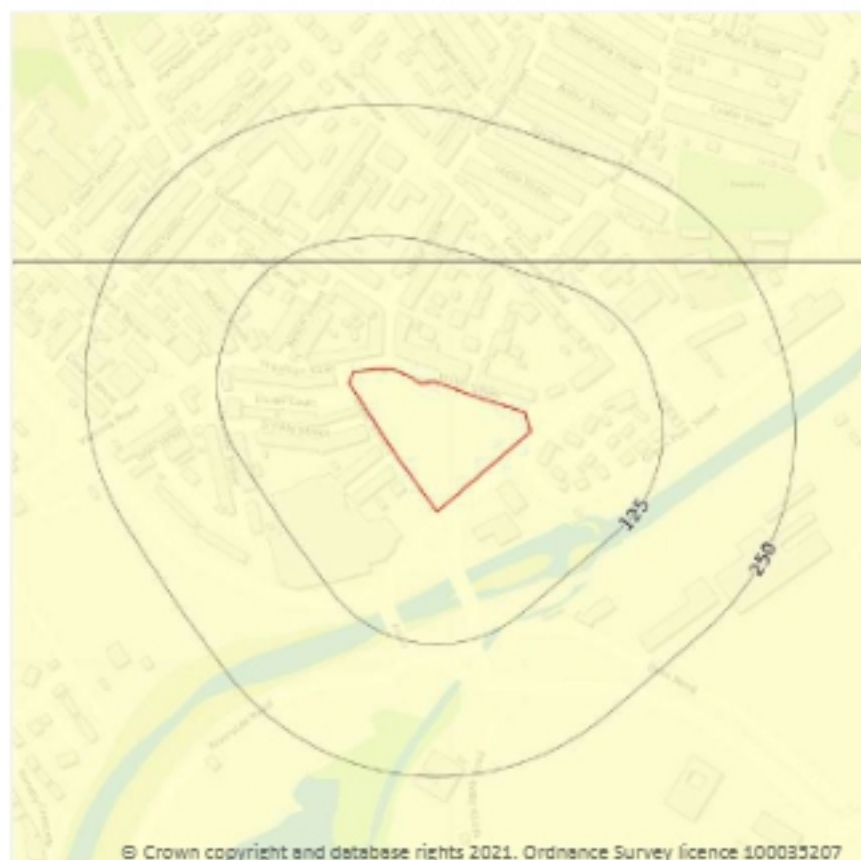
## Natural ground subsidence - Ground dissolution of soluble rocks

The potential hazard presented by ground dissolution, which occurs when water passing through soluble rocks produces underground cavities and cave systems. These cavities reduce support to the ground above and can cause localised collapse of the overlying rocks and deposits.

Features are displayed on the Natural ground subsidence - Ground dissolution of soluble rocks map on page 129

| Location | Hazard rating | Details |
|---|---|---|
| On site | Negligible | Soluble rocks are either not thought to be present within the ground, or not prone to dissolution. Dissolution features are unlikely to be present. |
