### Dusk Emergence Bat Surveys

The Rise, Glyncastle, Resolven, SA11 4NW

Surveys conducted May - July 2025

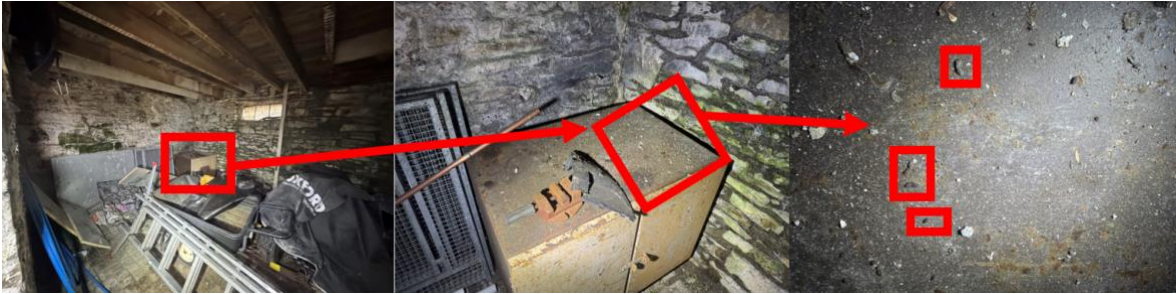
Approximately 6 bat droppings were found on the ground floor, which DNA analysis confirmed belong to lesser horseshoe bats (*Rhinolophus hipposideros*).

Droppings found on the storage container

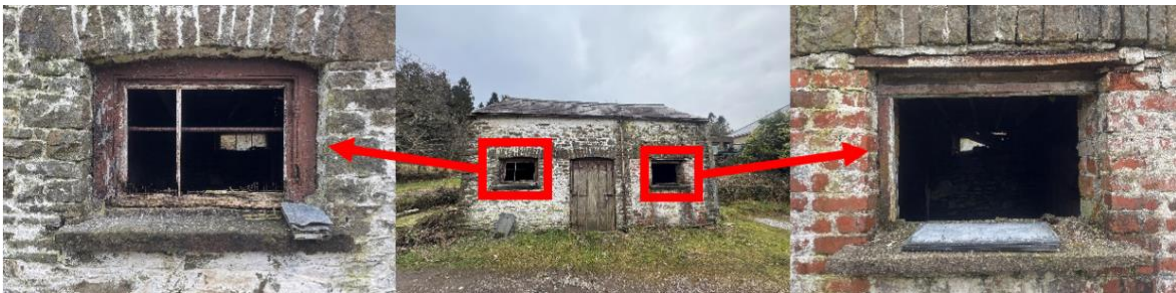
There is free flight access through windows with missing glass. Other potential access points include missing roof slates and gaps under damaged bargeboards. Potential roosting areas were identified in gaps in stonework, the cavity wall space, and under roof slates.

Windows with missing glass on front aspect

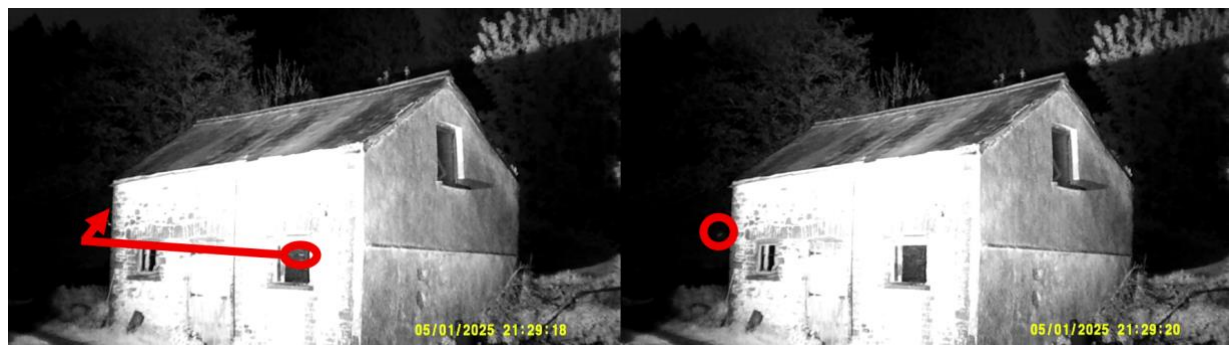
Lesser horseshoe emergence, 1<sup>st</sup> May

Lesser horseshoes are confirmed to be accessing the building through the left window on the front aspect of the building, and are exiting through the right window on the front aspect of the building.

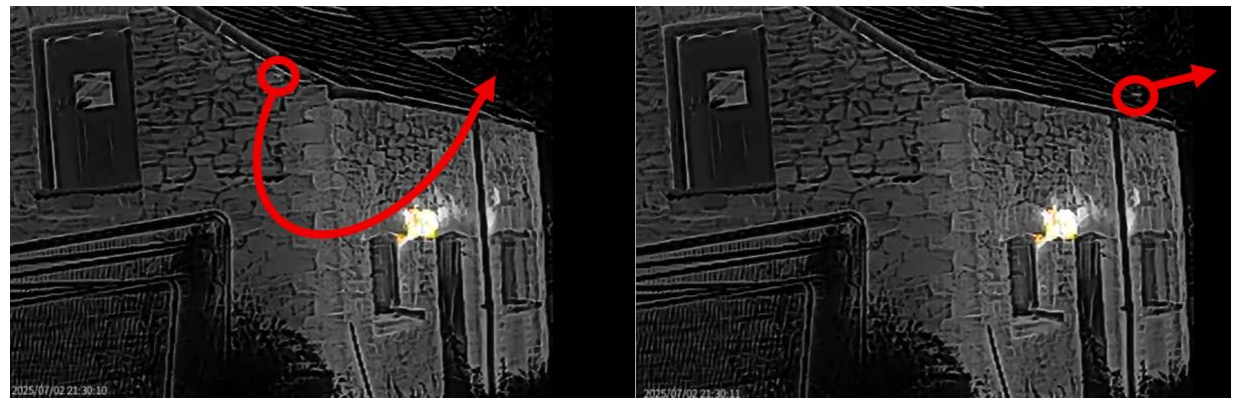
Pipistrelle emergence, 2<sup>nd</sup> July

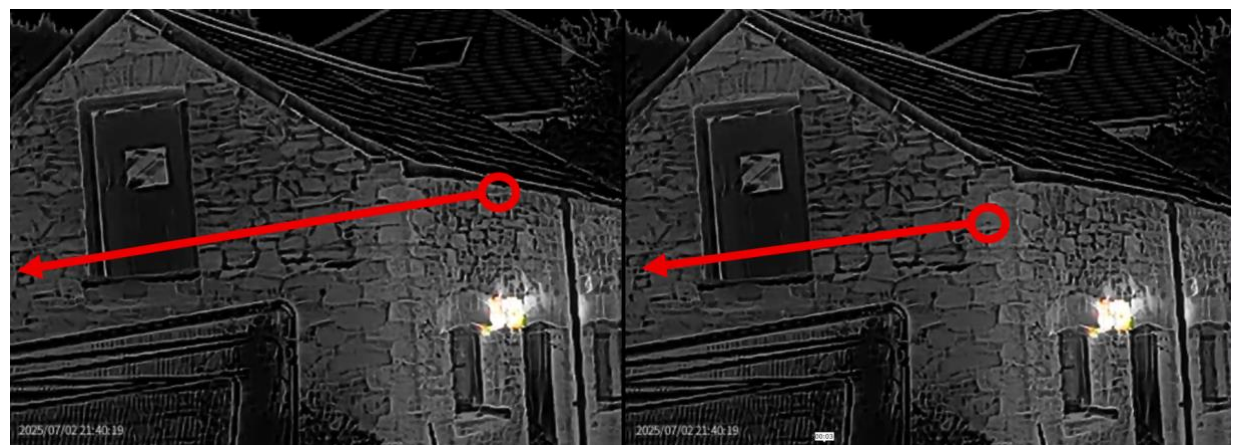
Pipistrelle emergence, 2<sup>nd</sup> July

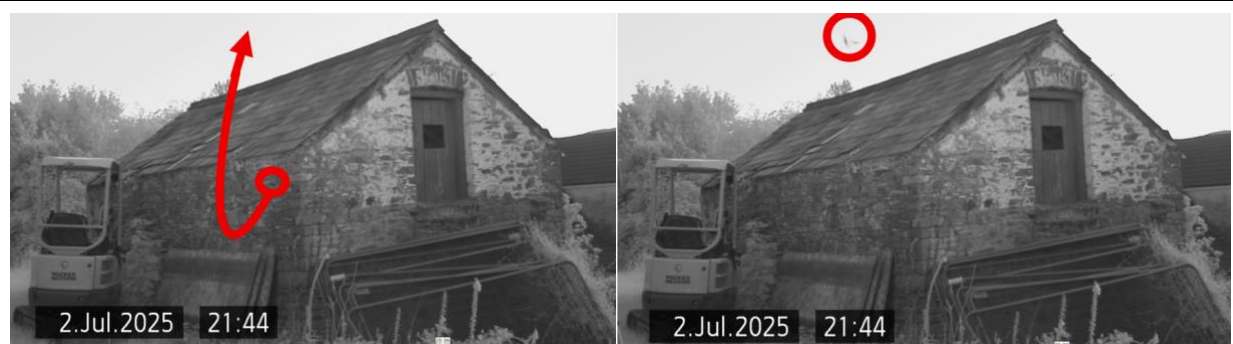
Pipistrelle emergence, 2<sup>nd</sup> July

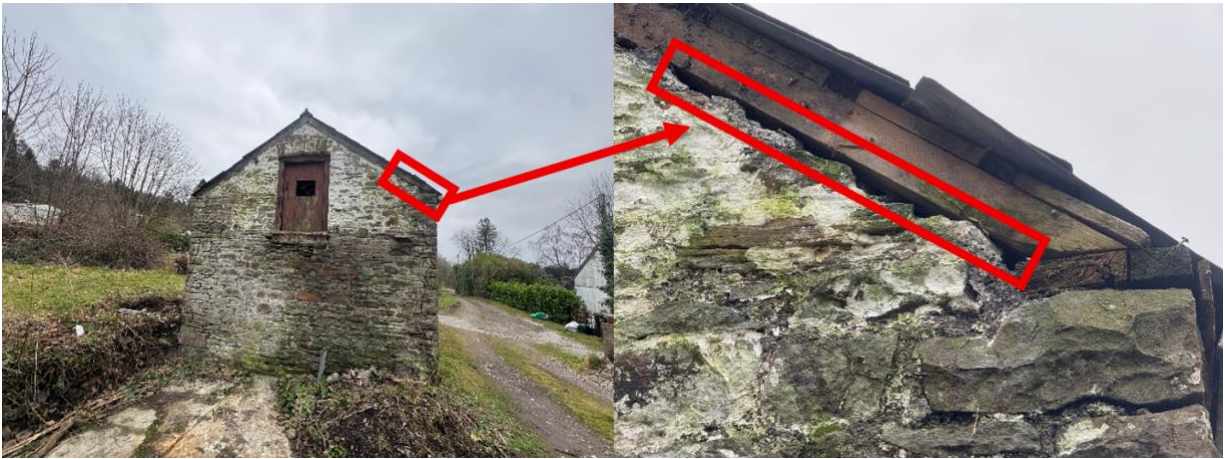
Pipistrelle access point A

Pipistrelles were also noted to emerge from the property from three separate access points: under the bargeboard on the southeast gable end, under the fascia board on the front northeast facing aspect of the building, and from gaps in the stonework on the rear southwest facing aspect of the building. A pipistrelle was also recorded entering the property using a different gap in the stonework on the rear southwest facing aspect of the building.

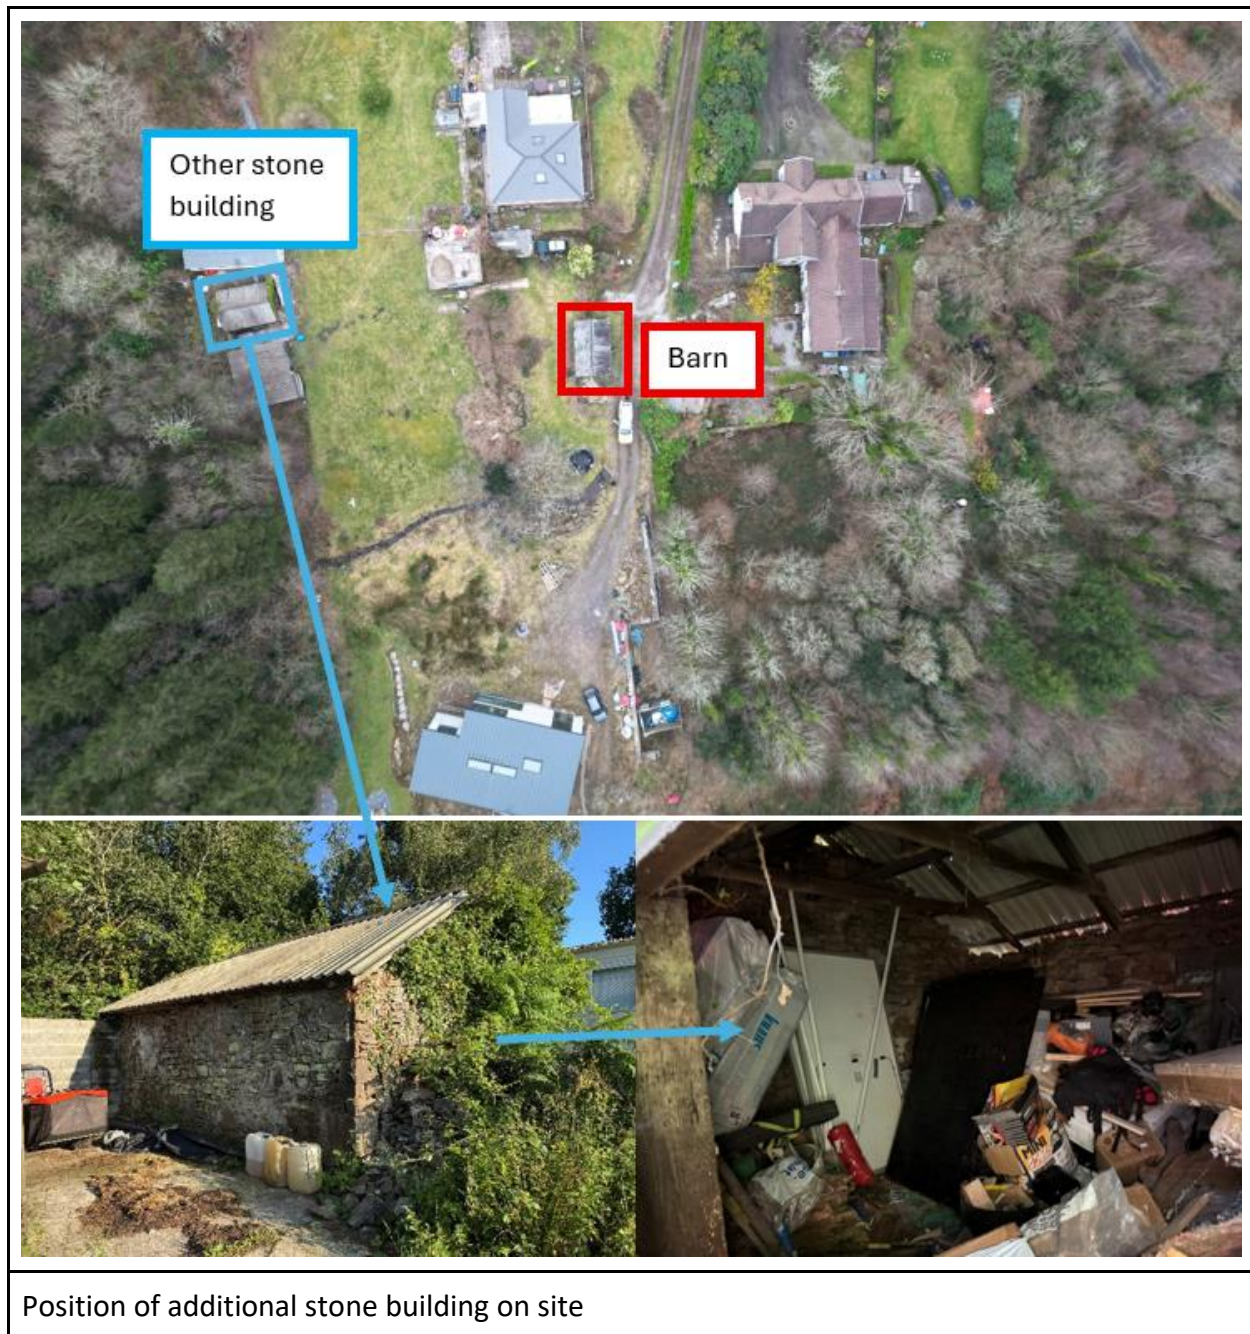
Position of additional stone building on site

**Additional building on site:** There is an additional stone building contained within the ownership that the homeowner has agreed to enhance for the purposes of mitigating against the loss of the lesser horseshoe roost. Enhancement would include the clearance of enough of the vegetation around the building to allow easy access which would allow the door to be opened permanently, allowing free-flight access into the space. The building already has gaps in the stone works for crevice dwelling bats to potentially use.
