## **GREEN INFRASTRUCTURE STATEMENT**

**Conversion of an Outbuilding  
to a Single Tourism Accommodation Unit  
at The Rise, Glyncastle, Resolven, Neath, SA11 4NW**

**Our Ref:** 1818.a

**Date:** July 2025

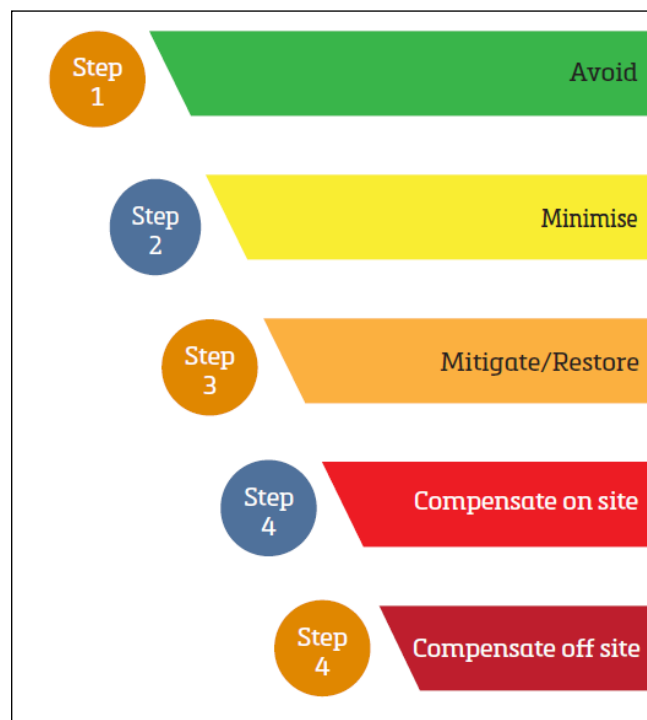
**Figure 1**

- 1.1 Evans Banks Planning Ltd has been instructed by Mr Davies (the Applicant) to prepare a Planning Statement for the conversion of an outbuilding to provide a single tourism accommodation unit at The Rise, Glyncastle, Resolven, Neath, SA11 4NW.
- 1.2 This proportionate GIS has been prepared with full regard to the guidance as set out in Chapter 6 of *Planning Policy Wales* (Edition 12) and in particular the 'Stepwise Approach' detailed in Paragraph 6.4.21 and Figure 12, which is reproduced below.

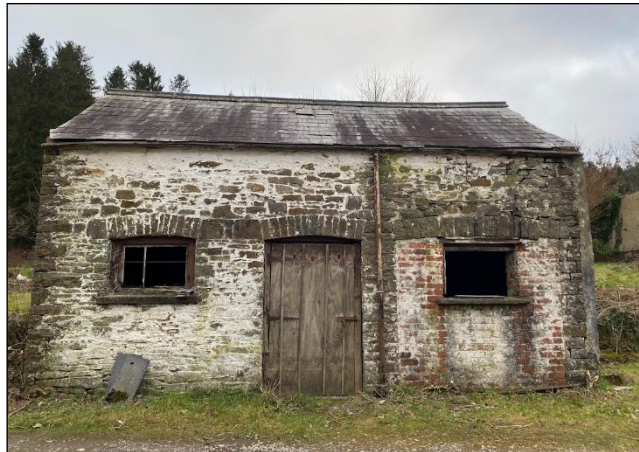
**Photograph 1**

- 2.1.1 The application relates to an existing outbuilding, thought to have originally been a cart house. The front elevation features a wide timber door and two small window openings with timber frames, as shown in Photograph 1 below.

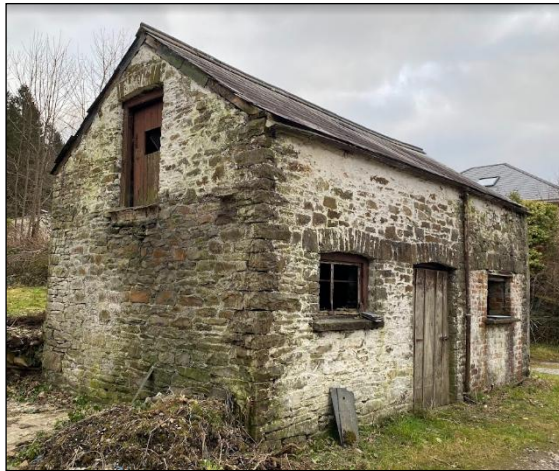
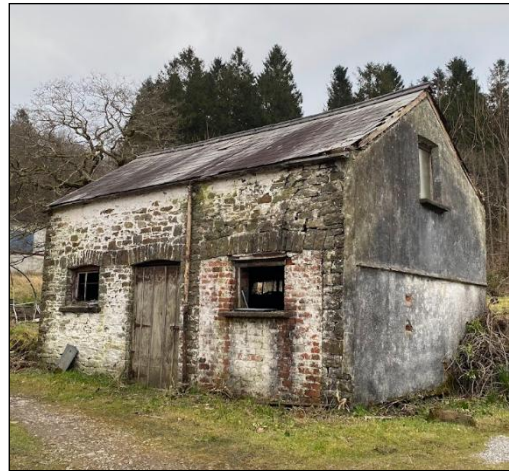
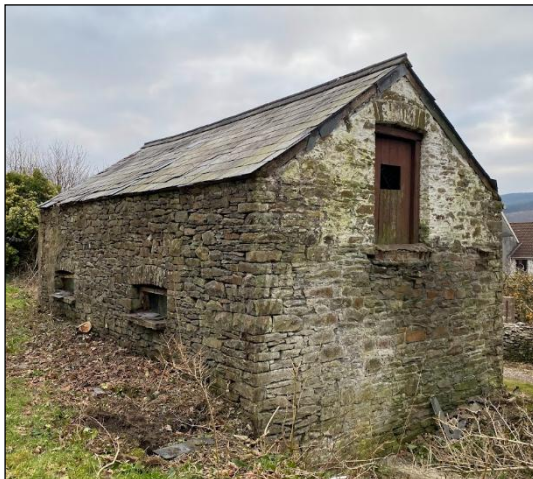
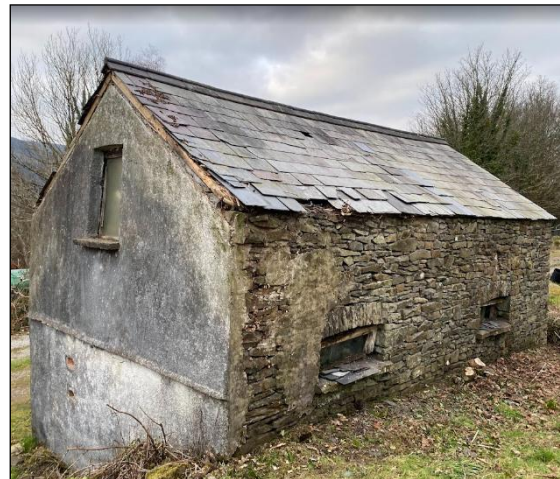
2.1.3 Photographs 2 – 5 below display all elevations of the existing building.

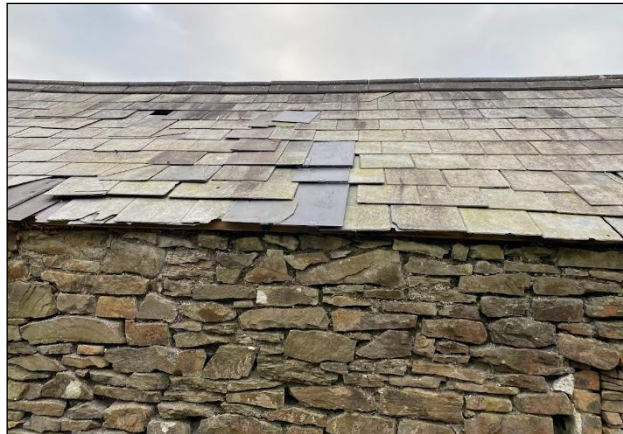
**Photograph 6**

2.1.4 The site consists of a traditional stone-built, two-storey outbuilding. The building is modest in size and is of simple rectangular form with solid stone walls and a pitched roof covered in slate. The building has several openings on each of its elevations. Photograph 6 displays a closer view of the building's slate roof and stone walls.

- 2.1.5 The building's walls and roof appear structurally sound and in relatively good condition, although the external stonework shows signs of weathering and the timber elements, including doors and windows, are in need of repair.
- 2.1.6 Internally, the building comprises a single open space, currently used for general storage purposes. Photographs 7 – 10 below show each of the internal elevations.

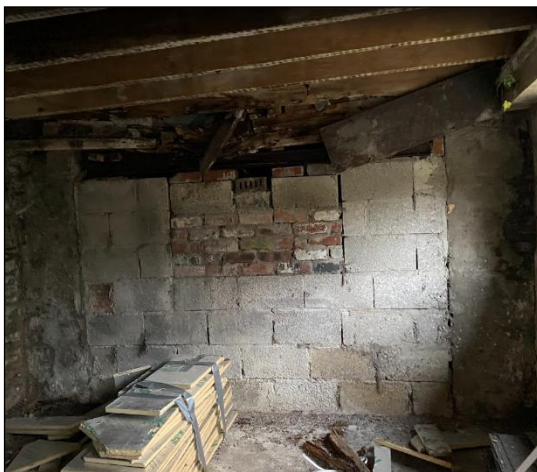
**Photograph 7**

2.1.7 As illustrated by the photographs above, the internal stone walls are generally intact and in sound condition. However, the southwestern elevation, shown in Photograph 7, appears to have undergone some maintenance or repair works, including the use of concrete blocks and mixed brickwork.

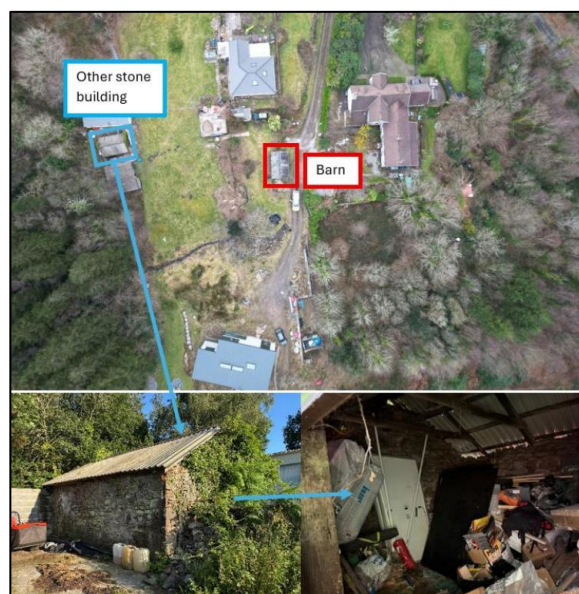
**Figure 4**

4.1.6 Finally, the Bat Survey Report notes that an additional stone building within the ownership of the property has been identified for enhancement to help mitigate the loss of the lesser horseshoe bat roost. The homeowner has agreed to undertake these improvements, which include clearing sufficient vegetation around the structure to enable easy access and allowing the door to remain permanently open, thereby providing unrestricted flight access for bats. The building already features gaps within the stonework, offering potential roosting opportunities for crevice-dwelling bat species. Figure 4 below displays an aerial image illustrating the position of the additional stone building on the site, as well as photographs of its interior and exterior, extracted from the Bat Survey Report.

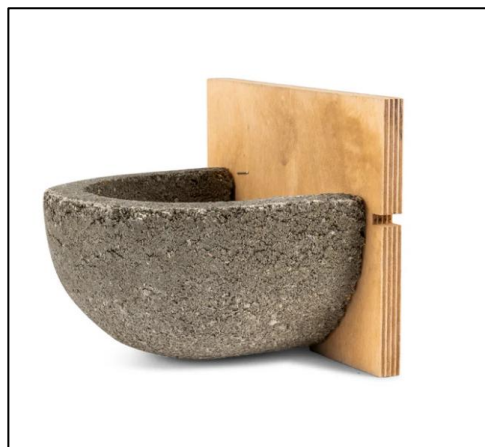
**Figure 6**

4.3.2 Figure 6 below displays an example of a swallow nest cup.

4.3.1 The Bat Survey Report recommends the installation of two swallow nest cups on the additional stone building within the application site. The exact placement of these nesting features will be determined and approved by the ecologist.
