RHONDDA  
GEOTECHNICAL  
SERVICES

# PHASE 2 CONTAMINATED LAND REPORT

PROPOSED REDEVELOPMENT

AFAN UNITED F.C.

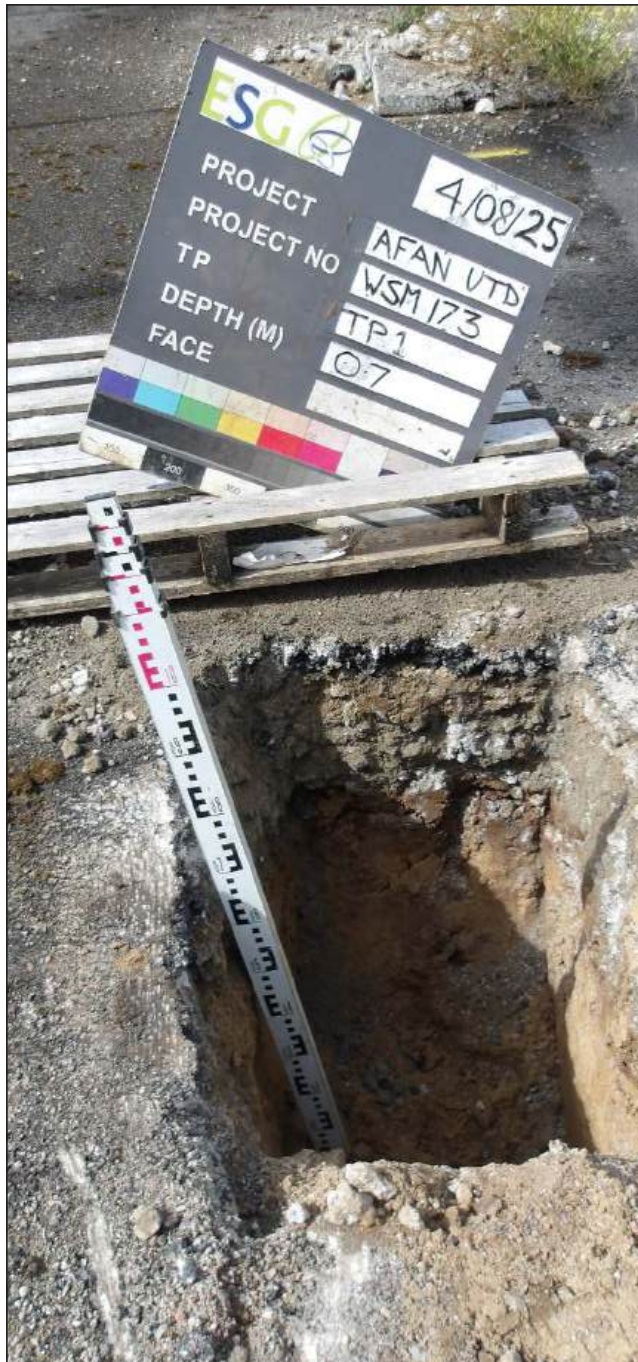
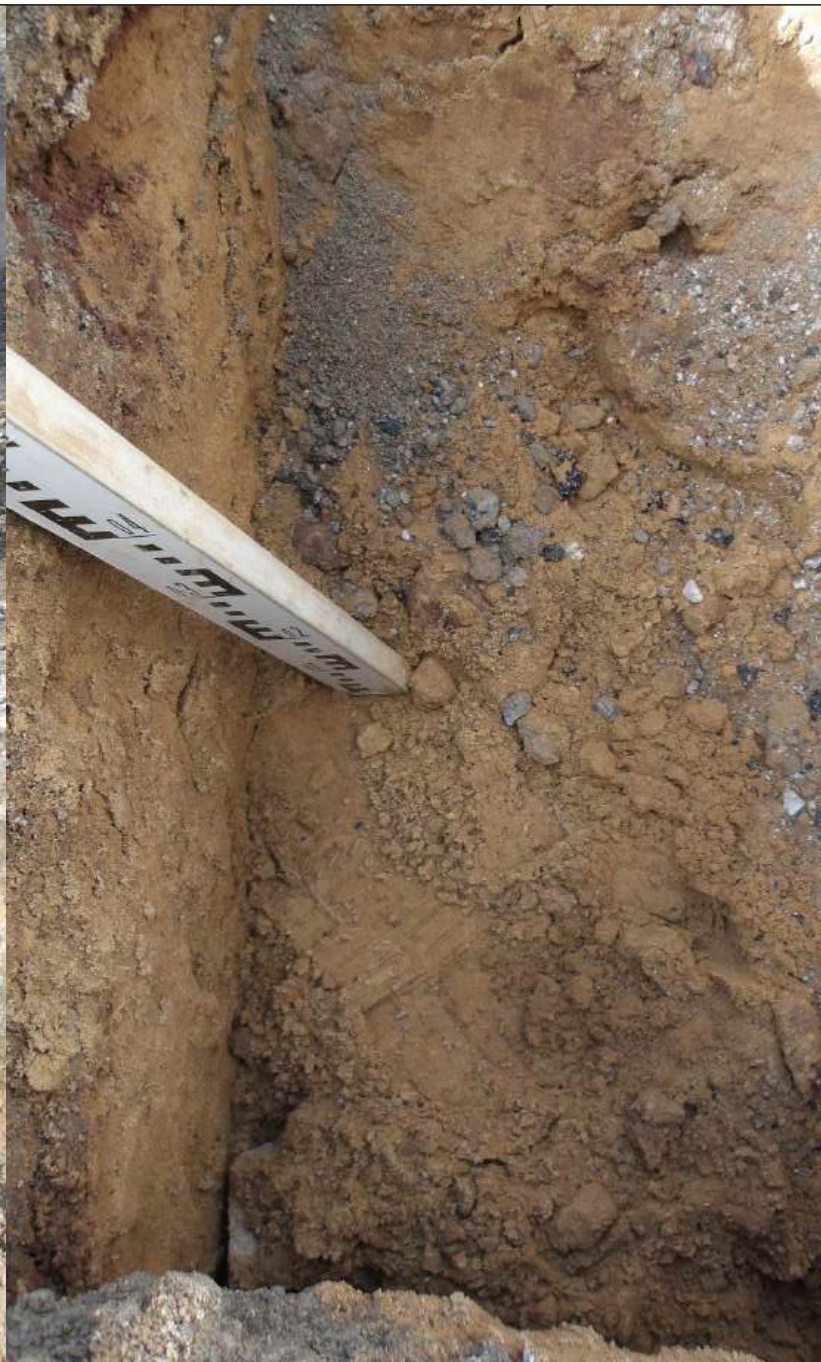
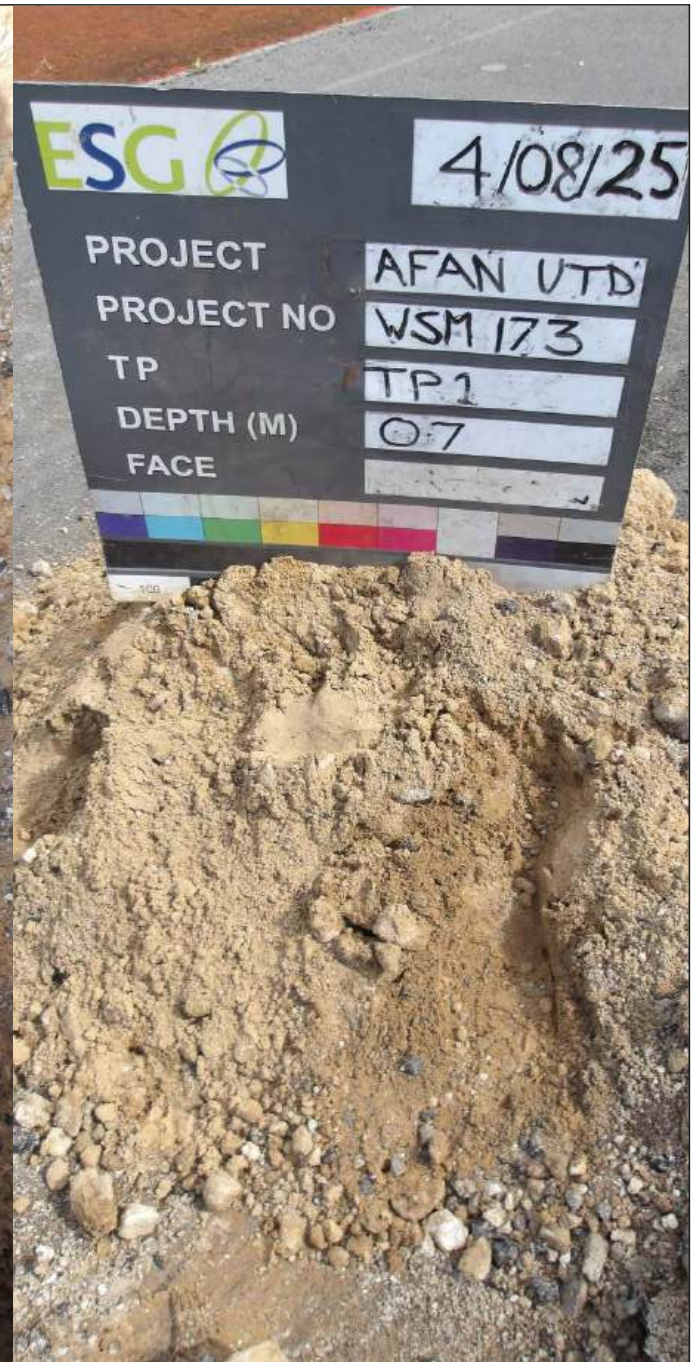
TP 1

| Samples and Tests | | Strata | |
|---|---|---|---|
| | | G.L. | Concrete with 75mm Tarmac |
| | | 0.35 | Loose brown fine to medium SAND |
| 0.4 | ES1 | | |

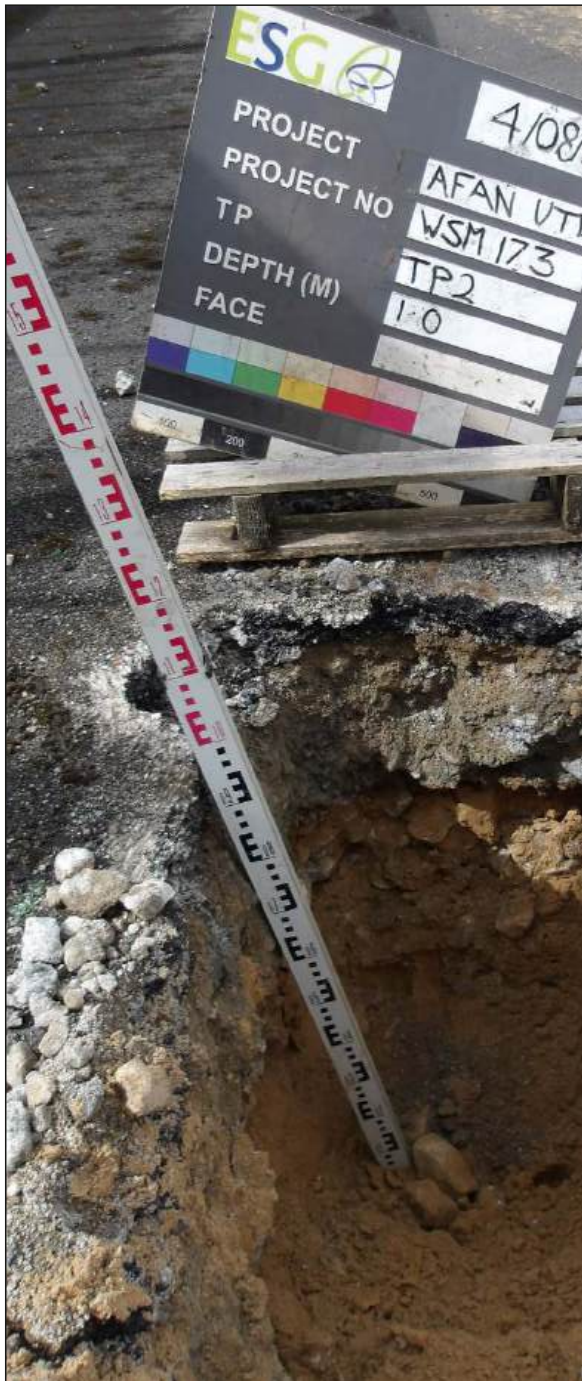
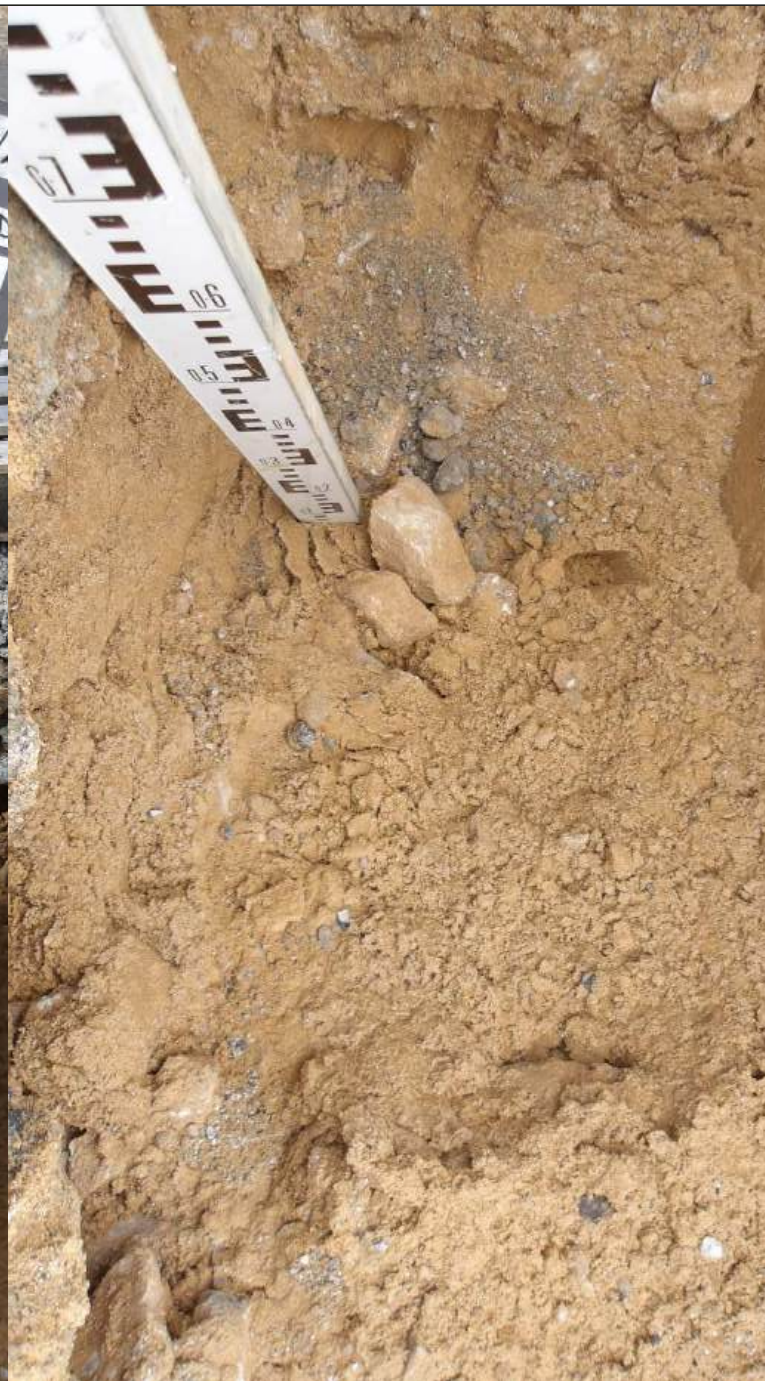
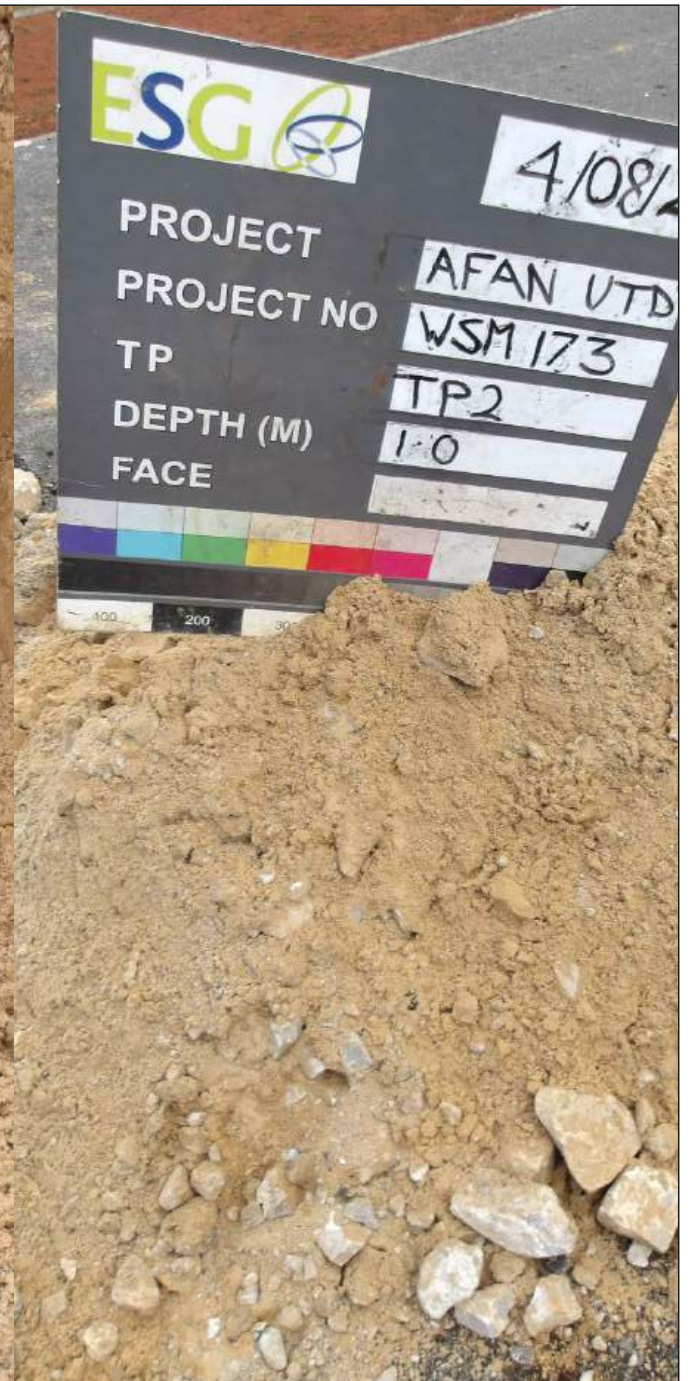
TP 2

| Samples and Tests | | Strata | |
|---|---|---|---|
| | | 0.35 | Loose brown fine to medium SAND with angular limestone aggregate. MADE GROUND |
| 0.7 | ES2 | 0.65 | Loose brown fine to medium SAND. |

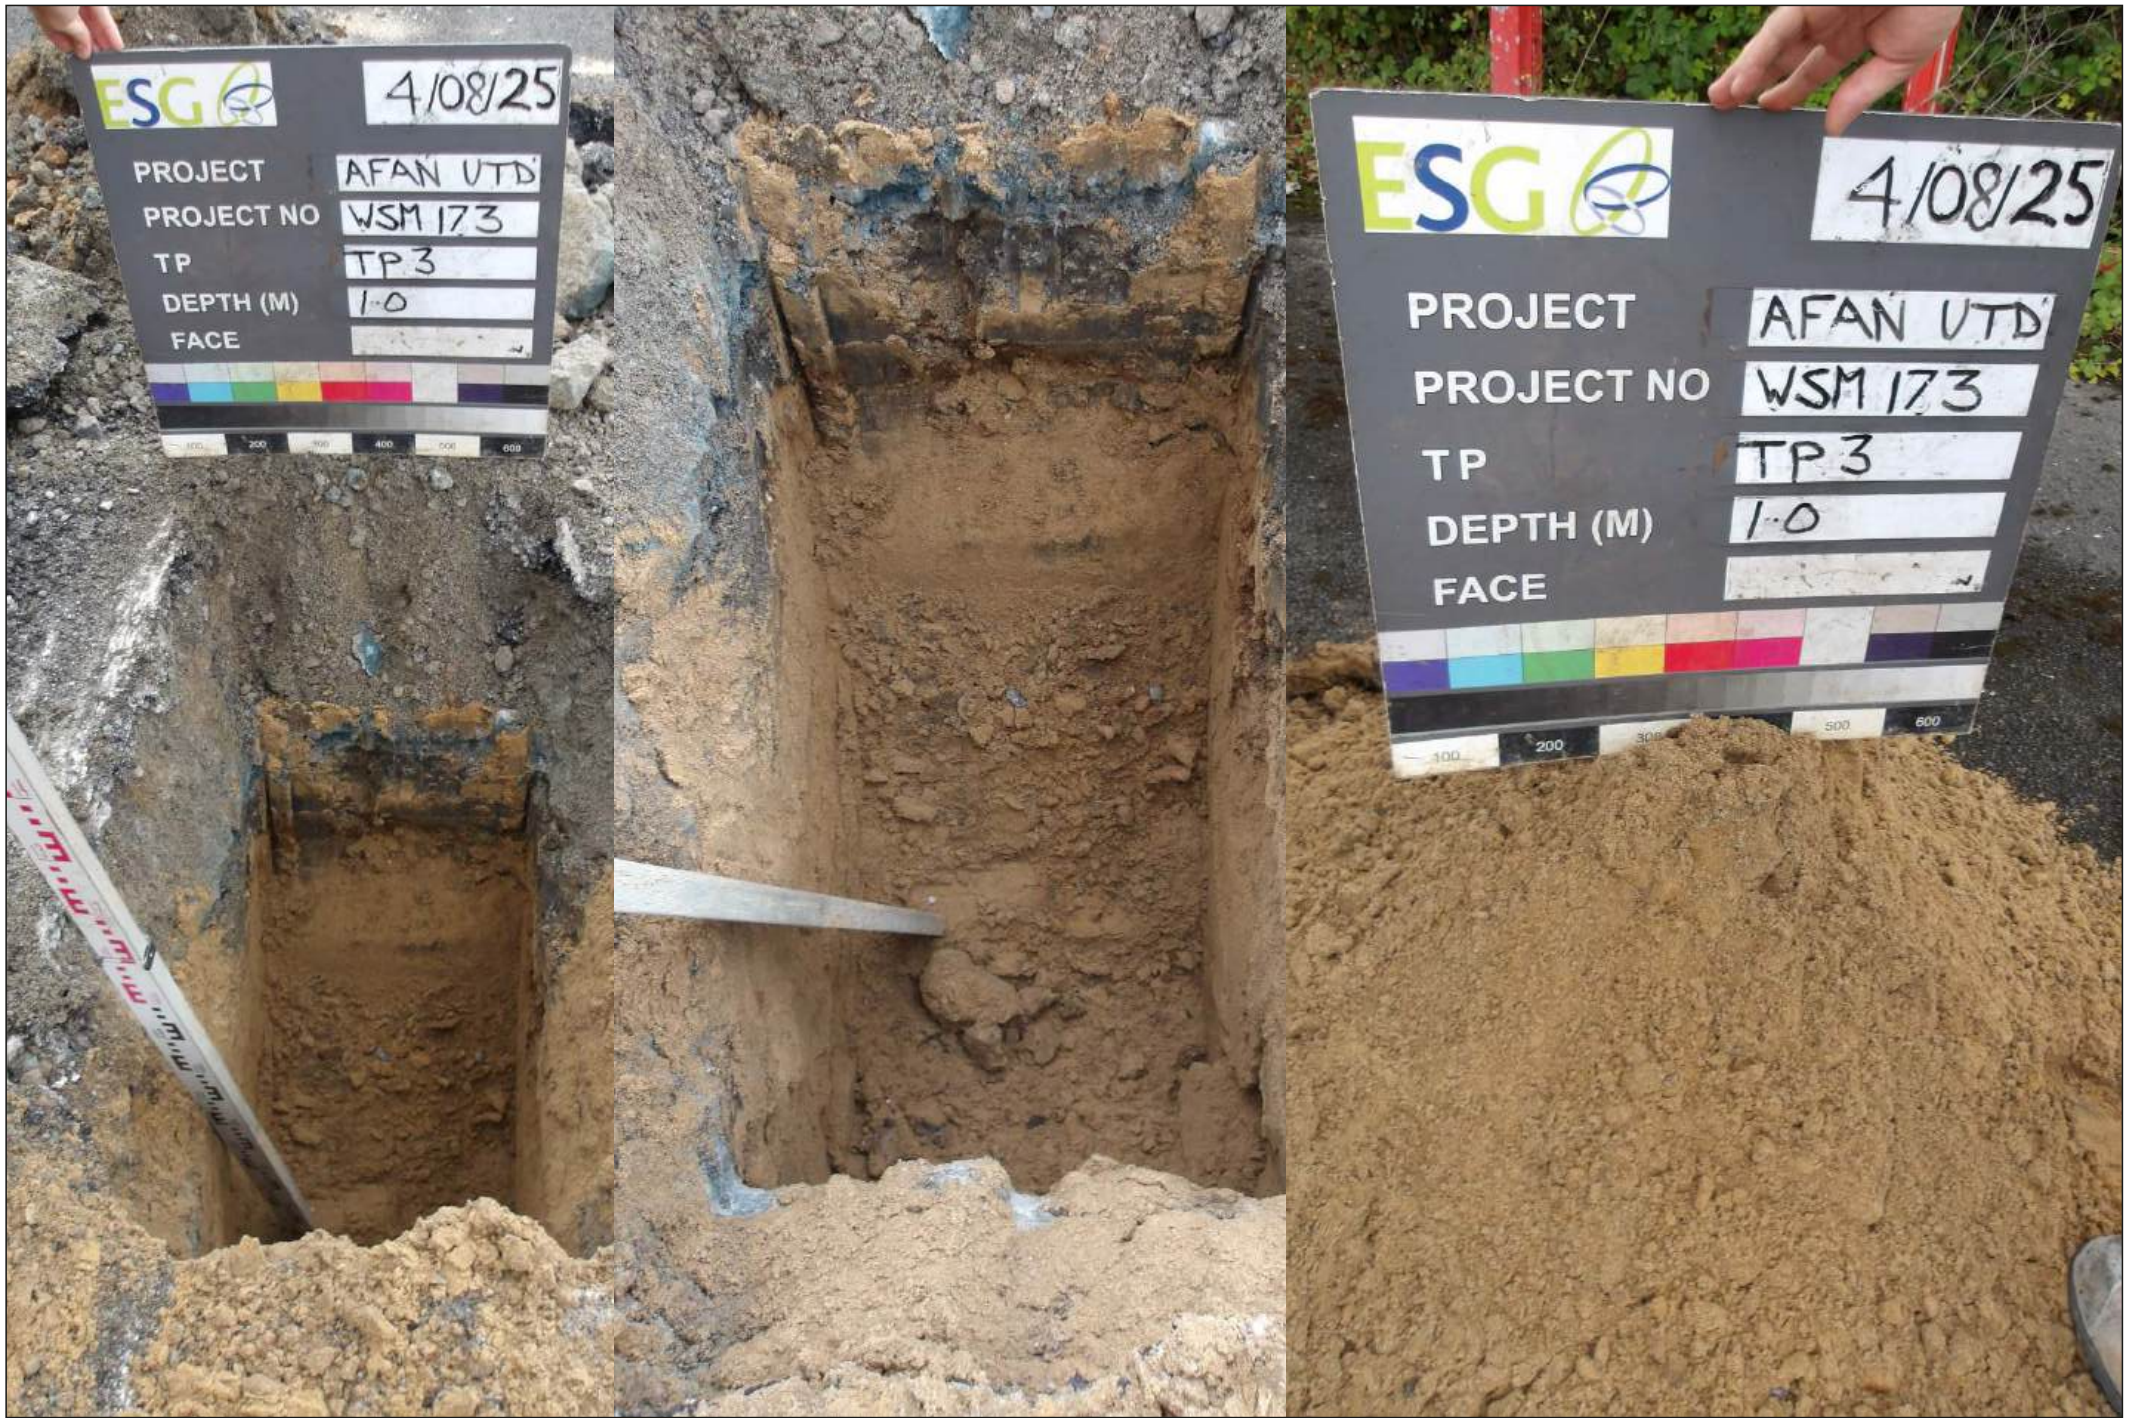
TP 3

| Samples and Tests | | Strata | |
|---|---|---|---|
| | | | Loose brown fine to medium SAND with angular steelworks slag. MADE GROUND |
| | | | Loose brown fine to medium SAND. |

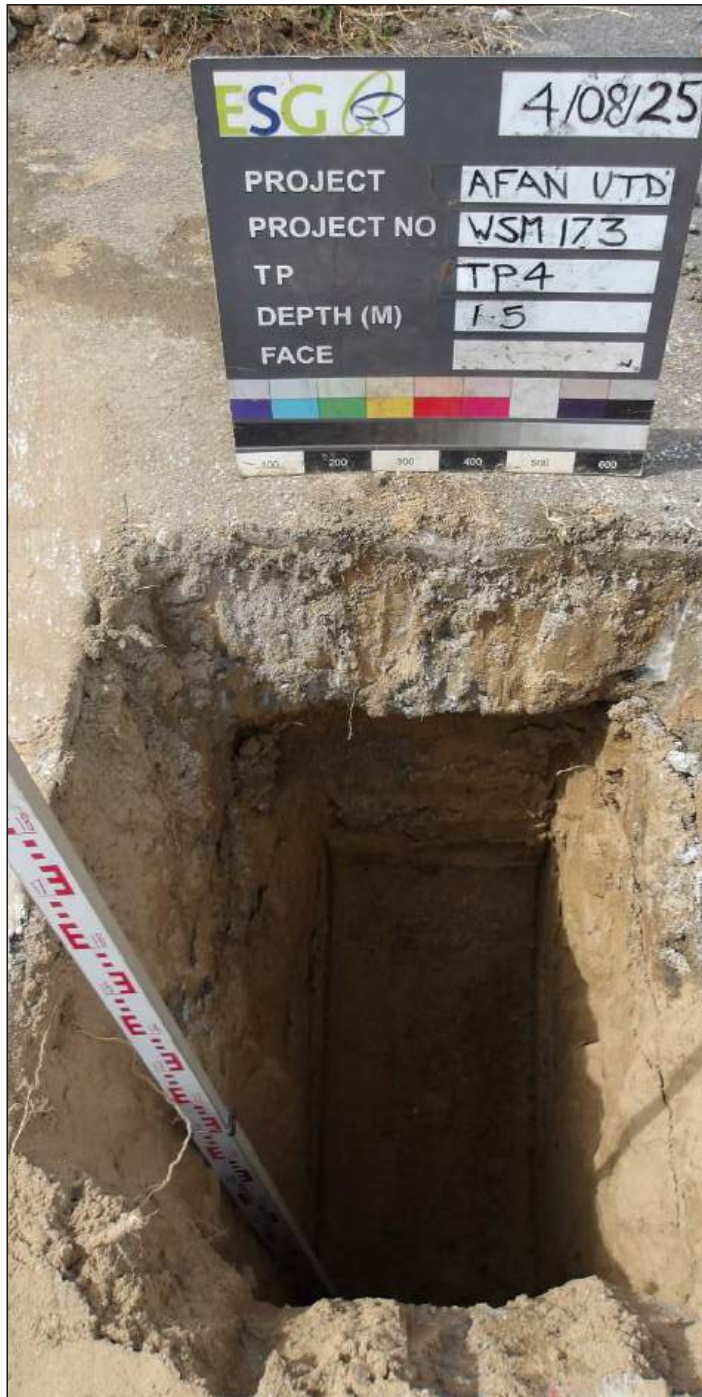
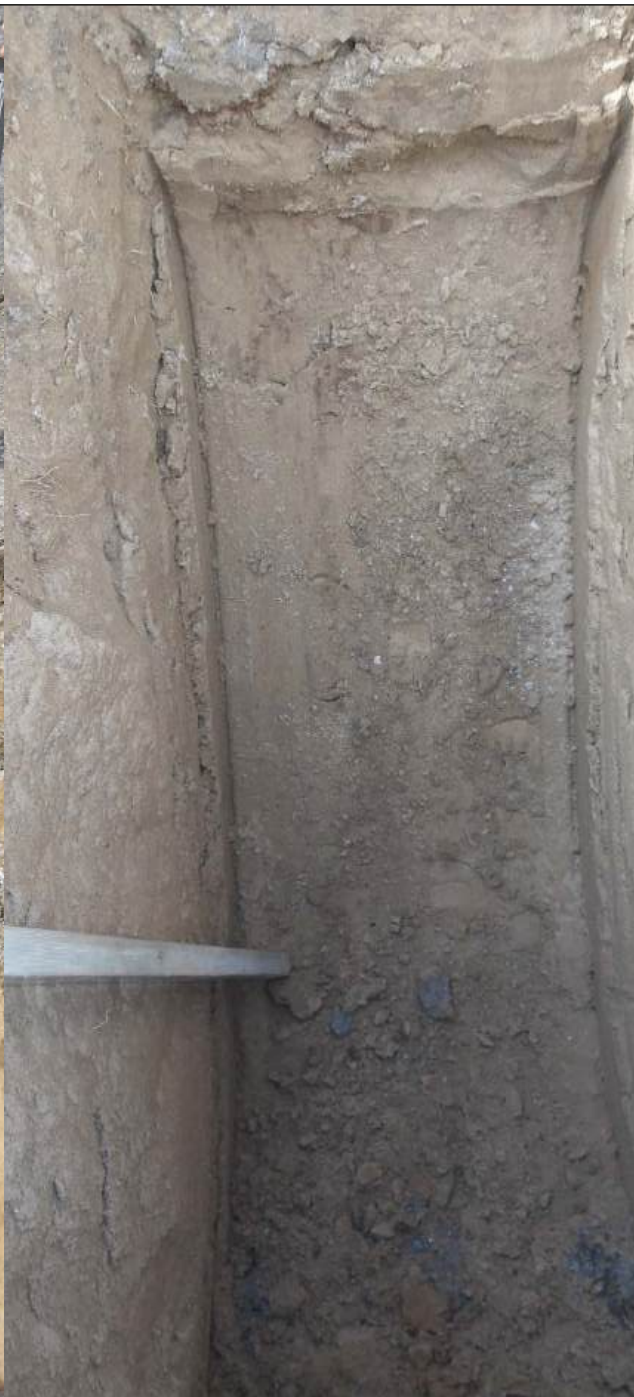
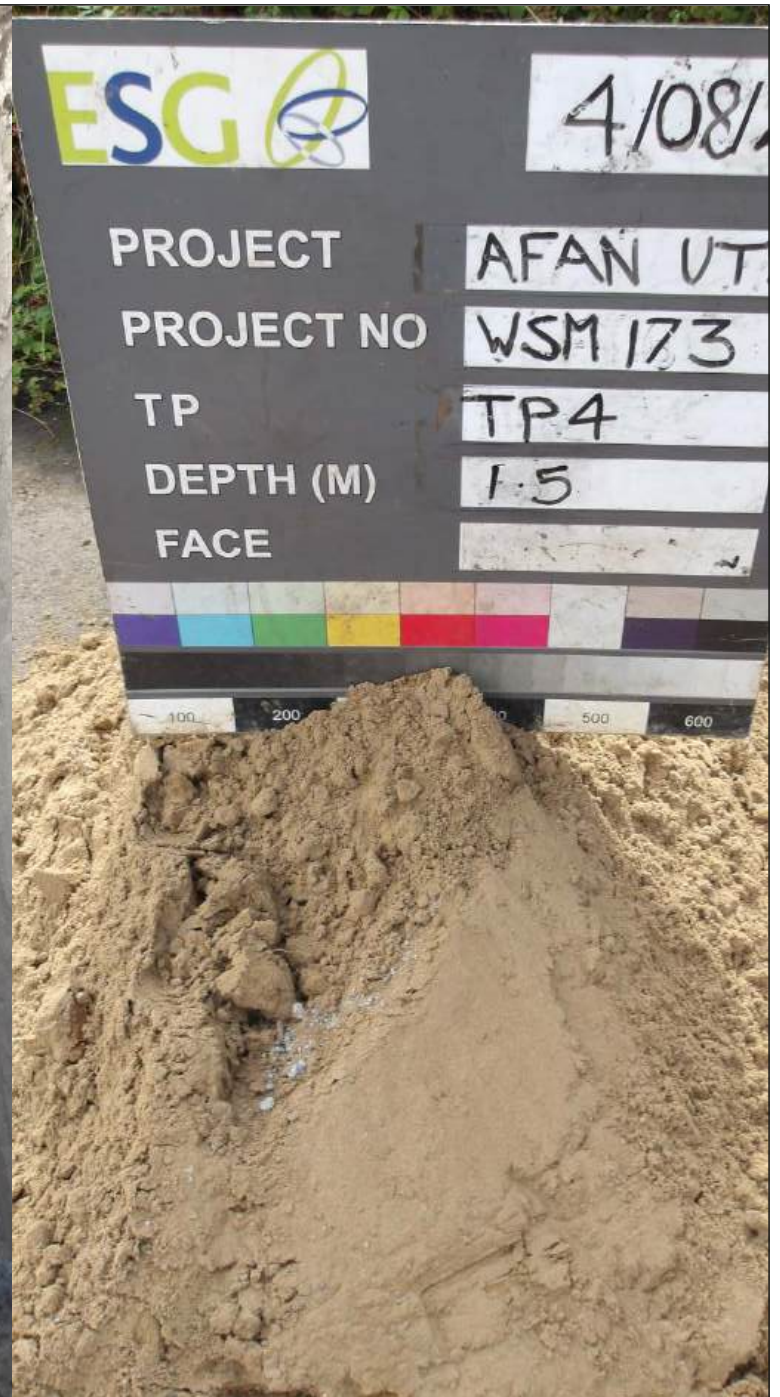
TP 4

| Samples and Tests | | Strata | |
|---|---|---|---|
| | | 0.35 | Loose brown fine to medium SAND with angular limestone aggregate. MADE GROUND |
| | | 0.55 | Loose brown fine to medium SAND. |

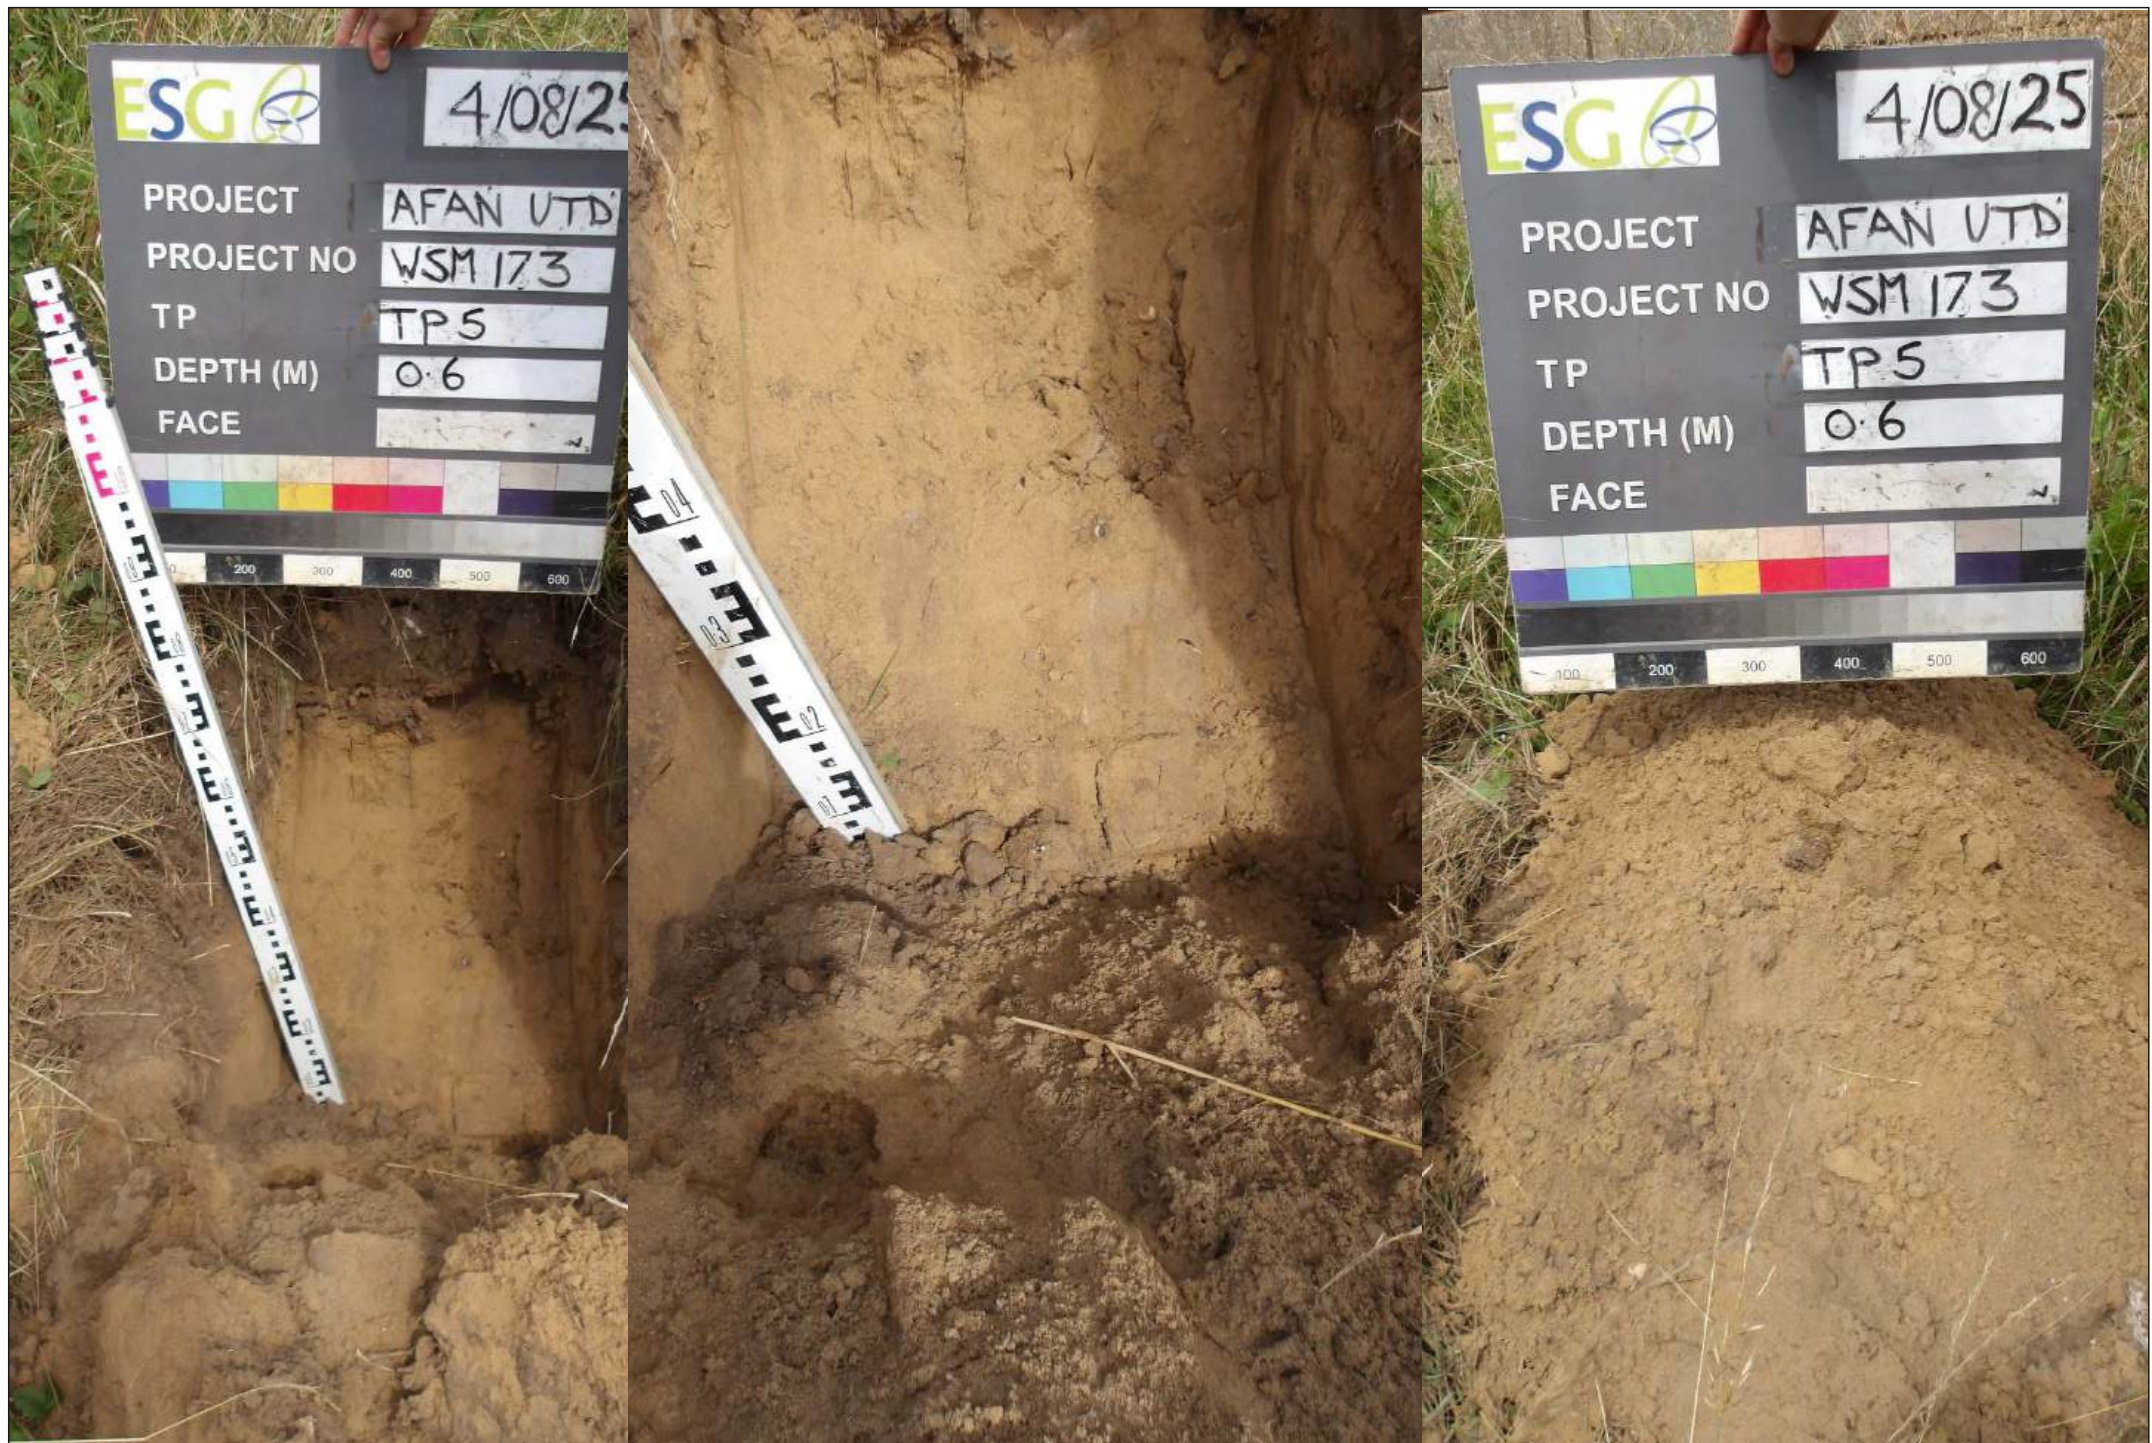
TP 5

| Samples and Tests | | Strata | |
|---|---|---|---|
| | | | Loose brown fine to medium SAND |

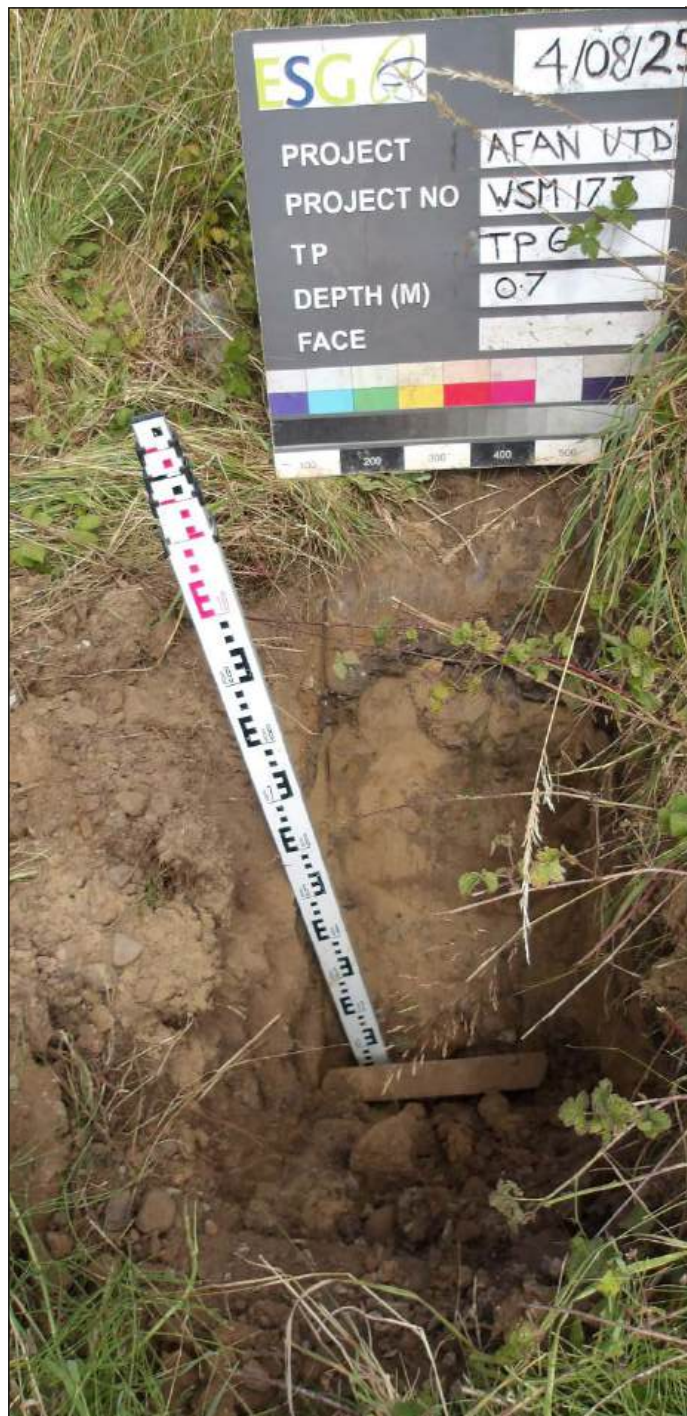
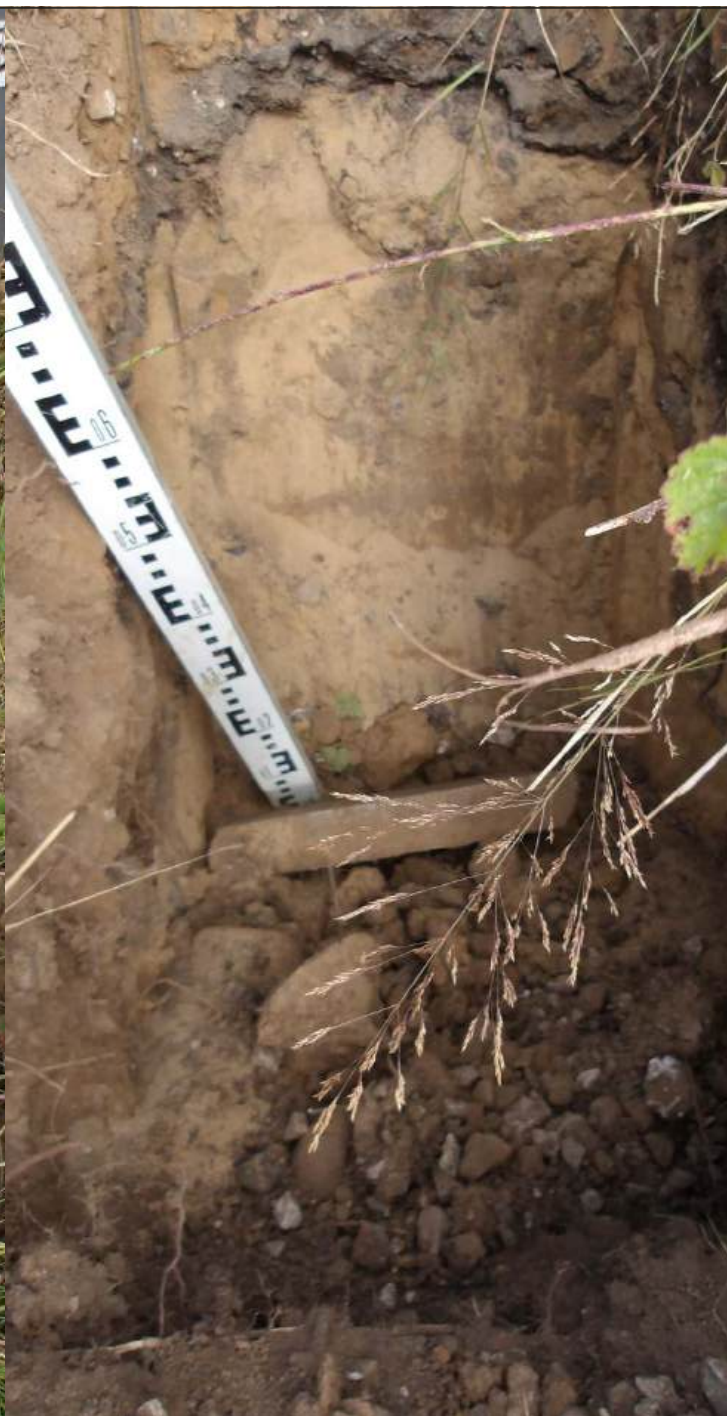
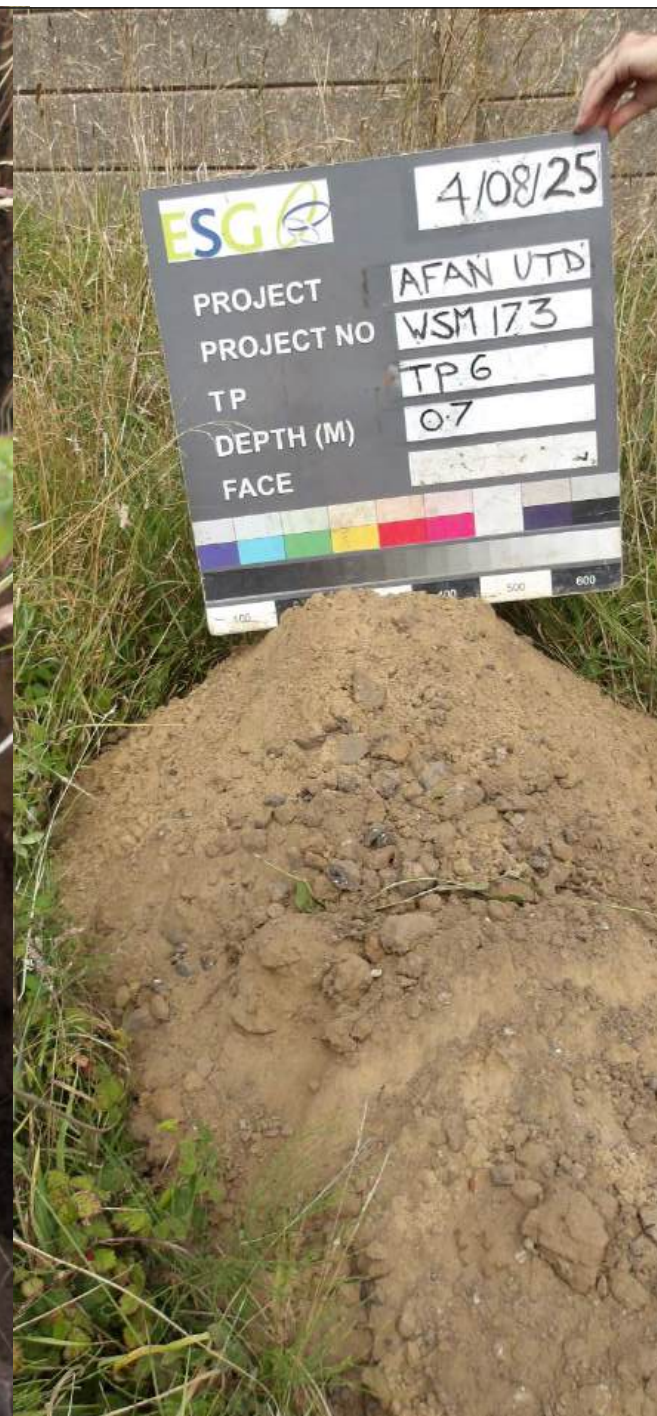
TP 6

| Samples and Tests | | Strata | |
|---|---|---|---|
| 0.3 | ES6 | 0.3 | Loose brown fine to medium SAND |
