## SITE INVESTIGATION REPORT

### Afan Way

| Report number | R070022#1 |

## Ground Investigation Report

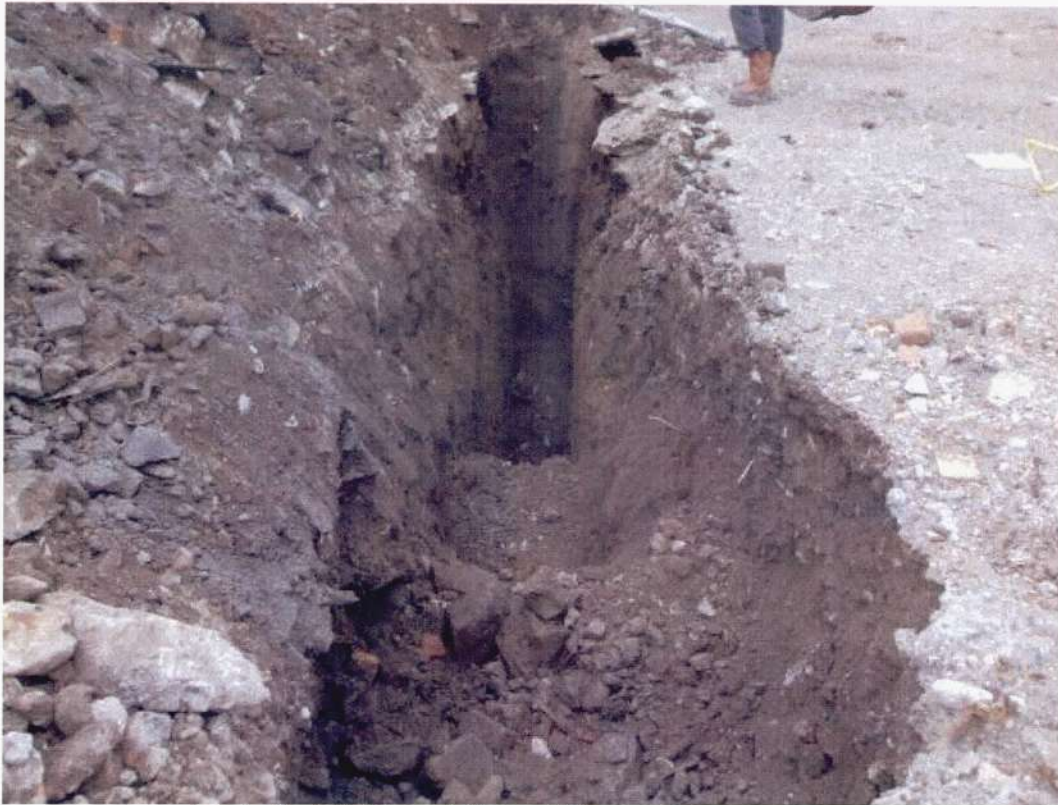
The trial trench was excavated from the central point of the former UST compound firstly to the south and latterly to the north. The excavation was characteristic in the greater depth of made ground present almost entirely composed of site generated crushed materials. The trenching contained concrete infrastructure at 1.7 – 2.0M depth, potentially from the former UST compound although no staining or visual contamination was present. Perched water was encountered at approximately 1.8m within the southern section of the trench adjacent to the residual concrete structure. No samples were collected from the treatment trench.

Photo 1 – Trial trench through former compound area.

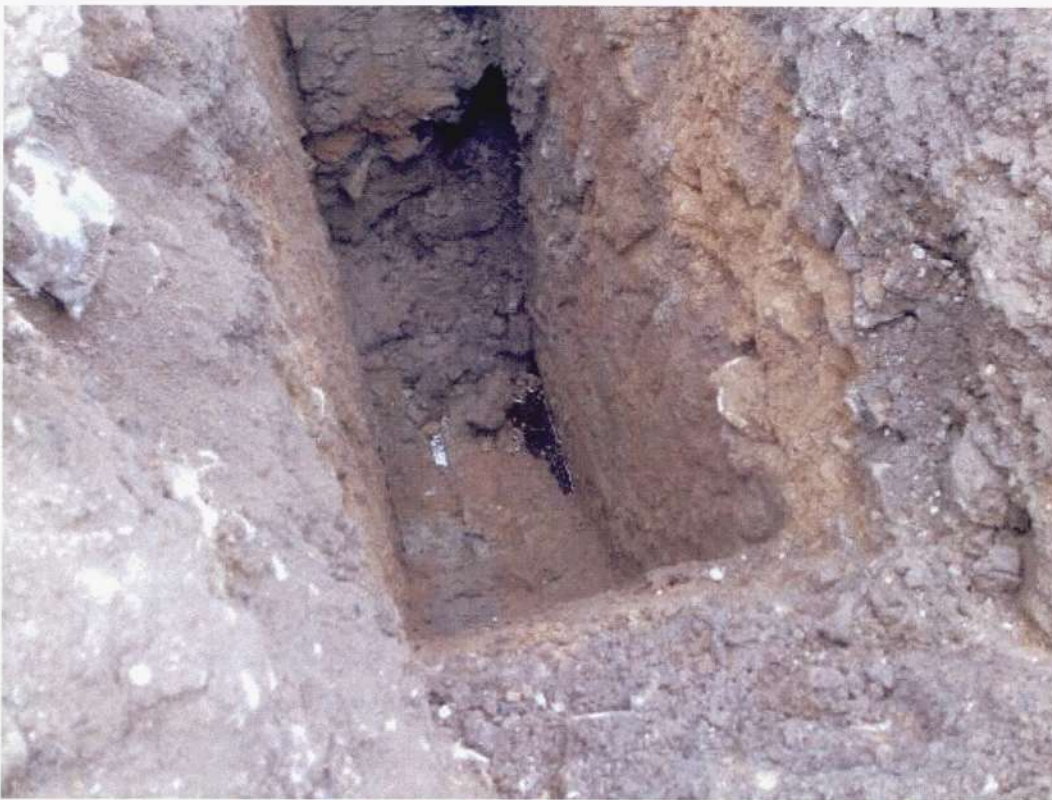
Free product ingress at NW corner of pit at 2.3M, Sample (impacted CLAY) from 2.6M.

Headspace reading with PID = 652ppm.

Photo 2 – Ingress of free phase product into LEE pit 2.

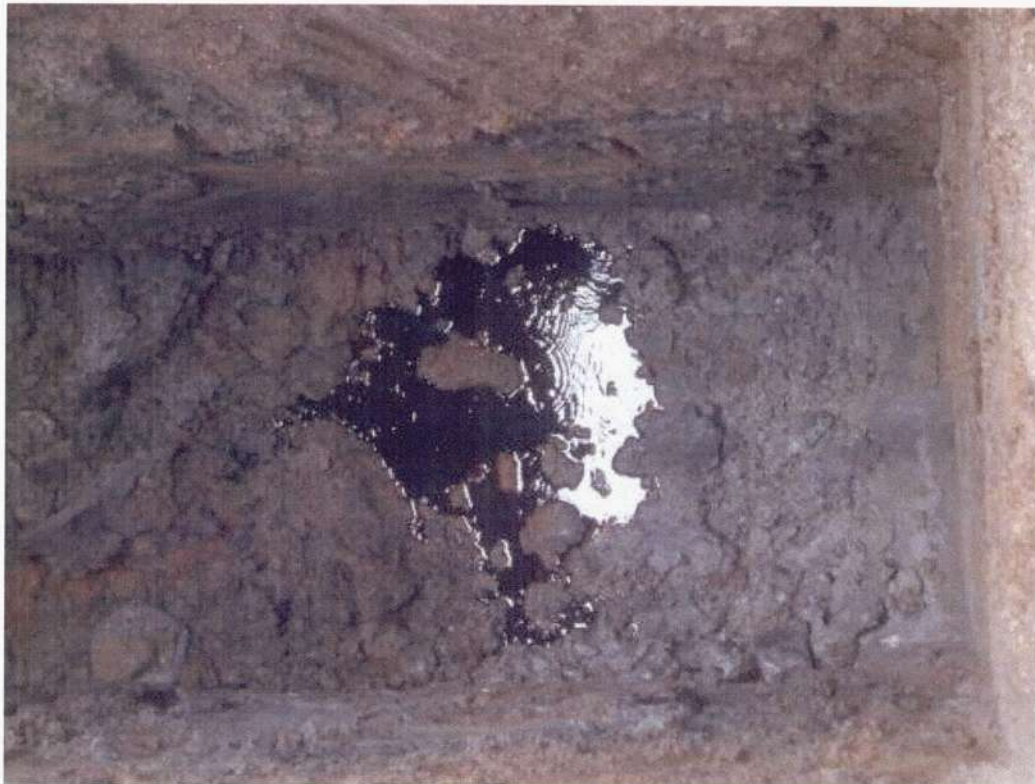
Ingress of free phase product at 3.3M depth. Sample (CLAY) from 2.1M.

**Photo 3 – Ingress of free phase product into LEE pit 7.**

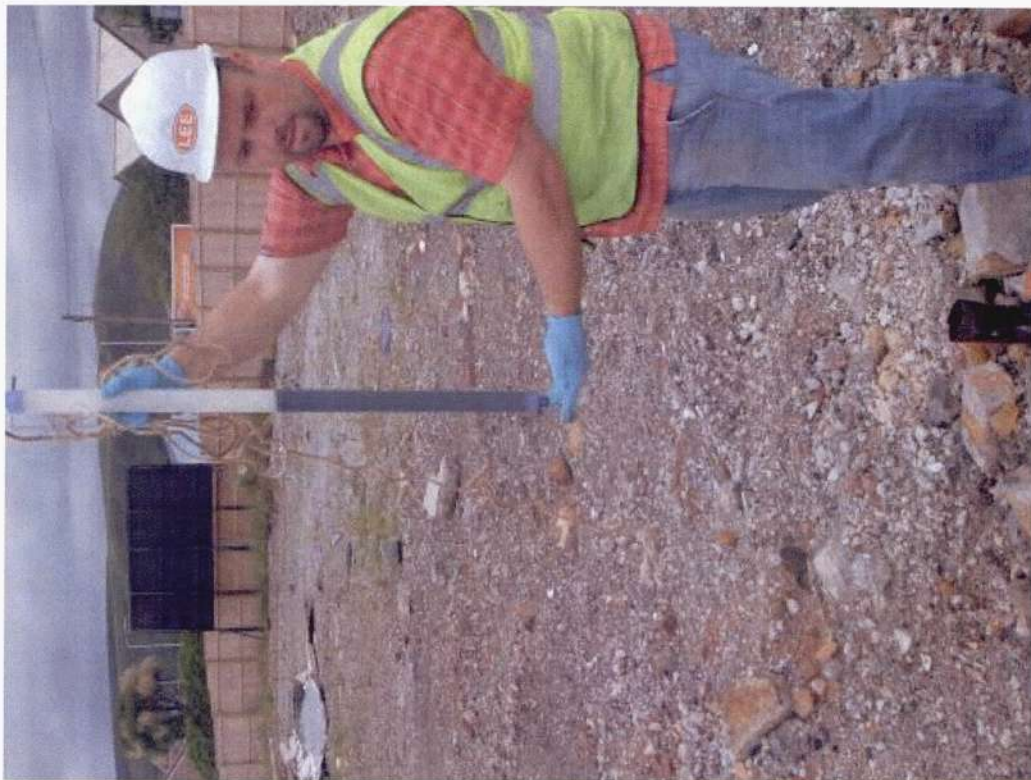
A product baler was dropped into the borehole and returned full of phase separated product with a strong petroleum odour. This was repeated with no water being recorded in the baler until the sixth repetition. Approximately 10 litres of the product was subsequently recovered reducing the recorded column of phase separated product to 185mm within the baler. The borehole was then left to recharge for a period of 1 hour whereupon the baler was recorded as having recharged to 670mm of phase separated product with no water present.

**Photo 4 – Free phase Product from Borehole E4.**
