*Report No. BC/MB/02.25.04/2.*

# **Geo-Environmental Report (Tier 2): Land at Abergarwed Farm.**

***Absolute Scaffolding***

## **Geo-Environmental Report (Tier 2): Land at Abergarwed Farm.**

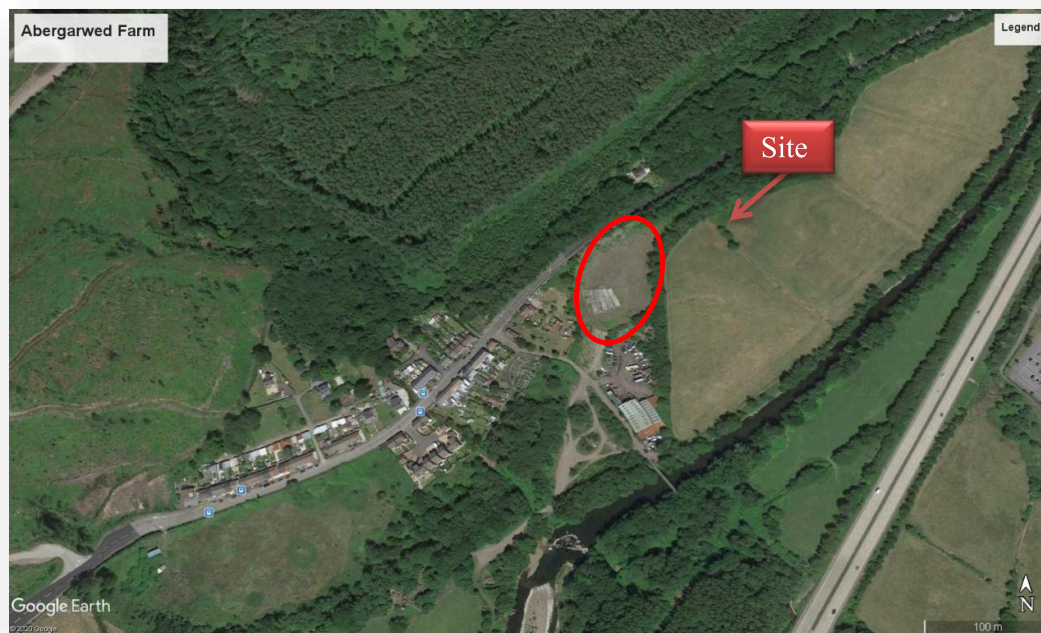
**Figure 1**  
**Aerial View of Site**

The plot of land where it is proposed to construct the storage facility, 'the Site' is located in a rural area and is situated on the floor of the Neath Valley, approximately 11km east of the commercial centre of Neath and 7.5m south-west of the centre of Glyn Neath (see Figure 1 and *General Location Plan, drawing no. BC/MB/02.25.04.01*). The Site is located at the eastern fringes of Abergarwed and close to the River Neath and is largely surrounded by a mixture of woodland and agricultural enclosures. The Site is irregular in outline and the proposed storage building has dimensions of approximately 30m by 20m; the planning application site occupies an area of approximately 1.18 hectares within the Site, all of which is fairly level at an elevation of approximately 22m aod (see Figure 1 and *Detailed Location Plan, drawing no. BC/MB/02.25.04.03*).

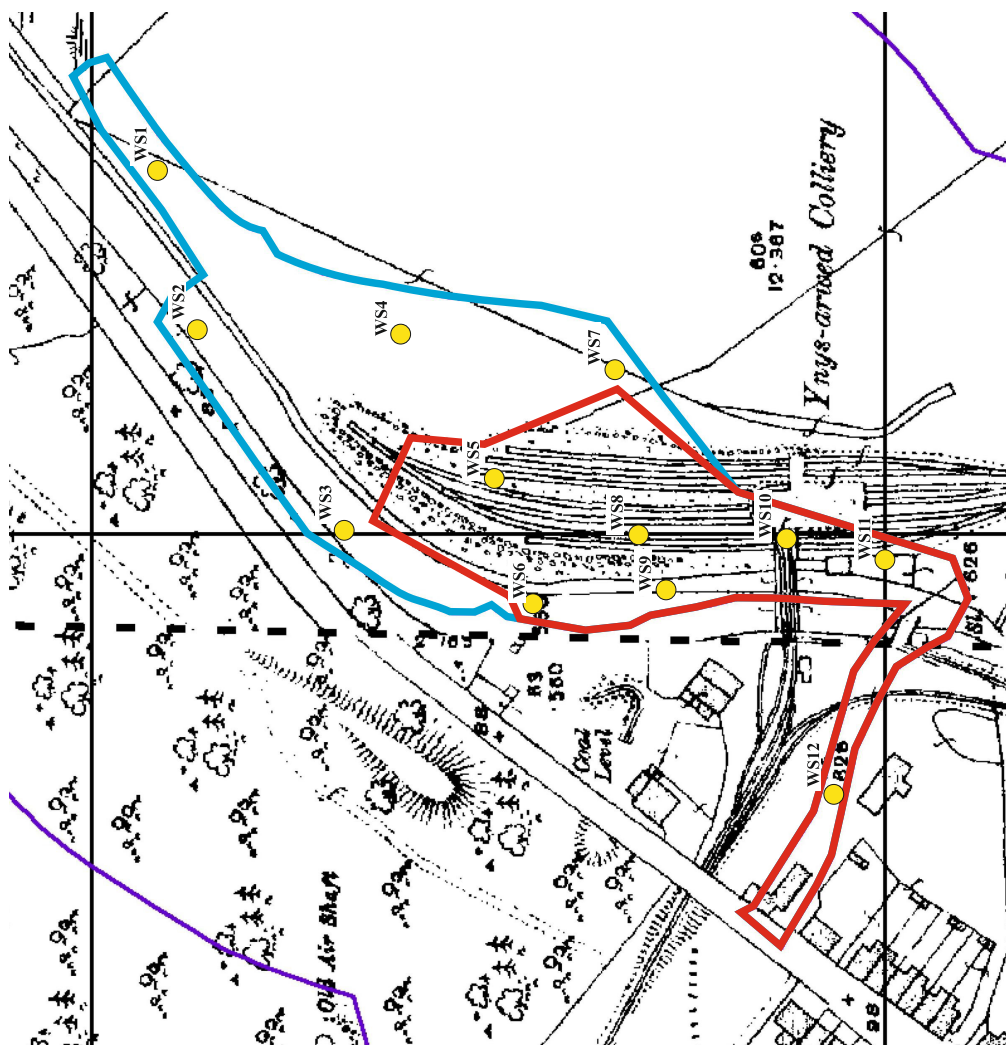
Drawing No: BC/MB/02.25.04.14.

(Current Surface Features) and the Site Investigation Plan (1918 Surface Features), drawing nos. BC/MB/02.25.04.13 and BC/MB/02.25.04.14. Geotechnical logs and photographs of the probeholes are included at Appendix I.

## Site Investigation Plan (1918 Surface Features).
