| Job Name: | <b>1 HENFAES ROAD, TONNA, NEATH PROPOSED DEVELOPMENT OF 8 DWELLINGS ON FORMER CARE HOME SITE</b> | Job N <sup>o</sup> : | <b>IMA-24-077</b> |

## **IMA Covering Note Ref: Site Investigation Reports**

**COMPLIATION  
REPORT  
on  
INVESTIGATIVE WORK**

## **Geo-Environmental Site Assessment Report**

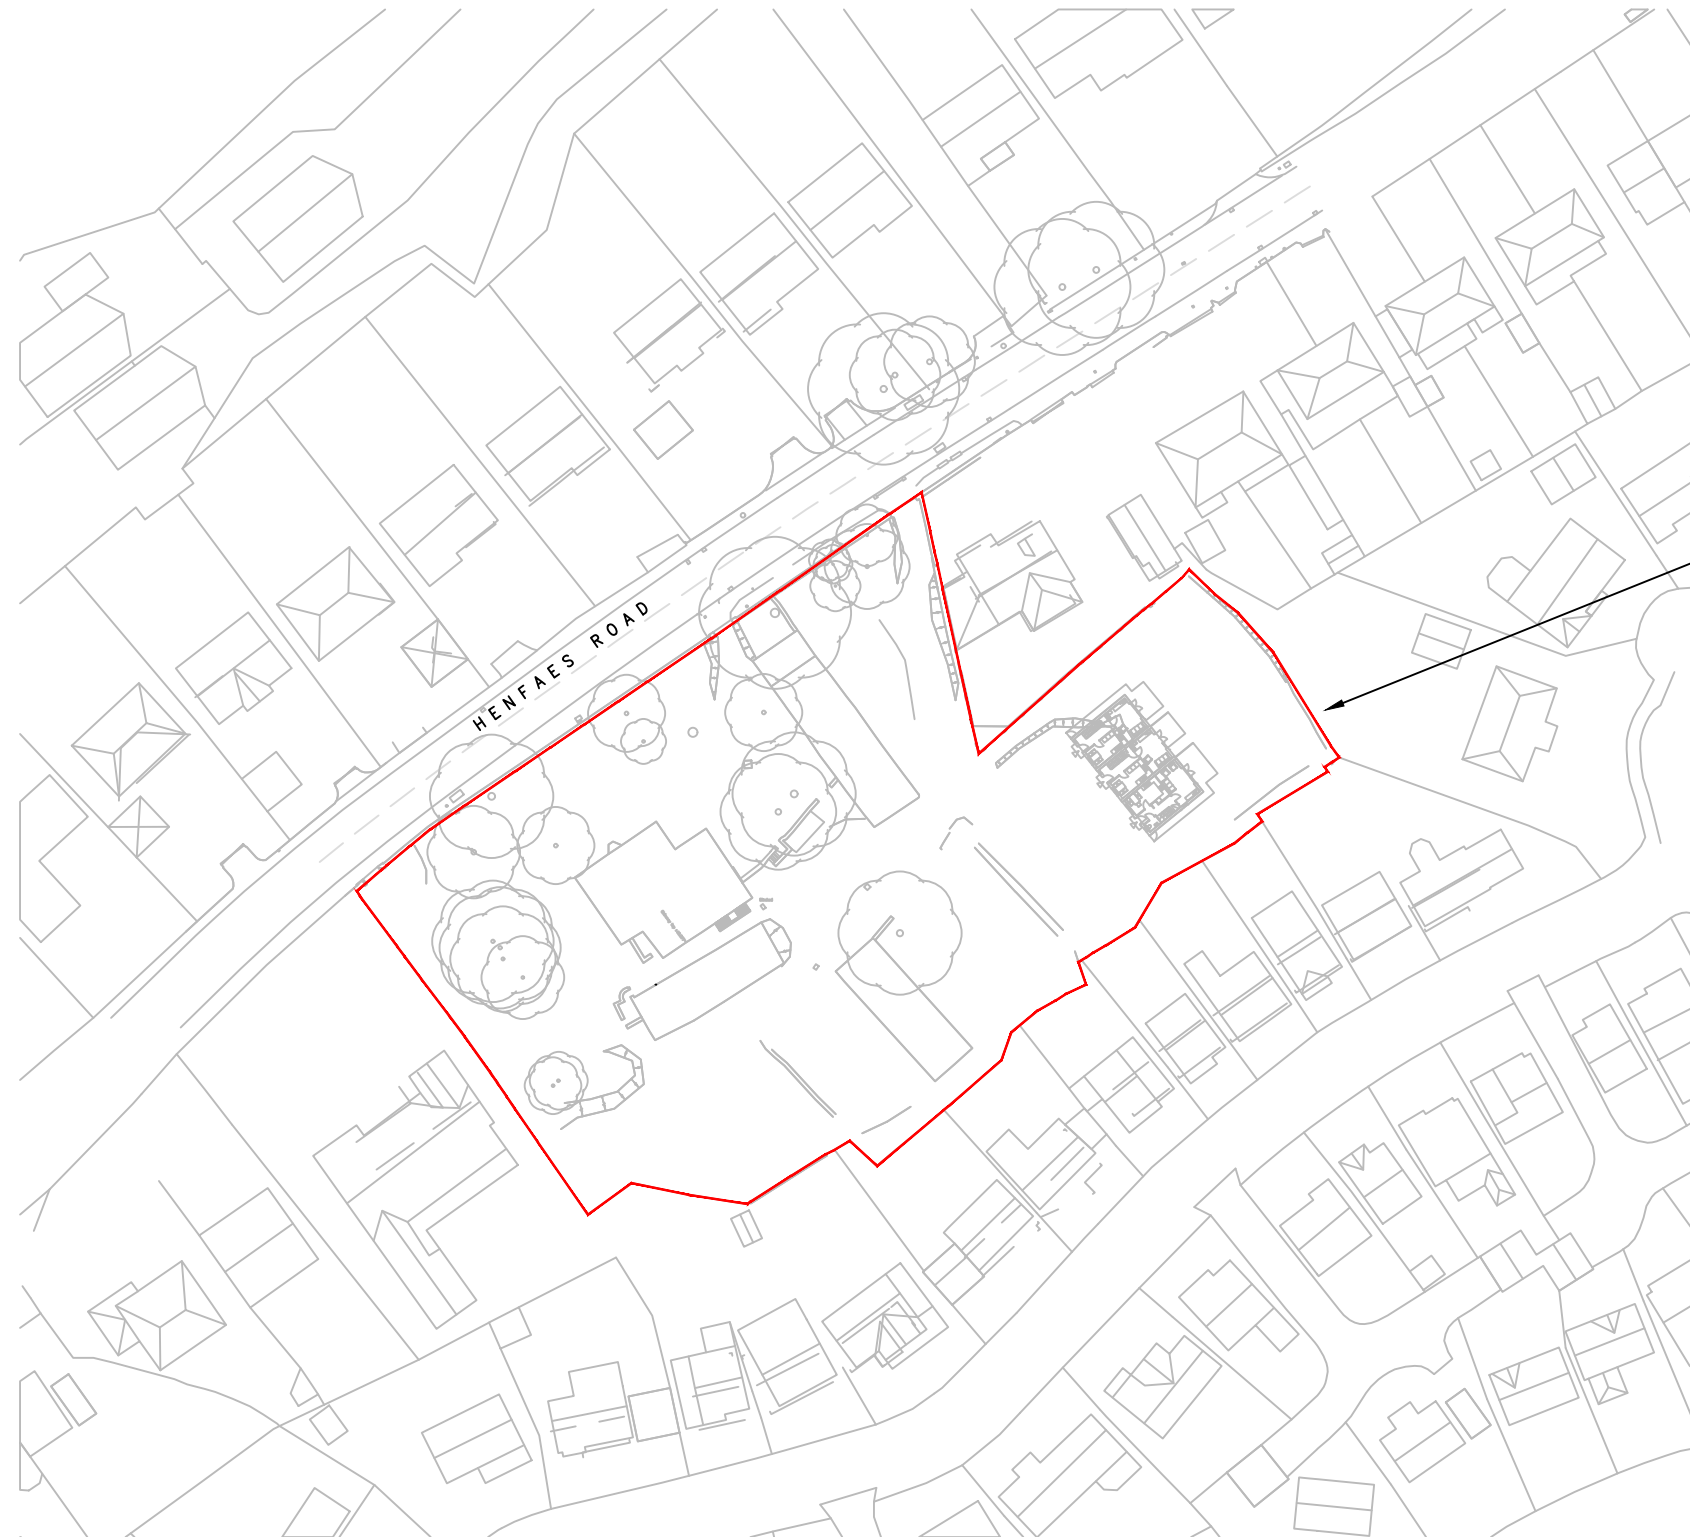
**Appendix A**  
Site Location Plan

The red line indicates the boundary for the new development

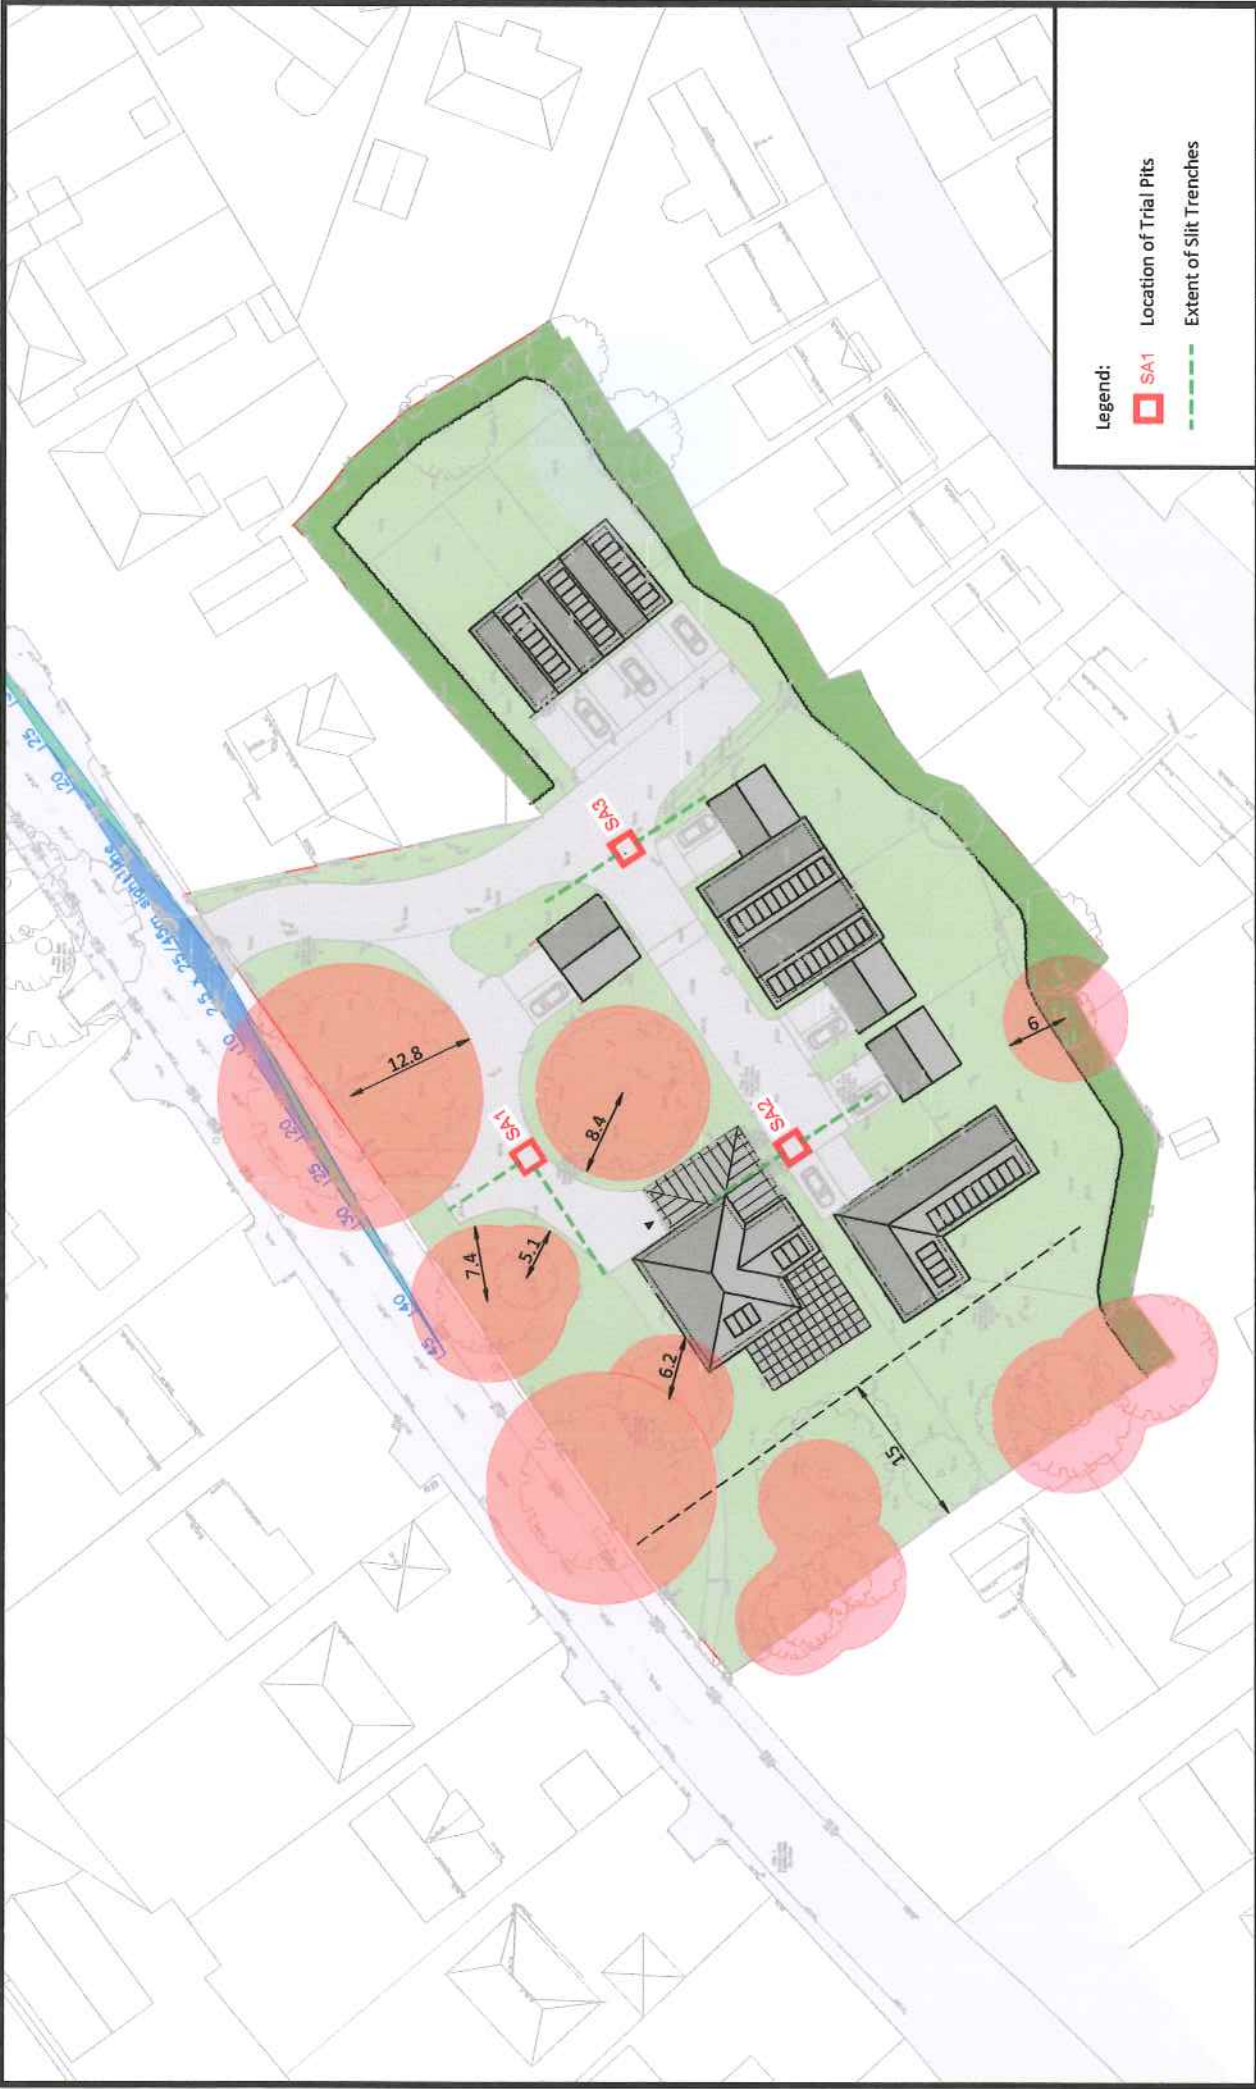
## **BRE 365 FIELD TEST LOCATIONS.**

Legend:  
SA1 Location of Trial Pits  
Extent of Silt Trenches

The plan appended to this report indicates the approximate position of the three trenches/trial holes constructed during the investigation. The excavation works, trenches, insitu testing and sampling were undertaken in October 2024 in fair weather conditions.

The location of the BRE 365 trial hole was determined by the Drainage Consultant [Messrs IMA of Bath] in the light of the site conditions, the positions of underground services, existing underground, and surface features and tree preservation orders. These were adjusted to avoid where possible disturbance in relation to access.
