## Preliminary Roost Assessment (PRA) and Dusk Emergence Survey

Glamorgan Services, Rockfield, Longford Road,  
Neath Abbey, SA10 7HQ

Survey conducted September 2025

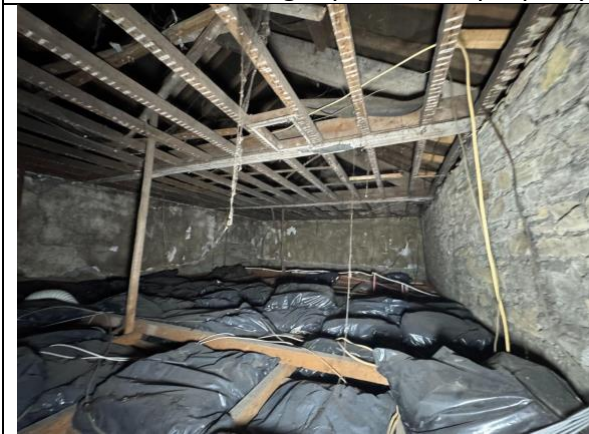
Internally, there is a large loft space lined with bitumen felt with exposed rafters and ceiling joists. The loft space is dark, draughty, and is not used. Due to safety concerns, the loft space could not be thoroughly inspected.

Large loft space

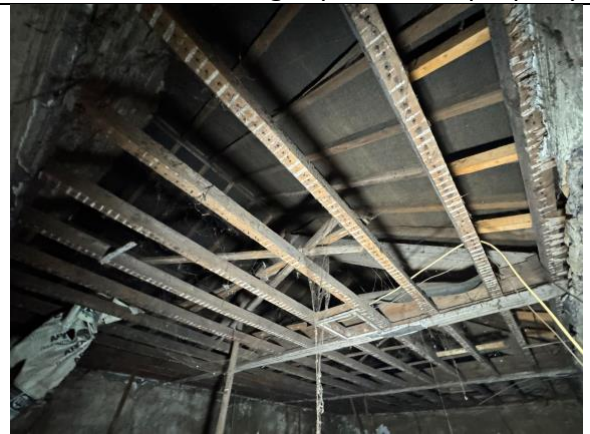
Bitumen felt lining

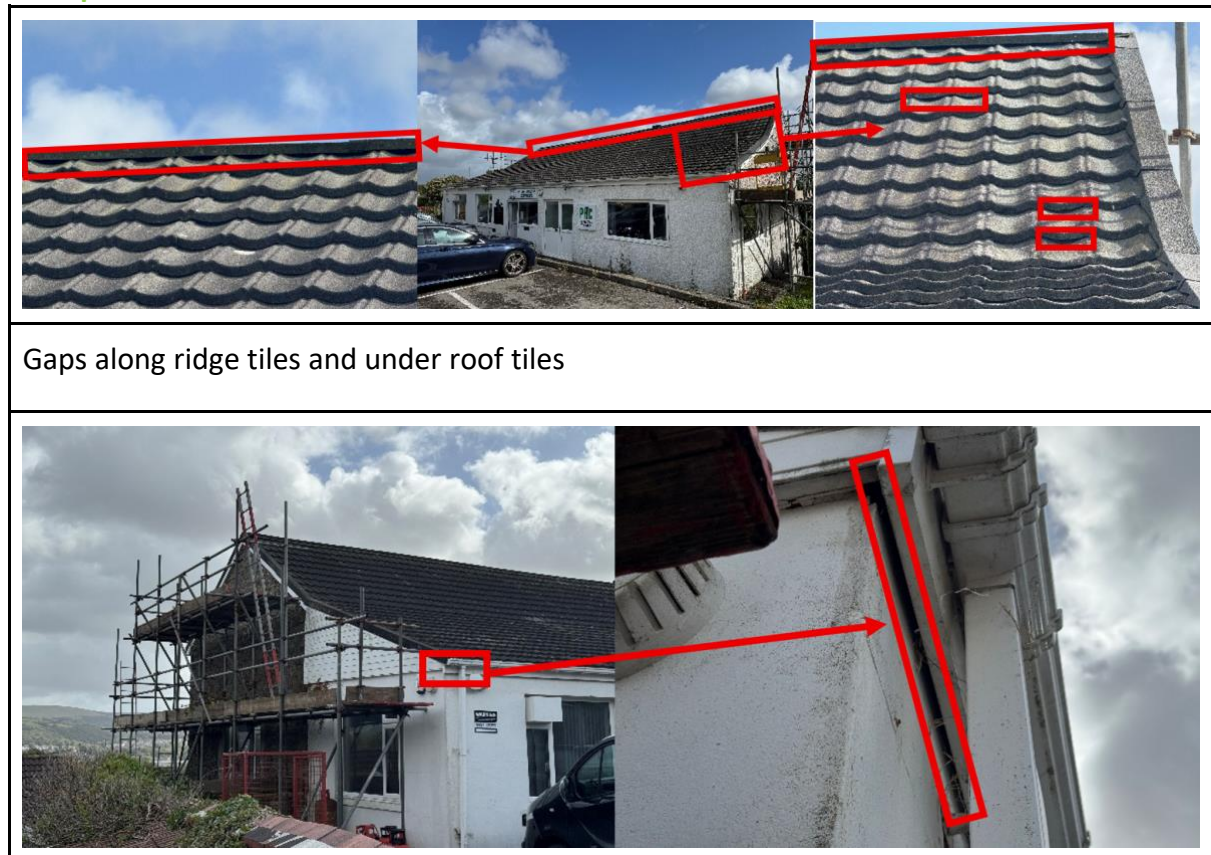
Identified potential bat access points included gaps under ridge tiles along the entire length of the roof, gaps under concrete roof tiles, and gaps under fascia boards.

Gaps along ridge tiles and under roof tiles

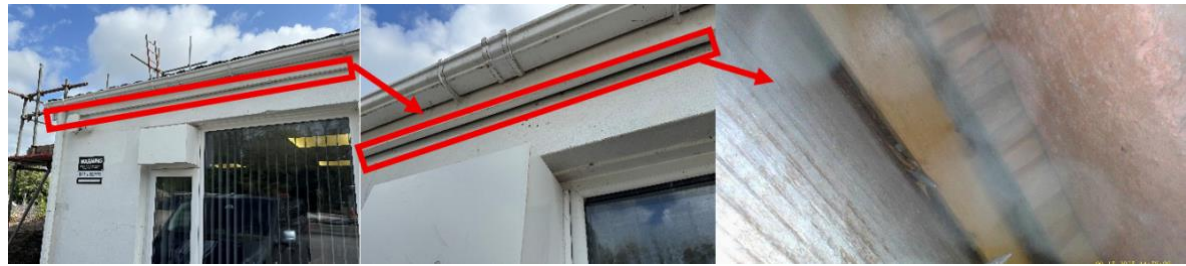
The gaps under the fascia boards on the front aspect of the property were endoscopically inspected. Inspection revealed relatively deep crevices that act as potential bat roosting areas. Crevices were relatively clean, with cobwebs appearing fresh. Other potential bat roosting areas included gaps under the felt flashing, the loft space, gaps in the stonework on the rear aspect of the property, and gaps between roof tiles and bitumen felt lining. A draught could be felt in the loft space.

Gaps under fascia boards

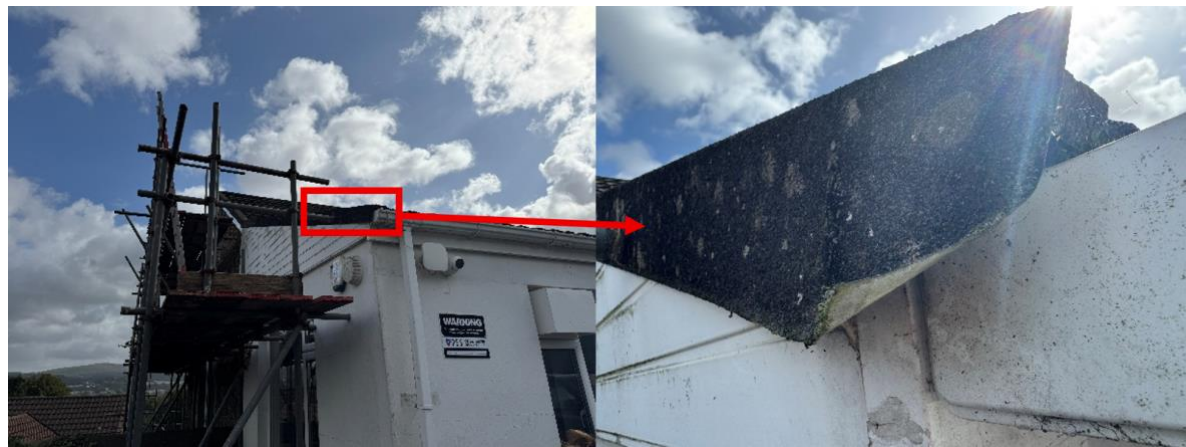
Lifted felt flashing

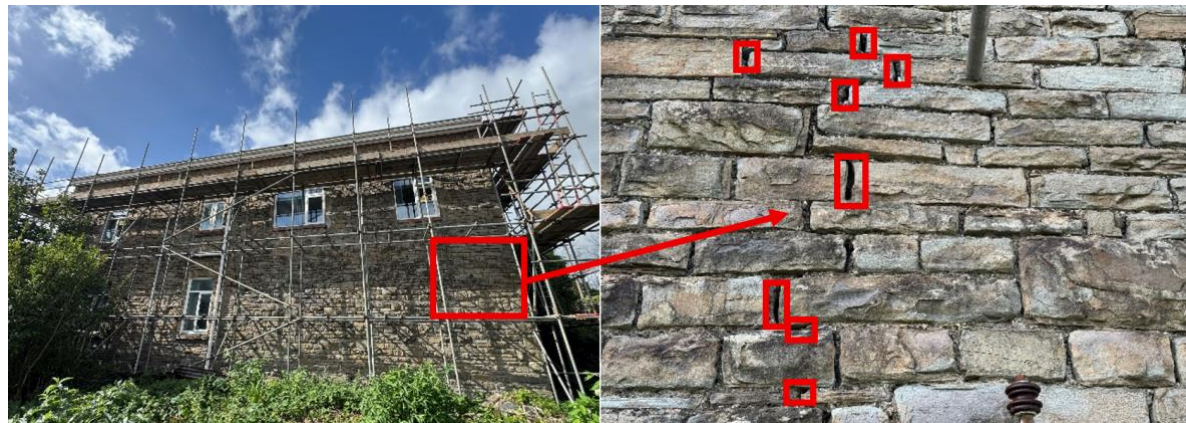
Gaps in stonework

The property was deemed to have hibernation potential in gaps in the stonewalls. However, it was not deemed practical to conduct surveys on this part of the building.

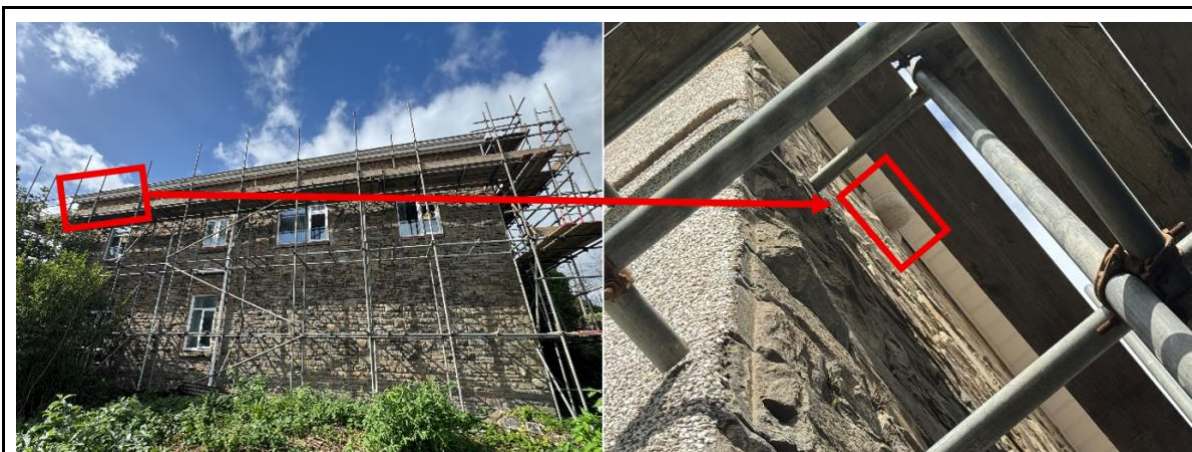
Bird droppings were found around the windowsill and on the wall below a crevice between the fascia and the wall on the front aspect of the building. Several artificial swallow cups are already installed on the rear aspect of the property, underneath the soffits.

Artificial swallow cups on rear of the building

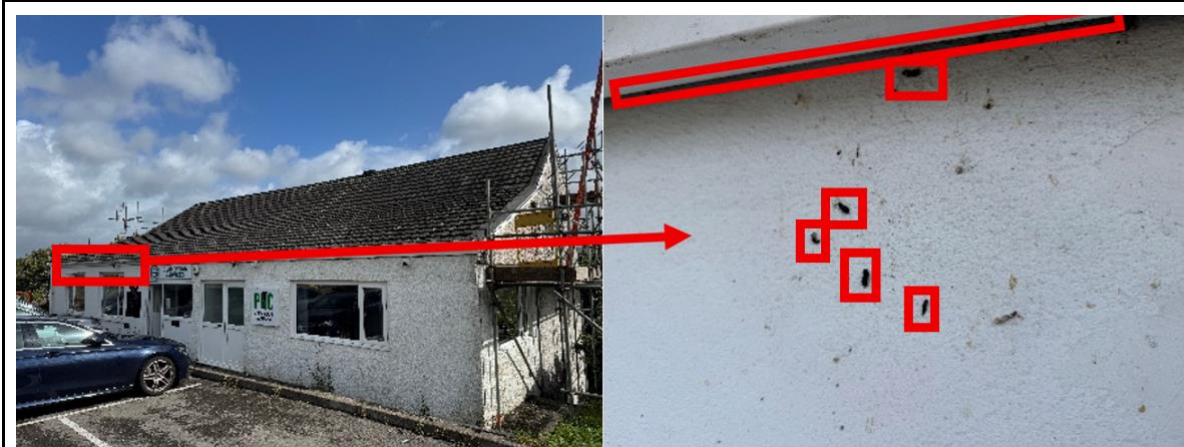
Example of bird droppings found on the front of the building
