# **Phase 2 Ground Investigation**

**Client: Lidl Great Britain Ltd**

**Briton Ferry Road, Neath**

**Report No: 769.02.04**

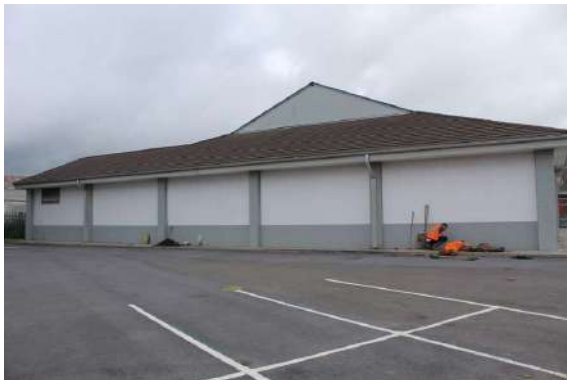
**Photo 1:** View northwards of the southern façade of the existing Lidl store building in July 2020.

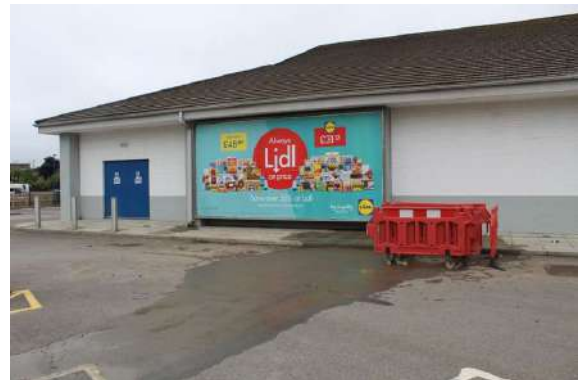
**Photo 2:** View westwards of the eastern façade of the existing Lidl store building in July 2020.

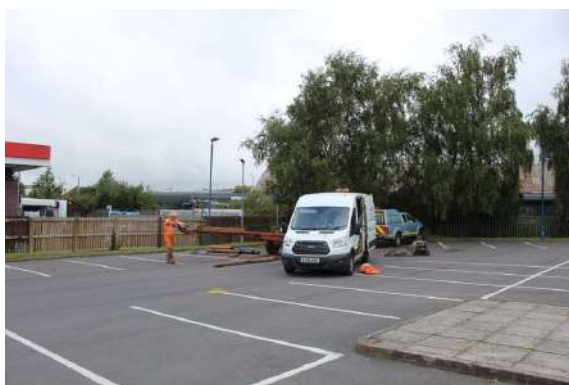
**Photo 3:** View south-westwards across the southern car park area in July 2020, with the off-site Esso Mile End fuel filling station beyond.

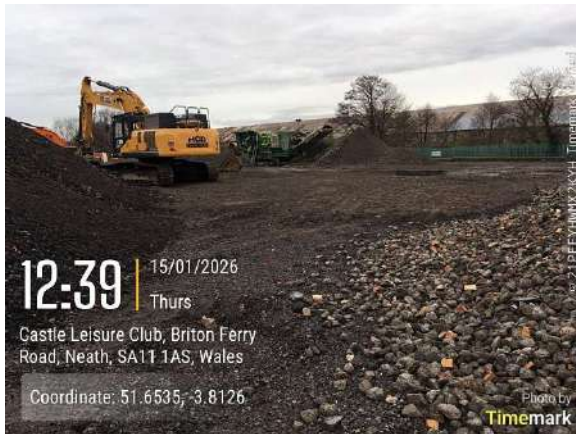
**Photo 4:** View south-westwards across the northern half of the site in the area of the proposed car park.

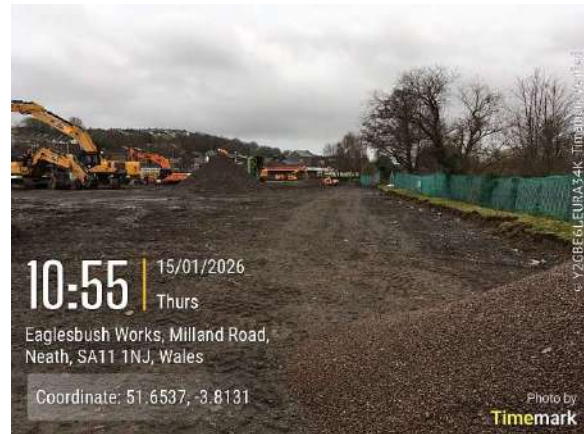
**Photo 5:** View approximately southwards along the eastern boundary, in the direction of the proposed new store.

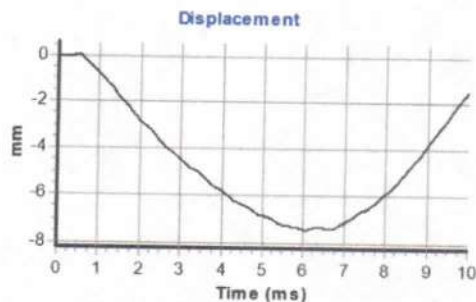
Client: Vincent Camron Drilling  
Location: JFTS Laboratory  
Hammer Type: Trip Hammer

Area of Rod  $A$  (mm<sup>2</sup>): 970  
Theoretical Energy  $E_{theor}$  (J): 473  
Measured Energy  $E_{meas}$  (J): 411
