## Appendix J

### Infiltration Testing

**COMPLIATION  
REPORT  
on  
INVESTIGATIVE WORK**

**1, HENFAES ROAD  
TONNA  
NEATH GLAMORGAN.**

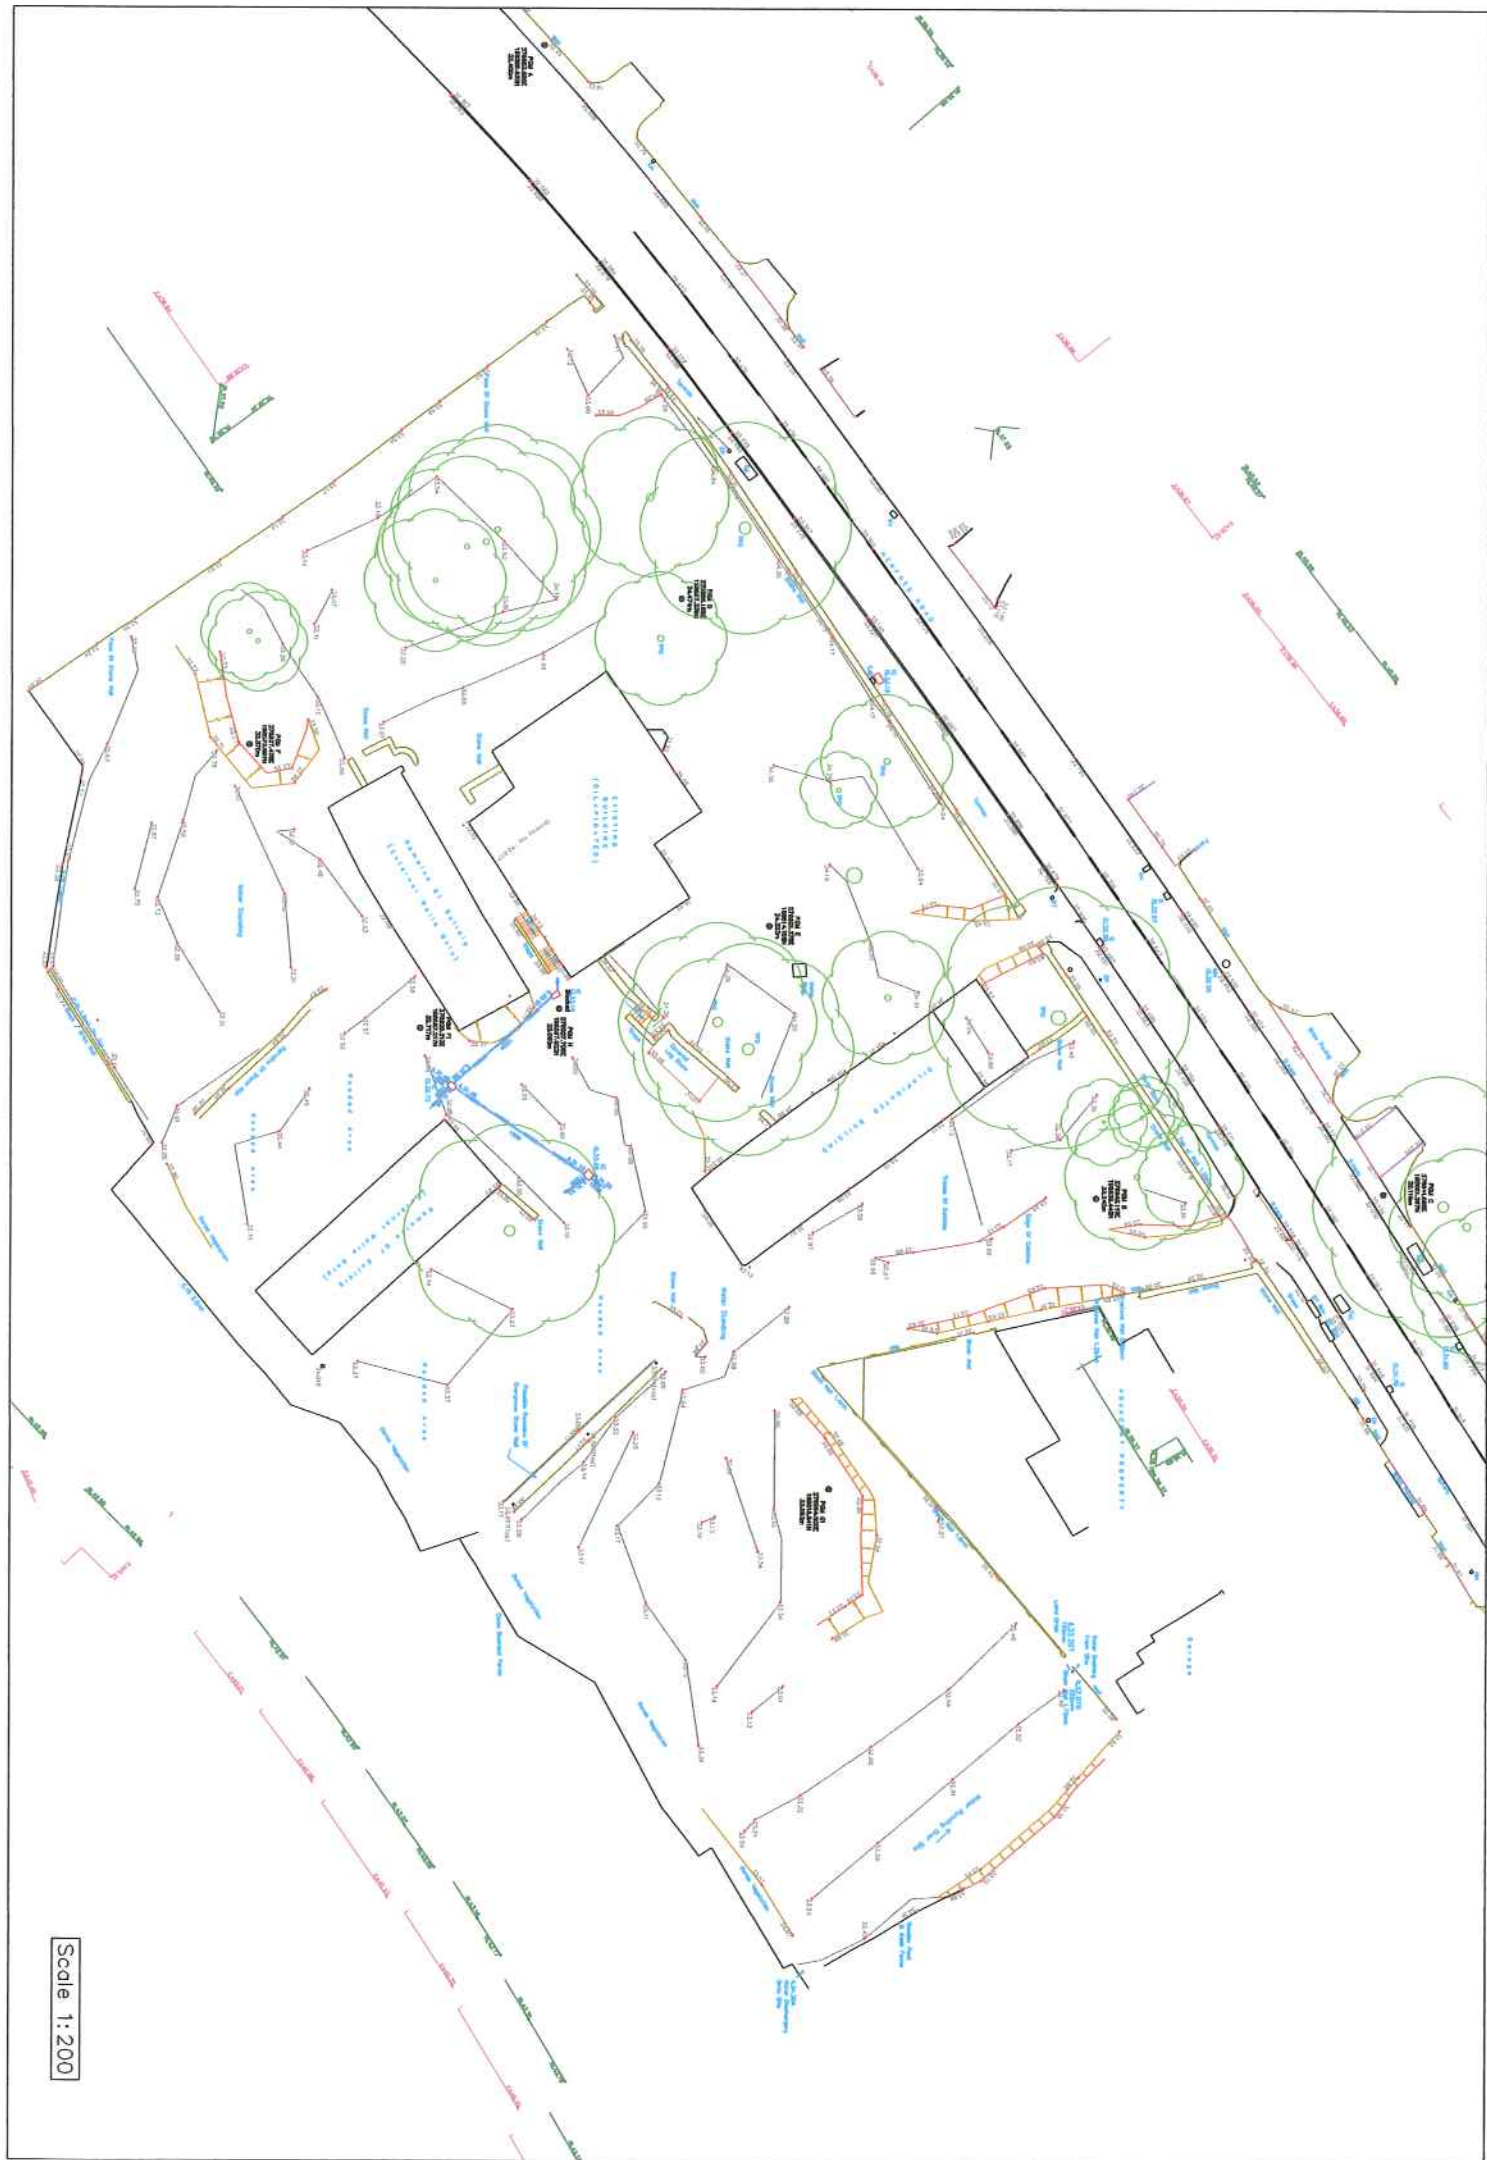
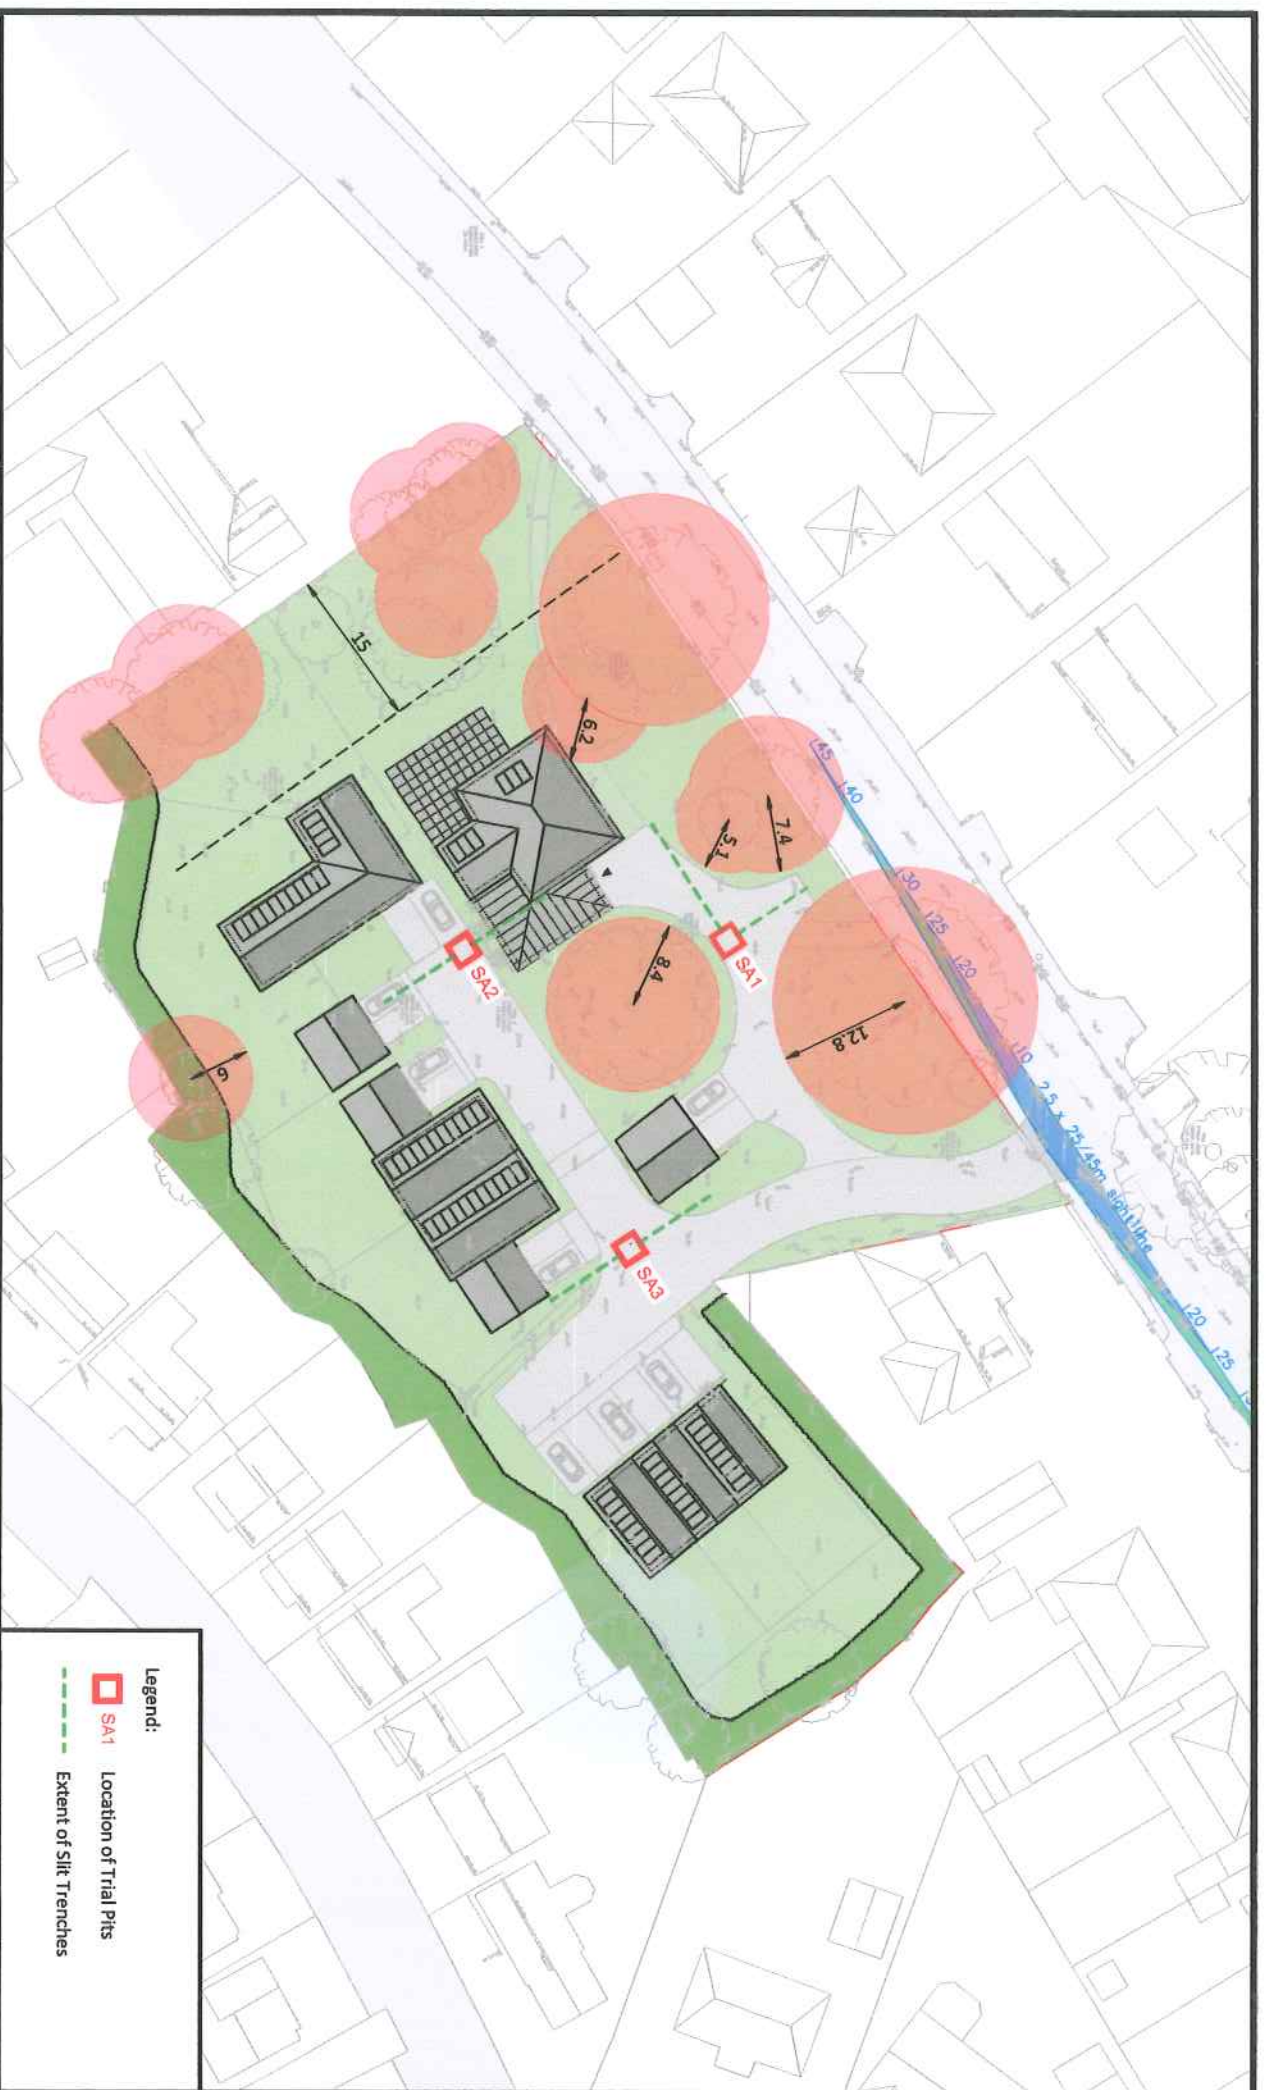
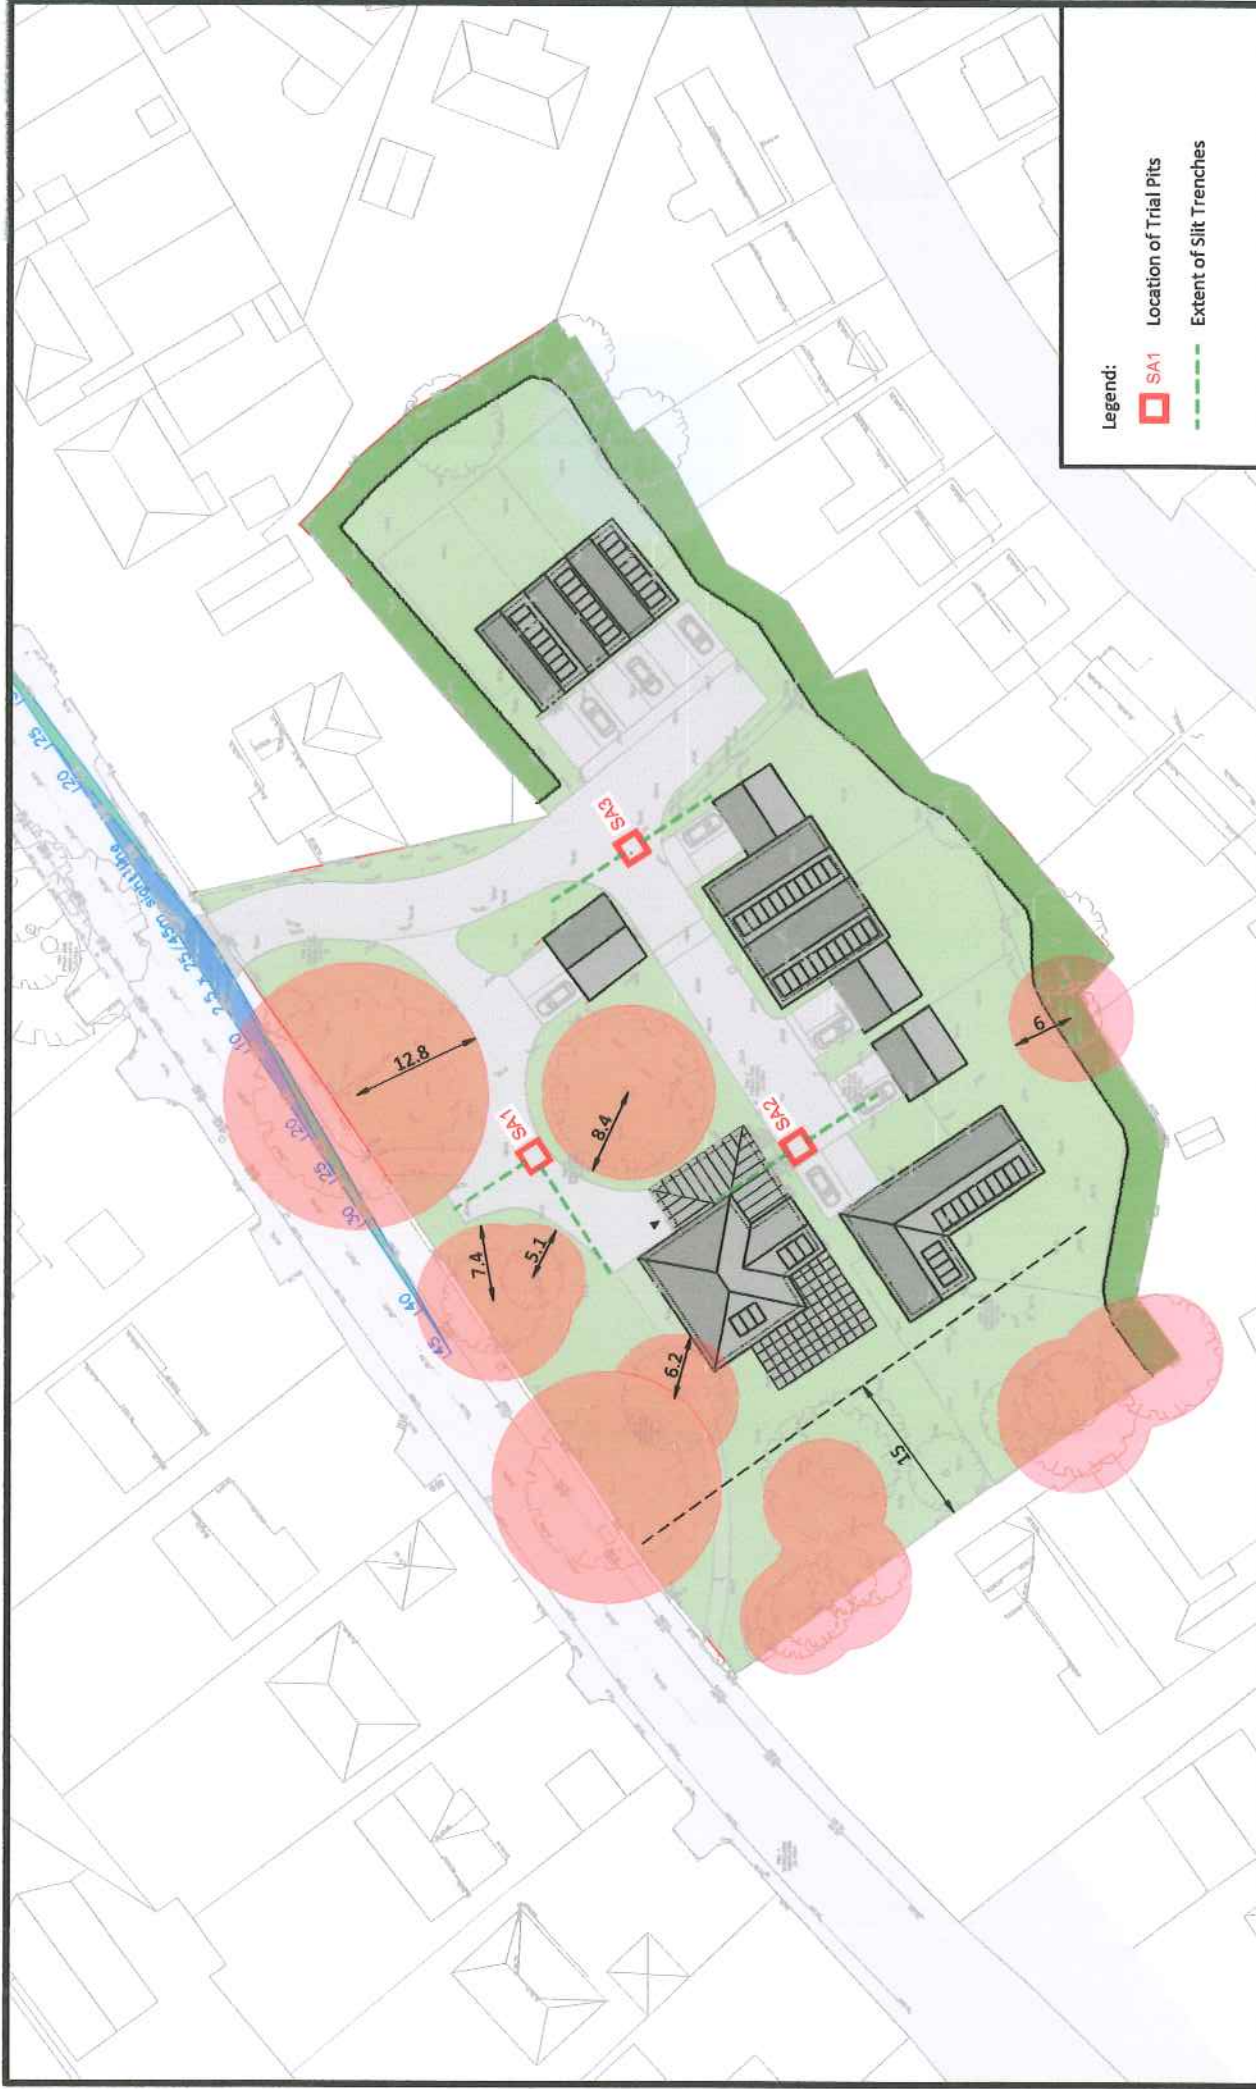
**SITE LOCATION/PLAN SURVEY.**

The plan appended to this report indicates the approximate position of the three trenches/trial holes constructed during the investigation. The excavation works, trenches, insitu testing and sampling were undertaken in October 2024 in fair weather conditions.

SA1 Location of Trial Pits
