YGG Tregelles

Bat Survey Report

Date: October 2025

Megan Price  
Ecologist (Planning &  
Consultancy)  
Countryside and Wildlife Team  
Neath Port Talbot CBC

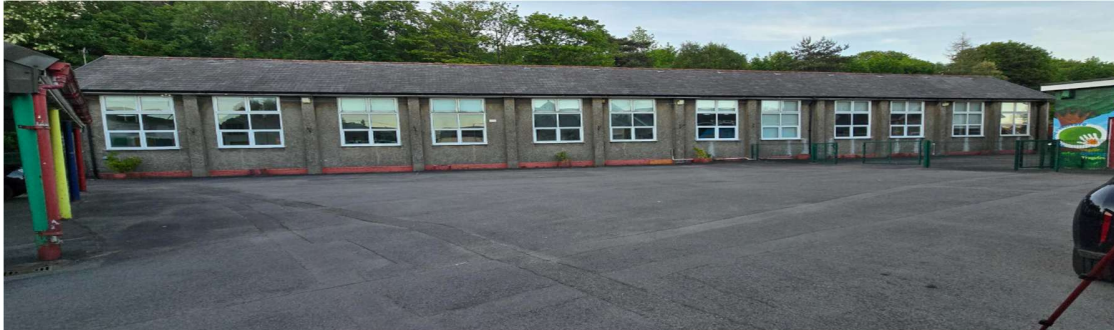
South elevation of the school showing slate roof

The building is an old teaching block with slate roof and rendered walls. It is one storey with tall internal ceilings with suspended ceilings.

Potential access points for roosting bats were observed during the preliminary roosting assessment: gaps were observed between the ridgetiles and roof, the soffits and fascias also had several gaps all the way around the building. Overall, the building was considered to be of Moderate/high potential to support roosting bats, given the features present.

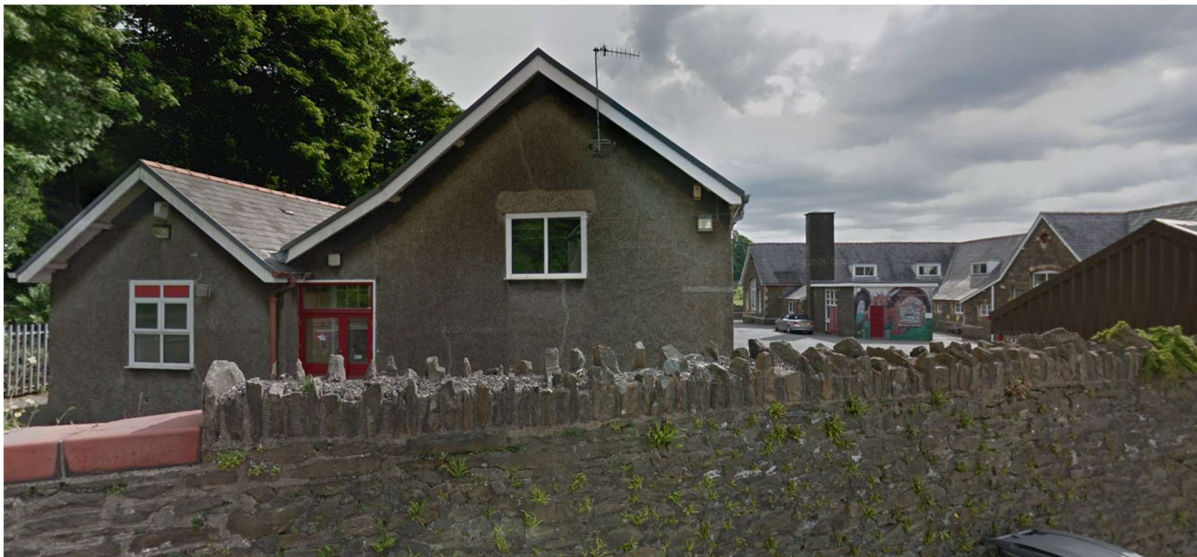
End of building facing east

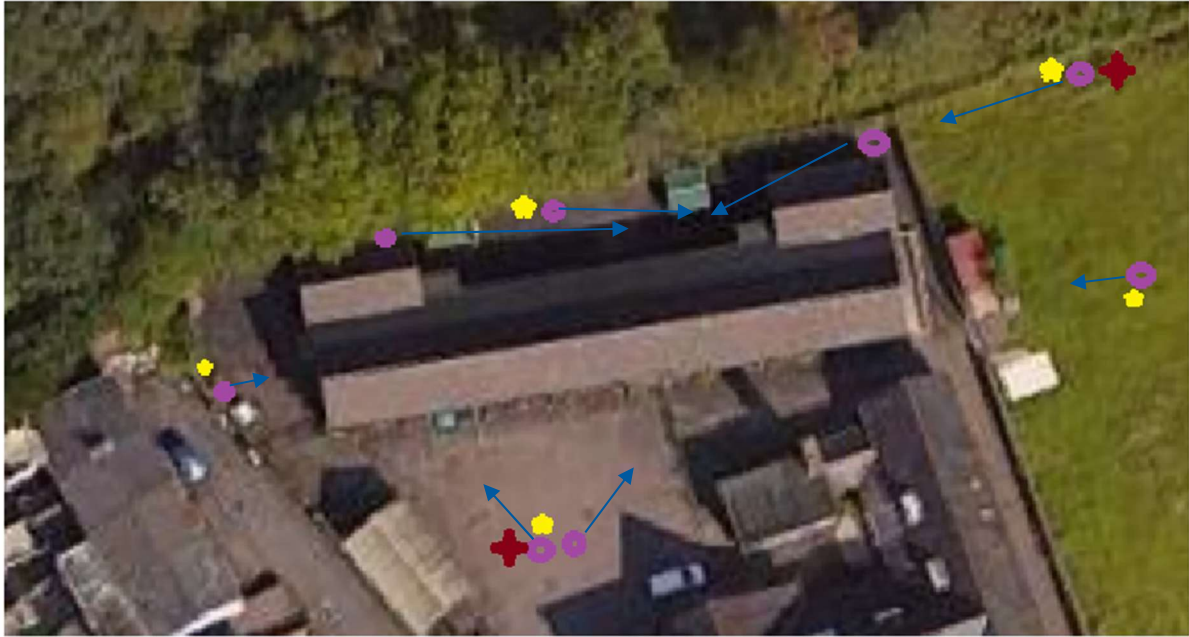
Figure 2 - Location of Thermal cameras and scout detectors

8 thermal cameras were deployed to cover the building elevations appropriately (including areas that were unable to be viewed by the surveyors), 4 scout bat detectors were used to record bat activity throughout the site.
