## Tier 1 Geoenvironmental & Geotechnical Report

Site: Pontrhydyfen RFC

**REPORT TITLE** : Tier 1 Geoenvironmental and Geotechnical Report: Proposed Commercial Development, Pontrhydyfen RFC, Port Talbot

**REPORT REFERENCE** : T1-250326-TF-25-583-CA-01

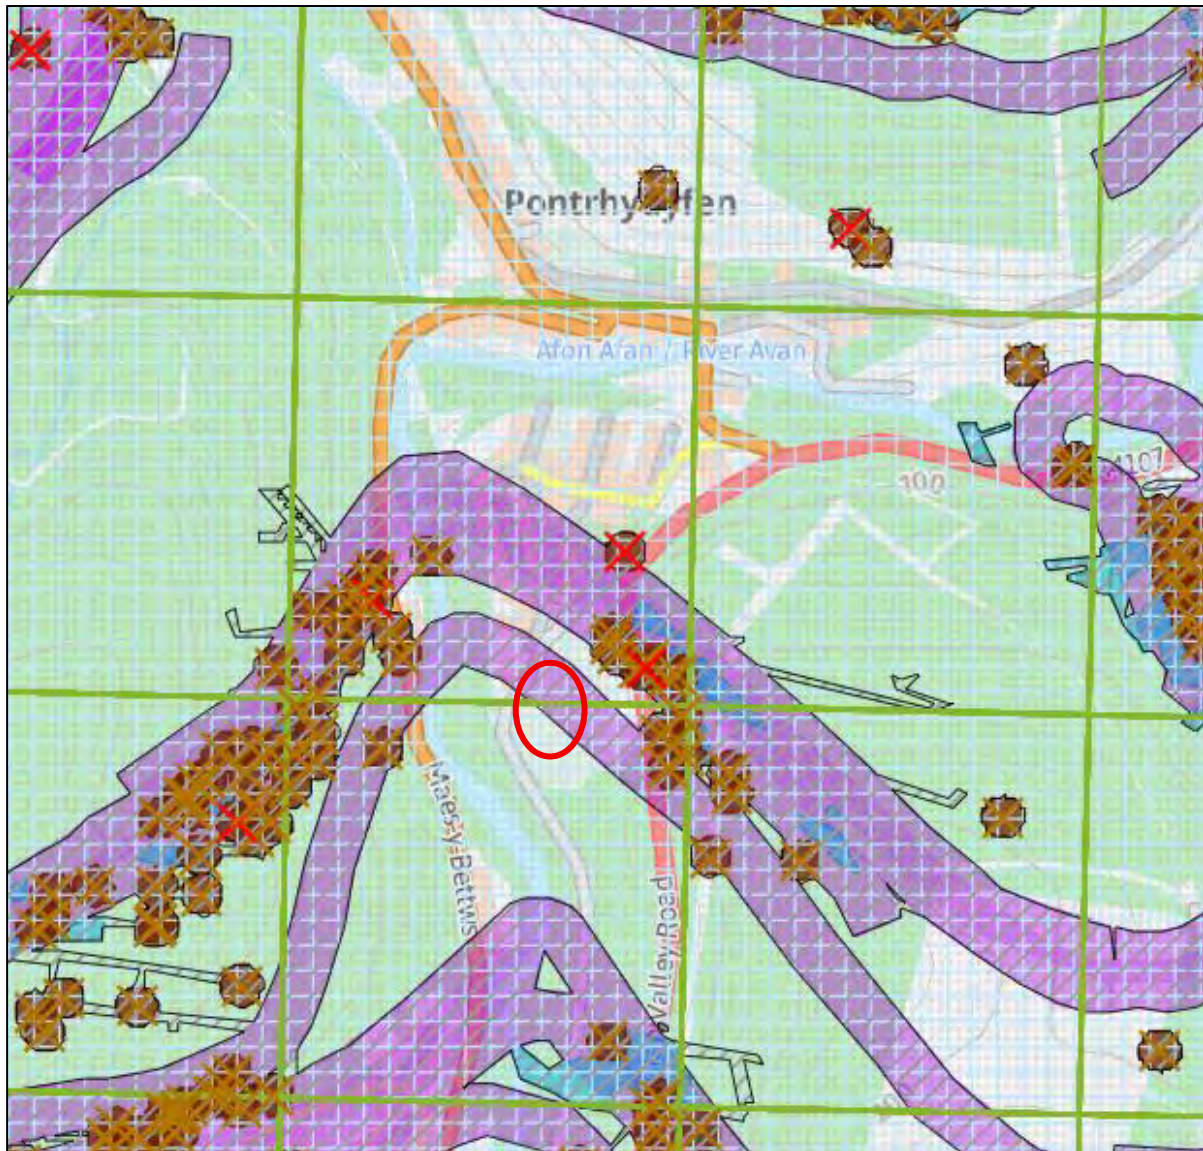
**Figure 2.3 Coal Authority Viewer Extract**

The Mining Remediation Authority online viewer indicates the site is located within a coal mining reporting area, within a development high risk area.

The map below, taken from the Coal Authority shows the site (represented by a red circle). The area around the site shows mine entries, (shafts or adits) and coal outcrops within an appreciable distance from the site.

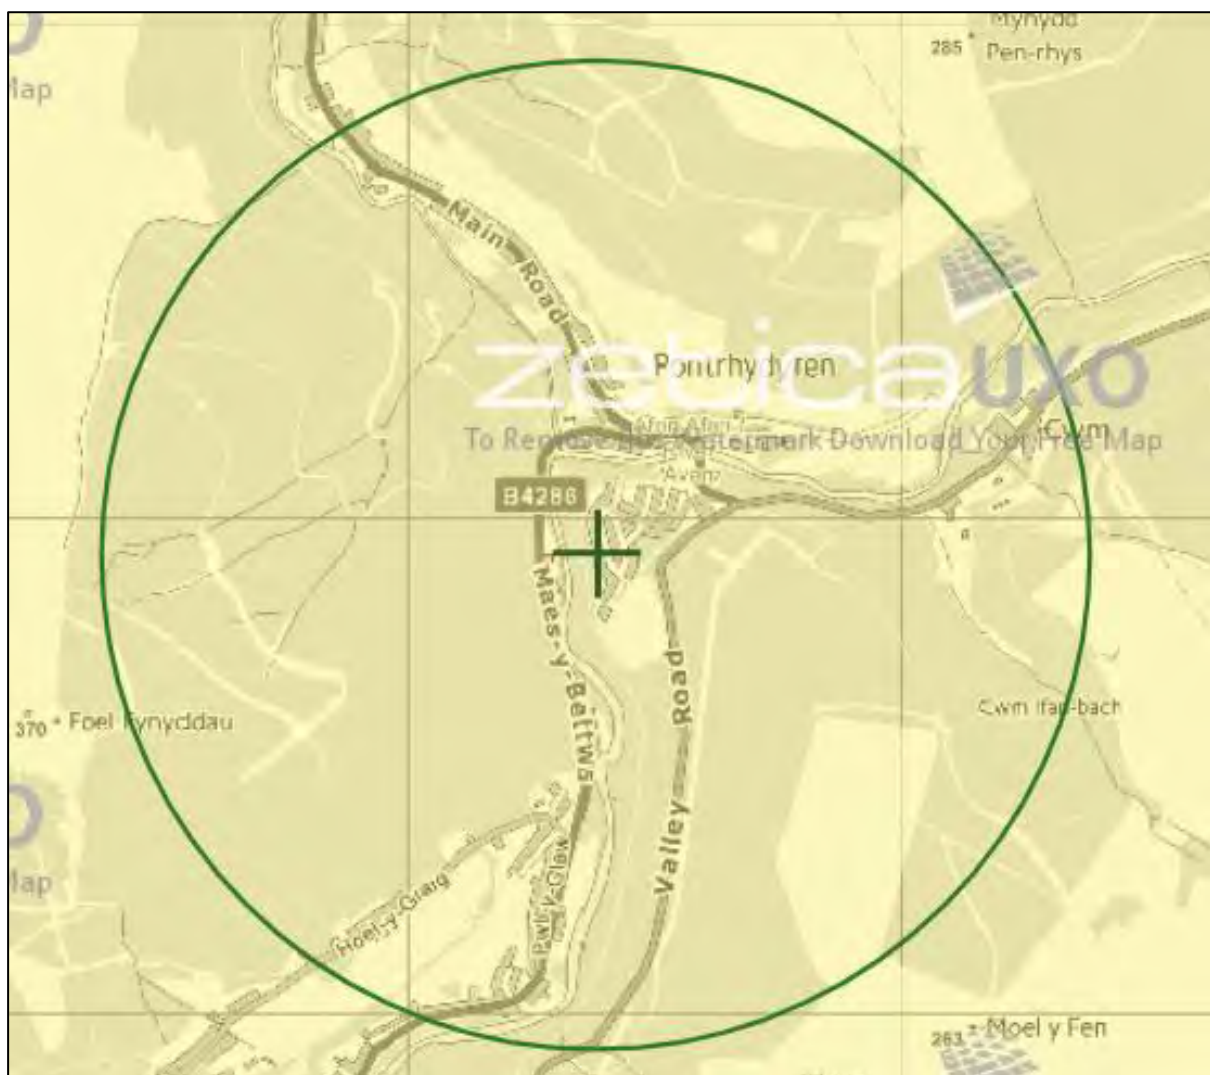
**Figure 2.5 Zetica UXO risk map.**

Based on the historical setting of the site and Zetica UXO Risk Maps, little or no military activity has been recorded within the area. Therefore, the risk from Unexploded Ordnance is considered to be low.

An extract of the Zetica UXO map can be found in **Figure 2.5**.
