*Report No. BC/MB/10.17.03/2.*

# **Stage 1 Site Investigation Report on Land at the Former Tirbach Washery, Ystalyfera.**

**HANSAK Ltd.**

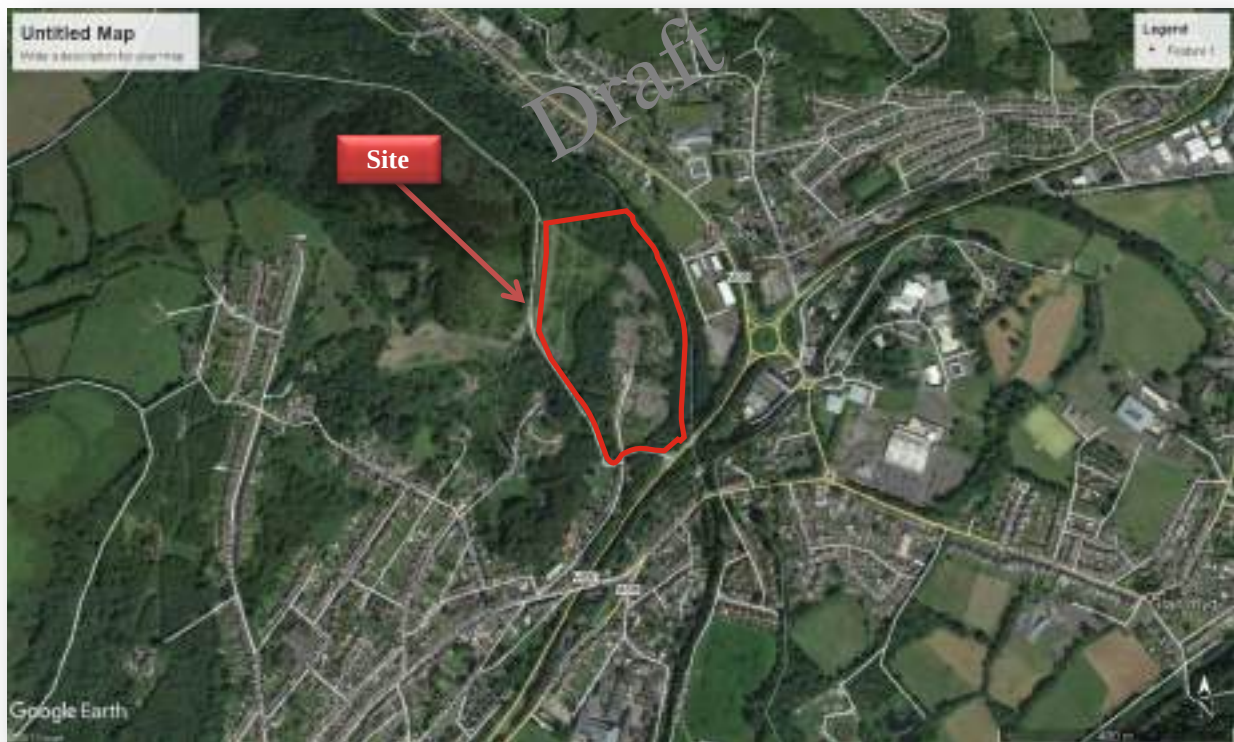
**Figure 1**  
**Aerial View of Site**

along the south-eastern corner of the Site and the Afon Twrch forms the eastern boundary. A partially concreted track forms the western boundary, beyond which is a forested area. The Site generally slopes south-eastwards at various gradients that reflect the former uses of the Site as a colliery and as a washery. Slopes on the Site are largely man-made and there are several remains of buildings and foundations on the Site. The Site rises steeply along its western boundary above a public footpath and there are two distinct plateaux towards the northern end; the steeper part of the Site will not be developed for housing but are included in this assessment for completeness. The Site occupies an area of approximately 9.56 hectares, of which approximately 6.21 ha south of the footpath are planned to be developed for housing. Elevations on the Site vary from approximately 80m aod to approximately 130m aod.

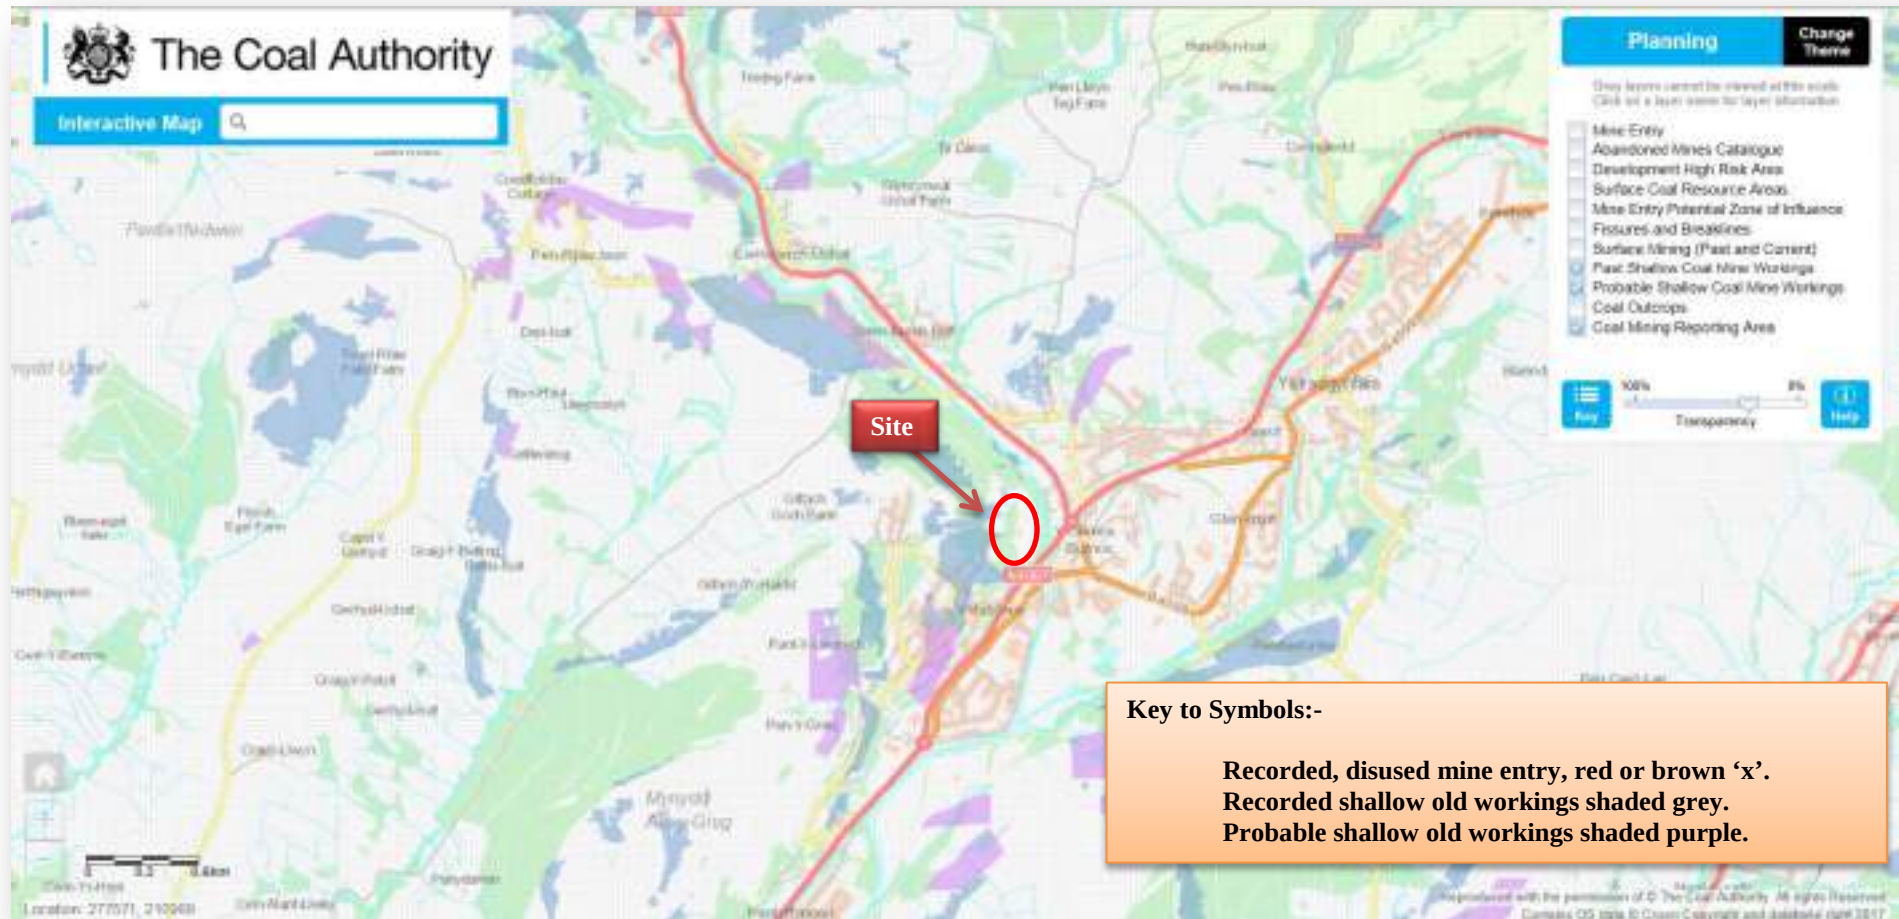
**Figure 3**  
**Mining Risk: The Coal Authority's Interactive Map**  
*(Interrogated 16<sup>th</sup> November 2017)*

The review of mining records at Section 5, above, identified that shallow old workings at the western end of the Site are beyond the Palleg Fault and do not encroach onto the Site. Otherwise there are no recorded or ‘probable’ shallow mine workings underlying the Site (see Figures 3 and 4).

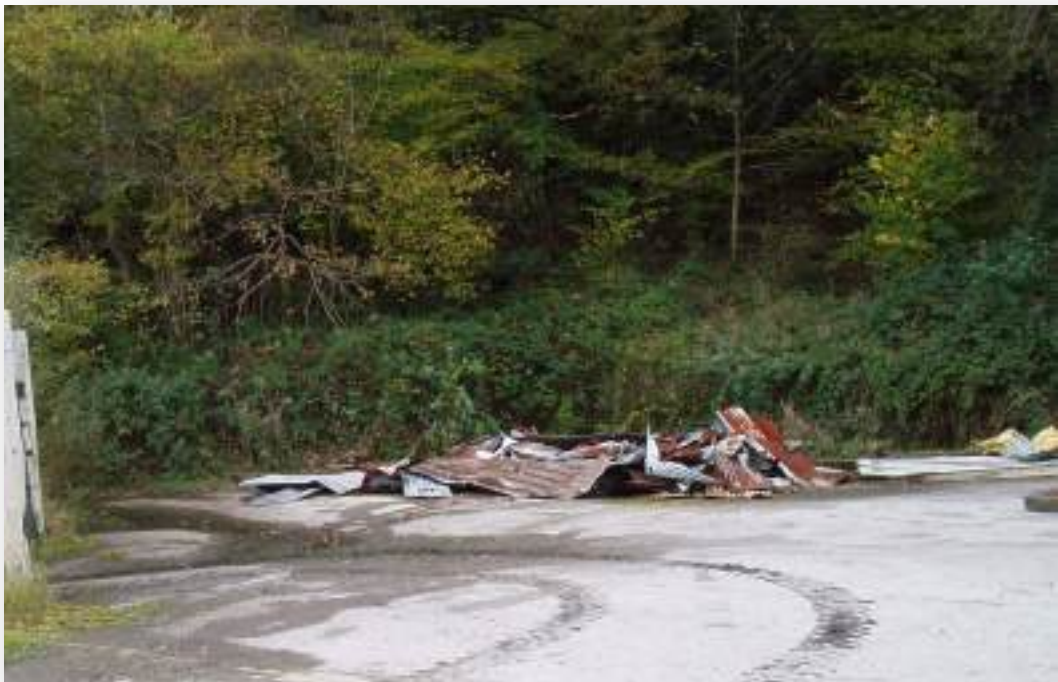
**Figure 5**  
**Steep Wooded Slope Around Location of Adit 277209-003**

Adit 277209-003 lies a short distance beyond the western boundary of the proposed development area on land that is at a slightly higher elevation and heavily wooded (see Figure 5). Underground roadways extending from the adit would be westwards into the steep slope. A collapse of this adit or a roadway associated with it would not affect the proposed development area.

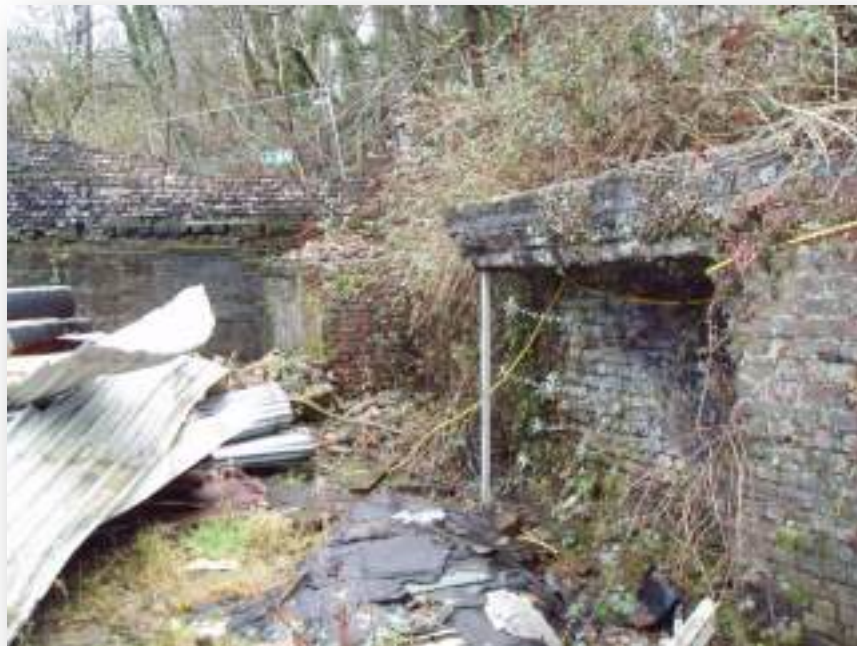
**Figure 6**  
**Brick Ventilation Tunnel Adjacent to Adit 277209-057**

Records held by The Coal Authority hold no information on what measures, if any, have been carried out to seal up the mouth of adit 277209-002, the former Tirbach Colliery Intake. Records show that a hole in the brick portal of this adit was made good to secure the mine entry; the date of the work is not stated. The same description of repairs to the brick portal is attached to adit 277209-057. We have spoken with the son of the person who occupied the land when the repairs to the blockwork were undertaken after the occupier notified The Coal Authority of the defect. The son recalls the repairs being carried out. The repairs were carried out on the side of the brick ventilation tunnel that runs from the Return Adit (277209-058) to the fan house located immediately adjacent to adit 277209-058 and not on adits 277209-002 and 277209-057 as stated in The Coal Authority's records.

It is recommended that the remaining brick tunnels are demolished back to the point where they pass into the hillside and there safely stopped up. The mouth of adit 227209-057 should be excavated and uncovered and safely stopped up. There are no longer any physical remains of adit 227209-060 evident on the Site or of the greater part of the length of the tunnel that ran from it to adit 227209-057. The area around the location of adit 227209-060 should be excavated to confirm that the adit has been removed. Any mining feature that might be found to be present must be made safe.

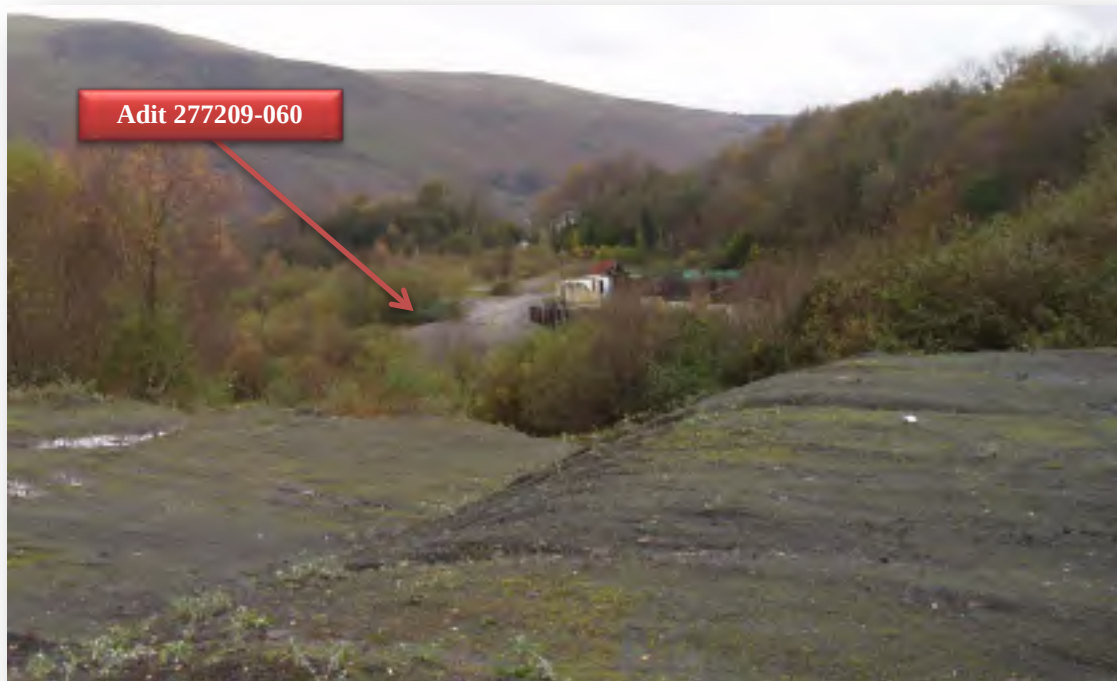
**Figure 9**  
**Steep Vegetated Slope at Location of Adit 277209-060**

The position of adit 277209-060 has been identified on site at the side of a steep, heavily vegetated slope (see Figure 9). There is no evidence at the location of the adit itself. However, it is known that at various times since Tirbach Colliery closed the land at that location has been the subject of both demolition and construction work and the land immediately above the slope is now concrete surfaced.

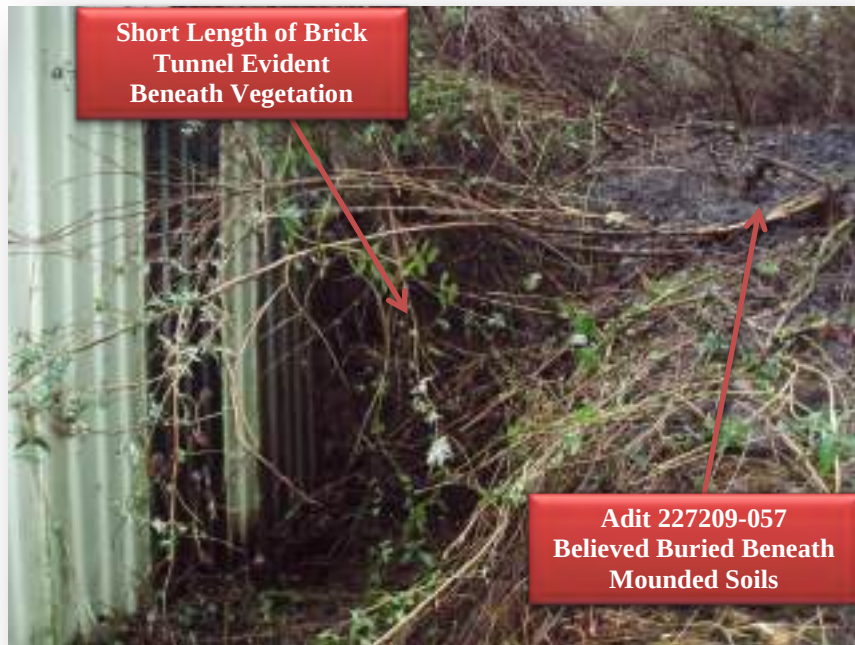
**Figure 10**  
**Convergence of Brick Tunnel from Adit 277209-060**  
**with Adit 277209-057**

The location of Adit 227209-057 appears to be beneath the mounded soils shown in Figure 10. This location is where the tunnel extending from adit 227209-060 is shown on abandonment plans to intersect adit 227009-057 (see *Extract from Tirbach Colliery, Lower Vein, Abandonment Plan, drawing no. BC/MB/10.17.03.19*). There is now no tunnel on the surface running from adit 227009-057 to adit 227009-002 and no evidence of the latter adit.

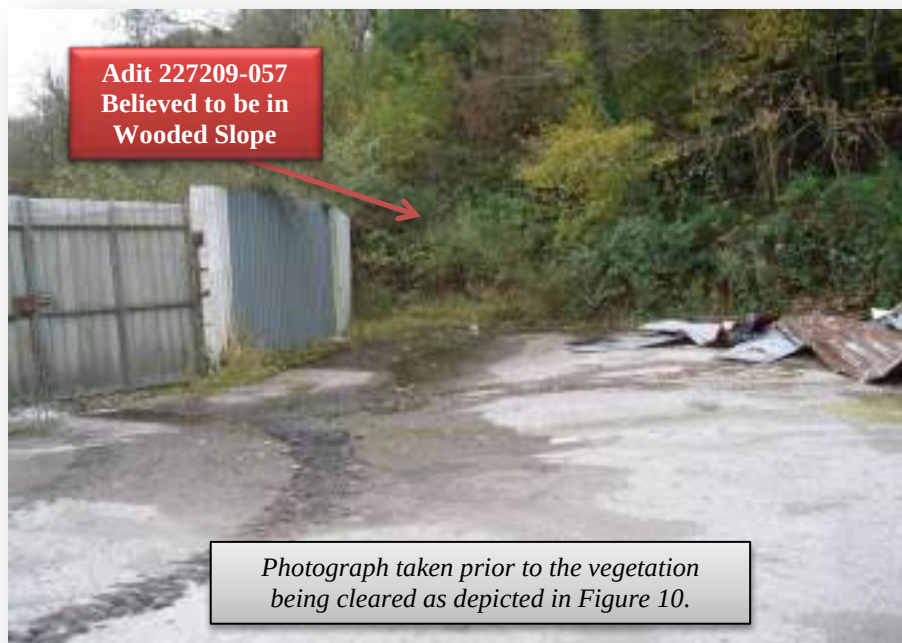
**Figure 11**  
**The Location of Adit 277209-002**

The abandonment plans show a roadway extending westwards from adit 227209-002 where it would be evident in Figure 11. The abandonment plans show no adit at the position of adit 227009-057. The most reasonable interpretation is that a brick tunnel similar to others on the site previously ran on the surface from the location of adit 227009-002 to the point where it entered the hillside, which is at the position of adit 227009-057. The brick tunnel, including its mouth at adit 227009-002 has been demolished back to the hillside at adit 227009-057 and removed.

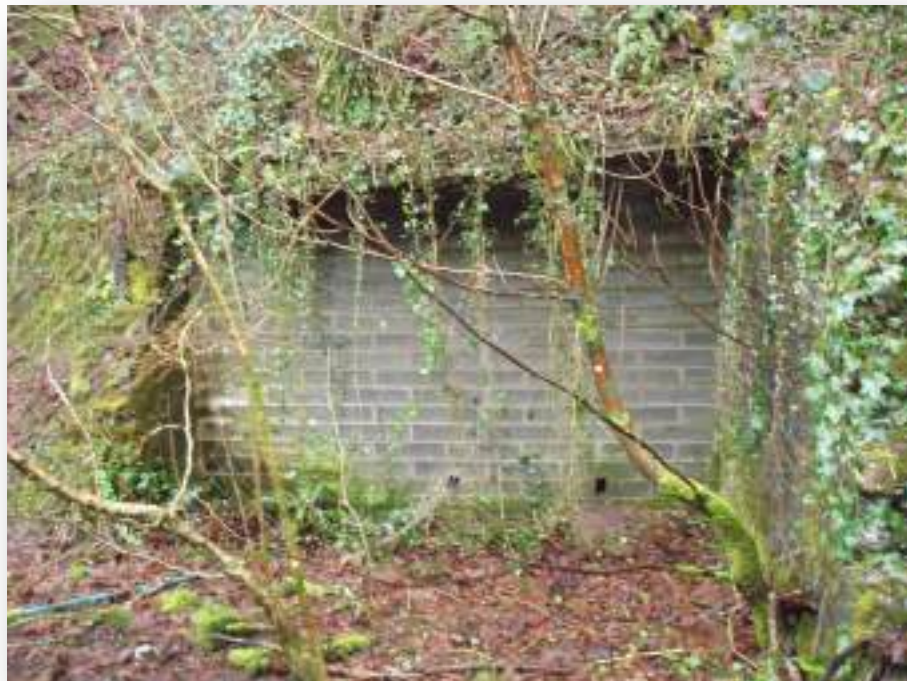
**Figure 12**  
**The Blocked Up Entrance of Adit 277209-058**

Records held by The Coal Authority show that the Tirbach Colliery Return Adit, adit 227209-058, was sealed to an unknown specification approximately 5 metres inbye of the entrance. In 2001 the adit portal was secured with blockwork by Wardell Armstrong acting on behalf of the Coal Authority (see Figure 12).

A collapse of the underground tunnel extending from adit 227209-057 where it passes into the hillside would not affect the proposed development area. The precise location and condition of adit 227209-058 is uncertain but will become evident when the recommendation to excavate it out is carried out. The subsequent scheme of work to securely stop up the adit must also take into account any risk of a collapse of the first 35m or so of the adit inbye of its mouth that may be identified.

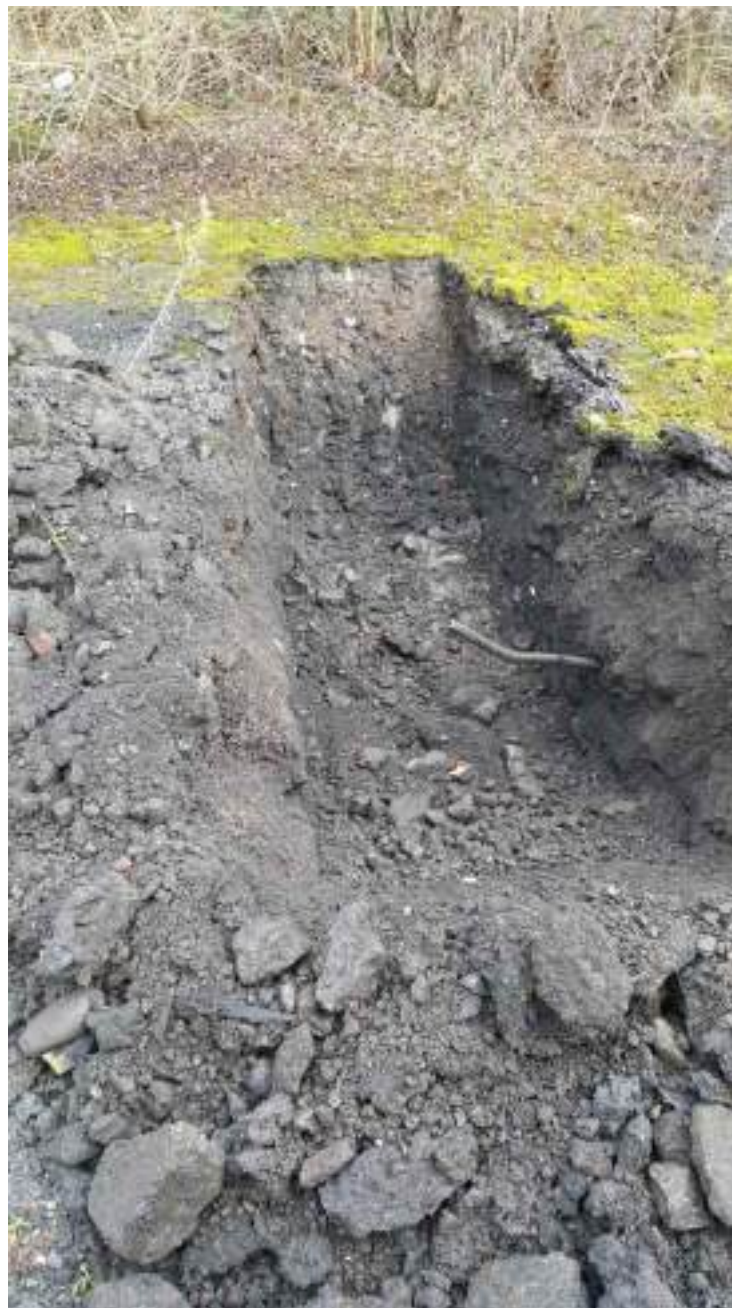
## Photographic Plate: Trial Pit 3

The Tier 1 (Desk Study) Risk Assessment identified several sources of potential contamination that might have been present on the Site, all of which were associated with the use of the Site as a colliery surface/coal washery/brickworks/tin-plate works: these included features such as rail/tram lines and colliery spoil. The material found within the trial pits is consistent with the former uses of the Site. Groundwater was encountered in Trial Pit 3 at 1.7m depth and in Boreholes 2, 3 and 4.
