## Tier 2 Geotechnical and Geoenvironmental Report

Site: Unit D, North Bank Road, Port  
Talbot, SA13 1RE

Job No: 18045

**REPORT TITLE** : **Geoenvironmental and Geotechnical Report:  
Proposed MOT Centre, Unit D, North Bank  
Road, Port Talbot, SA13 1RE**

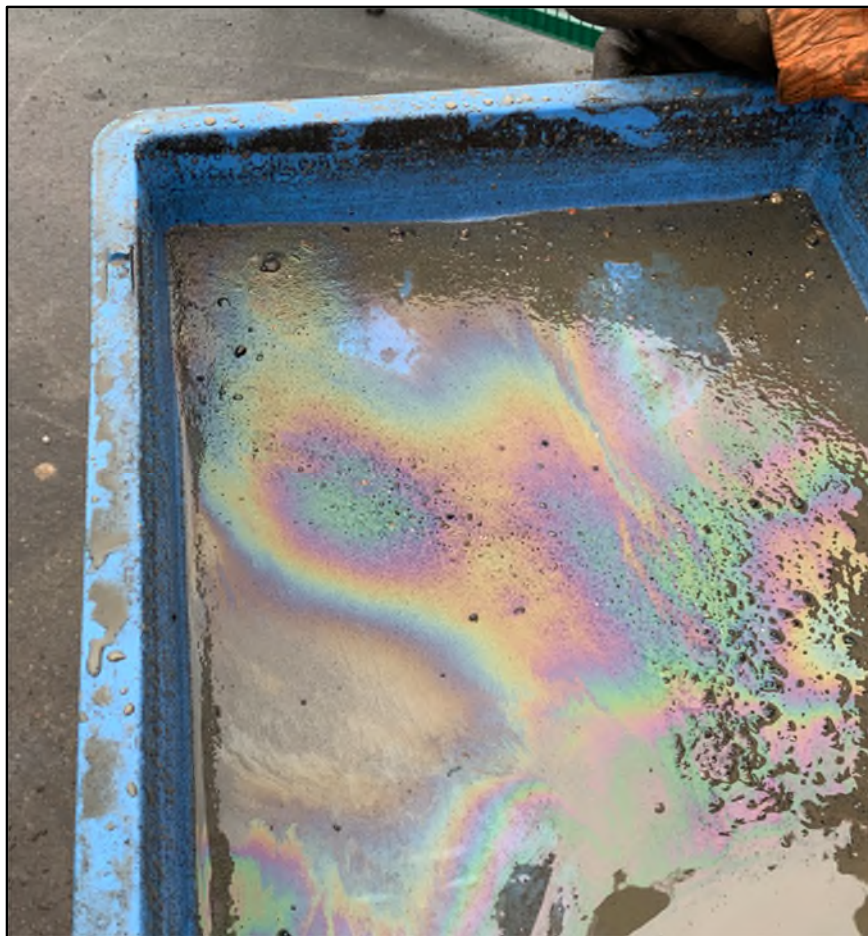
| Location | Depth (m) | Details |
|---|---|---|
| BH03 | 2.70 | Strong smell and visible evidence of hydrocarbons during drilling. Drilling stopped due to risk to health and environment. |

As drilling progressed, groundwater contaminated with hydrocarbons was encountered and expelled at the surface, identified both visually and by odour. This is illustrated in **Table 3.1** below, where thin-film interference produces a distinct rainbow pattern. The contamination present was first identified at a depth of 8.0m.

**Figure 3.1** Groundwater collected from BH03 during drilling showing thin-film interference due to the presence of hydrocarbons.

Due to the presence of significant hydrocarbon contamination encountered in the groundwater during the drilling, it is recommended that an assessment of the risk to the aquatic environment is carried out. Following an initial generic assessment, it is expected that a detailed quantitative risk assessment will be required.

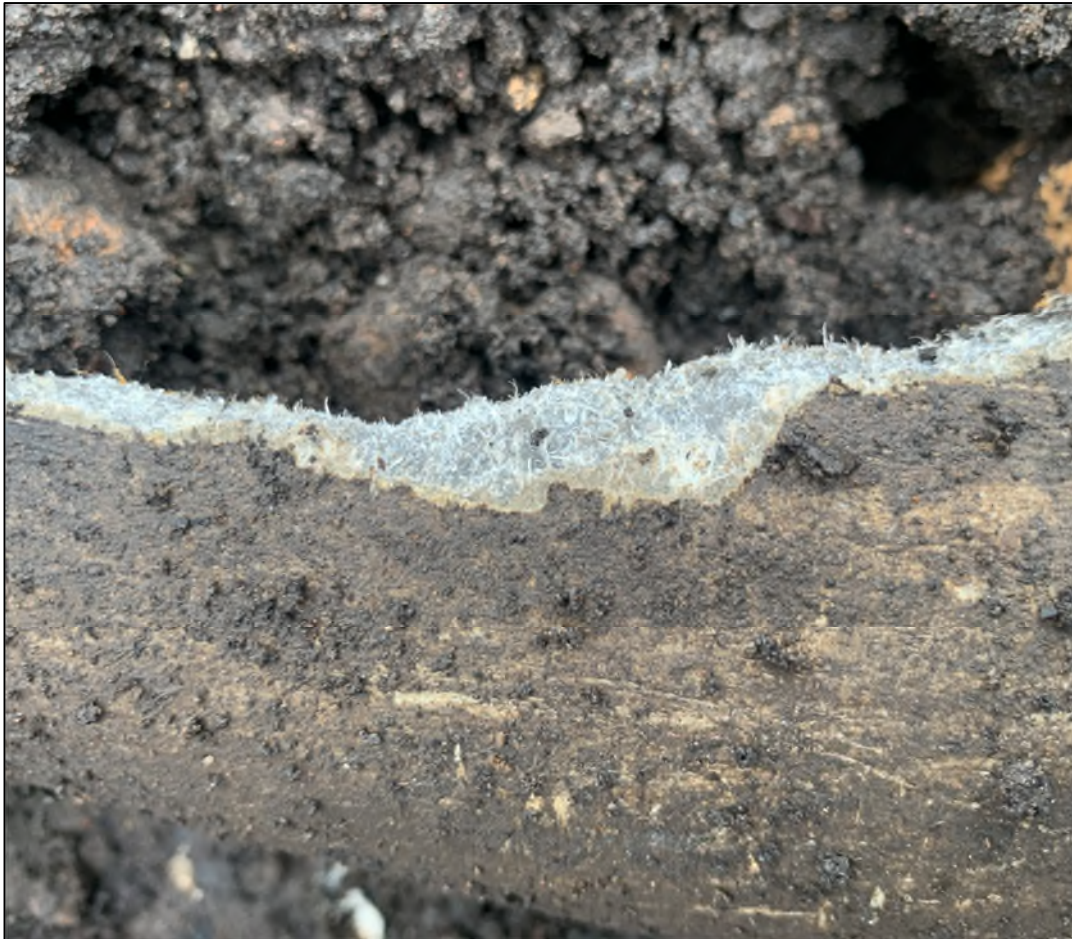
All soil samples were scheduled for asbestos screening. Asbestos was not detected although the likely presence of asbestos was observed in TP03 at 0.4m in the form of possible asbestos pipe. **Figure 4.1** shows the segment of asbestos pipe

Figure 4.1 Segment of asbestos pipe located at a depth of 0.4m in TP03.

| | Due to the presence of made ground and building rubble encountered beneath the site further chemical samples should be taken and frequent asbestos samples across the site. | | | | |
