## Margam Country Park Gatehouse

### Bat Report

June 2026

EC2023 022

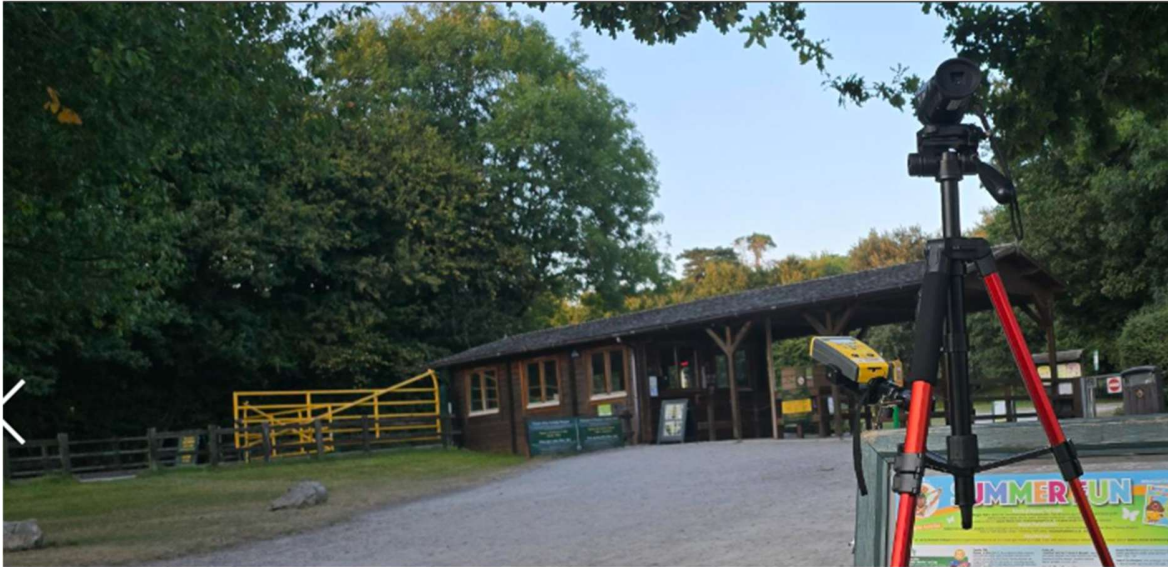
Figure 2 - Photo showing gatehouse

The building was assessed as having moderate suitability for roosting bats, based on the presence of several features providing potential roosting opportunities. In particular, the cedar shingle roof covering presents areas of overlap and potential lifting, which can create narrow crevices suitable for use by crevice-dwelling bat species. Additional features of note include gaps associated with the roofline and junctions between materials, which may provide access points into sheltered voids or cavities. Whilst the structure is relatively small and lacks a substantial roof void, these features, in combination with the building's location within high-quality parkland habitat with adjacent woodland and water, increase its potential to support opportunistic or transient bat roosting.

- A pre-commencement check of the building should be undertaken by a suitably qualified ecologist if works are delayed beyond two years from the survey date or if the building condition changes
- All works affecting the roof, including the removal of cedar shingles and roofline features, should be undertaken using a sensitive, supervised approach, with materials removed carefully by hand where practicable
