Client:  
**KNOX & WELLS**

Project:  
**YGG TREGES**

Drawing Title:  
**EXISTING DRAINAGE  
CONDITION - CCTV SURVEY**

Drawing No.  
**CC2970 CAM XX XX DR C 0030**

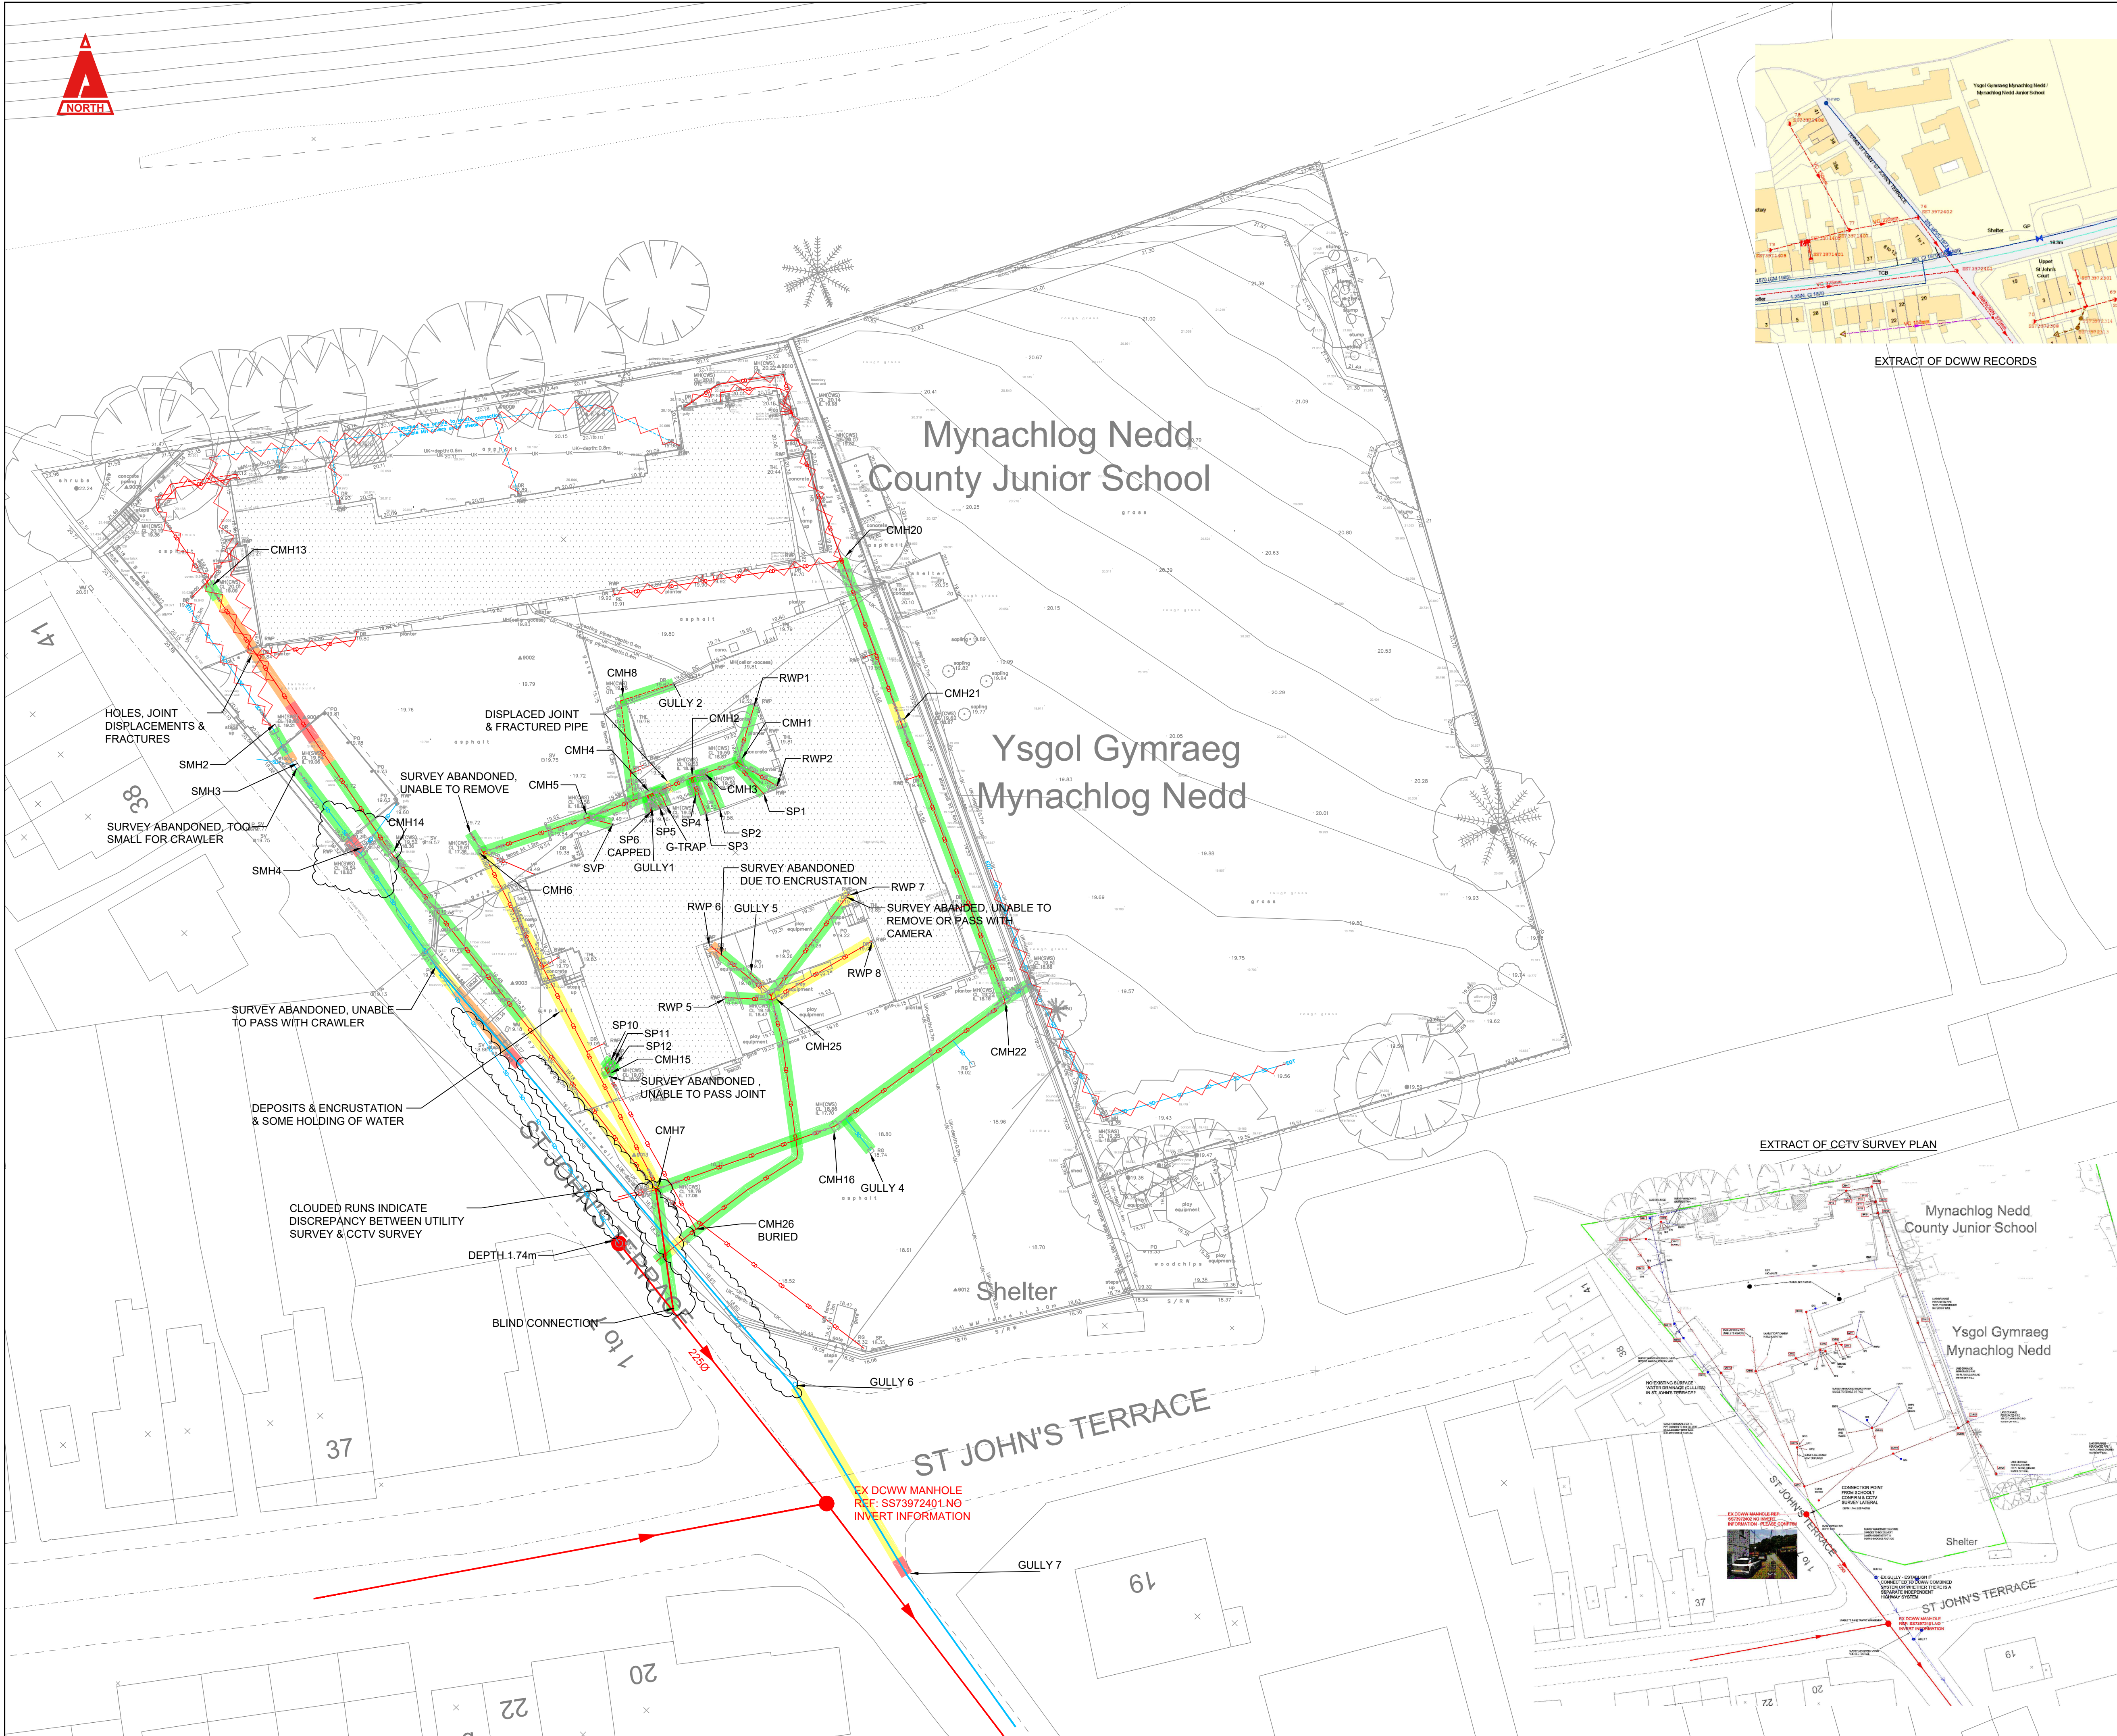
EXTRACT OF CCTV SURVEY PLAN

- GRADE 1 - 2: MINOR / SLIGHT
- GRADE 3: MODERATE
- GRADE 4: SERIOUS
- GRADE 5: SEVERE

NO COLOUR INDICATES NO SURVEY INFORMATION / ABANDONED CCTV SURVEY

- ILLUSTRATIVE CONDITION OF EXISTING DRAINAGE CONDITION BASED UPON DRAINECH CCTV REPORT REF 1642-YGG TREGES CCTV DRAINAGE SURVEY 21347
- DRAINAGE RUNS ANTICIPATED TO BE MADE REDUNDANT AS PART OF PROPOSED REDEVELOPMENT HAVE NOT BEEN INCLUDED.

LINE TO BE ABANDONED
