# **DRAINAGE STRATEGY REPORT**

Project: 121 Heol Cae Gurwen, Gwaun-Cae-Gurwen

Job No: C2434

This drainage strategy report has been prepared to support a Full Planning Application for the redevelopment of 121 Heol Cae Gurwen to a commercial development at Heol Cae Gurwen, Gwaun-Cae-Gurwen, SA18 1PD.

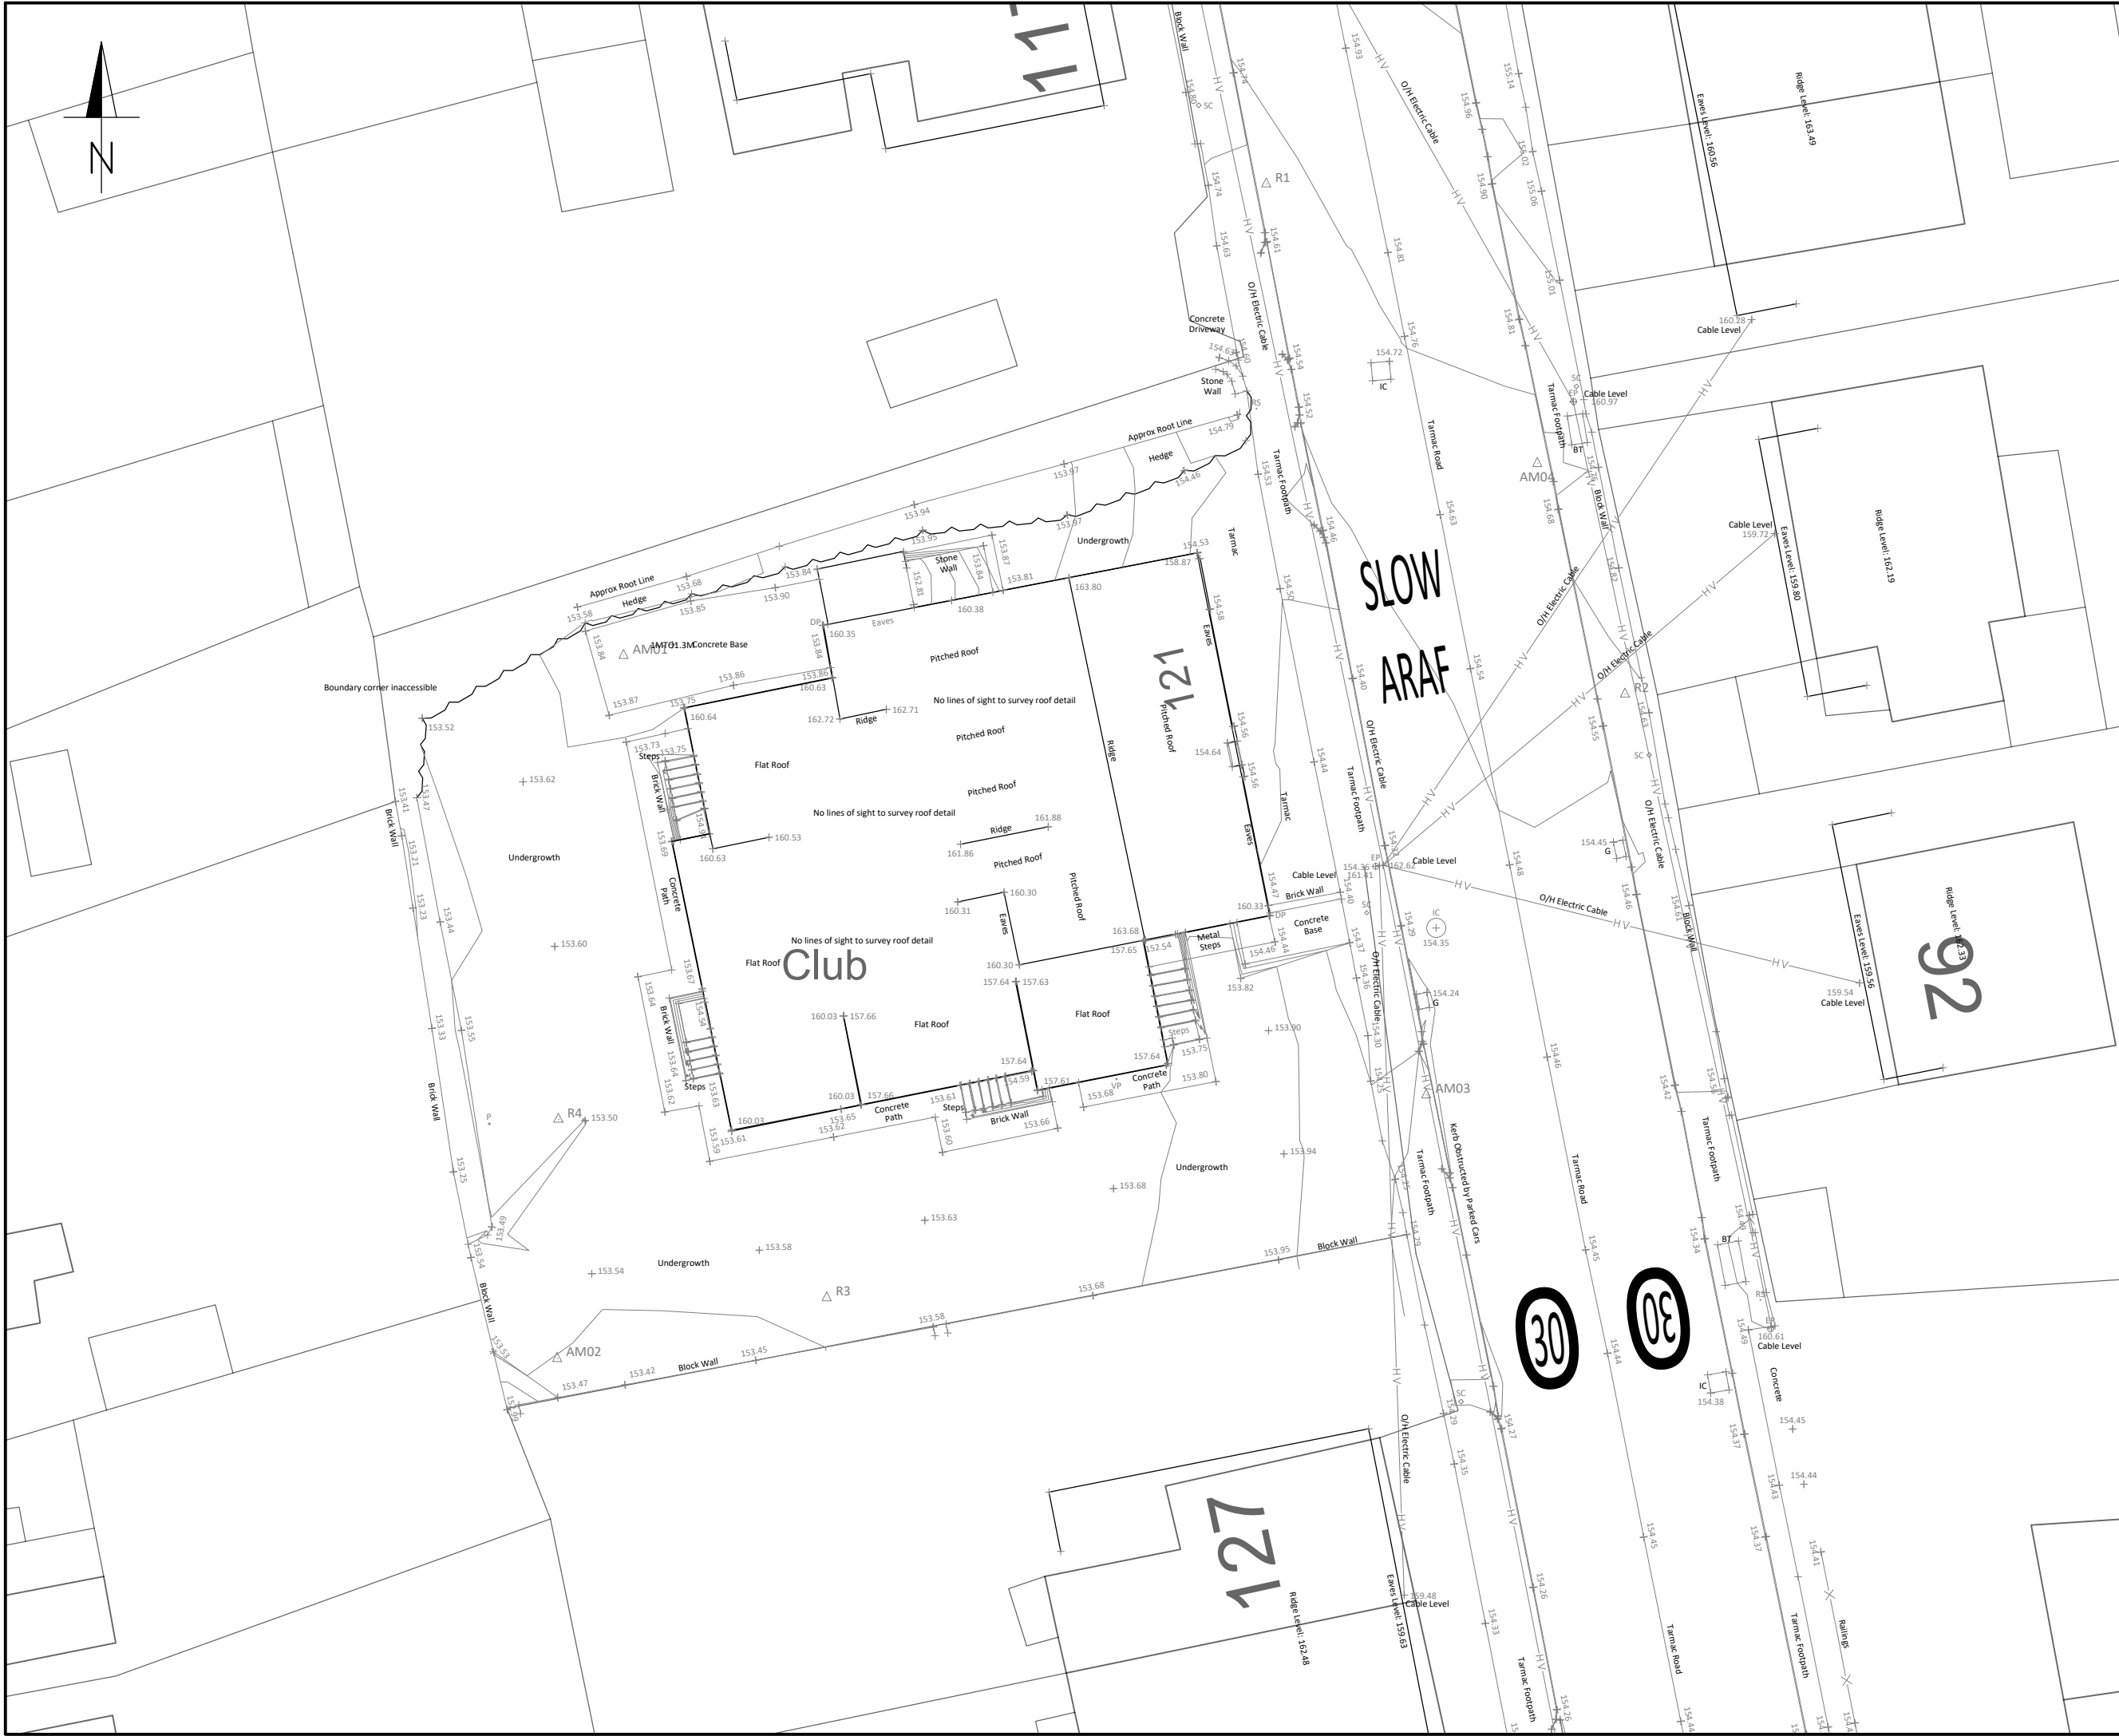
Drawing Title  
**EXISTING LAYOUT  
PLAN**

2.2 A topographical survey of the site is included in Appendix A. The site existing soft landscaping is generally flat with external levels set at circa 153.6mAOD with an elevated building finish floor level of 154.6mAOD.

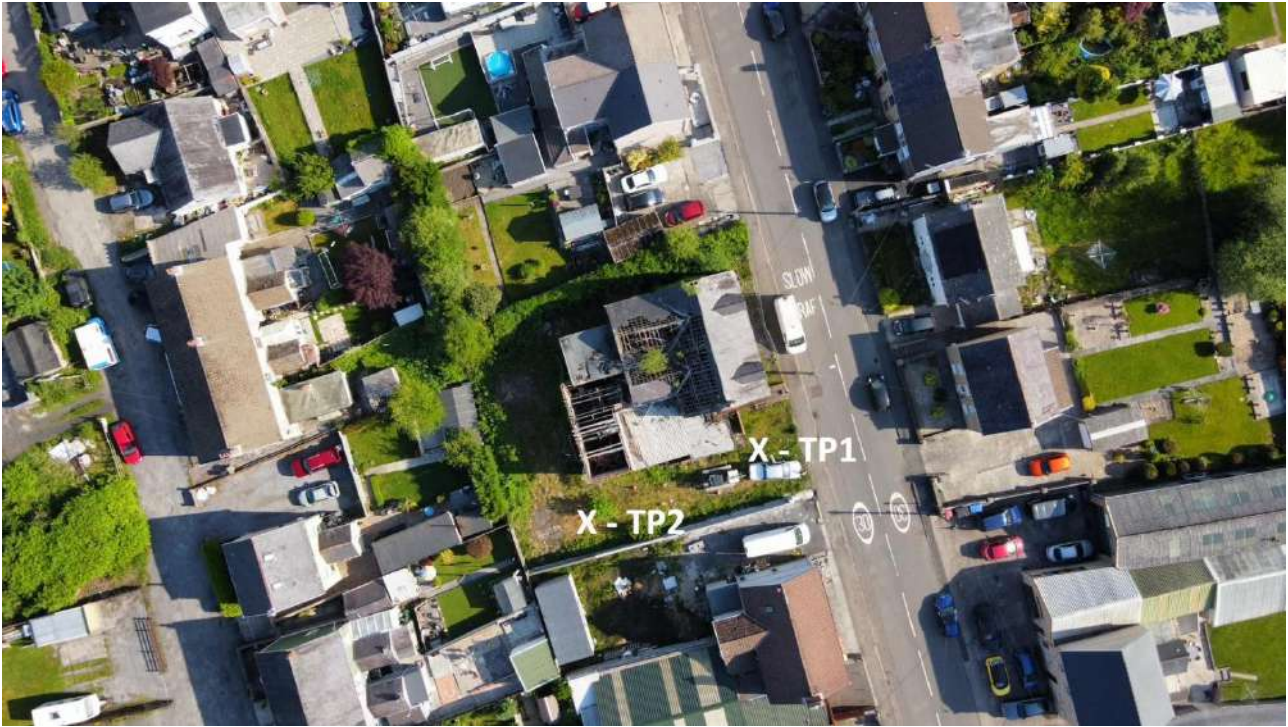
*Figure 1- Test pit locations*

The following tests were performed to the best of the ability of those involved, subject to site constraints and weather conditions. The test pits were successfully excavated to 1.0m and 1.25m depth, shown in the location on **Appendix A**.
