**TAI TARIAN LTD**

**CWMCLAIS ROAD, CWMAFAN**

**PRELIMINARY ECOLOGICAL APPRAISAL & BAT ACTIVITY SURVEY**

02 July 2026

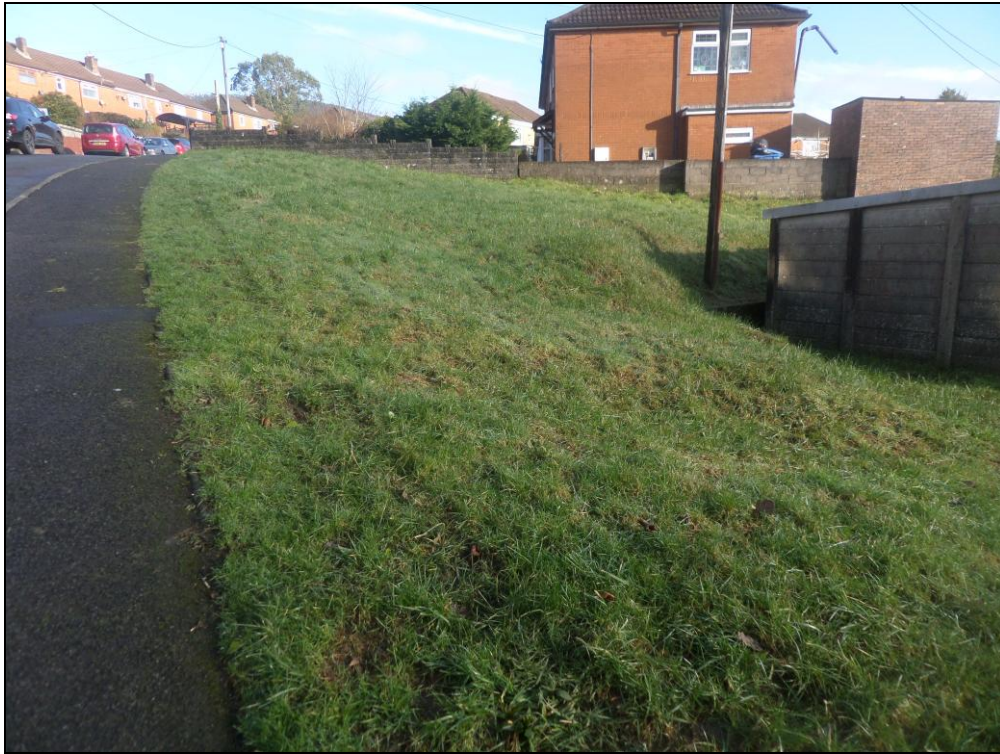
3.3 The corner plot was dominated by managed amenity grassland (Photo 1) and was generally of limited botanical interest and was comprised of such species as Annual Meadow Grass *Poa annua*, Yorkshire Fog *Holcus lanatus*, Common Daisy *Bellis perennis*, Common Dandelion *Taraxacum officinale* and Ribwort Plantain *Plantago lanceolata* with some Sphagnum also evident.

***Photo 1: Managed amenity grassland ascending to northern extent of site (view looking north east).***

- 5.4 The site was still an isolated feature with no connectivity to suitable reptile habitat that was dominated by managed amenity grassland, hard standing and garages. However, the margins of the grassland and small area of cleared Bramble could be utilised by individual common reptiles and as such it is recommended

that the site is managed to regularly to maintain a short sward and vegetation length allowing any potential reptiles to disperse naturally offsite.

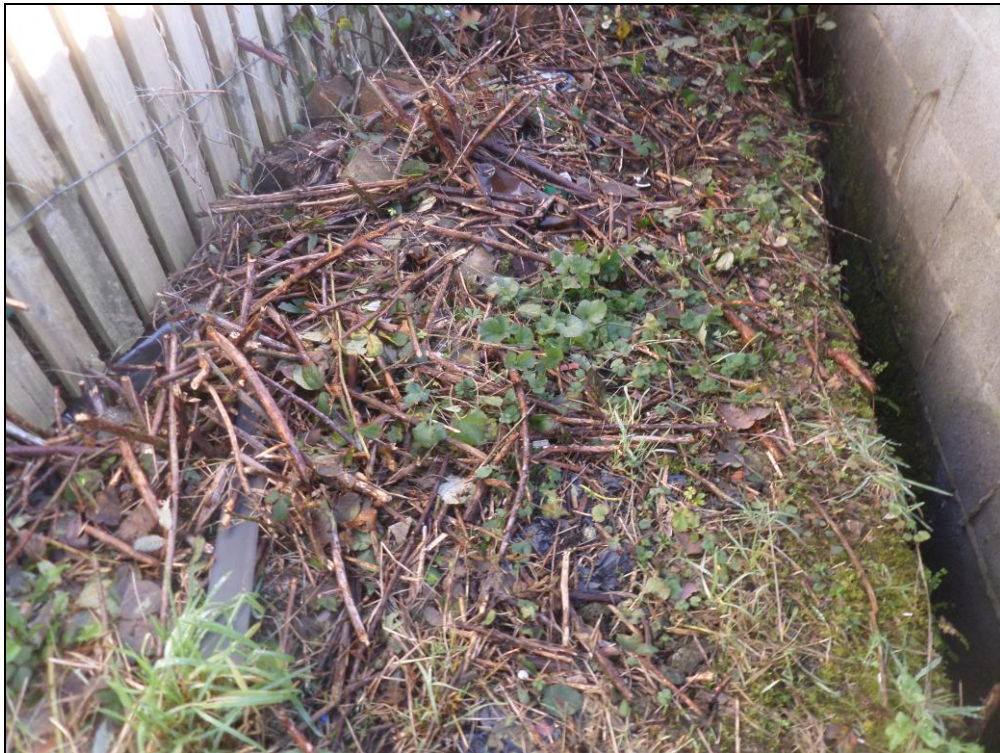
3.4 A small area of cleared Bramble was evident at the rear of the garages towards the north eastern extent of site (Photo 2).

***Photo 2: Cleared Bramble located at the rear of garages at north eastern extent of site.***

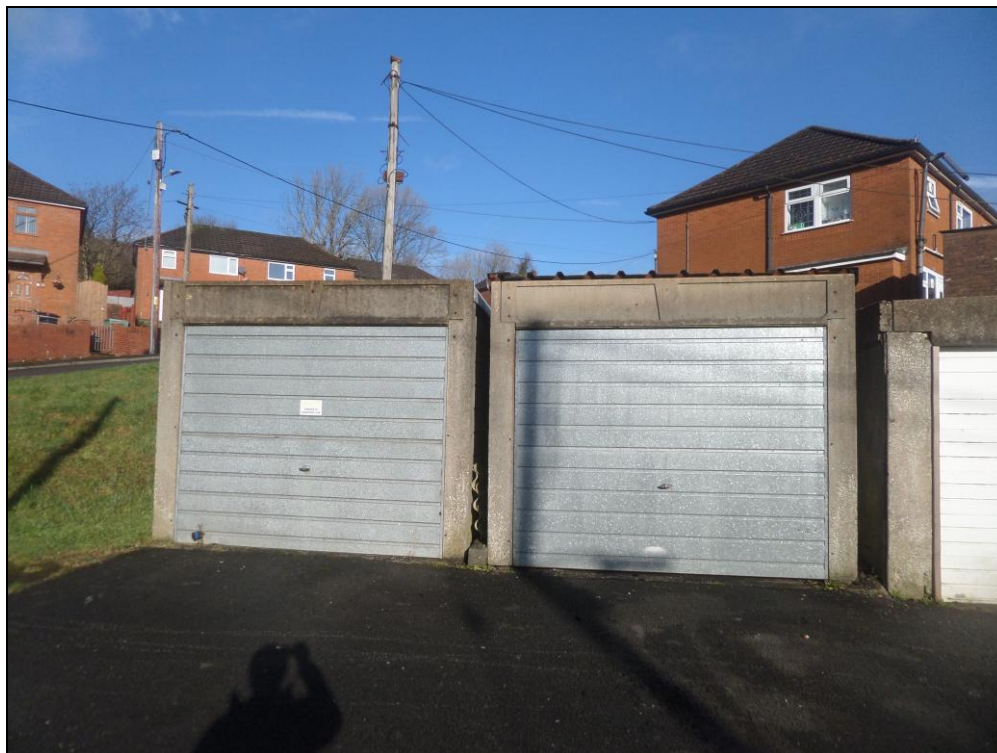
3.6 A row of nine single garages were identified onsite (Photos 3-5). The garages were generally constructed from concrete shuttering, rendered brick and metal garage doors; with flat corrugated roofs that were made from asbestos and metal sheeting (Photo 6). The exception was the easternmost detached garage that was constructed from breeze block with a pebble dashed southern elevation and a corrugated metal roof with wooden fascias (Photo 7).

*Photo 3: Garages 1 & 2 (west to east) (view looking north).*

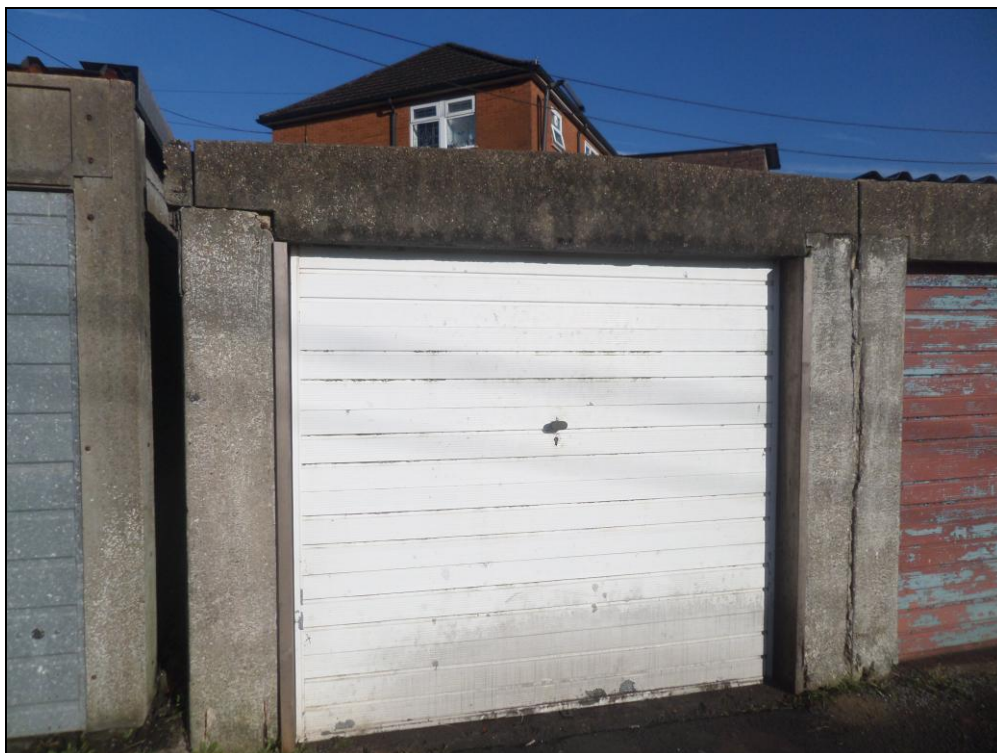
*Photo 4: Third garage (west to east) (View looking north west).*

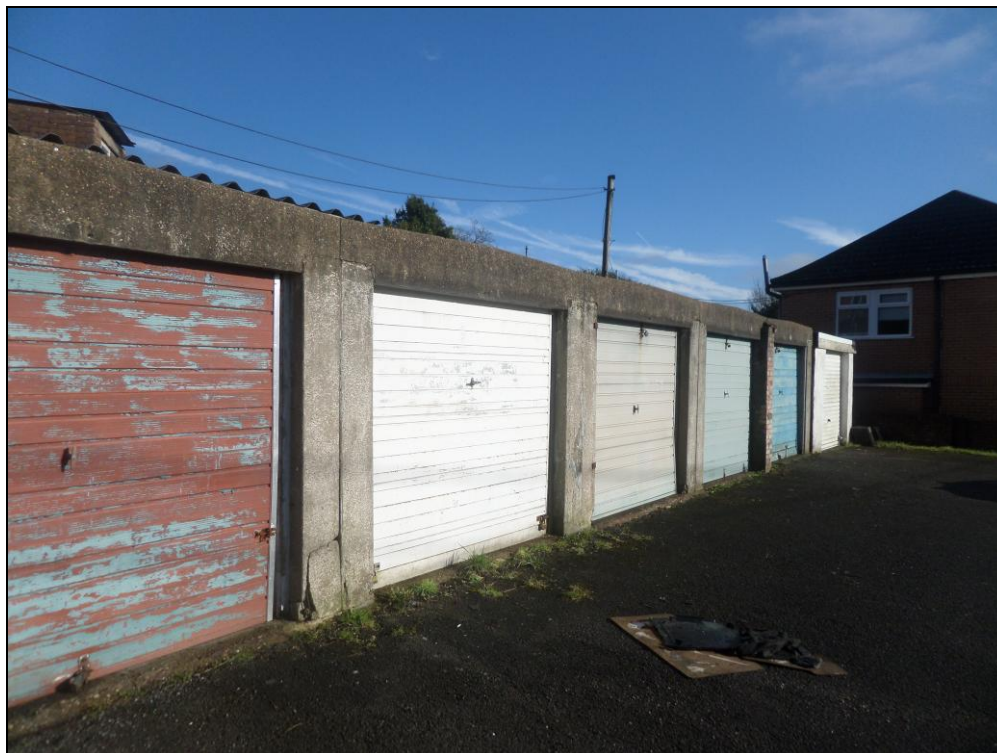
*Photo 5: Garages 4 – 9 (west to east)(view looking east).*

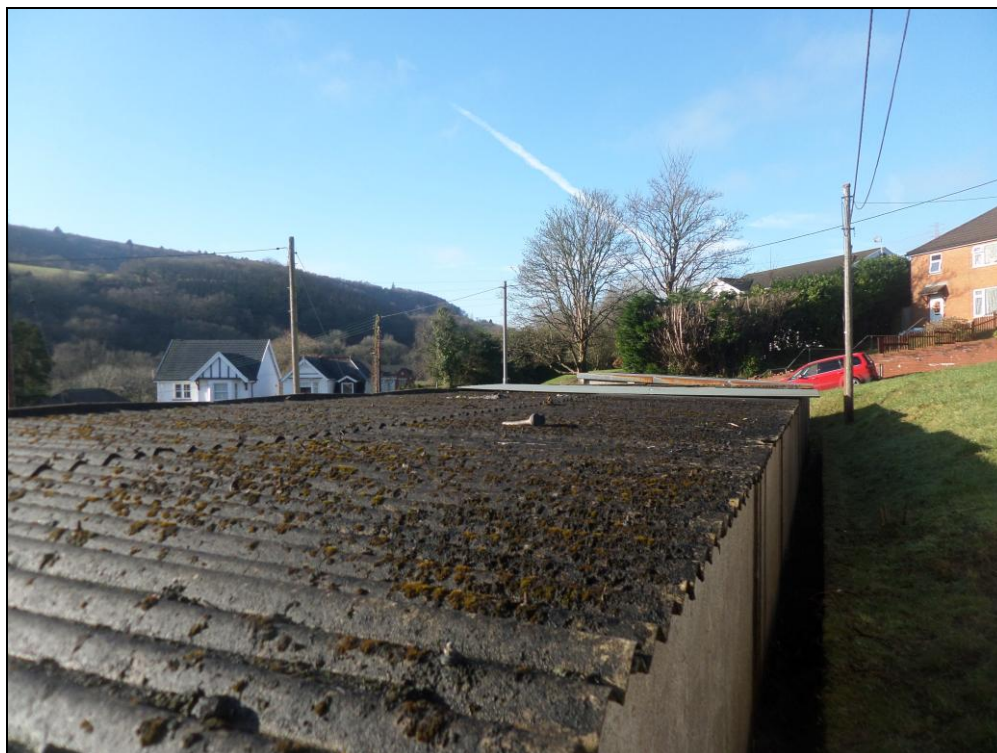
*Photo 6: Corrugated asbestos and metal flat roof on garages (view looking west).*

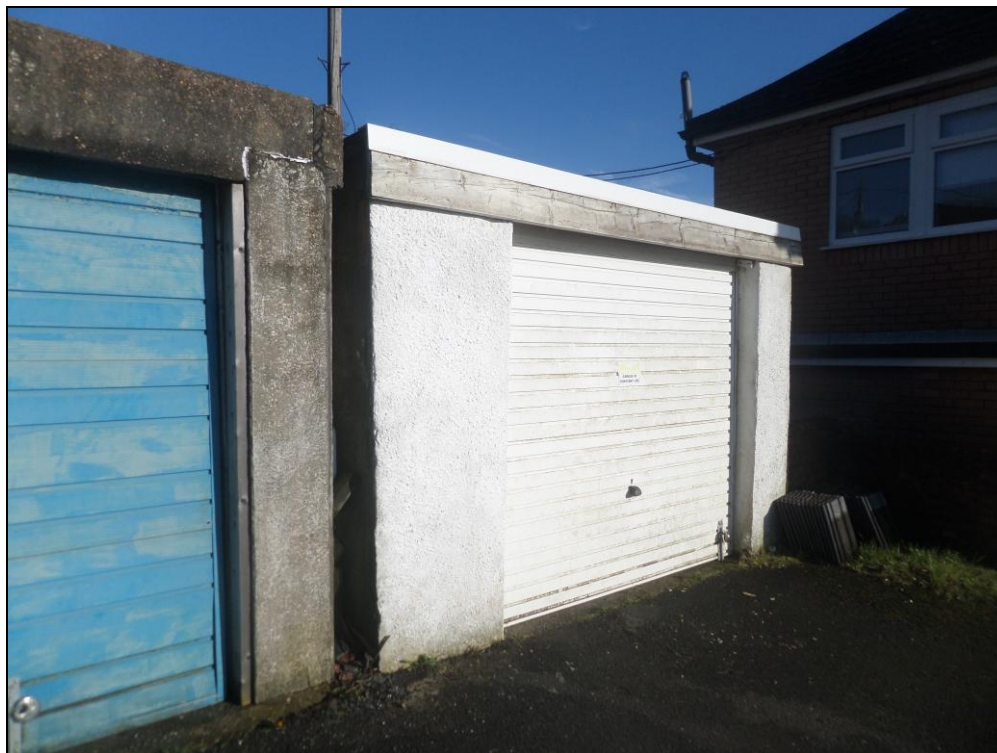
*Photo 7: Detached garage 9 (View looking north east).*

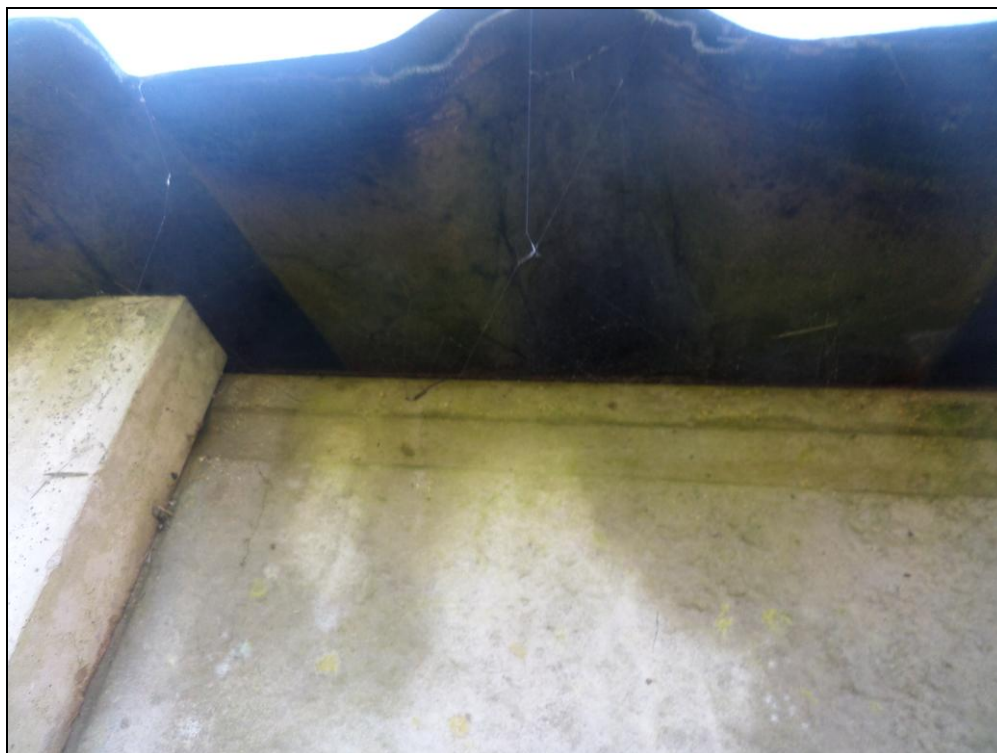
3.7 No evidence of roosting bats was identified externally. However, potential access to the internal of the garages was identified beneath the corrugated roofs (Photo 8) and around fascias (Photo 9). No internal access was available at the time of the survey.

3.8 In the absence of a thorough internal inspection and the identification of external potential access points to the interior, the garages were considered to be low suitability for roosting bats.

*Photo 8: Gaps beneath corrugated roof providing access to interior.*

- 5.2 The row of single garages possessed potential bat access points to the interiors beneath corrugated metal and asbestos roofs and around fascias. However, no evidence of roosting bats was identified externally. A thorough internal inspection of the garages, including an endoscope survey of accessible PRFs conducted in May 2026 identified no evidence of roosting bats; whilst the dusk emergence survey conducted June 2026 identified no roosting bats and low levels of bat activity.

- 5.3 On this basis, it is considered that the proposed works will not require further surveys or a European Protected Species (EPS) derogation licence. However, it is recommended that a precautionary approach to the demolition works be adopted given the itinerant nature of roosting Pipistrelle sp. that were identified foraging/commuting across site in the activity survey. The possibility that the structures could potentially be utilised by individual bats on an irregular or occasional basis during future bat activity seasons could not be ruled out and a precautionary approach as follows would be appropriate:

- Builders advised prior to the start of works of the low risk that bats could be present and the action to take should a bat be discovered (see below);

- Removal of roof features to be undertaken by hand or using hand-tools (e.g. crowbars etc.);
  - In the unlikely event that a bat were discovered, all works would cease immediately

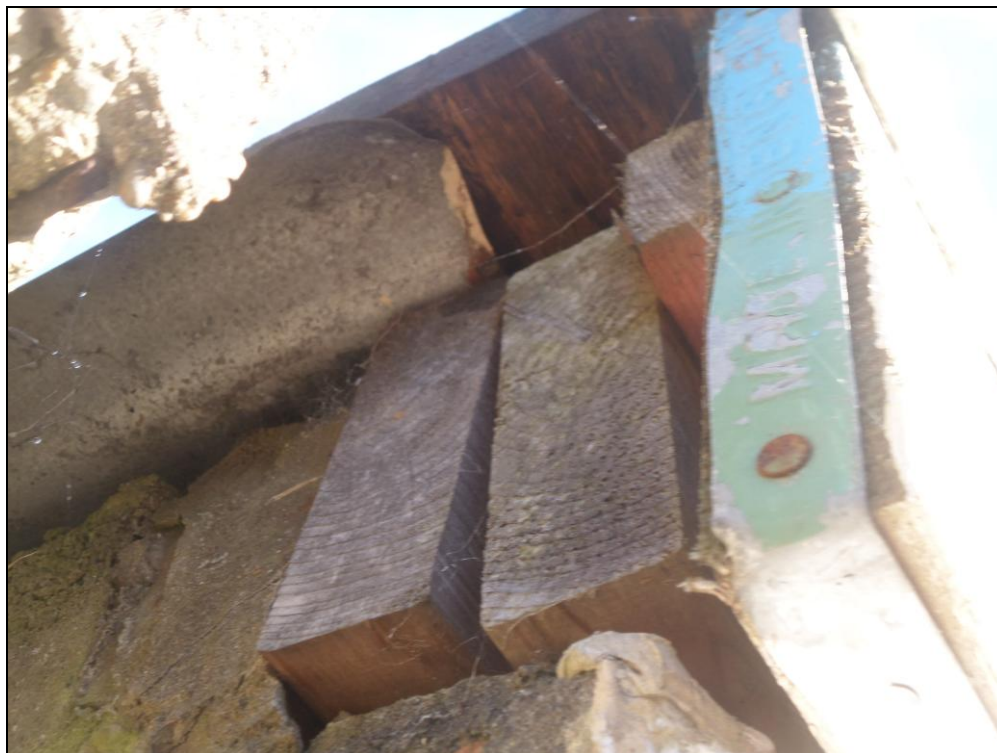
***Photo 9: Gaps beneath fascia on detached easternmost garage.***

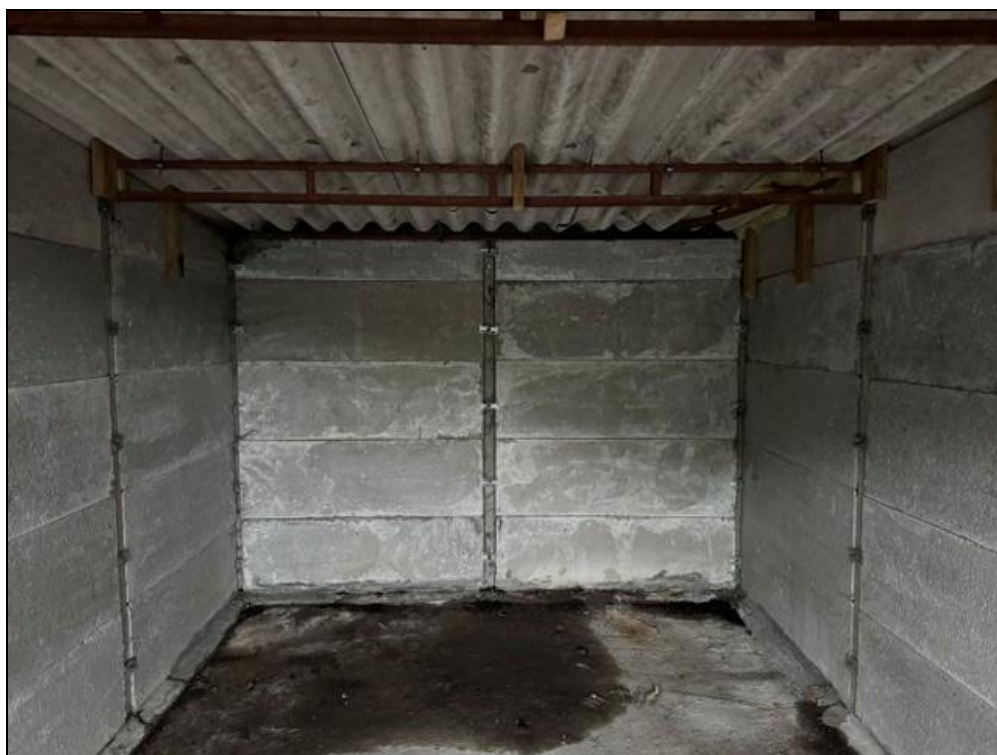
3.9 A further internal inspection of the garages and endoscope survey of the identified PRFs was conducted on the 20<sup>th</sup> May 2026, which identified exposed asbestos roofs (Photos 10 & 11) and no evidence of roosting bats.

***Photos 10: Interior of garage with exposed asbestos roof.***

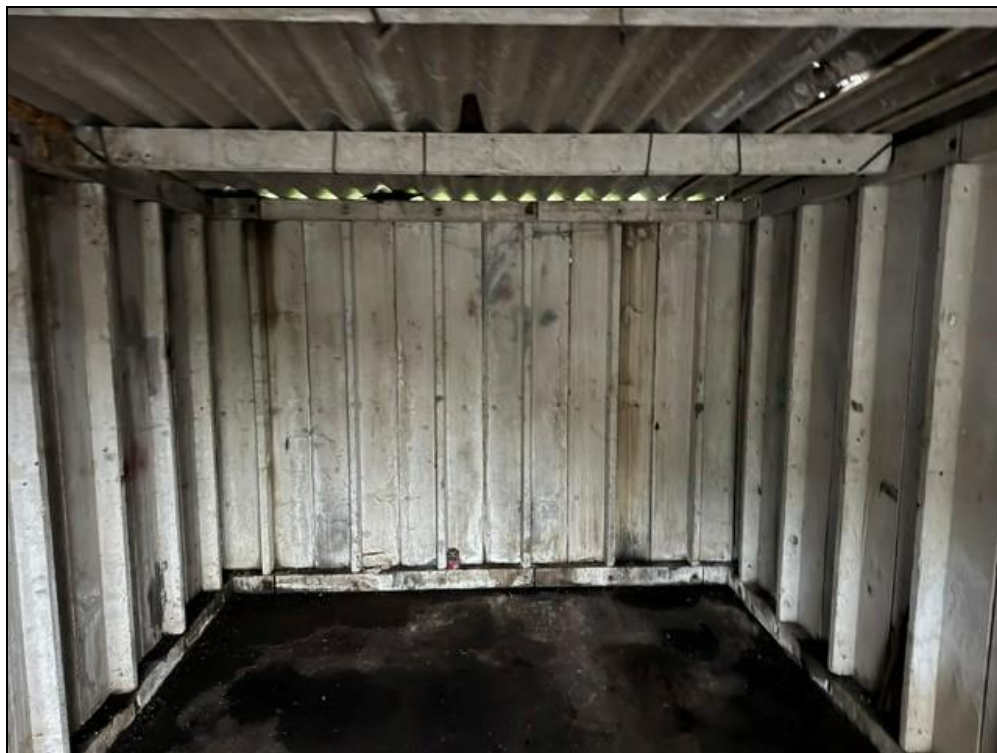
**Photo 11: Interior of garage with exposed asbestos roof.**

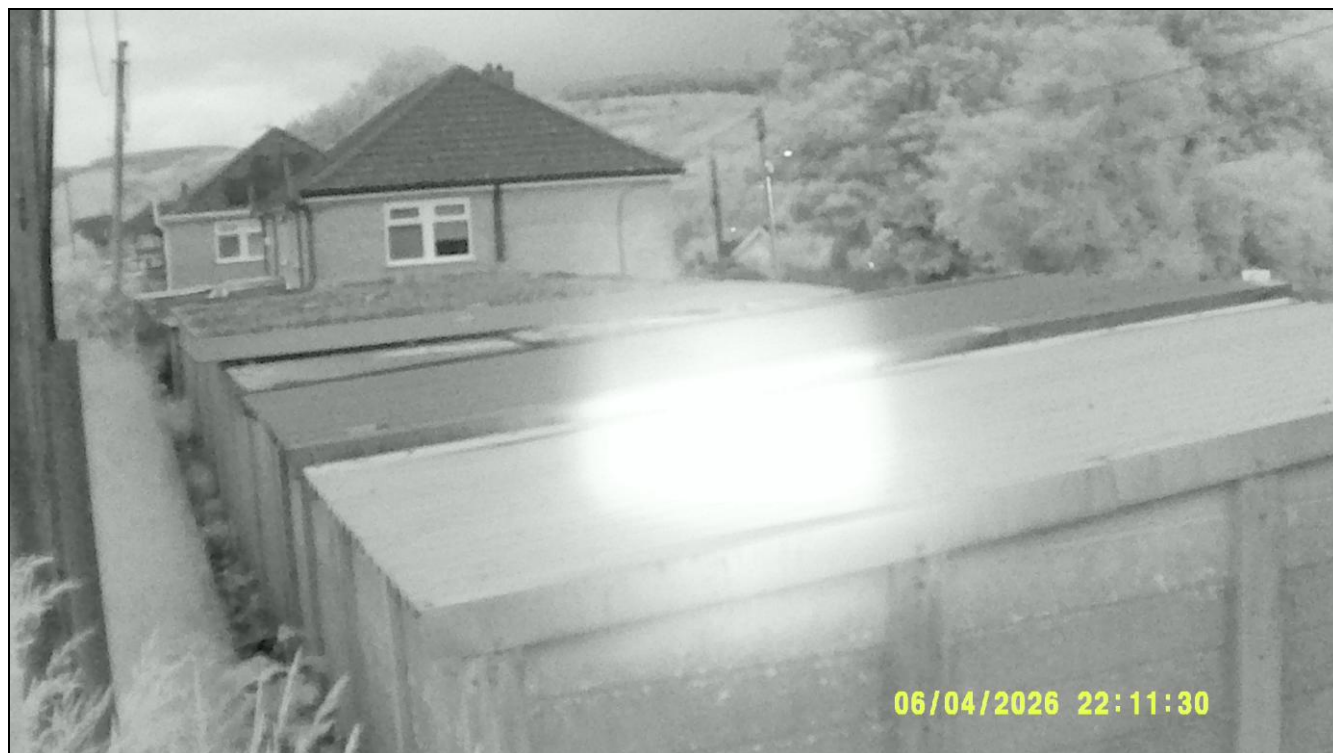
3.10 No bats were recorded emerging from the structure. In general, very low levels of bat activity were recorded during the survey with only a single bat recorded commuting across site from south to north at 22.03h, approximately 36mins post sunset (21.27h). From in-field and sonogram analysis it was determined that the call was attributed to a single foraging and commuting Common Pipistrelle bat. Figures 1 & 2 shows the typical views from the static infrared and thermal camera located to the north west and south west of the structures (Appendix II).

Figure 1: IR camera view located north west of site (view looking south east).

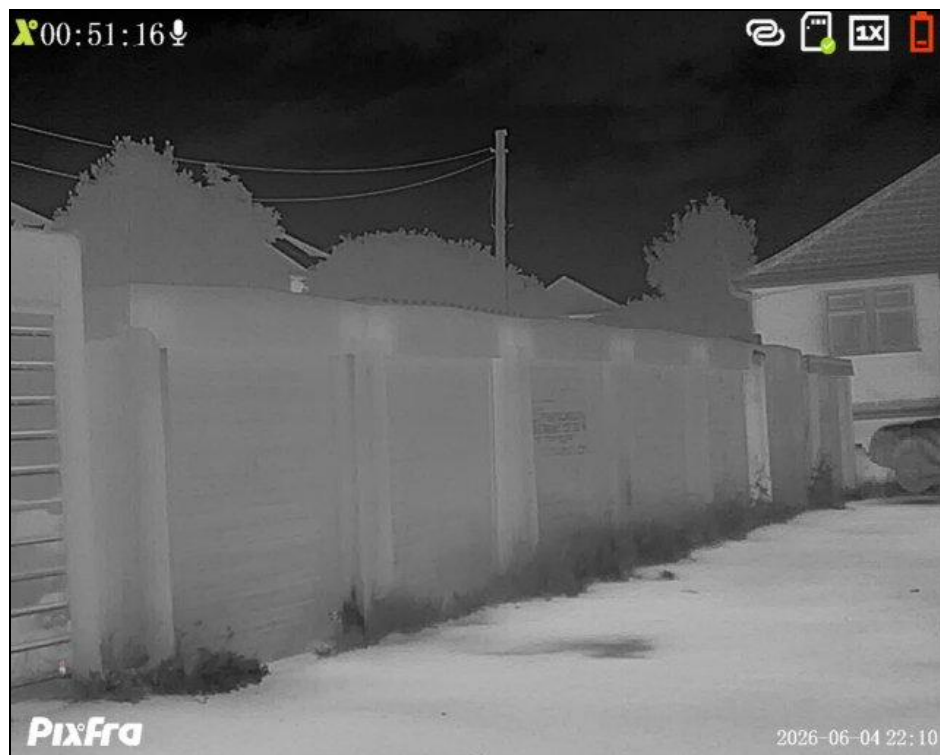
Figure 2: Thermal camera view located south west of site (view looking north east).

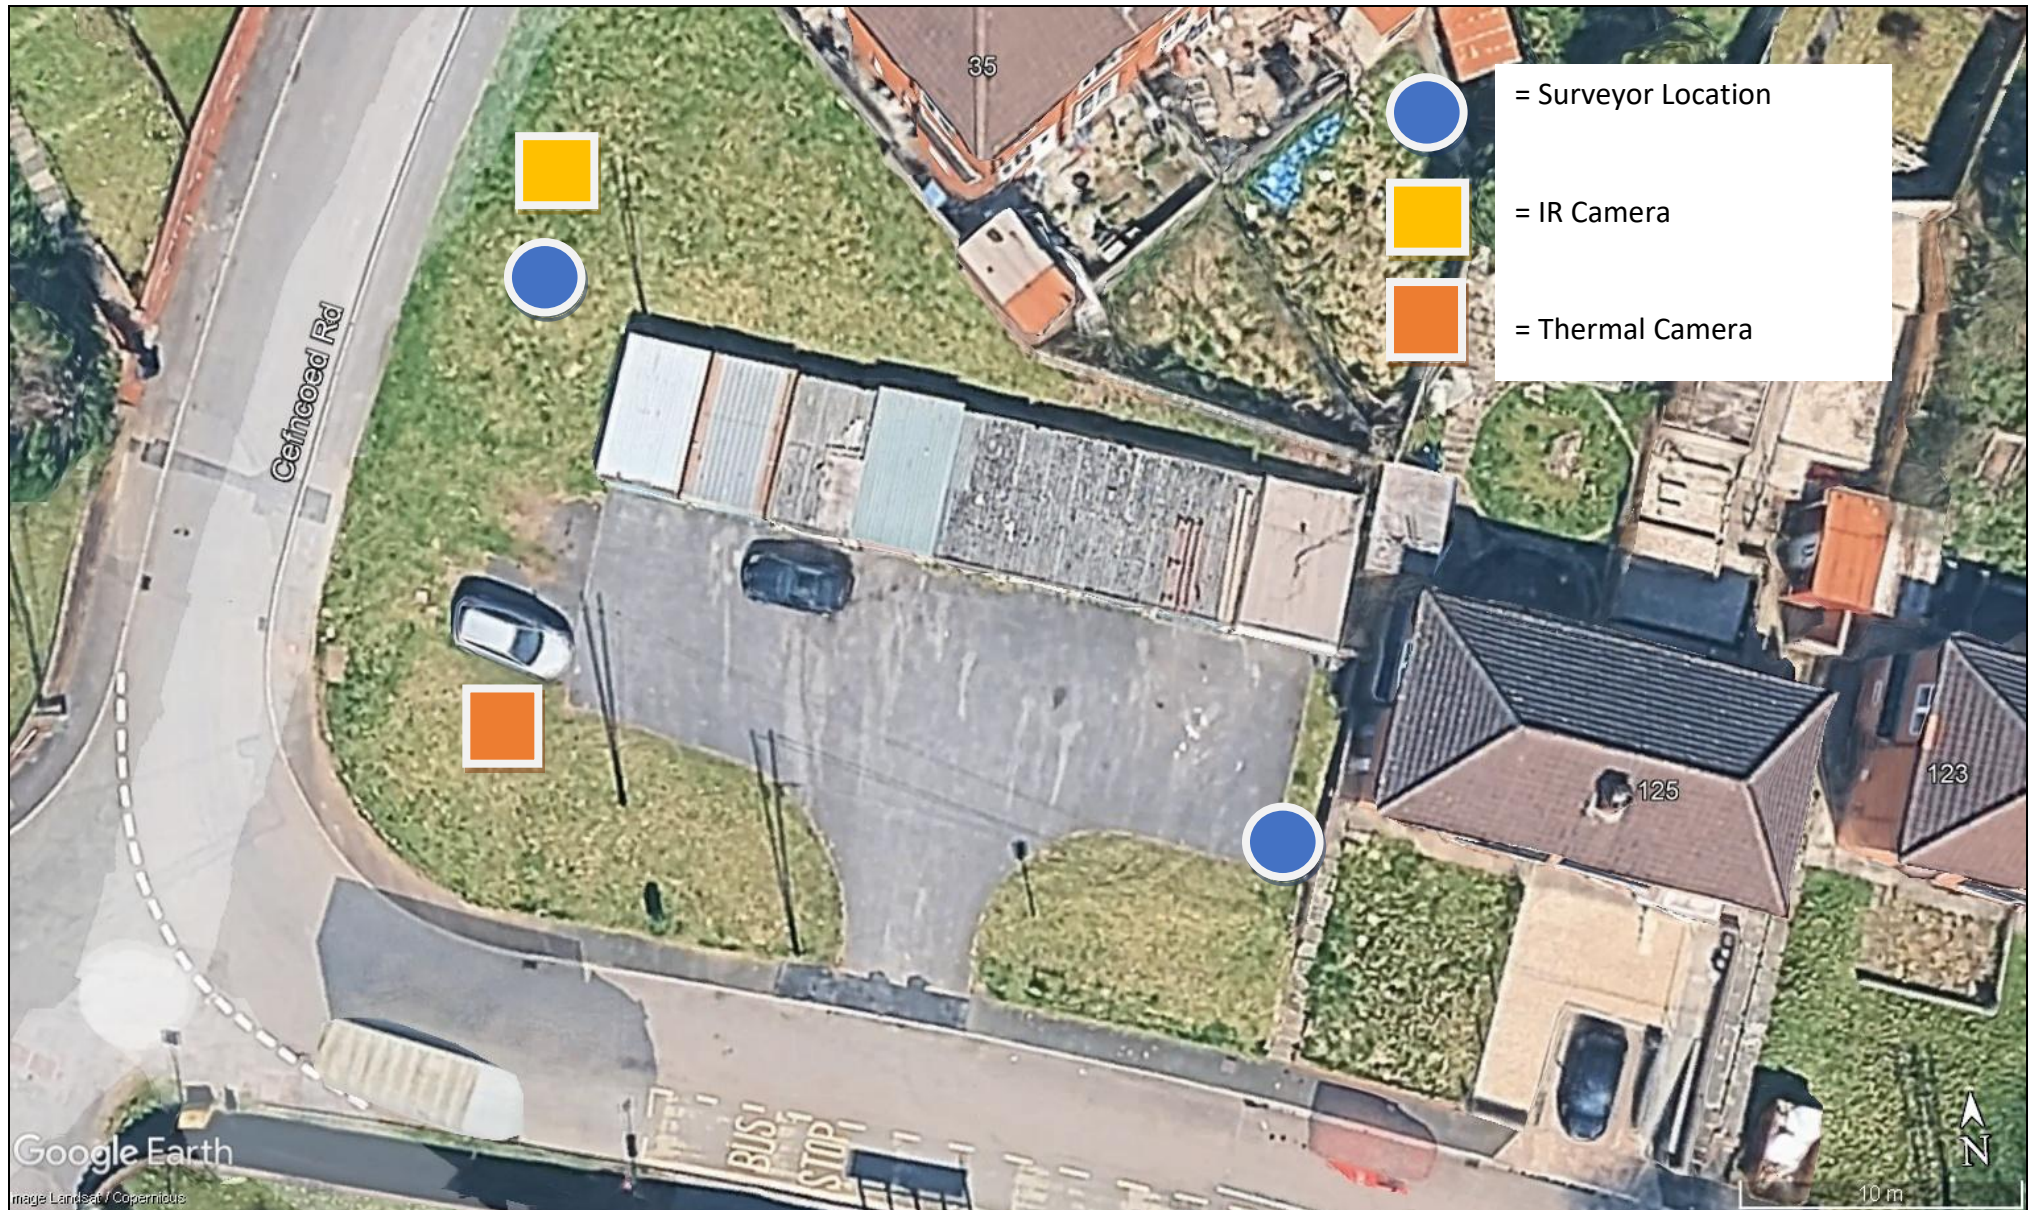
## APPENDIX II SURVEYOR & CAMERA LOCATION

- 2.6 The surveyors were positioned to ensure maximum coverage of the building's potential bat roosting features, with the surveyors located north west and south east of the structure providing maximum coverage of the identified features (Appendix II). During the surveys an InfraRed and Thermal cameras were placed north west and south west of the structure to provide additional coverage (Pixfra A613 and NightFox Nova camera) of the identified access points. During the survey full spectrum detectors (Peersonic) were used to allow both in field and office based sonogram analysis of bat calls. All calls were recorded and identified on computer-based sonogram analysis software (Wavesurfer) and BatClassify.
