RHONDDA  
GEOTECHNICAL  
SERVICES

PHASE 2 CONTAMINATED LAND ASSESSMENT

DEMOLITION OF EXISTING BUILDINGS AND  
ERECTION OF 11 RESIDENTIAL PROPERTIES

CHURCH STREET/KENNEL ROW

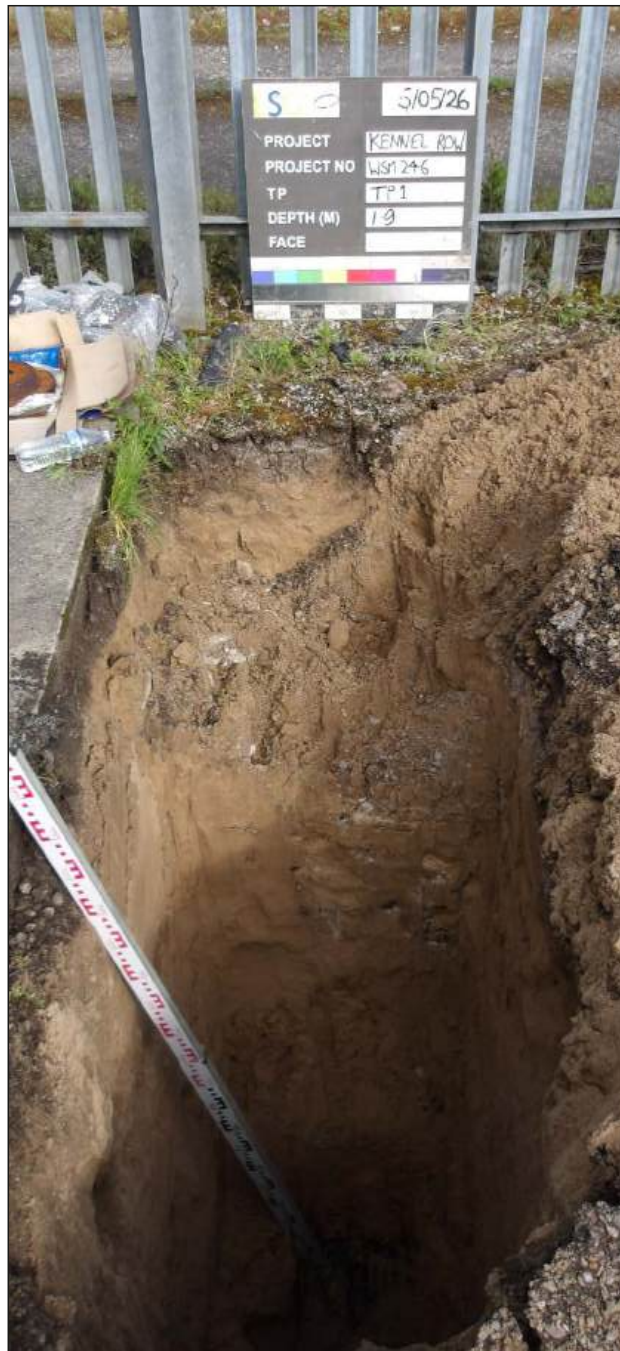
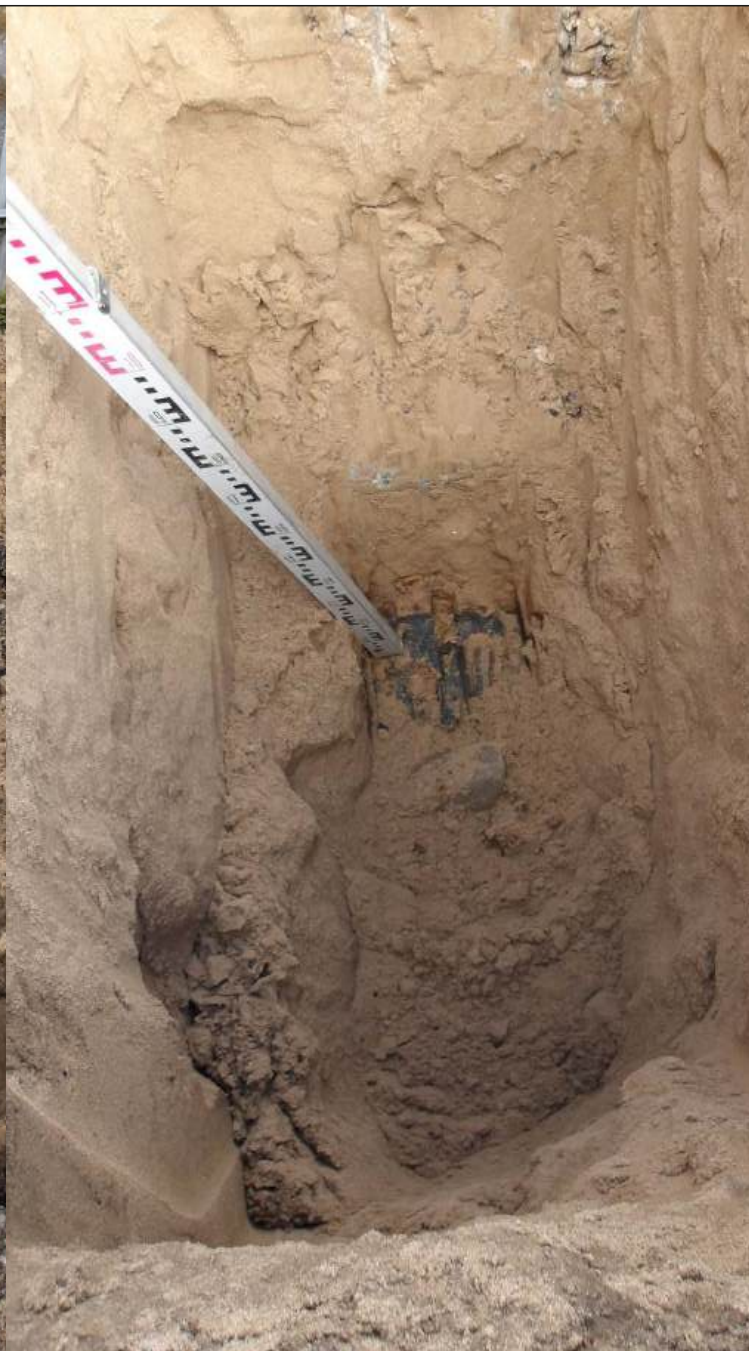
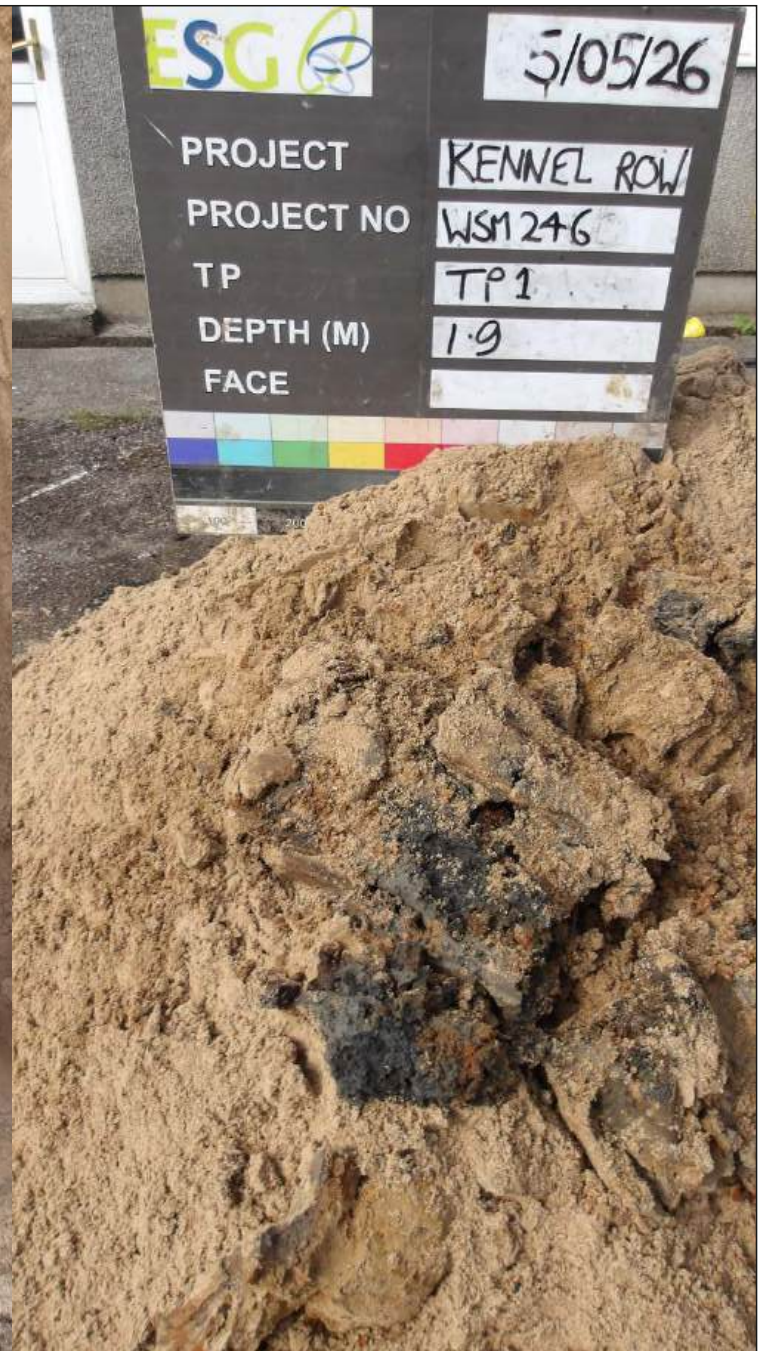
TP 1

| Samples and Tests | | Strata | |
|---|---|---|---|
| | | 0.45 | MADE GROUND. Medium dense black and grey sandy GRAVEL. Gravel is angular, fine to coarse of Sandstone masonry, crushed concrete, ash and clinker. Sand is similar to the natural ground but stained. |

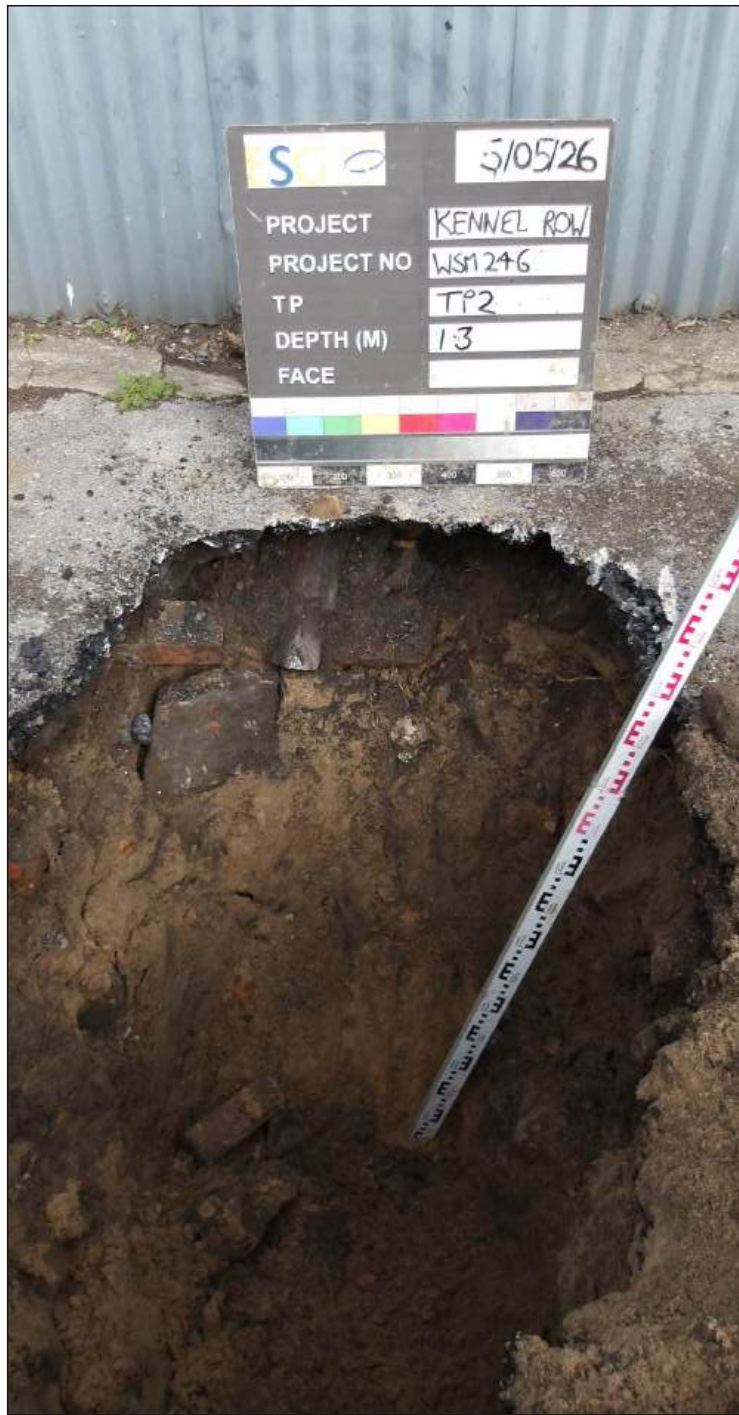
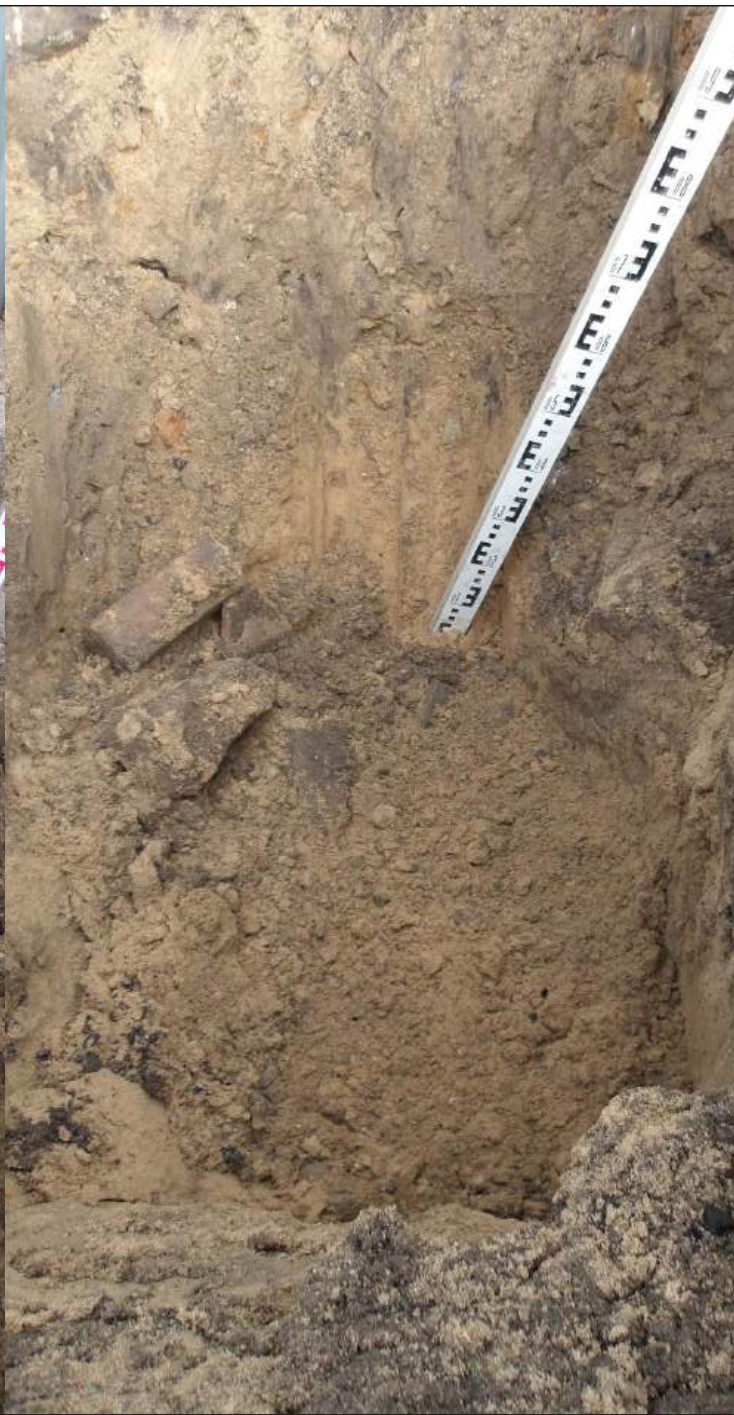
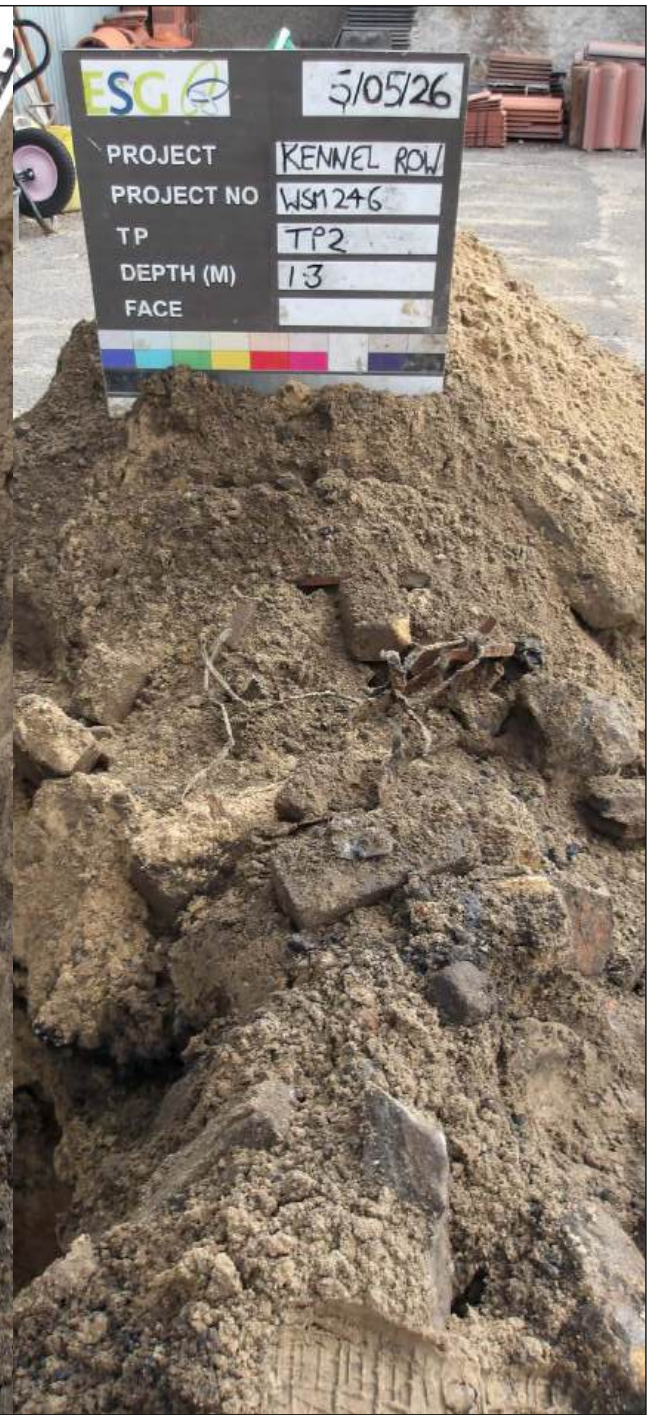
TP 2

| Samples and Tests | | Strata | |
|---|---|---|---|
| | | 0.65 | MADE GROUND. Medium dense black and grey sandy GRAVEL. Gravel is angular, fine to coarse of Sandstone masonry, crushed concrete, ash and clinker. Sand is similar to the natural ground but stained. |

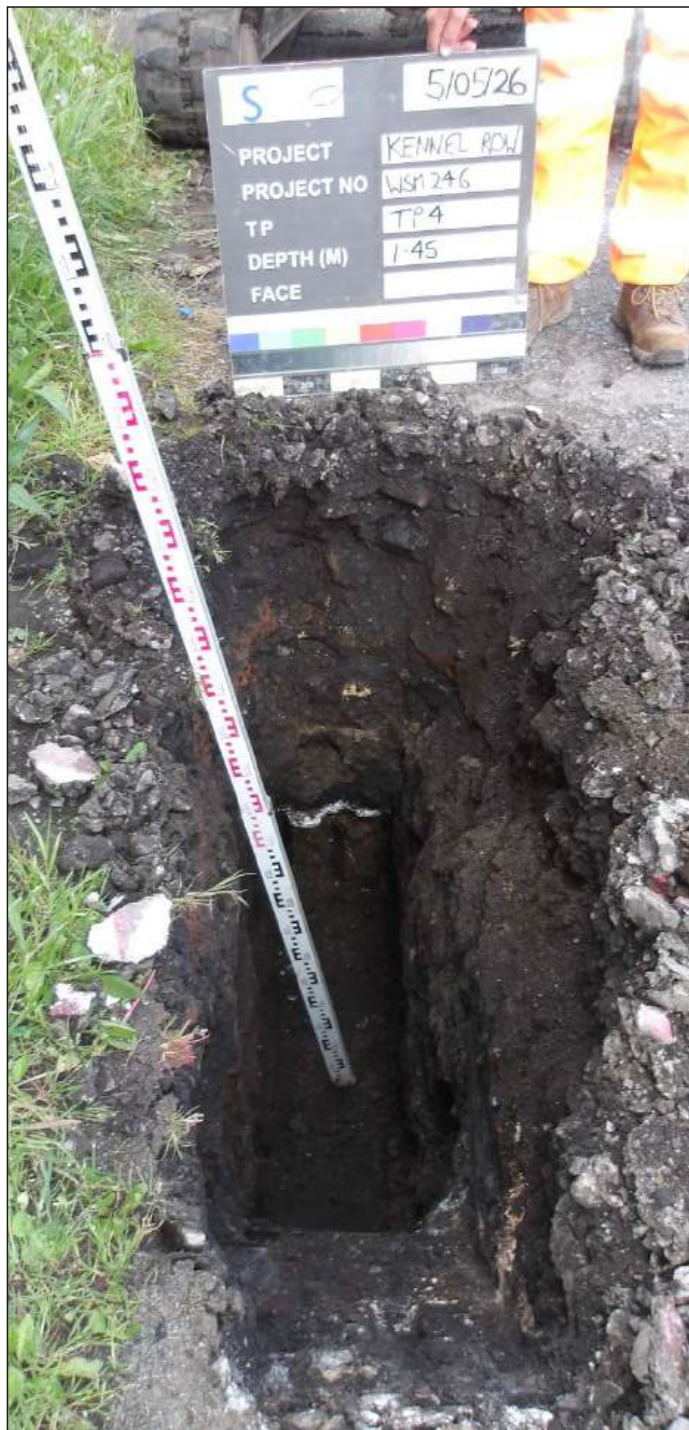
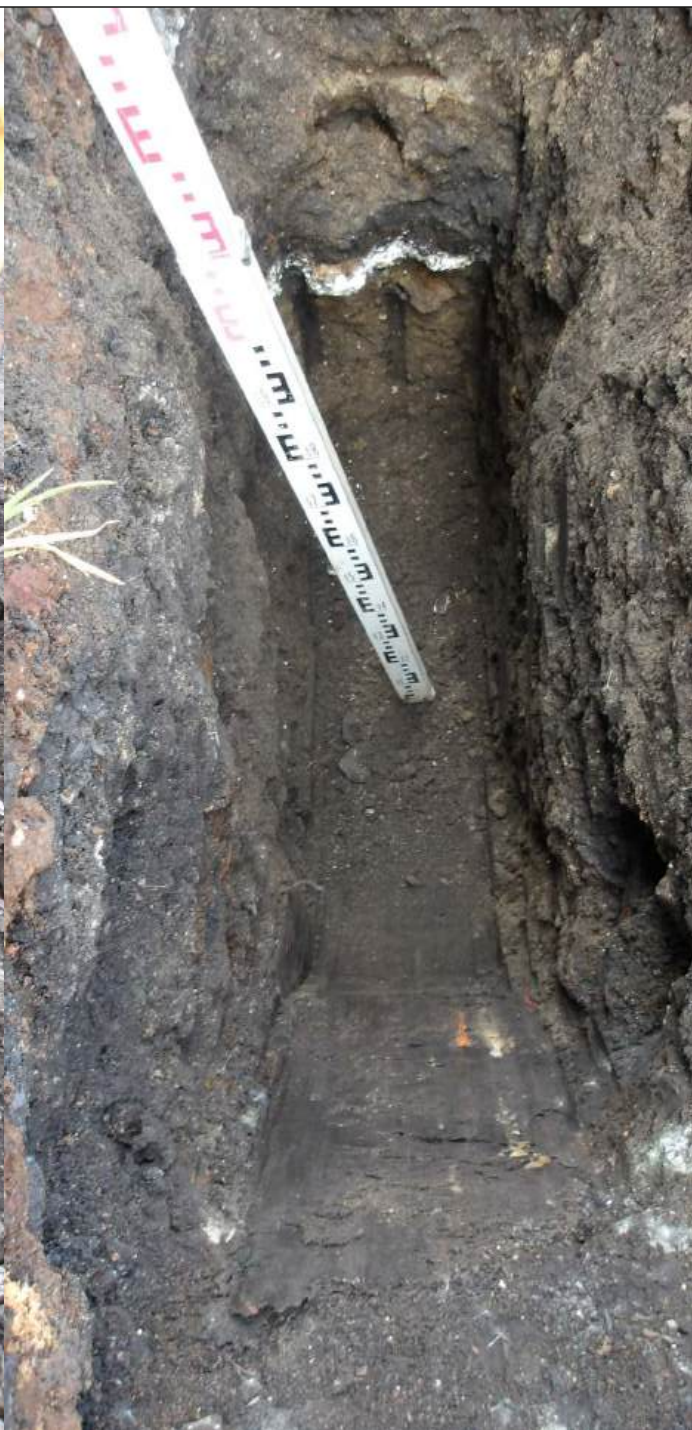
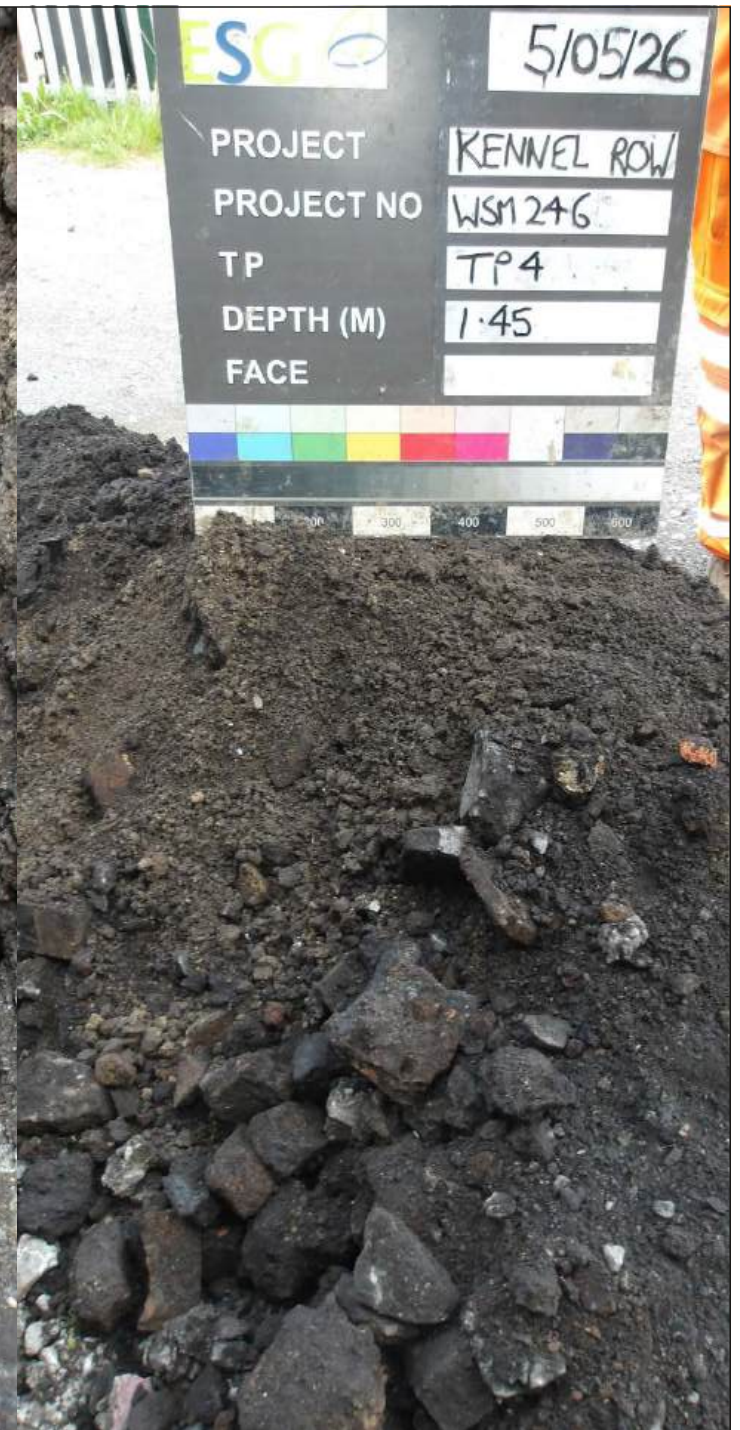
TP 4

| Samples and Tests | | Strata | |
|---|---|---|---|
| | | 0.65 | MADE GROUND. Medium dense black and grey sandy GRAVEL. Gravel is angular, fine to coarse of Sandstone masonry, Brick, ash and clinker. Sand is similar to the natural ground but stained. |

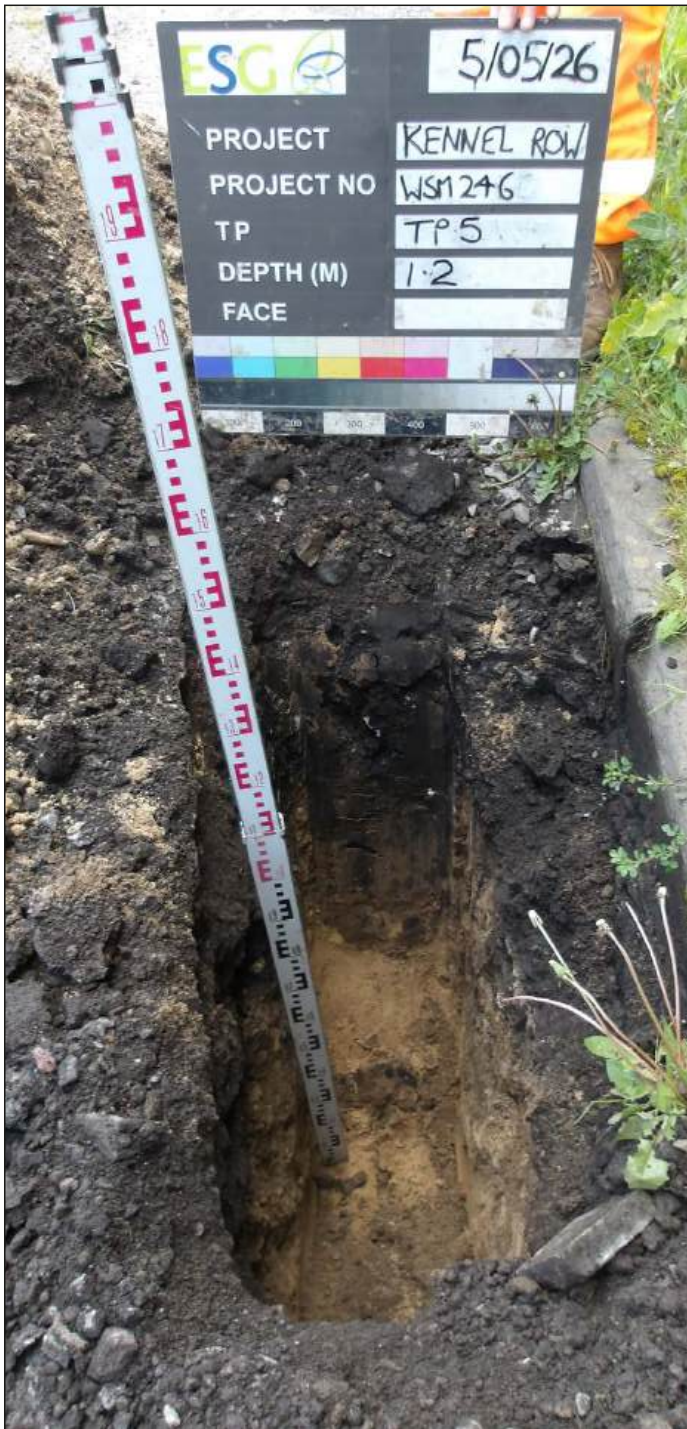
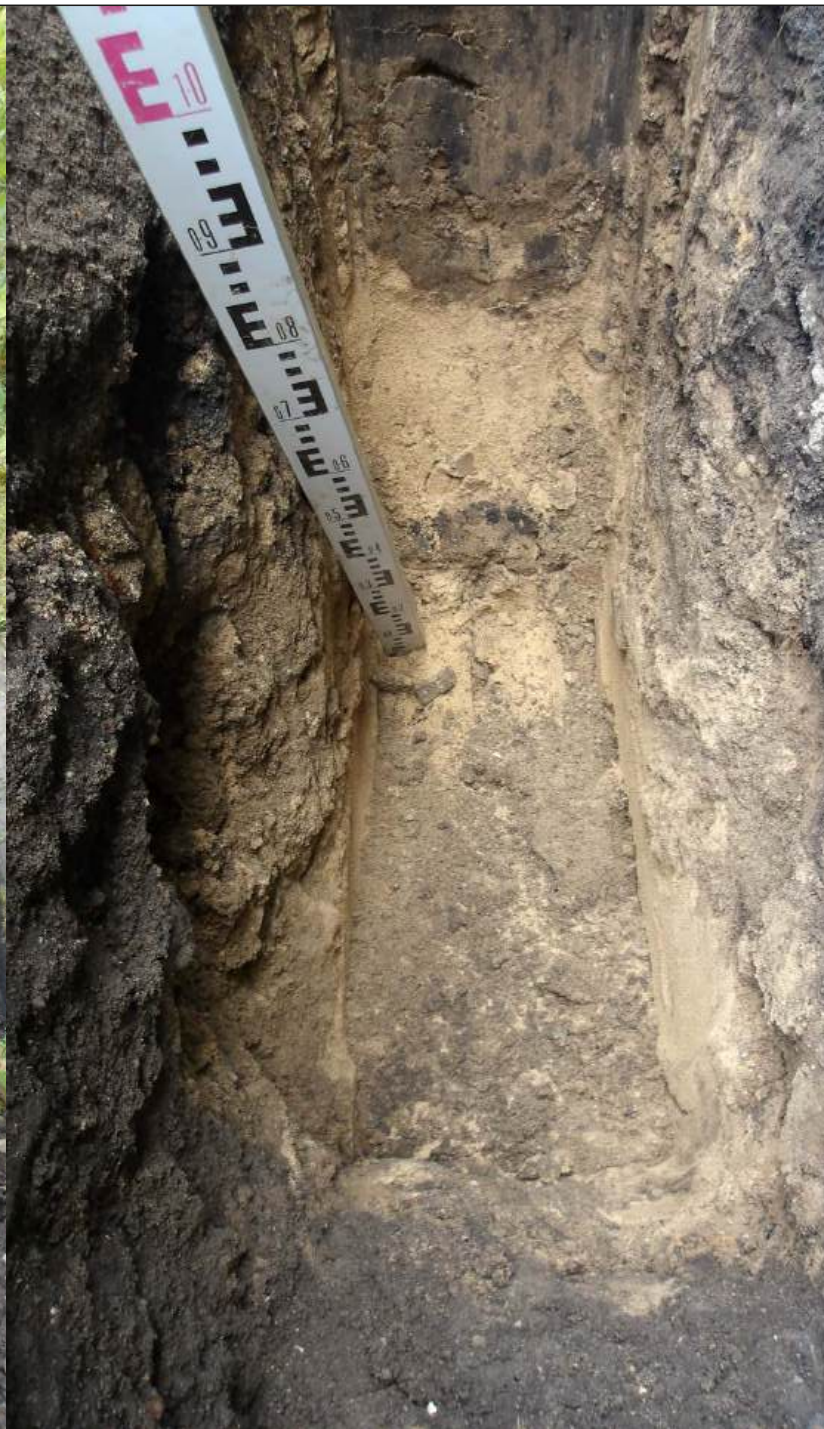
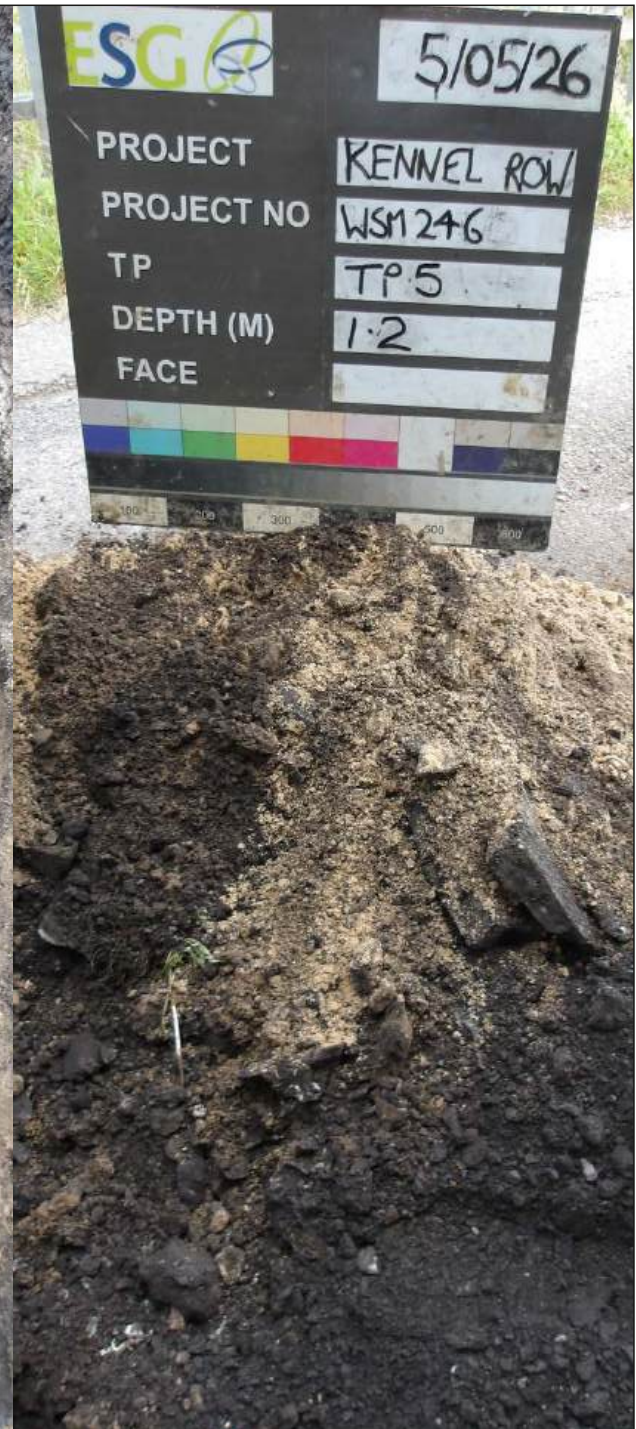
TP 5

| Samples and Tests | | Strata | |
|---|---|---|---|
| | | 0.9 | MADE GROUND. Medium dense black and grey sandy, GRAVEL. Gravel is angular, fine to coarse of Sandstone masonry, Brick, ash and clinker. Sand is similar to the natural ground but stained. |
