## Preliminary Roost Assessment

46 Park Drive, Skewen, Neath Port Talbot SA10 6SG

This report is prepared to inform a planning application with Neath Port Talbot County Borough Council. This proposal can be described as "The side and rear 2 storey extension of 46 Park Drive."

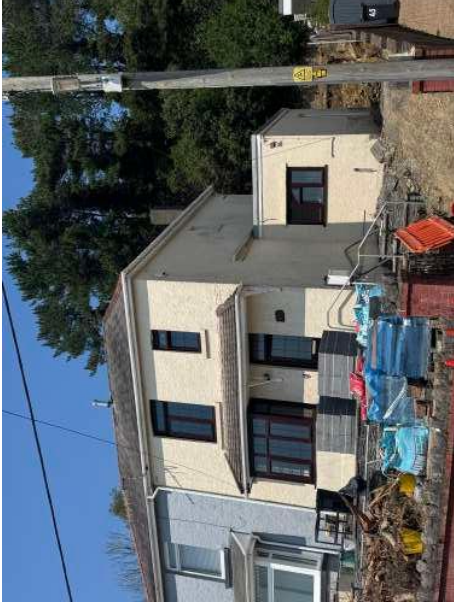
The building is a semi-detached residential dwelling. At the time of the survey, internal strip-out works had already commenced, including the demolition of the northern conservatory and the removal of floors and plaster. Notably, the ceilings have also been removed, exposing the roof rafters.

Due to the timing of the site visit, a retrospective assessment of whether this loft space or tiles were actively utilised by bats prior to its removal cannot be made. In its current, fully exposed and actively disturbed state, the remaining building structure is assessed as providing negligible roosting suitability. Building features are described below.

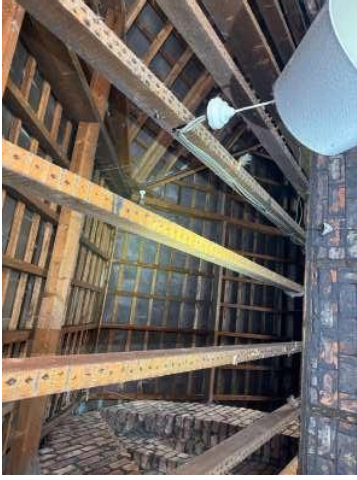
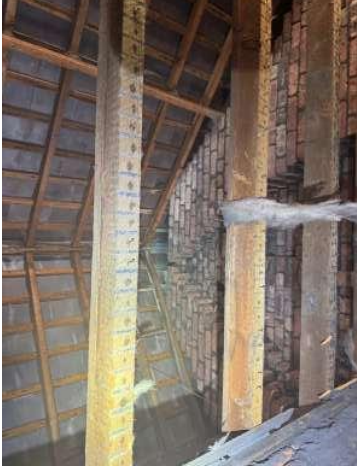
**Loft spaces** - Prior to these works, the loft space possessed features - specifically ridge gaps and an unlined roof - that could have provided potential access points and roosting opportunities for bats. However, because the ceilings have been dismantled, this enclosed loft void no longer exists, and the area is now entirely open to the gutted lower floors, including the high lux levels from the first-floor windows.

Exposed loft space

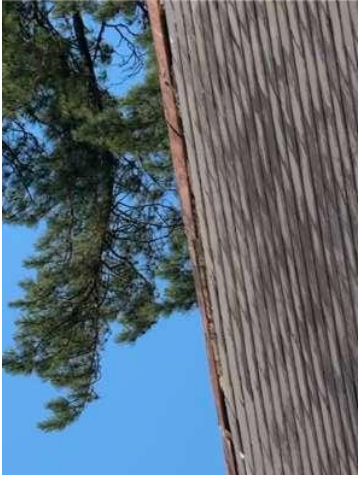
**Roof tiles** – The ridge tiles have gaps in the mortar. As the roof is entirely unlined, and because the internal ceilings have been removed, any gaps under the ridge tiles are directly exposed to the open, gutted rooms below. Consequently, these features are subject to draft, internal light spill, and ongoing acoustic and physical disturbance from the active renovation works.

The slate roof tiles appeared to be well sealed, with no apparent gaps or subsequent access points.

Clay ridge tiles with gaps and well-sealed slate tiles.

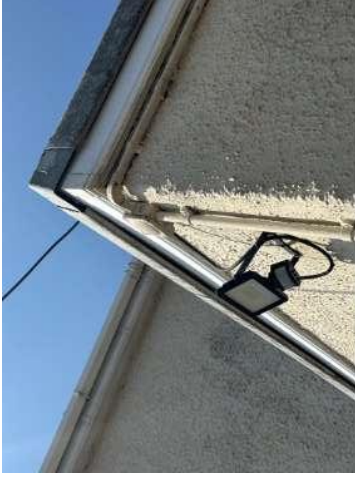
**Eaves** – The eaves consist of a very shallow uPVC soffit box and barge board. These are well sealed and in good condition across the hipped roof. There is some slight lifting on the southeastern corner of the flat roof extension. There is also a slight gap where the flat roof felt is coming away from the barge board. The gap on the flat-roof extension is considered suboptimal given the poor thermal stability of the materials and exposure to drafts and wind wash.

Slight gap under flat roof felt and barge board.

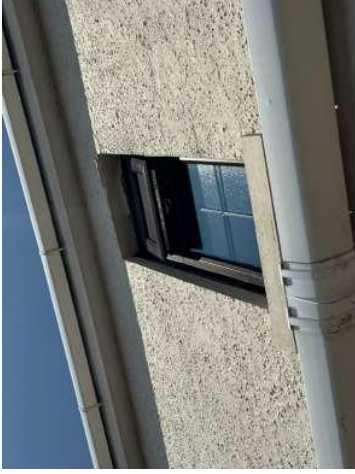
Well-sealed eaves at the hipped roof.

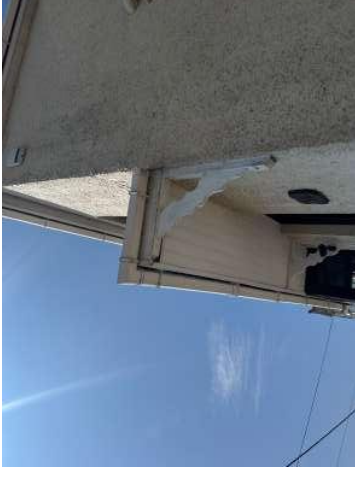
Well-sealed retained soffit box above the porch.

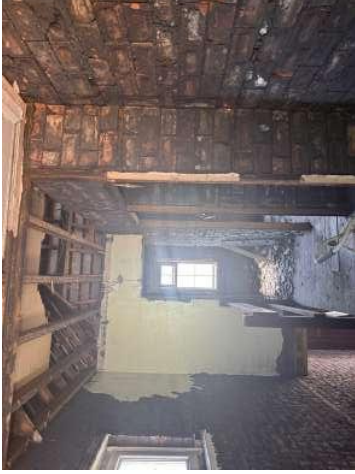
**Walls** – The external walls have pebbledash render in good condition with no gaps or damage. The internal walls have recently been de-plastered, exposing damaged mortar and gaps. These brick and mortar gaps are poorly accessible; whilst access is theoretically possible through the ridge gaps now that the loft space is removed, colonising any new features during the high disturbance of the ongoing renovation works is considered highly unlikely.

Exposed brick walls.

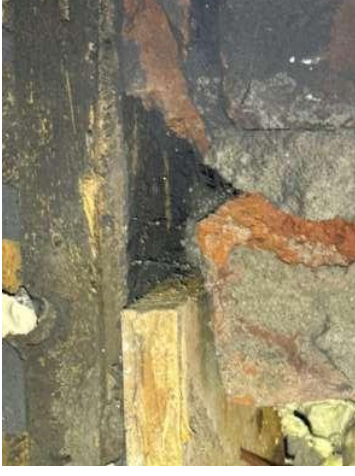
Mortar gap in the newly exposed brick walls.

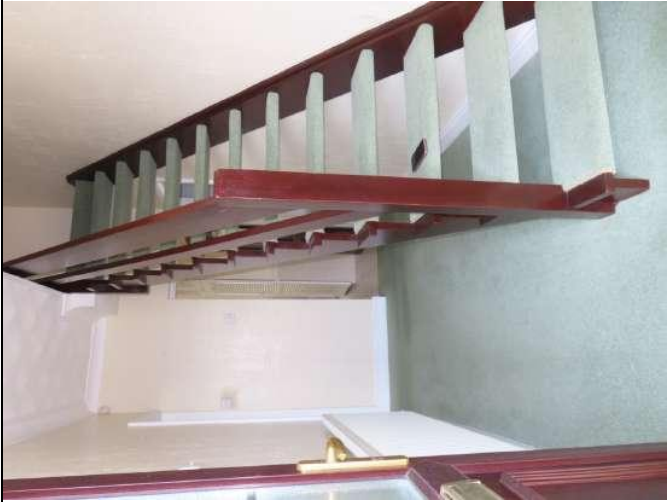
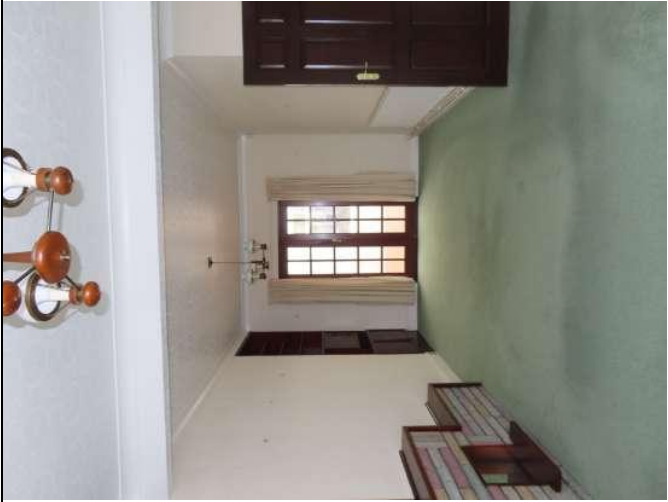
| <p>Photo 1: B1 pre recent renovation works.</p> | <p>Photo 2: B1 pre recent renovation works.</p> |

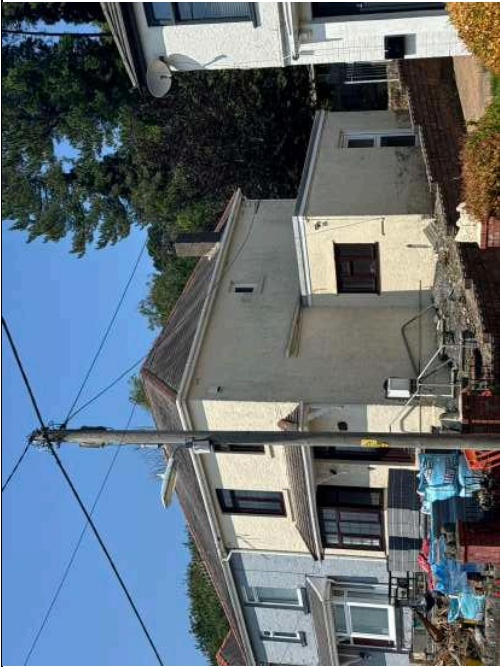
| <p>Photo 3: Southern and eastern elevations of B1.</p> | <p>Photo 4: Northern and eastern elevations of B1. Note the old location of the conservatory.</p> |
