## **FULL BAT SURVEY FOR PRESENCE OF BAT ROOSTS:**

**Graig Madoc, Llanmihangel, Pyle, CF33 6RL**

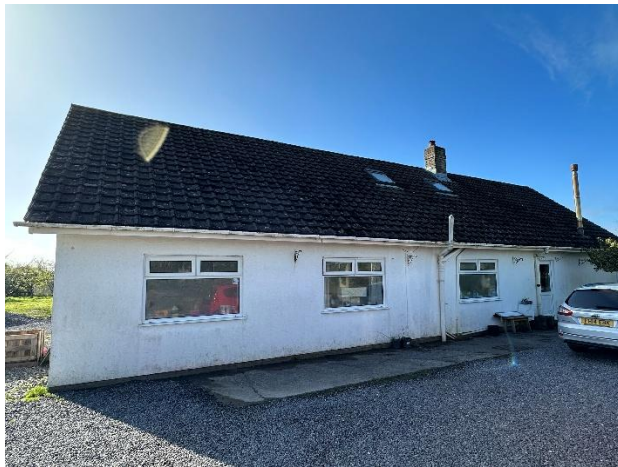
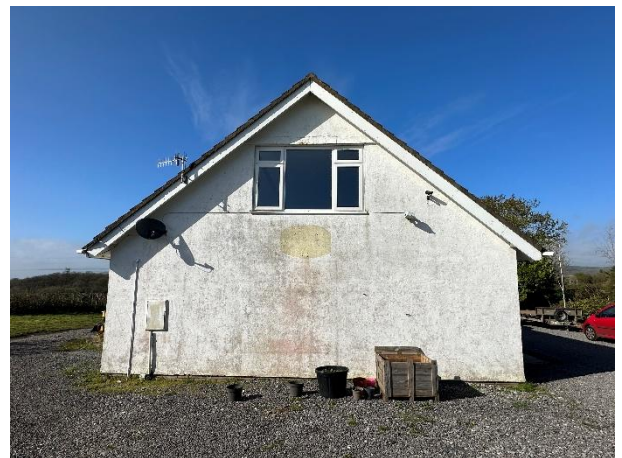
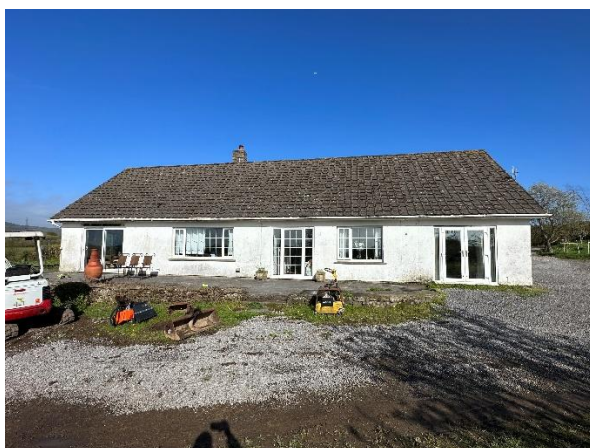
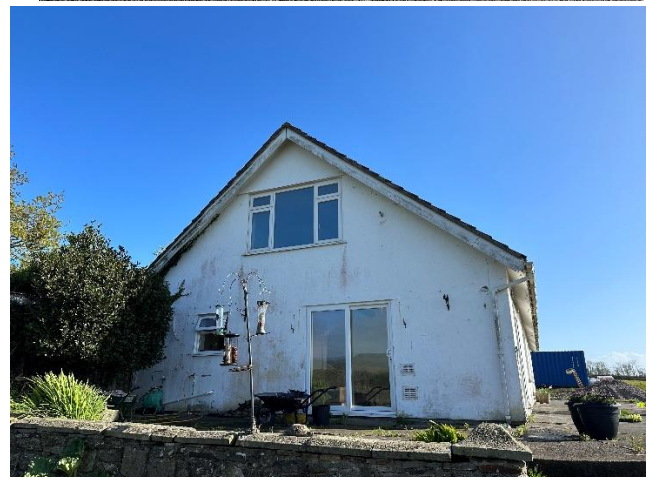
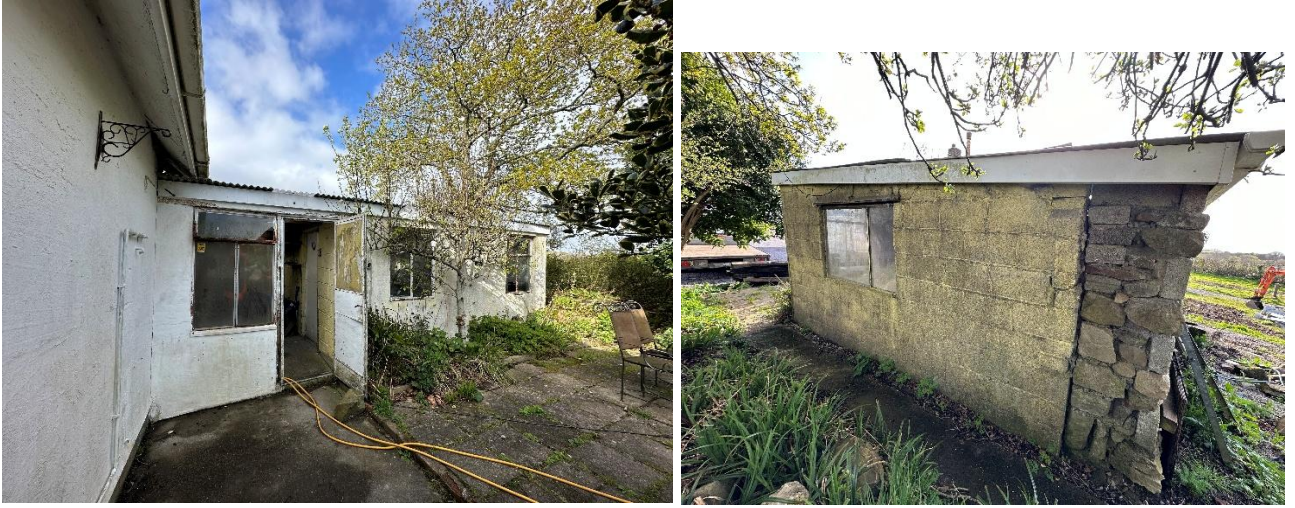
*Figure 1: Pictures of the Exterior of the Property 2026*

The structure is a single 2-storey dwelling within the rural area of Llanmihangel, Pyle. The structure is made of block and stone with cement render, with a single storey stone garage feature adjoined to the north-east section. The main dwelling has a timber-framed roof with tight-fitting interlocking tile covering and black plastic underlay with insulation. The garage feature has a flat roof comprised of corrugated concrete (possibly asbestos) and corrugated plastic sheets. The footprint of the main dwelling is 151sq.m.

1.1.2 The main dwelling structure is water-tight and in a generally sound condition. However the garage structure has multiple gaps and crevices in the exposed masonry, as well as around the roof section. There is some dilapidation around the roof corners of the main dwelling, with associated gaps and crevices. The soffits are tight-fitting with no associated gaps. There is a gap between the barge boards and the roof covering on the gable ends which could potentially provide roosting opportunity for bats.

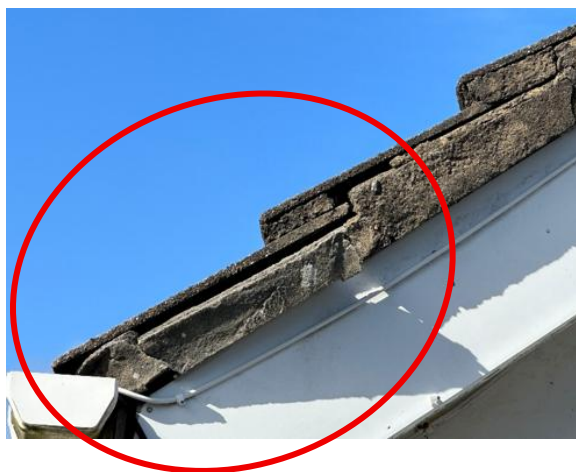
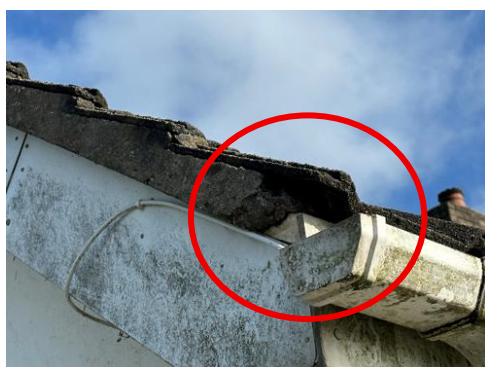
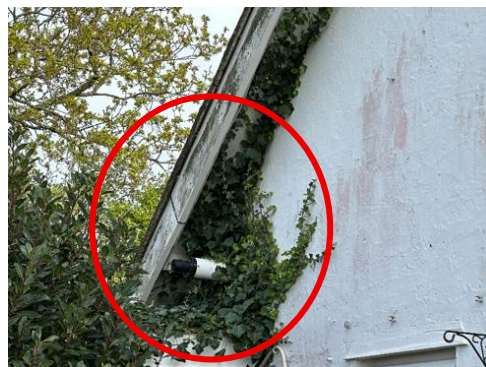
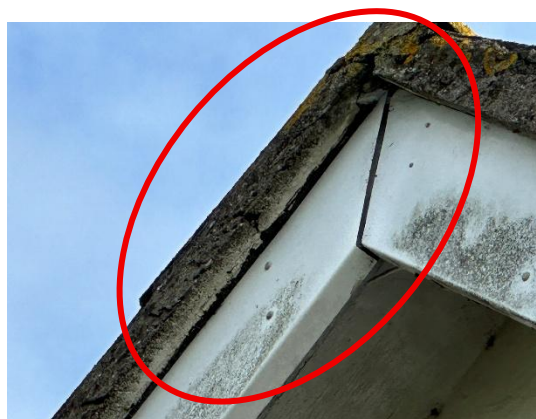
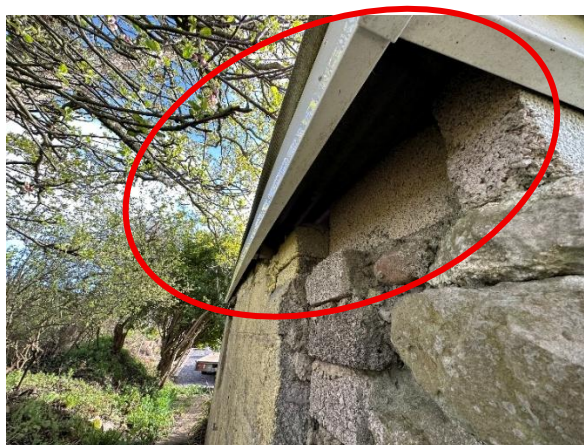
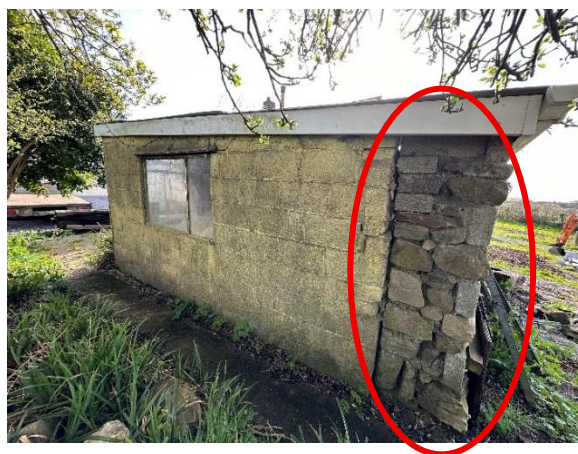
Figure 4: External features

2.3.1. **External Inspection:** The main residential dwelling building is of generally good condition, with no gaps or crevices associated with the masonry. The roof tiles are interlocking and tight-fitting. A small number of gaps are present beneath some of the ridge tiles where the mortar appears to have come away. The soffits are tight-fitting with no associated gaps. However, gaps are present along the top edge of the barge boards on the gable ends in certain sections, where they meet the roof edges. The gaps could potentially provide access to roosting bats. Certain gaps are also present on the roof edges where there is missing mortar beneath the tiles. With the

exception of gaps associated with the ridge tiles, all of these features were able to be investigated with the use of the endoscope and no evidence of roosting bats was found, including any droppings, staining or feeding remains.

- 2.3.2. The adjoining single-storey garage feature is of stone construction and generally in a more dilapidated condition than the main structure, with exposed masonry and numerous gaps and cavities associated with missing mortar. Numerous caps and cavities were also present along the flat roof edges. This includes gaps and cavities beneath the uPVC fascia boards, between the boards and the wall / masonry. All such features have potential for roosting bats and were able to be thoroughly searched using the endoscope and lamp. No evidence of roosting bats was found.

- 2.3.2. A dense covering of ivy is present on the north-east corner, where the main dwelling adjoins the garage feature, which could provide opportunities for roosting bats. This was able to be thoroughly investigated with no evidence found.

- 2.3.3. **No bats or their field signs were found in or around any of the potential roosting features identified.**
- 2.3.4. The property is located within highly suitable surrounding habitat which has high potential for a number of bats species. The location has very good ecological connectivity to the wider landscape via the surrounding fields, hedgerows and green lanes, and the property contains a number of features known to be used by roosting bats. The structure contains a number of discrete crevice features capable of supporting individual bats, despite otherwise being of relatively modern and well-sealed construction. The structure should therefore be deemed to have **moderate suitability** for roosting bats, as assessed according to the BCT bat survey guidelines (4<sup>th</sup> edition 2022).

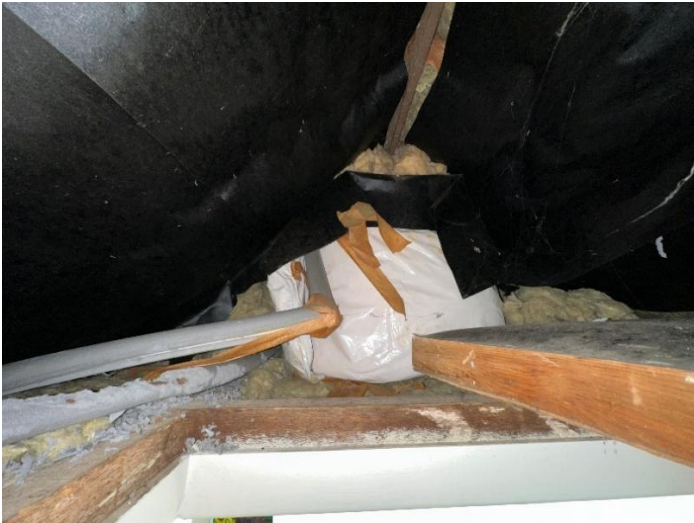
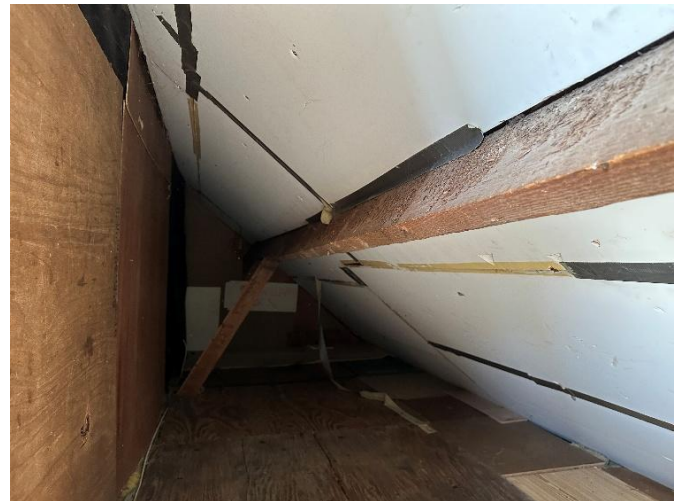
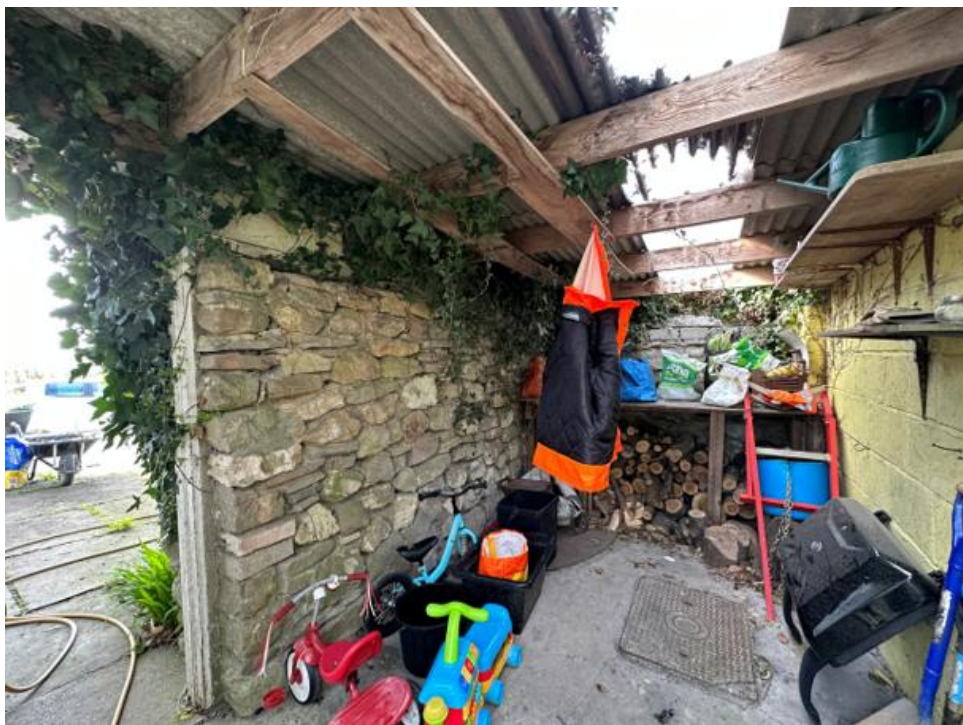
Figure 5: Internal Images

**2.4 Internal inspection:** The main dwelling is 2 storeys, with the 2<sup>nd</sup> storey built into the roof section, leaving only a small roof void along the ridge. This was not fully accessible due to the prohibitive size, but certain sections could be investigated via 3 access hatches. The eaves sections along the edges have been boxed in as storage cupboards and were fully accessible for inspection. From those inspections that were possible of the roof void along the ridge, it was observed that insulation was present throughout, backed with a plastic membrane. There was no visible light-bleed into the void which can be suggestive of potential access points. No droppings, staining, feeding remains or other evidence of roosting bats was found.

The interior of the garage feature is in regular use and functions as storage space for children's bikes, cut logs and garden equipment. The flat roof forms the ceiling and there is no roof cavity. There are potential access points to the interior via gaps along the roof edges and via the open doorway. There is exposed masonry internally as well as externally, with numerous associated gaps which could potentially provide opportunities for roosting bats, although this is less likely within a ground floor structure in regular use.

- 2.4.1. **All accessible areas of the interior were thoroughly searched for bats (alive / dead), droppings, staining, feeding remains and other evidence of roosting bats, with no such evidence found.**

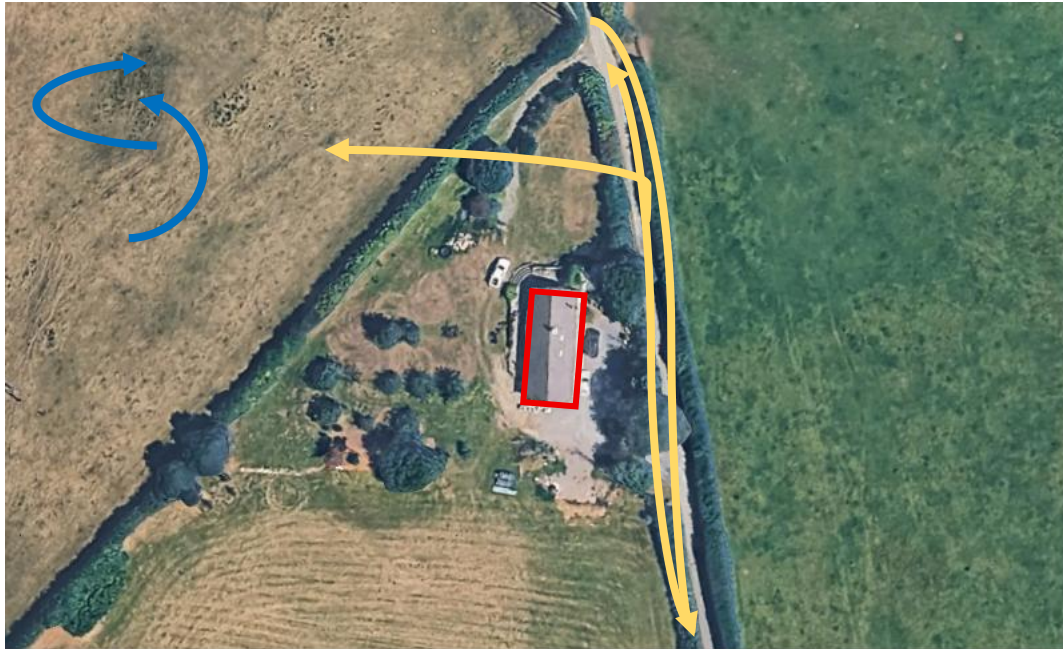
Figure 6: Observed bat flight paths (Noctule bat = blue, Common pipistrelle = yellow)

3.4.8 No bats were noted emerging from any of the structures within the property boundary at any point during the survey.

3.4.11 Surveyor positions and observed flight paths of Common pipistrelle bats:
