## Survey For Bats

**Survey Address:** 67 Gelligron Road, Pontardawe, Swansea SA8  
4NP

## **Executive Summary**

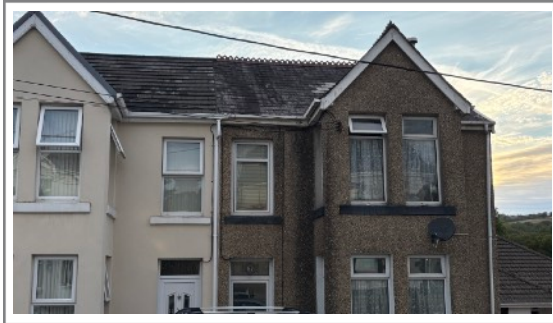
**Photo 1:** East facing elevations (front)

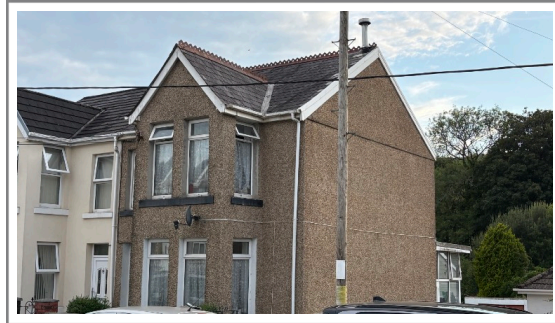
**Photo 2:** East/North facing elevations

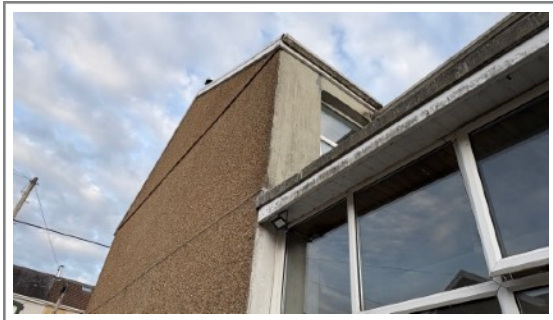
**Photo 3:** North facing elevations (detail)

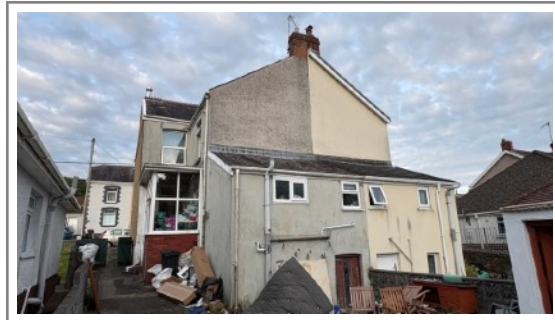
**Photo 4:** West facing elevations (rear)

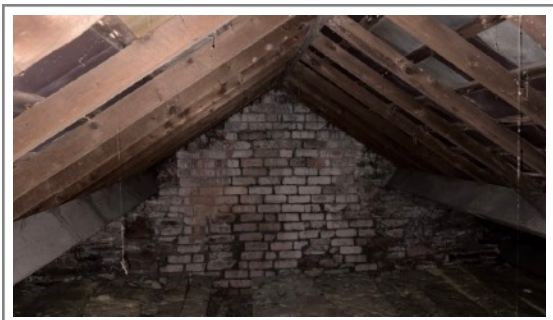
**Photo 5:** Typical view in the unlined roof void

The property is assessed as having low potential for bat use due to the general lack of features present in the fabric of property that could be deemed suitable for bats to use for in season roosting or forming winter hibernacula. The roof void is unlined therefore denying any crevice dwelling bats any roof tile/felt spaces to roost in. The general level of bat activity was low and the busy road immediately adjacent to the property could certainly be perceived as a discouragement to commuting bats, hence the low number of passing bats.

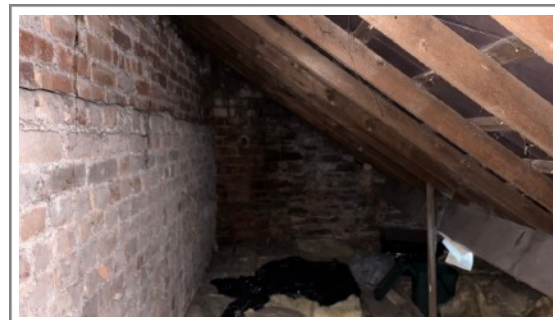
**Photo 6:** General view of the roof void area looking north

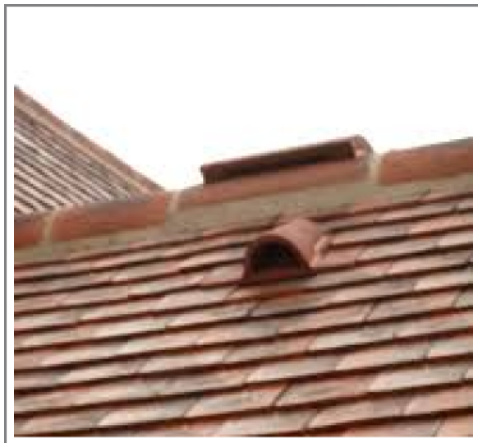
**iv) Bat Ridge and Roof Tiles**

These can be incorporated at various locations on all roof ridges and faces. There are numerous types on the market and the ones most sympathetic to the proposed design may be used.

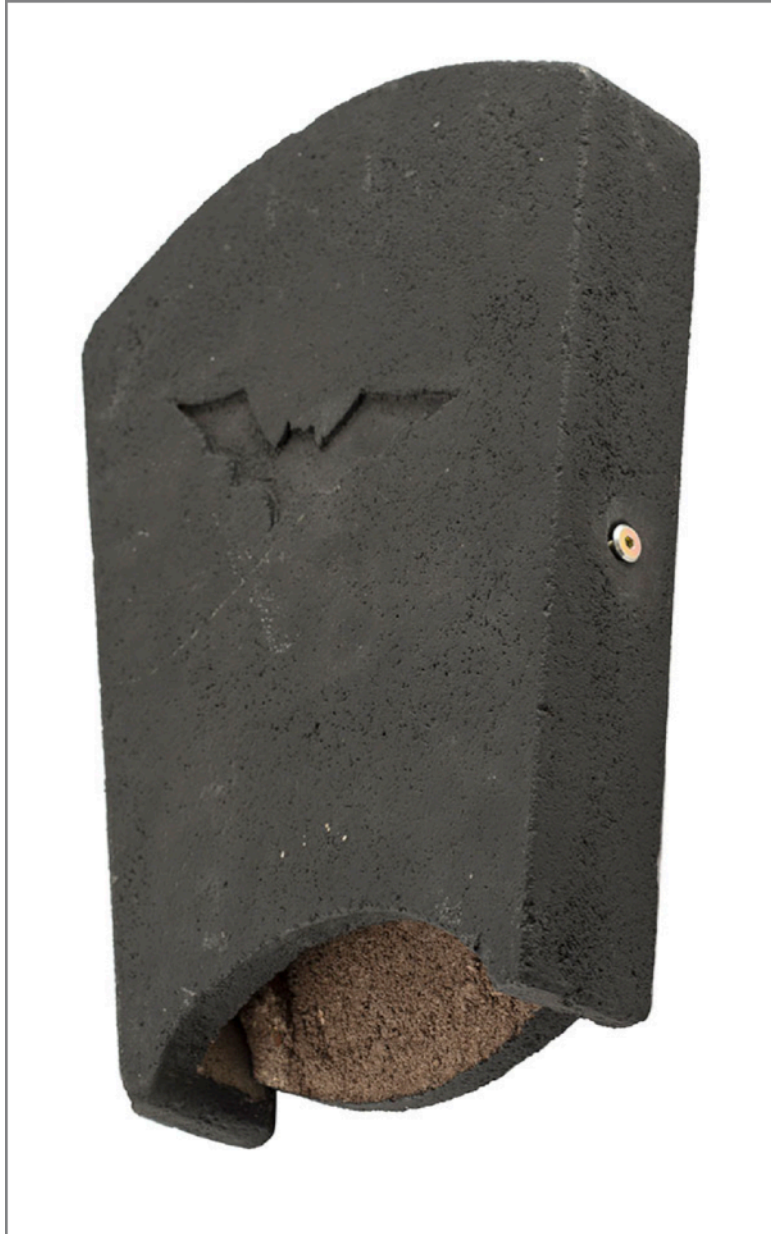
#### vi) **Bat Box Example**

Bat boxes can provide encouragement for bat use at the site. A typical type is presented below but there are many variations on the market.

“The attractive design of this bat box is suitable for crevice roosting bats and has a rough interior to provide lots of grip. Bats need to increase their body temperature before flight so prefer warm roosting spots, which is why many of our bat boxes have a black exterior to absorb heat from the sun. WoodStone isn’t just strong, it also has good thermal insulation, reducing temperature fluctuations inside the box and helping to make this an ideal roost site”<sup>2</sup>.

The Beaumaris Bat Box is made from 100% WoodStone which is very durable so this product has a 10 year warranty.

A bat box placed at the apex of the main south facing gable end above the entrance porch would be the most suitable location as an enhancement measure.
