## **Phillips and Son Roofing, Neath Proposed Commercial Development Contamination Assessment**

Report Reference: ESP.9766.4630

## Phillips and Son Roofing, Neath Proposed Commercial Development Contamination Assessment

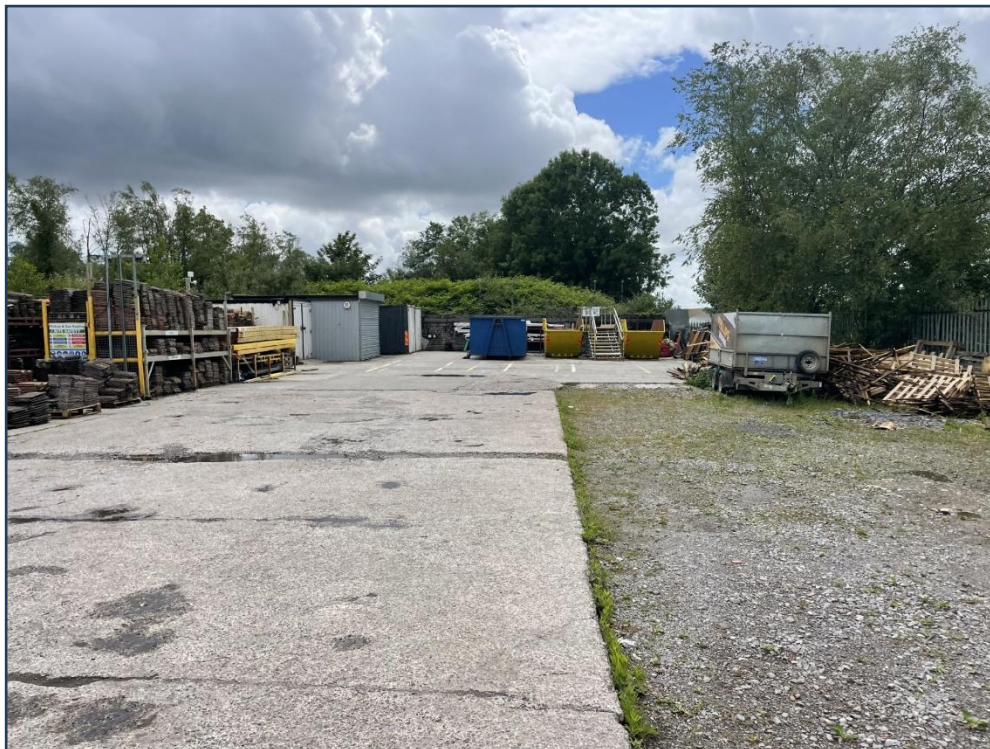
*Insert 2 – Area used to store roofing materials, small storage buildings, and waste management. View towards the southwest.*

To the east of the site, outdoor shelf storage of roofing material was present. Pile of wooden pallets, scrap wood, corrugated metal and plastic piping are observed in piles on a grassed area to the southwest of site.

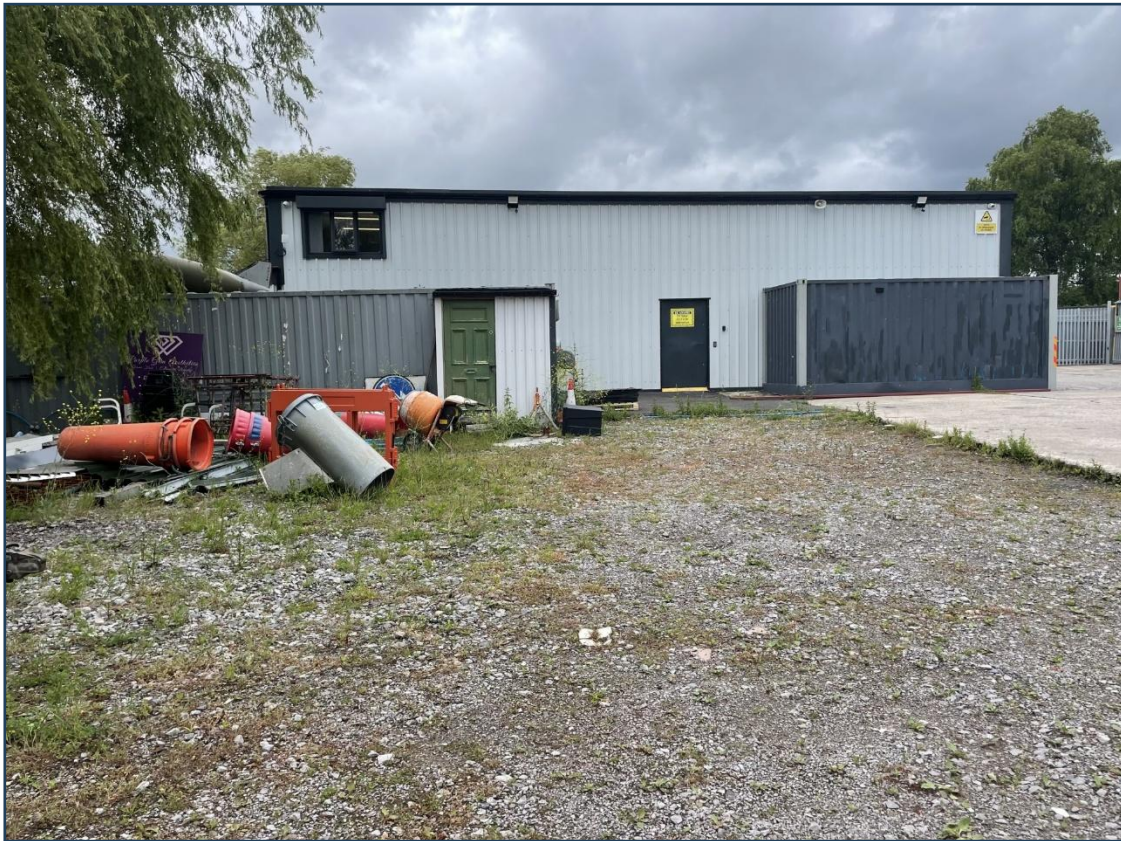
*Insert 3 – Side of warehouse. View to the northeast.*

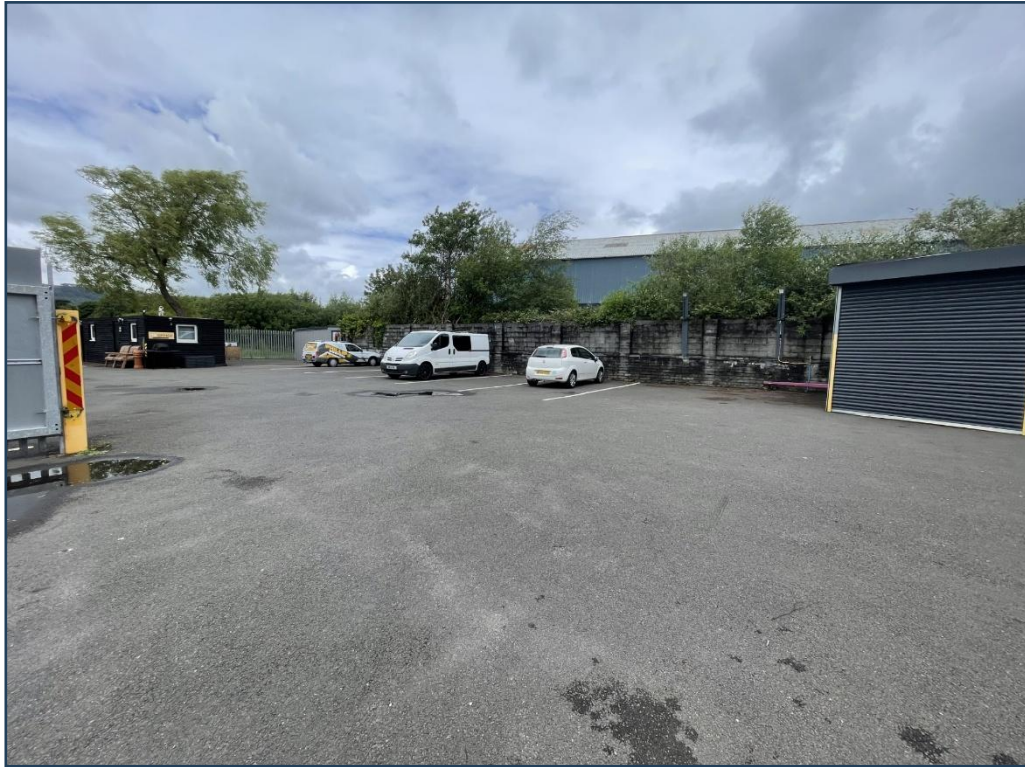
*Insert 4 – Tarmacked car park. View to the northwest.*
