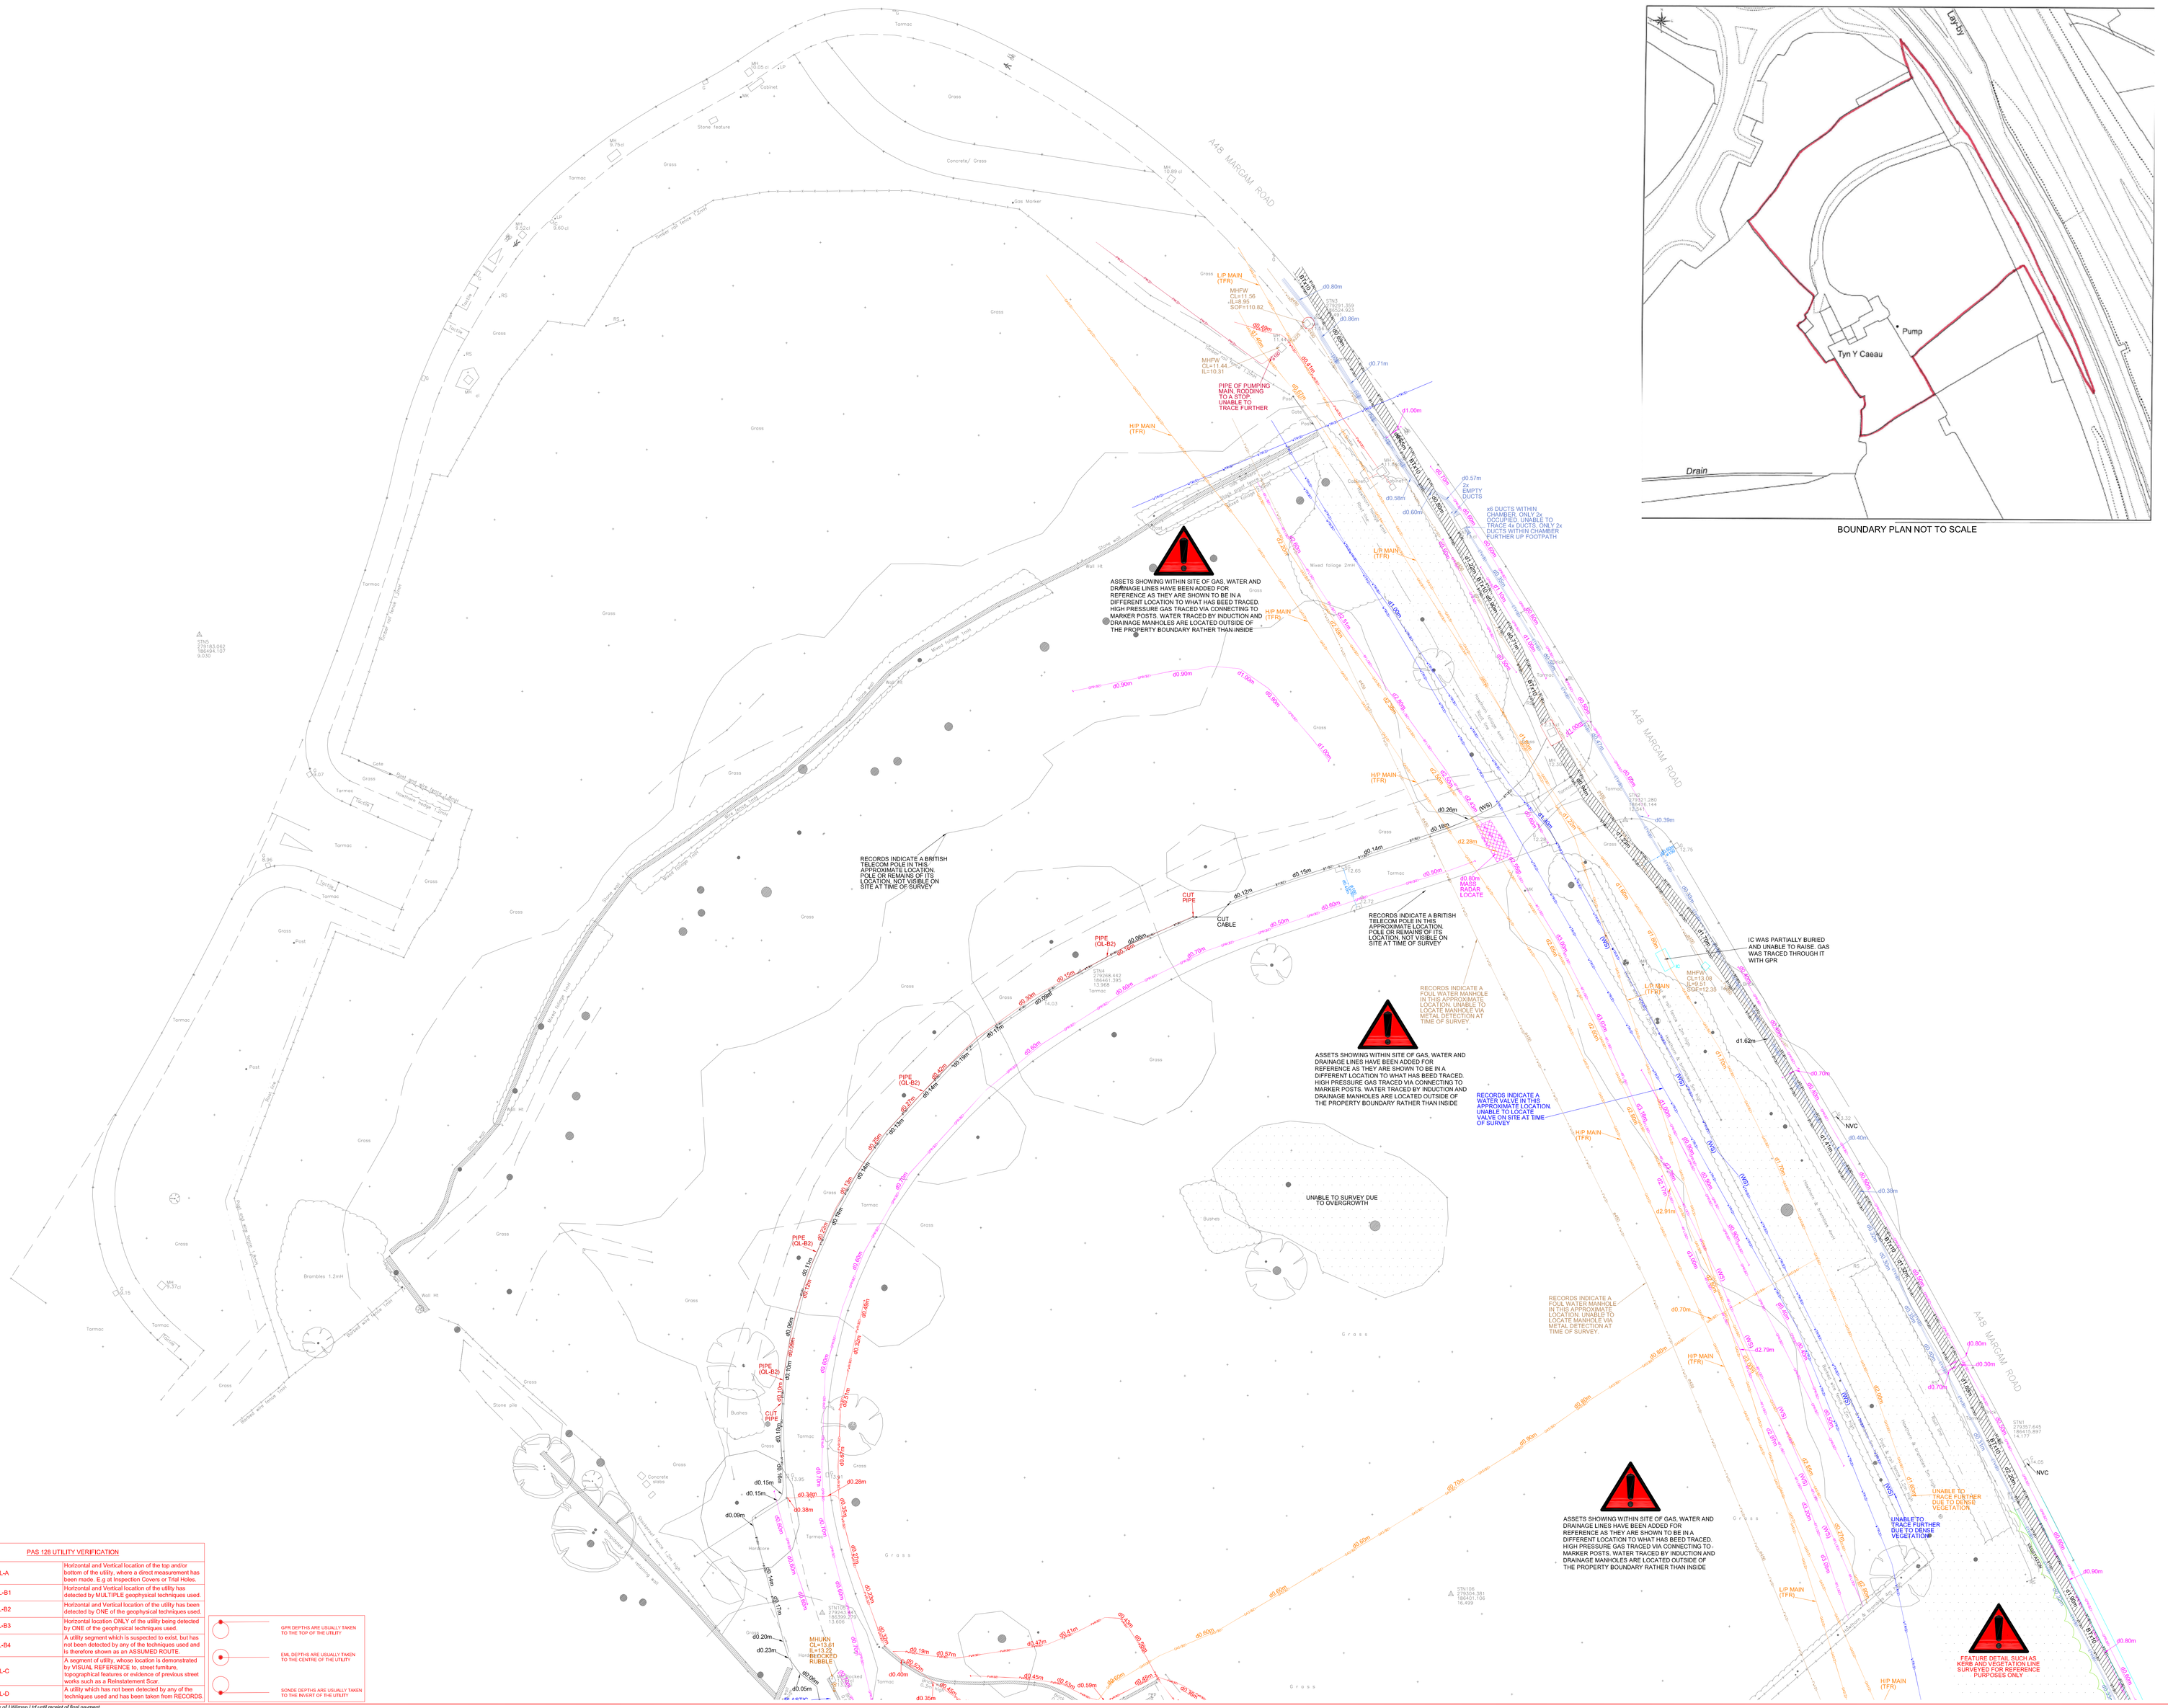
A48 MARGAM ROAD
ASSETS SHOWING WITHIN SITE OF GAS, WATER AND DRAINAGE LINES HAVE BEEN ADDED FOR REFERENCE AS THEY ARE SHOWN TO BE IN A DIFFERENT LOCATION TO WHAT HAS BEED TRACED. HIGH PRESSURE GAS TRACED VIA CONNECTING TO MARKER POSTS. WATER TRACED BY INDUCTION AND DRAINAGE MANHOLES ARE LOCATED OUTSIDE OF THE PROPERTY BOUNDARY RATHER THAN INSIDE
RECORDS INDICATE A BRITISH TELECOM POLE IN APPROXIMATE LOCATION. POLE OR REMAINS OF ITS LOCATION, NOT VISIBLE ON SITE AT TIME OF SURVEY
RECORDS INDICATE A FOUL WATER MANHOLE IN THIS APPROXIMATE LOCATION. UNABLE TO LOCATE MANHOLE VIA METAL DETECTION AT TIME OF SURVEY
RECORDS INDICATE A WATER VALVE IN THIS APPROXIMATE LOCATION. UNABLE TO LOCATE VALVE ON SITE AT TIME OF SURVEY
UNABLE TO SURVEY DUE TO OVERGROWTH
IC WAS PARTIALLY BURIED AND UNABLE TO RAISE. GAS WAS TRACED THROUGH IT WITH GPR
PIPE OF PUMPING MAIN ROODING TO A FIELD. UNABLE TO TRACE FURTHER

#8 DUCTS WITHIN CHAMBER. ONLY 2X OCCUPIED. UNABLE TO TRACE 4X DUCTS. ONLY 2x DUCTS WITHIN CHAMBER FURTHER UP FOOTPATH
UNABLE TO TRACE FURTHER DUE TO DENSE VEGETATION
FEATURE DETAIL SUCH AS KERB AND VEGETATION LINE SURVEYED FOR REFERENCE PURPOSES ONLY
MYLAN CL=11.01 IL=13.72 BLOCKED RUBBLE
Pump
Tyn Y Caeau
Drain
Lane
Gate
Stone Feature
Cabinet
Concrete/ Grass
Gas Marker
Stone pile
Bushes
Brambles 1.2mtrs
Mixed foliage 2mtrs
Hedge
Wall
Fence
Post
Gully
Manhole
Inspection Chamber
Tarmac
Grass
Concrete
Gravel
Soil
Rough cast block 1.0mtr
Rough cast block 1.5mtr
Rough cast block 2.0mtr
Rough cast block 2.5mtr
Rough cast block 3.0mtr
Rough cast block 3.5mtr
Rough cast block 4.0mtr
Rough cast block 4.5mtr
Rough cast block 5.0mtr
Rough cast block 5.5mtr
Rough cast block
