Report No	Date
25056/R1	September 2025
Project	
CWMAVON – REMEDIATION VERIFICATION REPORT	
Client	
TRJ

Project:
CWMAVON – REMEDIATION VERIFICATION REPORT

The work described in this report represents validation and verification of the required remediation, within that report, comprising a CS2 Gas Barrier System to the building, verification of the Cover System and bedding to drinking water pipes.

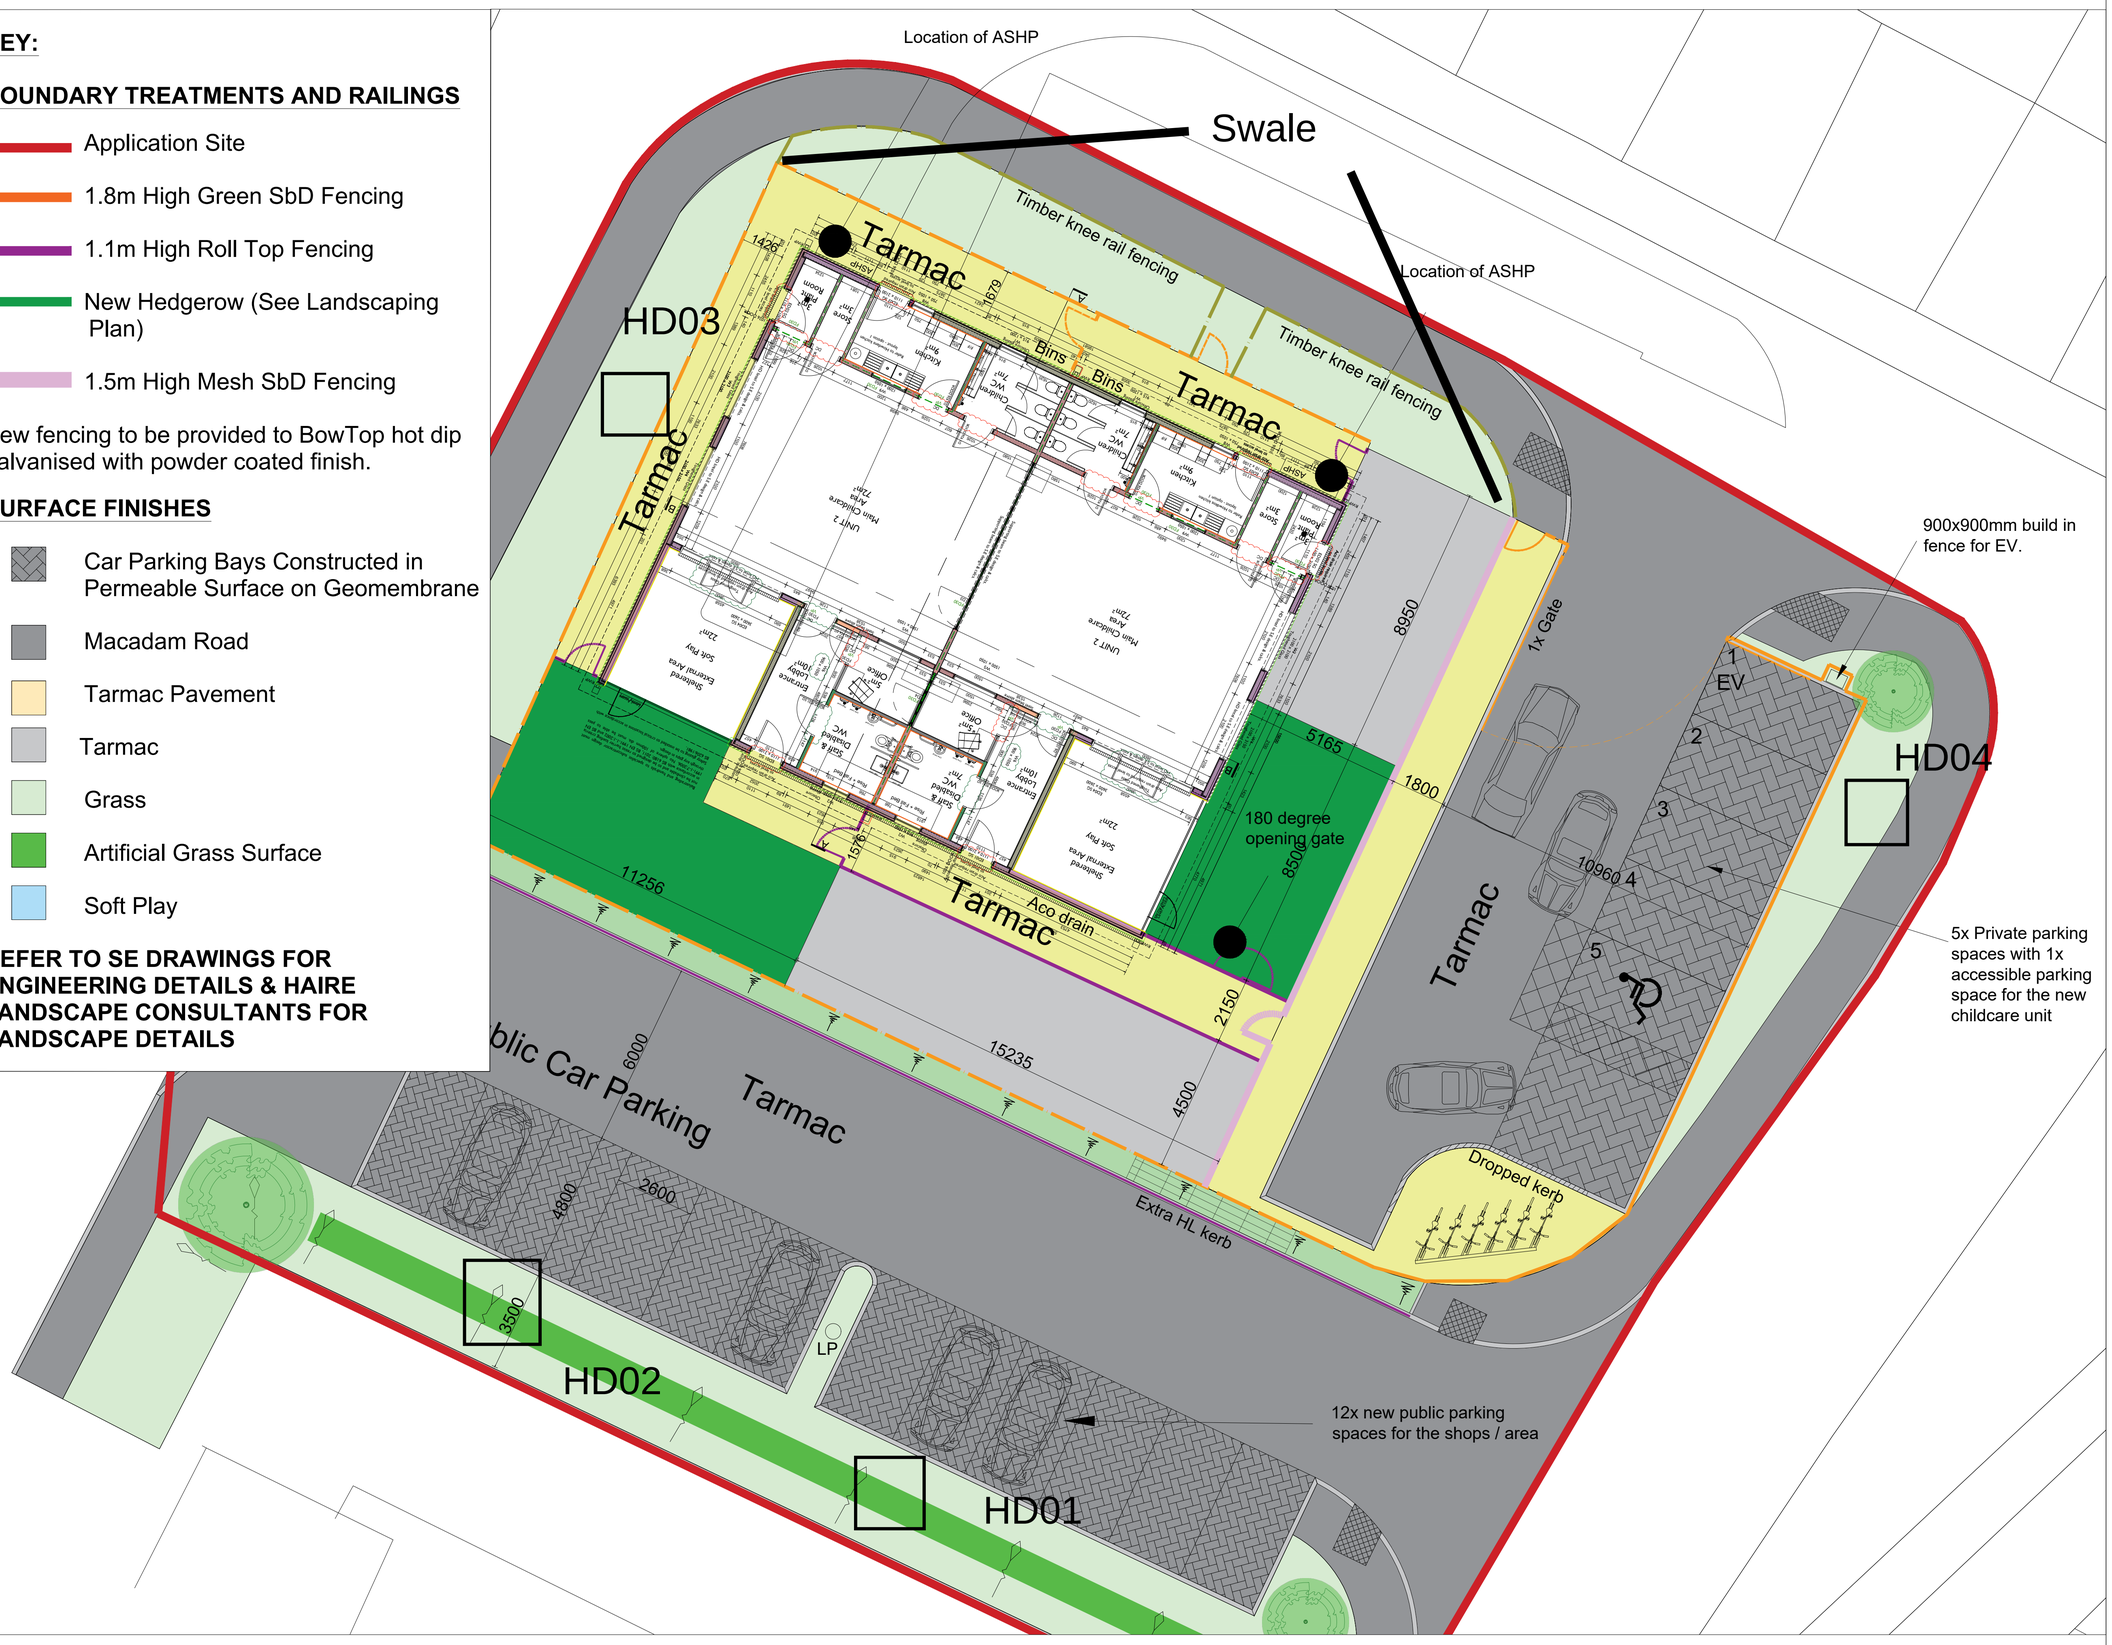
Hand Dug Pit Locations

Hand dug pits were undertaken to the no dig barrier and samples taken for laboratory analysis in accordance with the Remediation Strategy.

Hand dug trial pits noted there to be nominally 600mm of inert imported soils in the soft landscaped areas, which were found to comply with the chemical limits required in the Remediation Strategy. A no dig barrier was identified. It is noted that the play areas within the fenced boundary are all artificial, with no chance of contact with any site soils.

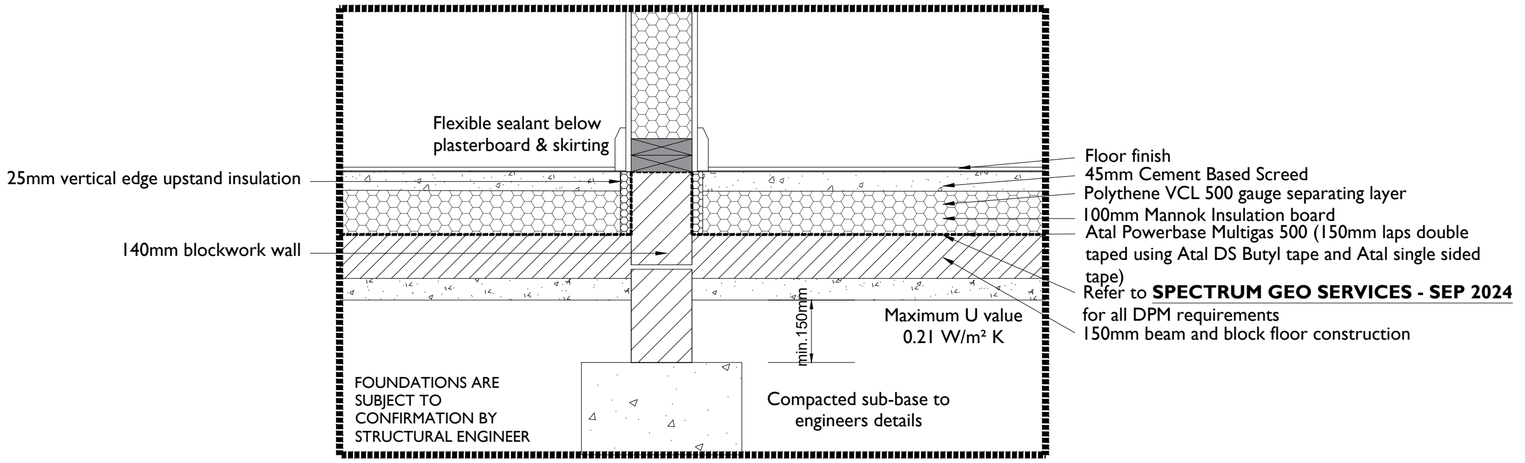
Gas Barrier Installation Photographs

Photographic evidence of the installation is appended.

The gas membrane was included in the appended substructure design and installed in accordance with that design.

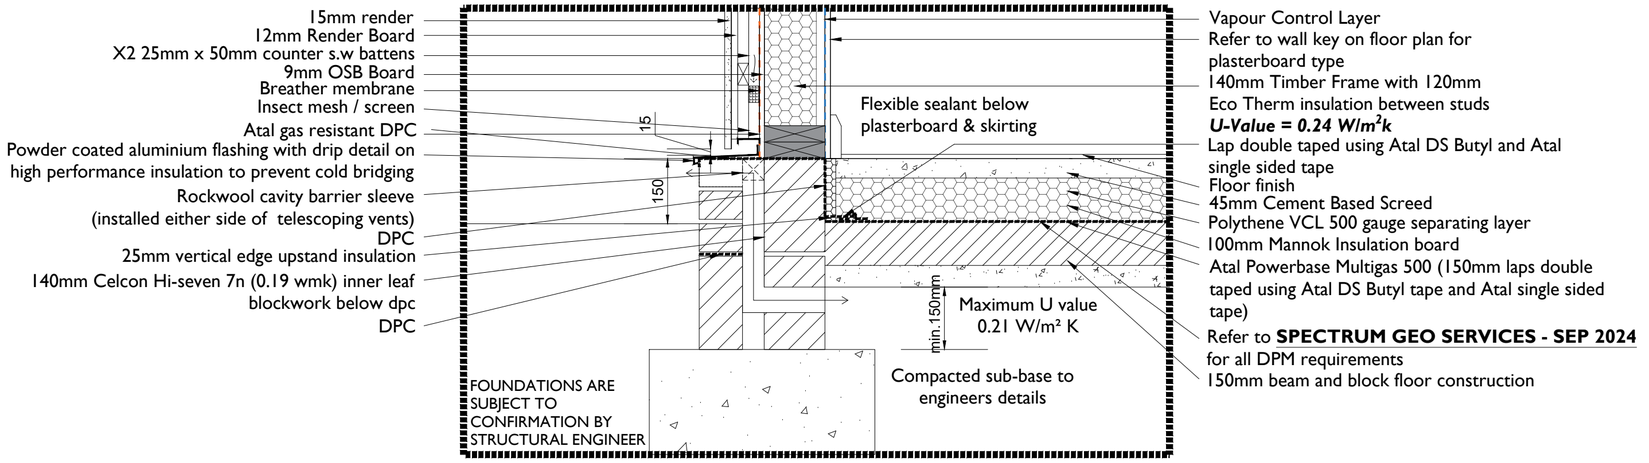
Design Details

Due to the CS2 classification within the remediation strategy and Risk Assessments, a suitable gas barrier system was included within the structural design.
