## **8 Wind Street, Neath**

Proposed Office Refurbishment

Structural Condition survey

*June 2019*

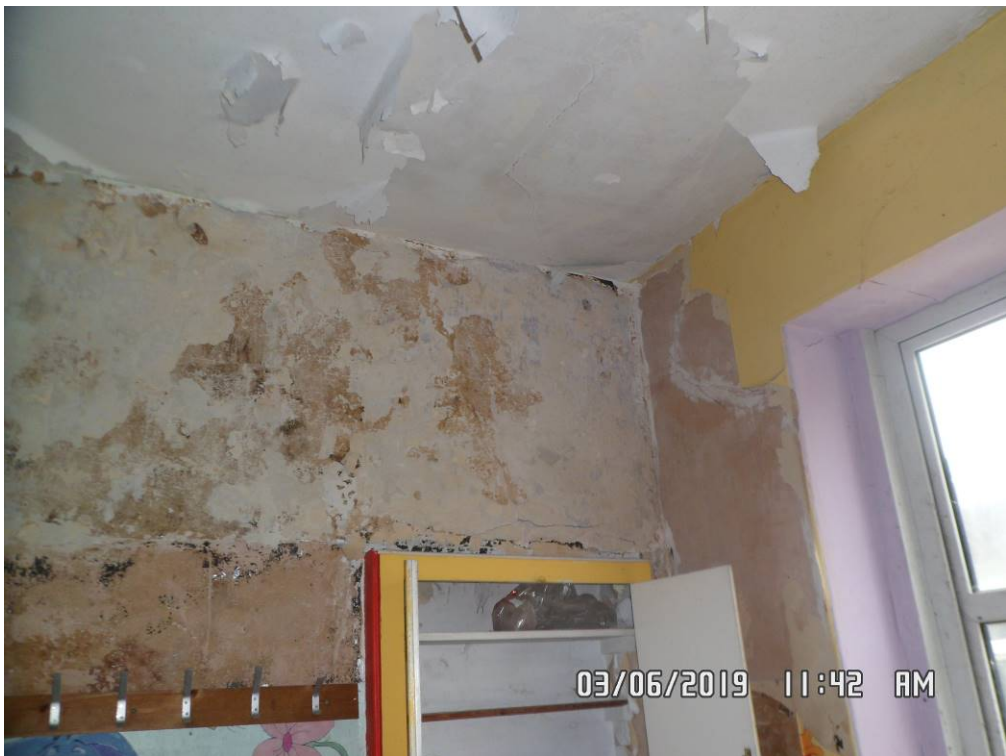
Photograph 7

There are also substantial cracks in the walls of the 2 storey annex and lean-to link into the demountable building (refer to photograph 2). These also manifest themselves internally where there is evidence of water ingress and damp causing damage to the plasterwork (refer to photograph 7)

- The cracking in the lean-to and office wall at high level appears to have been filled internally and the crack looks as if it has opened up since. Without having the benefit of hindsight or evidence of monitoring over the last 10 years it is difficult to assess whether this is an ongoing issue. Either way there is clearly a structural defect that carries inherent risks if this element were to be retained as part of any future development. Given the unknown cause for this cracking it may be worth considering investigating the foundations/ground conditions with the potential need for underpinning or even re-building.
